# Annual Environmental Management Report

Clyde Transfer Terminal

March 2017

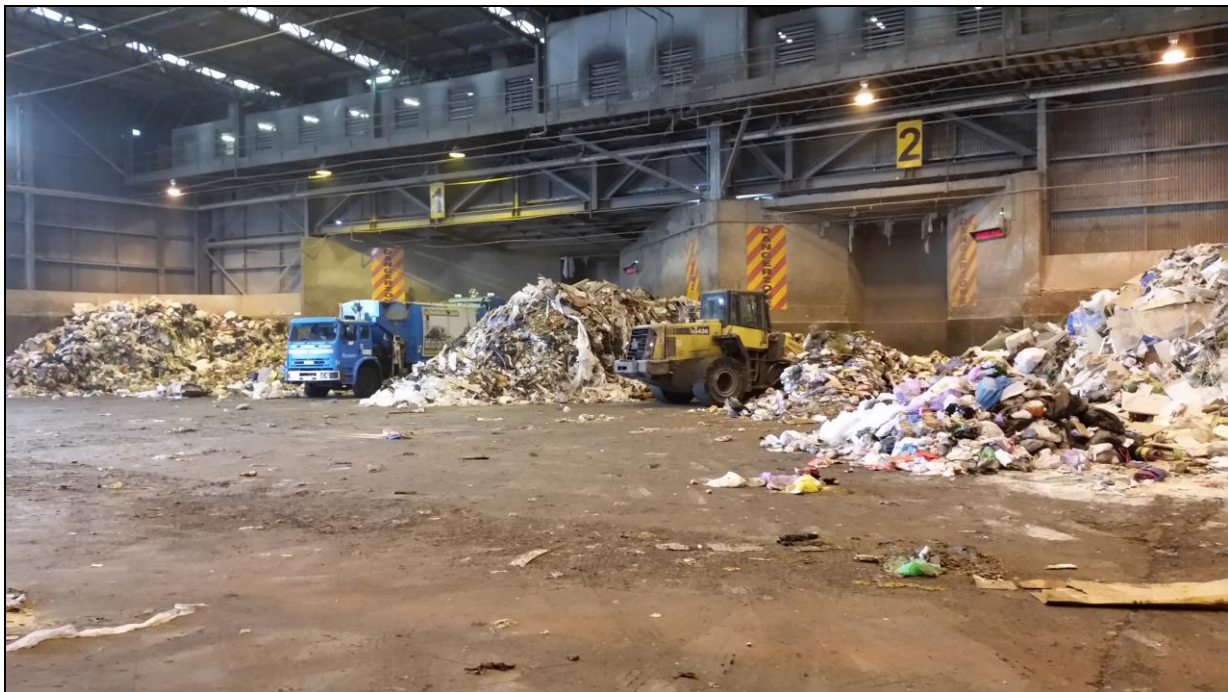
During the Odour Audit visit on 18 May 2016, there was approximately 350-400 tonnes of waste on the floor, according to the Site personnel. This tonnage is considered to be within the normal operational range of the Transfer Terminal Building (TTB). The TTB floor area not covered by waste material was observed to be reasonably clean, with little evidence of leachate or aged material. General housekeeping procedures of the TTB were good, as observed during several truck-unloading sequences. It was also observed that the Site's front-end loaders cleared the floor area of waste on a regular basis, minimising the exposed area of waste.

As with previous audits, and consistent with TOU's experience at other waste transfer stations, there was a weak to distinct level of odour observed within the TTB. A photo of the waste on the floor as found during the Odour Audit visit is shown in **Photo 2.1**.

**Photo 2.1** – Waste on-floor as found on 18 May 2016

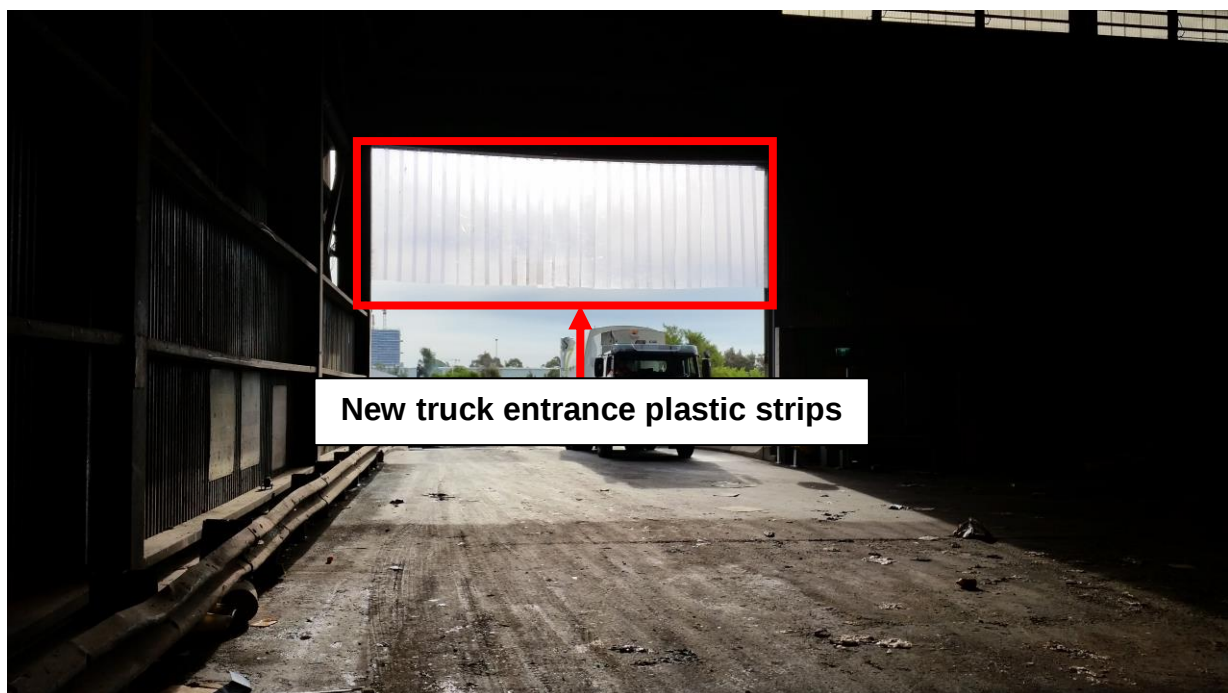
The truck entrance plastic strips of the TTB, used to reduce odour escaping through the opening, were now found to be fully replaced with new and much more robust strips (see **Photo 2.2**). The Odour Audit finds this to be a good outcome.

**Photo 2.2** – New truck entrance plastic strips as found on 18 May 2016

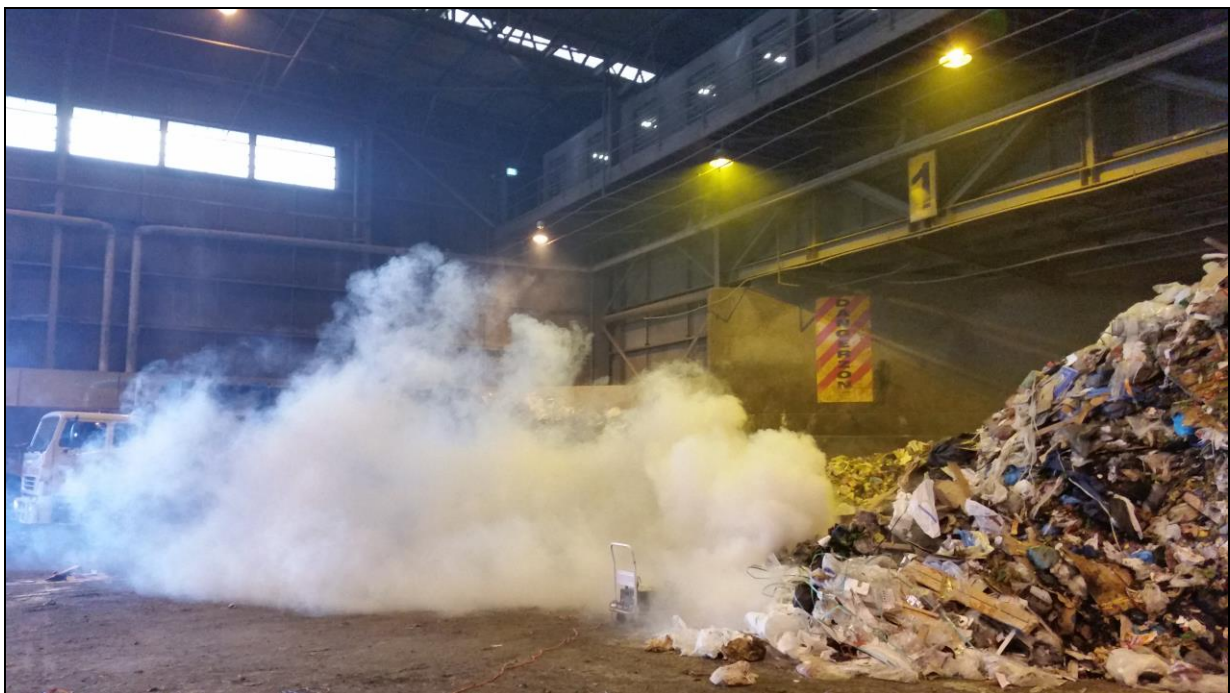
**Photo 2.3** – Smoke testing within the TTB on 18 May 2016

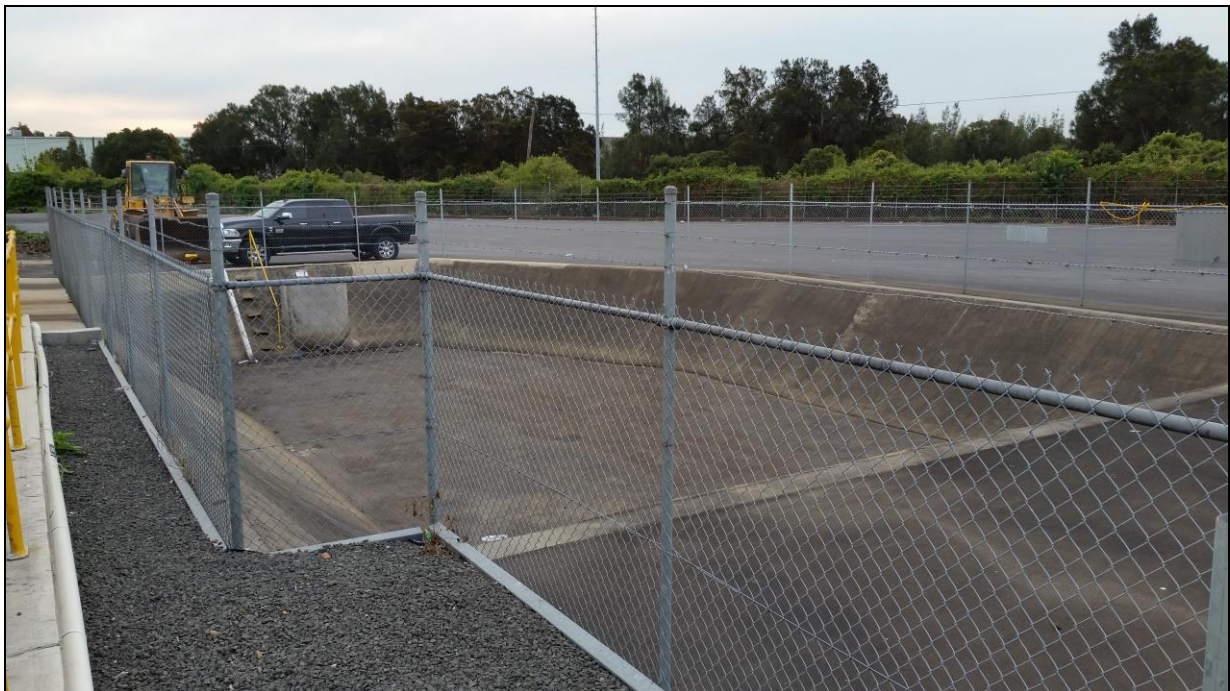
The auditor observed that there was no effluent in this pond at the time this Odour Audit was carried out. Moreover, there was no odour detectable during the Odour Audit visit that could be linked directly back to the stormwater retention pond. **Photo 2.4** shows the state of the pond on 18 May 2016.

**Photo 2.4** – Stormwater retention pond as found on 18 May 2016

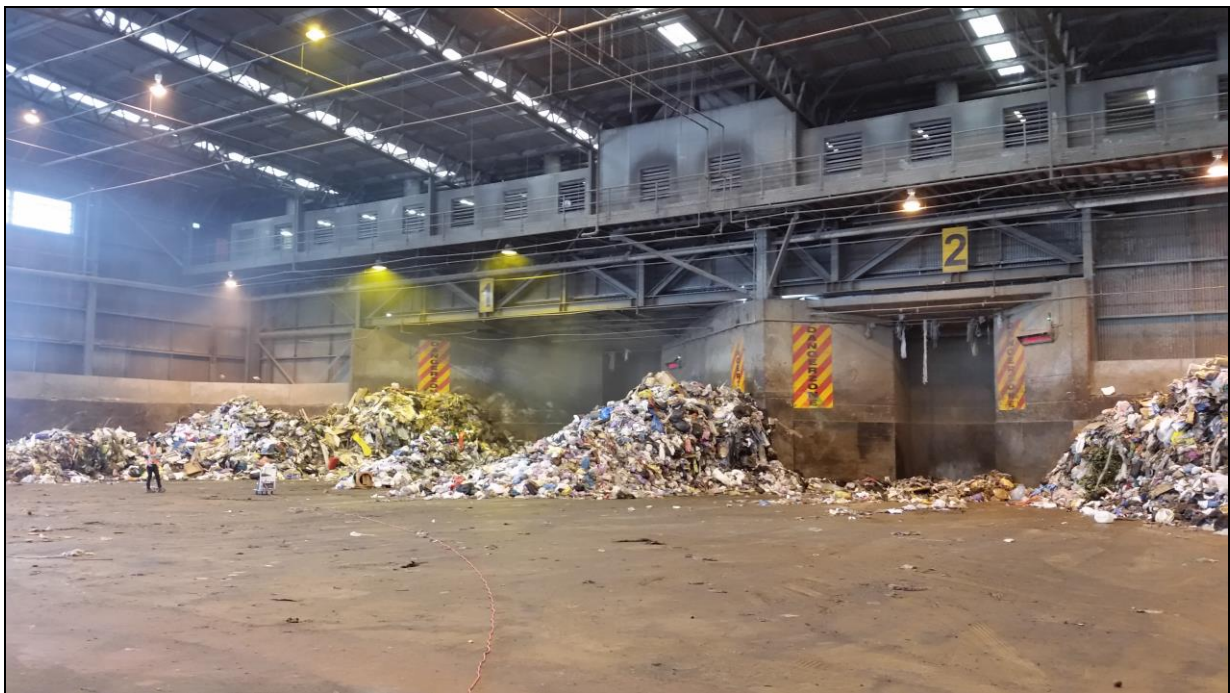
During the Odour Audit visit on 9 November 2016, there was approximately 250 to 350 tonnes of waste on the floor, according to the Site personnel. This tonnage is considered to be within the normal operational range of the Transfer Terminal Building (TTB). The TTB floor area not covered by waste material was observed to be reasonably clean, with little evidence of leachate or aged material. General housekeeping procedures of the TTB were good, as observed during several truck-unloading sequences. It was also observed that the Site's front-end loaders cleared the floor area of waste on a regular basis, minimising the exposed area of waste.

As with previous audits, and consistent with TOU's experience at other waste transfer stations, there was a weak to distinct level of odour observed within the TTB. A photo of the waste on the floor as found during the Odour Audit visit is shown in **Photo 2.1**.

**Photo 2.1** – Waste on-floor as found on 9 November 2016

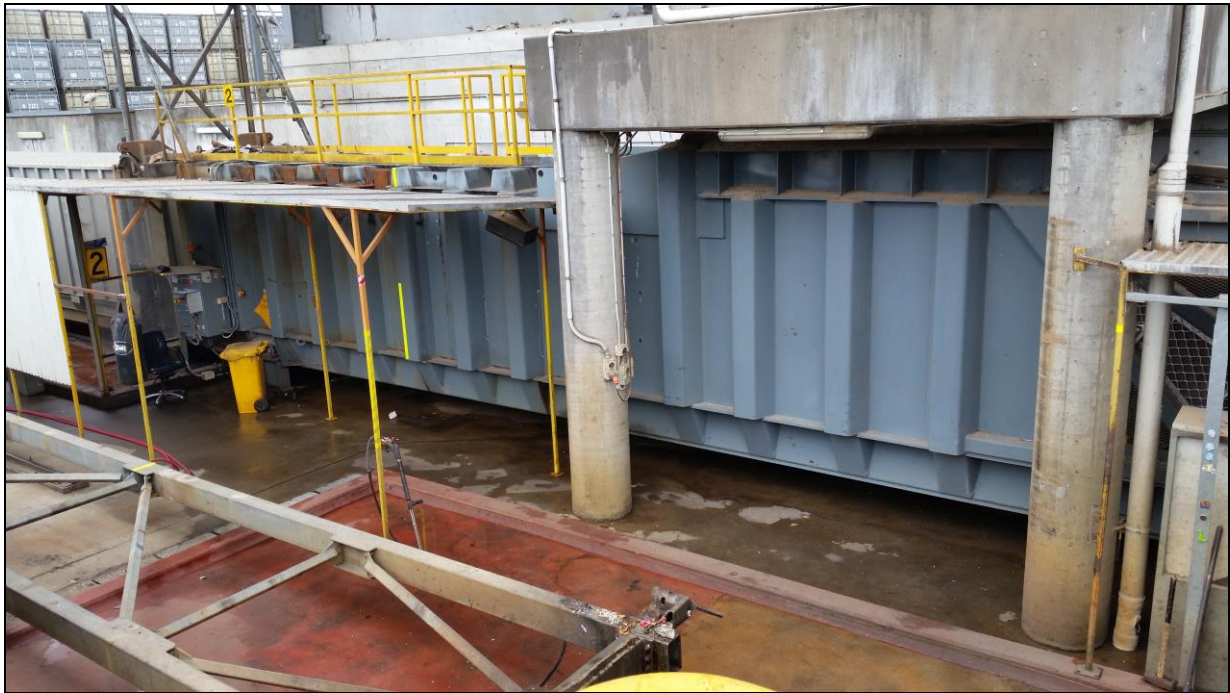
The container packing area and site roadways were found to be clean and well managed with no evidence of waste or exposed leachate. Similar to previous Odour Audits, the container compacting/train packing area had a weak to distinct odour that was intermittently detectable but was confined to this area only (see **Appendix C** for

Field Ambient Odour Assessment Survey results). Both compactors were operating at the time of the Odour Audit visit. The general house-keeping around this area was observed to be of high quality, with no evidence to suggest otherwise. The condition of the compactor area as found on 9 November 2016 is shown in **Photo 2.2**. As with previous Odour Audits, the containers are cleaned off-site at Veolia's Woodlawn Bioreactor Facility before being returned to the Site. The weight of each container is monitored to determine if there is any waste that has not been removed completely from each container, which in turn reduces the likelihood of the containers contributing to the Site's odour levels.

**Photo 2.2 – Compactor area as found on 9 November 2016**

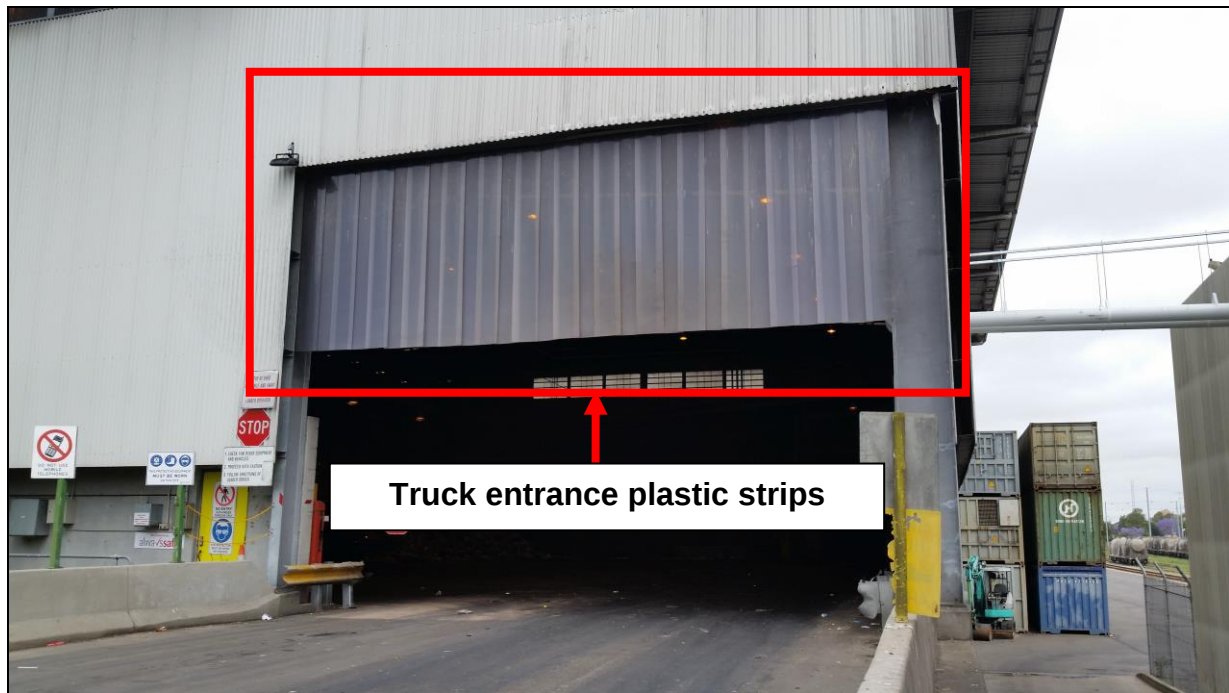
The truck entrance plastic strips of the TTB, used to reduce odour escaping through the opening, were now found to be fully replaced with new and much more robust strips (see **Photo 2.3**). The Odour Audit finds this to be a good outcome.

**Photo 2.3** –Truck entrance plastic strips as found on 9 November 2016

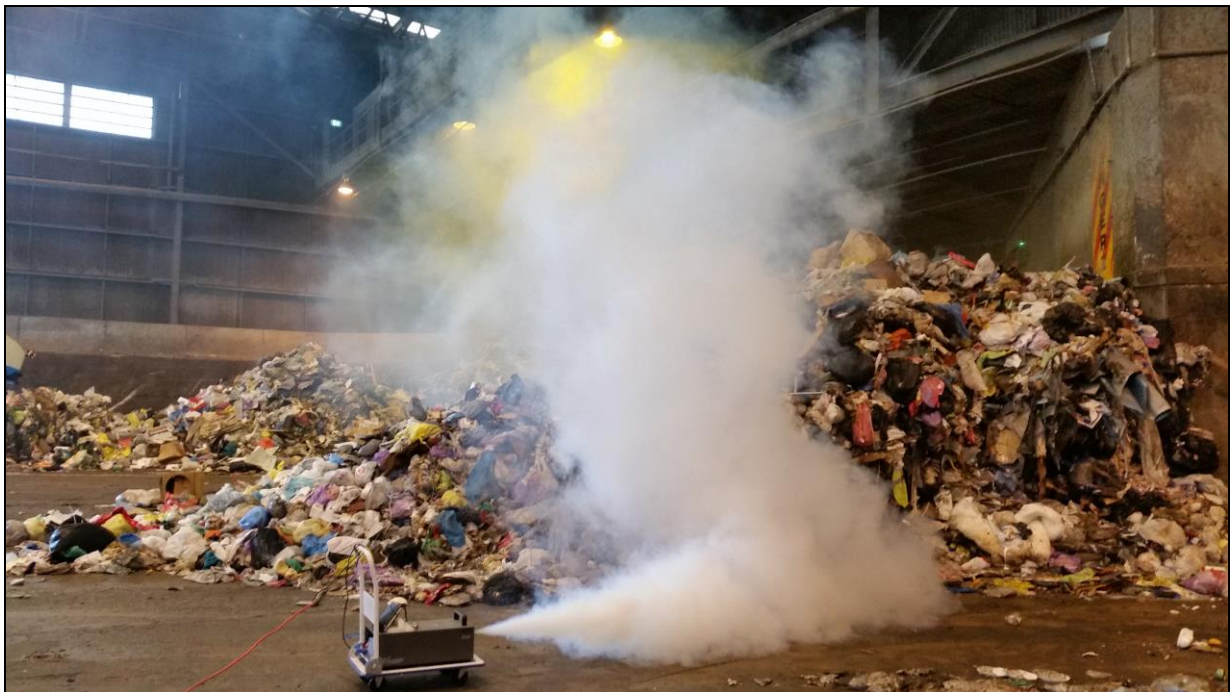
**Photo 2.4** – Smoke testing within the TTB on 9 November 2016

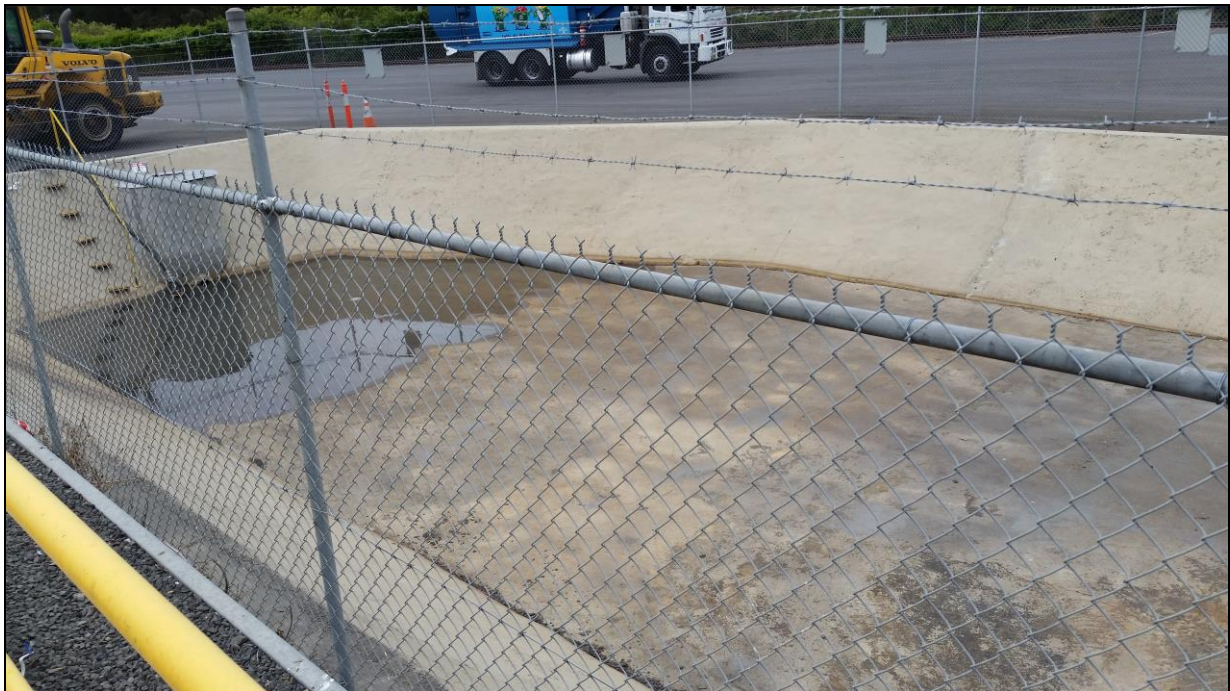
The auditor observed that there was no effluent in this pond at the time of the Odour Audit visit. Moreover, there was no odour detectable during the Odour Audit visit that could be linked directly back to the stormwater retention pond. **Photo 2.5** shows the state of the pond on 9 November 2016. The small puddle of water observed in the retention pond seen in **Photo 2.5** is stormwater from a rainfall event prior to the Odour Audit visit.

**Photo 2.5** – Stormwater retention pond as found on 9 November 2016
