# Annual Environmental Management Report - Clyde Transfer Terminal 2018-2019

Veolia has prepared this AEMR in accordance with Consent Condition 58 and 59 of the Development Consent DA 205-08-01 (the Consent) and subsequent modifications, as well as relevant legislative requirements and industry best practices.

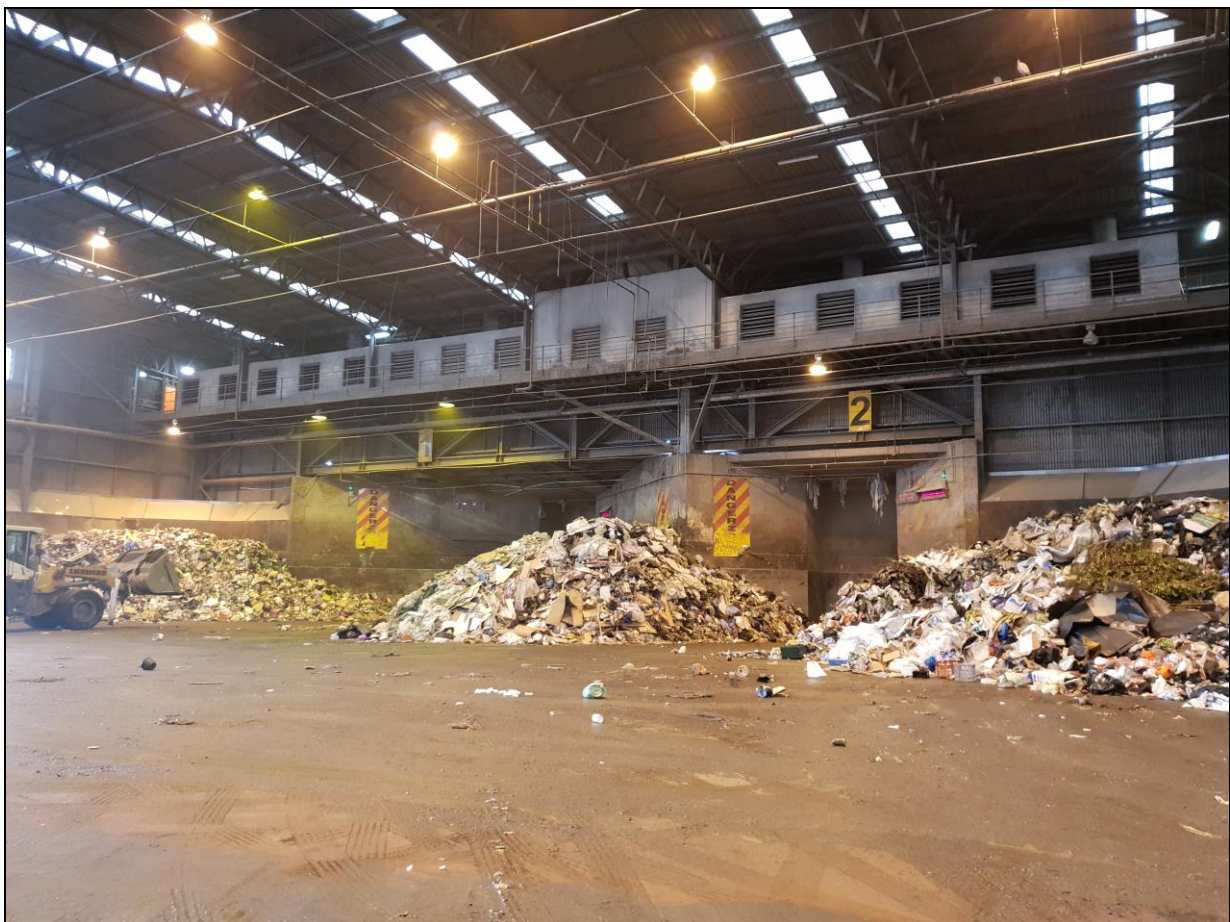
**Photo 2.1** – Waste on-floor as found on 24 May 2018

During the Odour Audit visit, there was approximately 300 to 400 tonnes of waste on the floor. This tonnage is considered to be within the normal operating range of the Transfer Terminal Building (TTB). The TTB floor area not covered by waste material was observed to be reasonably clean, with little evidence of leachate or aged material. General housekeeping procedures of the TTB were good, as found during several truck-unloading sequences. It was also observed that the TTB's front-end loaders cleared the floor area of waste on a regular basis, minimising the exposed area of waste.

As with previous audits, and consistent with TOU's experience at other waste transfer stations, there was a weak to distinct level of odour observed within the TTB. A photo of the waste on the floor as found during the Odour Audit visit is shown in **Photo 2.1**.

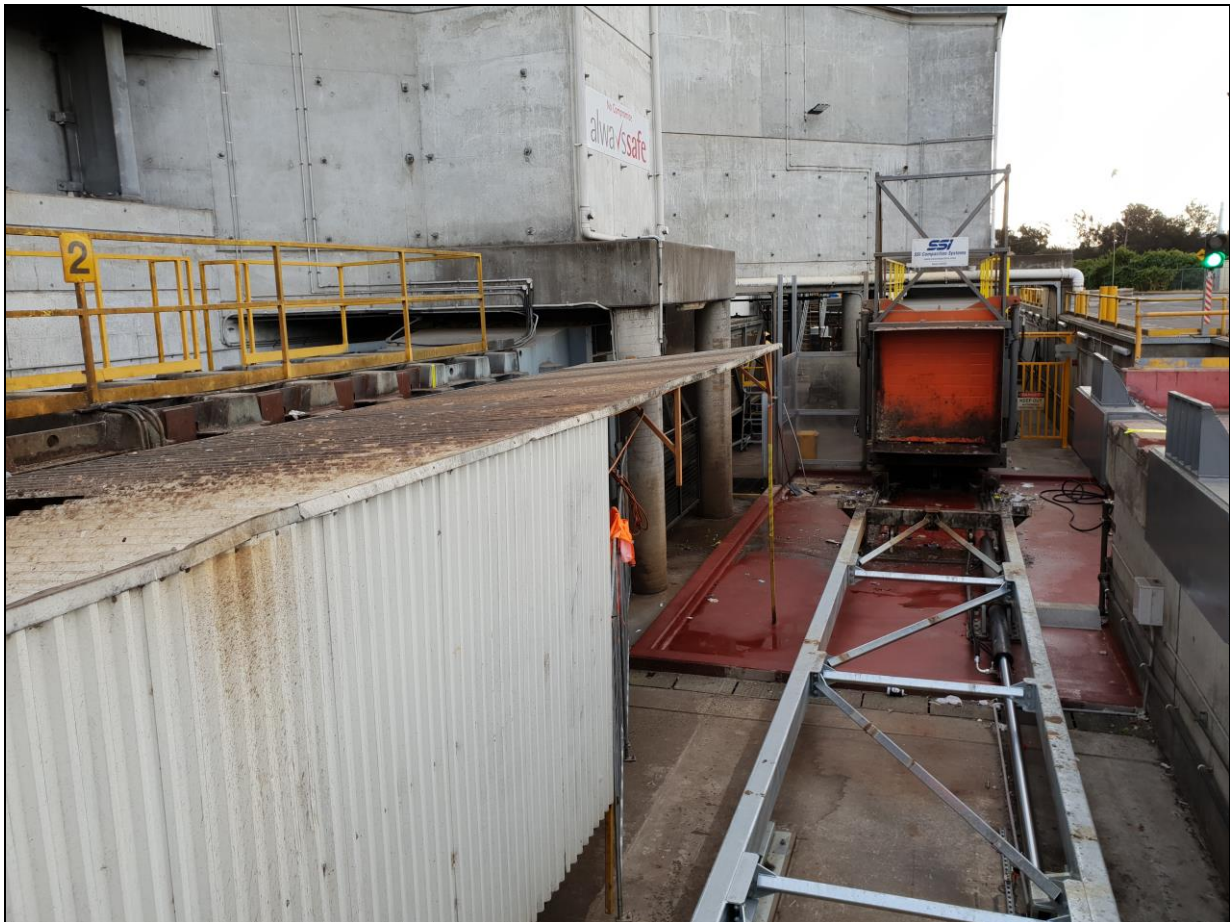
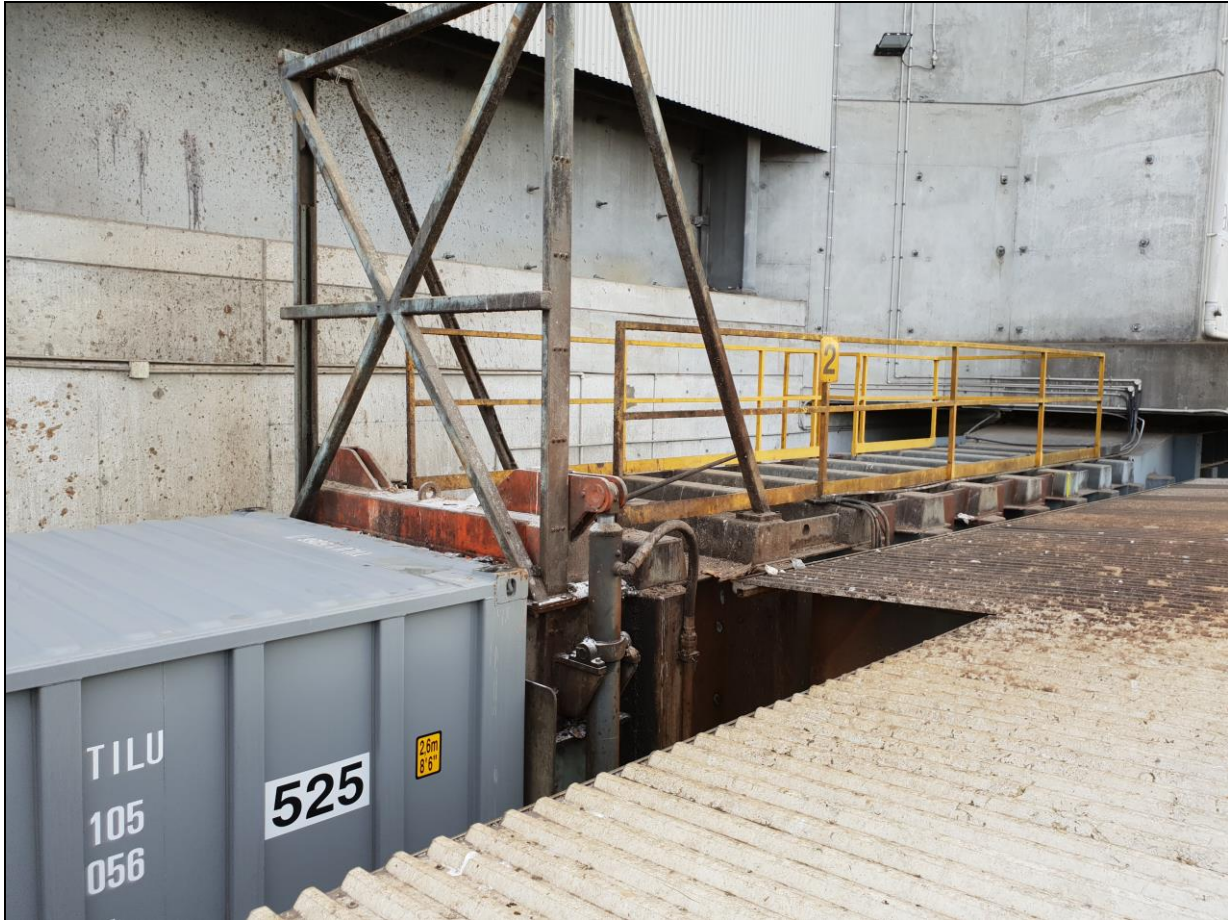
The container packing area and site roadways were found to be clean and well managed with no evidence of waste or exposed leachate. Like previous Odour Audits, the container compacting/train packing area had a weak to distinct odour that was intermittently detectable but was confined to this area only (see **Appendix C** for Field Ambient Odour Assessment Survey results). It appeared during the Odour Audit visit that just a single compactor was operating, with the other undergoing maintenance. The general house-keeping around this area was observed to be of high quality, with no evidence to suggest otherwise. The condition of the compactor area as found on 24 May 2018 is shown in **Photo 2.2** and **Photo 2.3**.

**Photo 2.2** – Compactor area as found on 24 May 2018 (1 of 2)

**Photo 2.3** – Compactor area as found on 24 May 2018 (2 of 2)

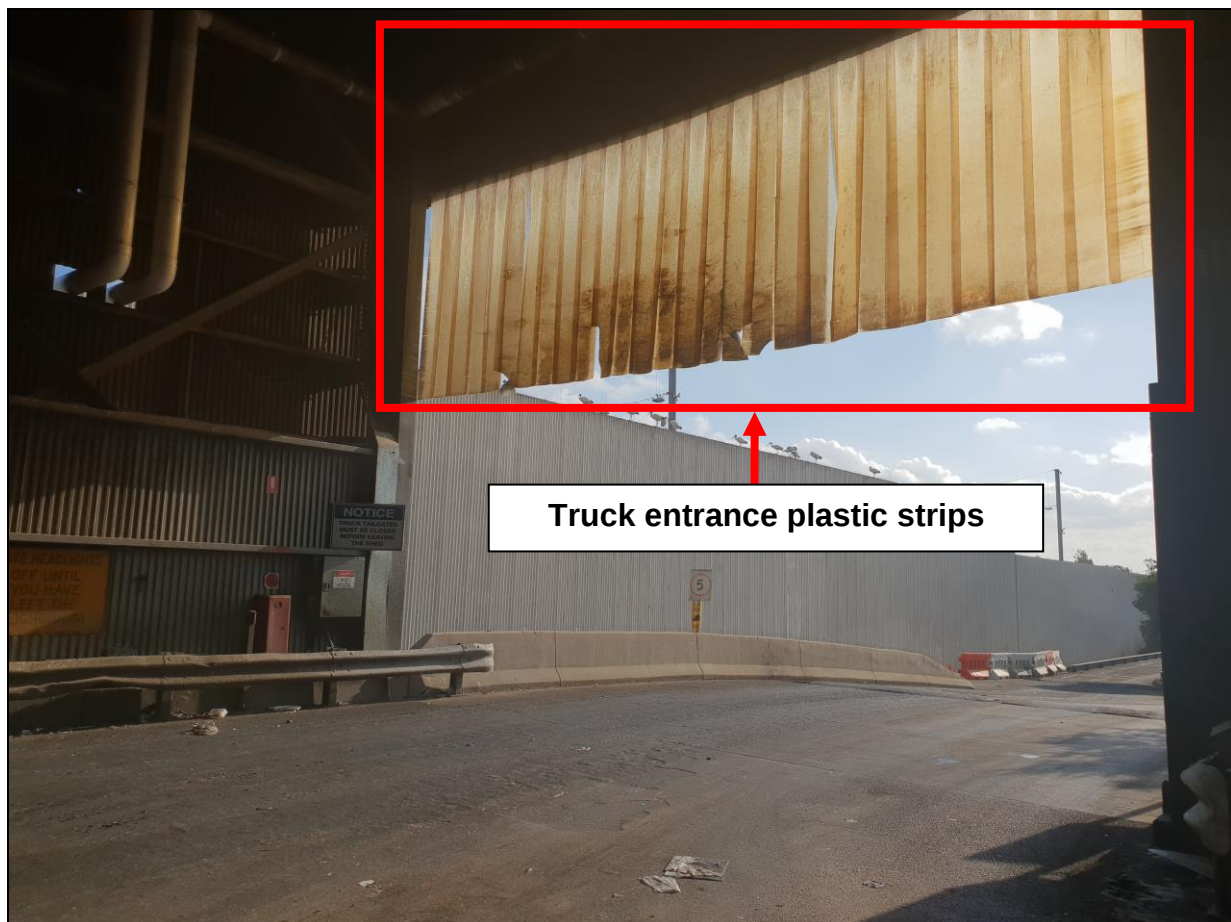
**Photo 2.4 –Truck entrance plastic strips as found on 24 May 2018**

The truck entrance plastic strips of the TTB, used to reduce odour escaping through the opening, were found to be in-tact and in good condition (see **Photo 2.4**).

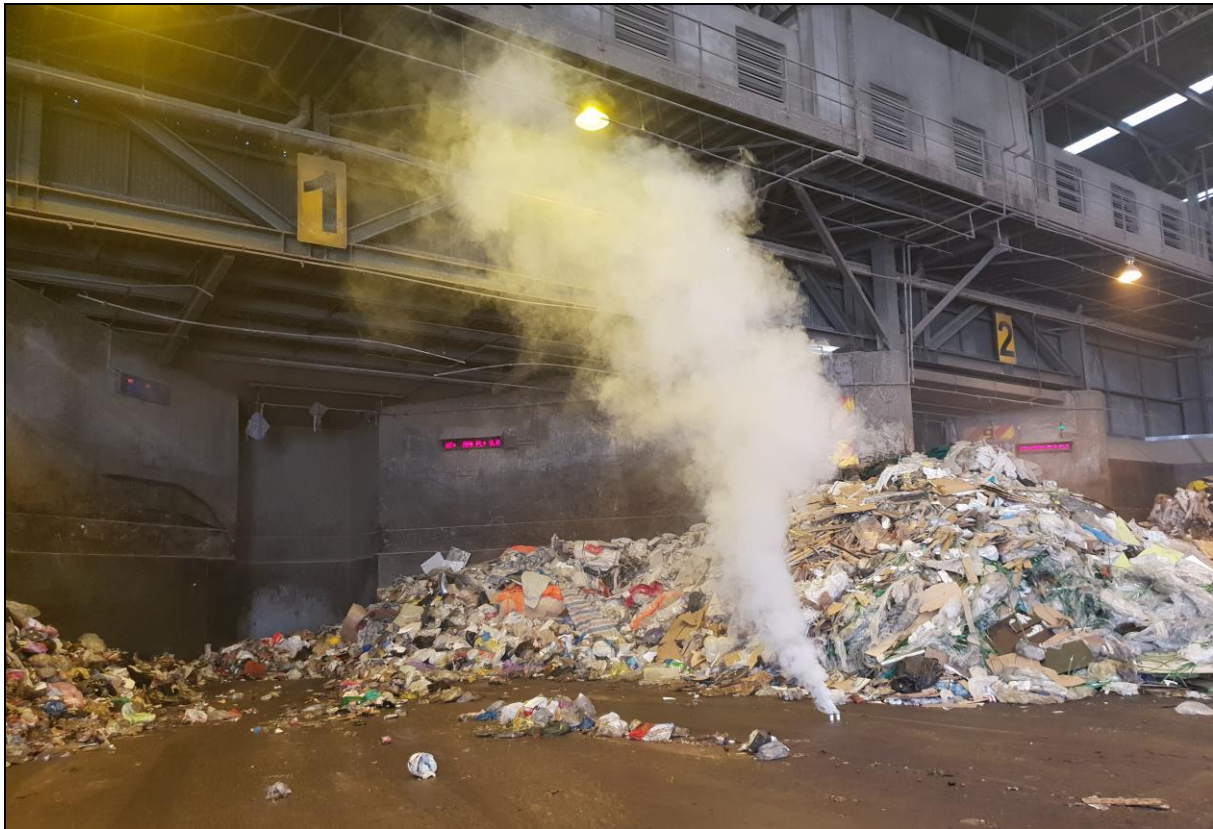
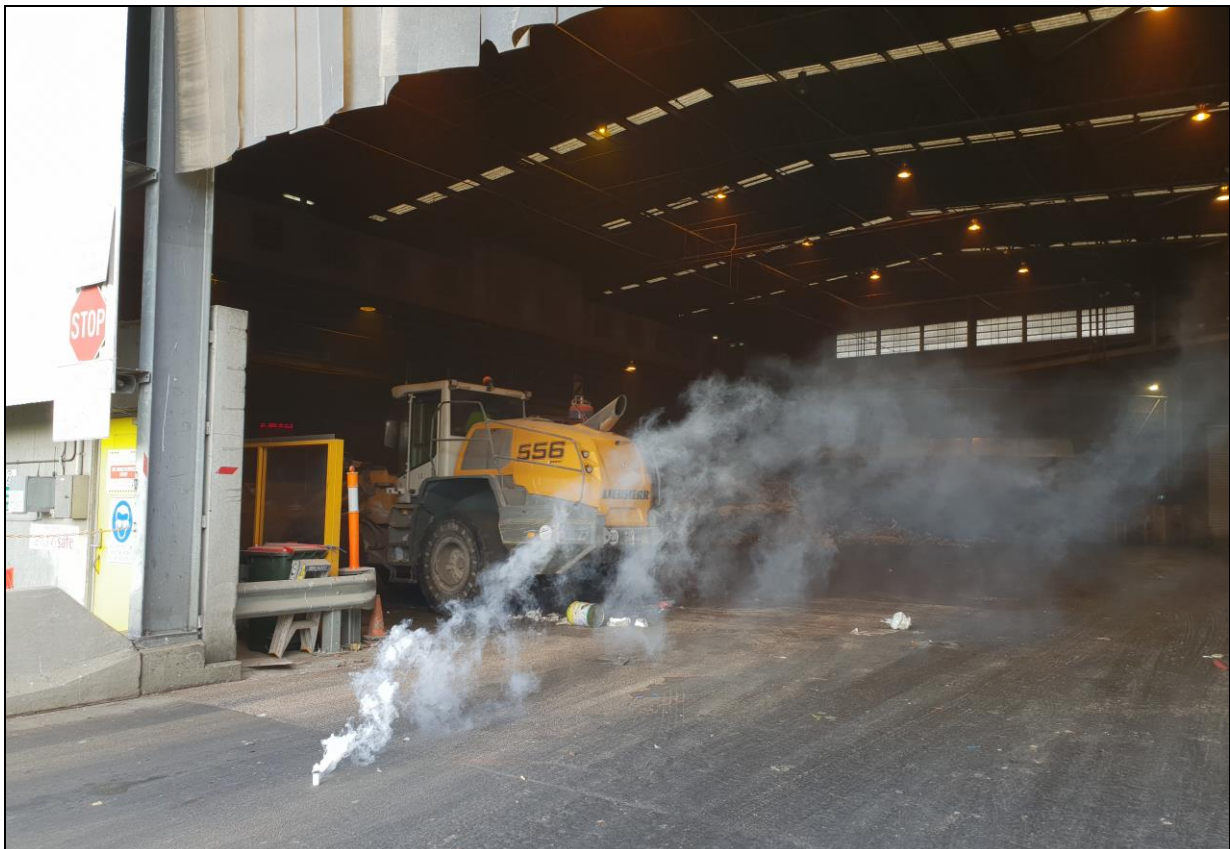
As per previous audits, smoke testing was carried out within the TTB to assist in determining the effectiveness of the forced air extraction system, as well as the extent to which the TTB has been sealed from leaks. As per previous audits, smoke was released from within the TTB at three points within the TTB. For the Odour Audit visit, an additional smoke testing point outside of the truck entrance was completed to assist with the observations made from smoke testing within the TTB (discussed in **Section 2.1.8.1**). **Figure 2.1** shows the three points where the smoke was released within the TTB. **Photo 2.5** and **Photo 2.6** shows smoke testing at one of the test locations (Smoke Testing Point #2) and outside of the truck entrance as occurred on 24 May 2018.

**Photo 2.5** – Smoke testing within the TTB on 24 May 2018

**Photo 2.6** – Smoke testing at the truck entrance of the TTB on 24 May 2018

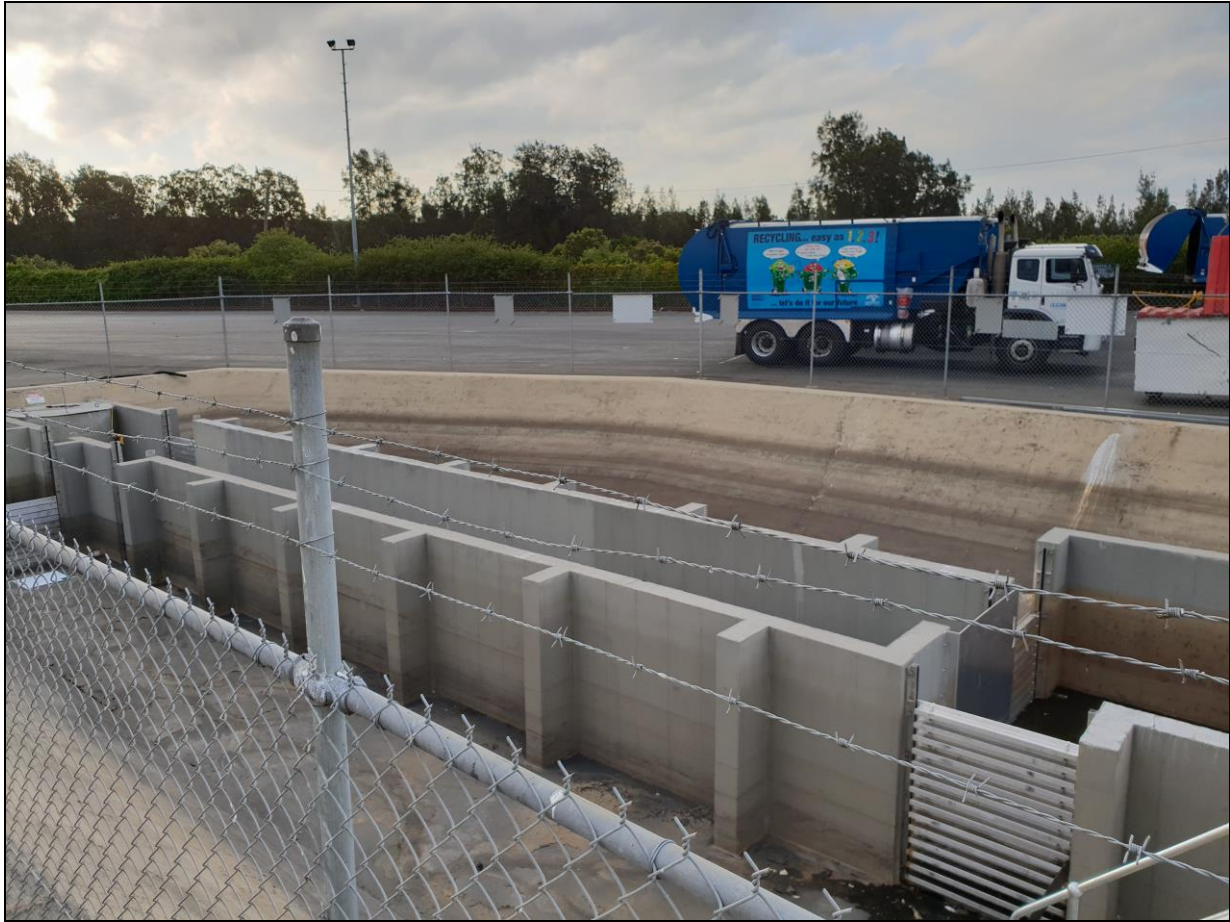
**Photo 2.7** – Stormwater retention pond as found on 24 May 2018

The auditor observed that there was no effluent in this pond at the time of the Odour Audit visit. Moreover, there was no odour detectable during the Odour Audit visit that could be linked directly back to the stormwater retention pond. **Photo 2.7** shows the state of the pond as found on 24 May 2018.

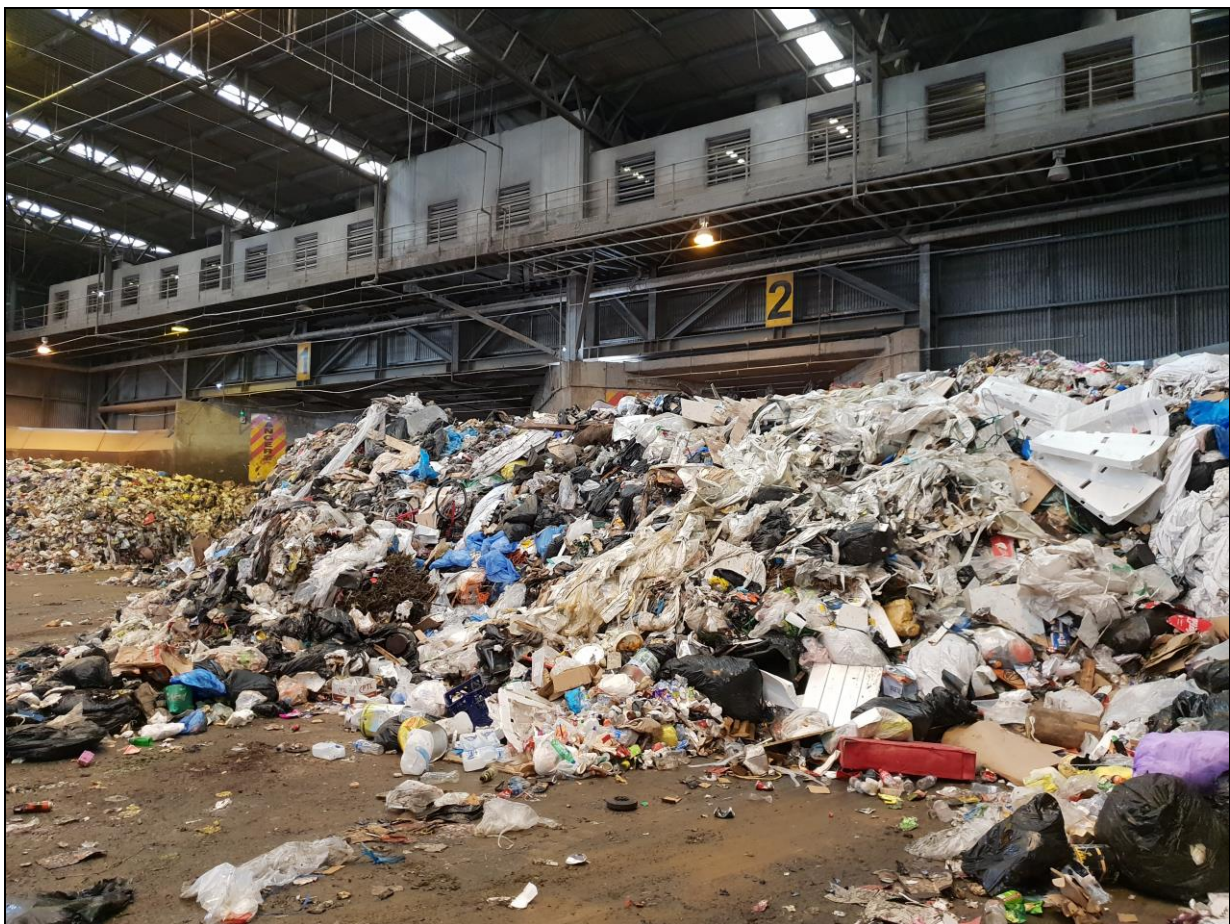
**Photo 2.1** – Waste on-floor as found on 15 November 2018

During the Odour Audit visit, there was approximately 350 to 450 tonnes of waste on the floor. This tonnage is considered to be within the normal operating range of the Transfer Terminal Building (TTB). The TTB floor area not covered by waste material was observed to be reasonably clean, with little evidence of leachate or aged material. General housekeeping procedures of the TTB were good, as found during several truck-unloading sequences. It was also observed that the TTB's front-end loaders cleared the floor area of waste on a regular basis, minimising the exposed area of waste.

As with previous audits, and consistent with TOU's experience at other waste transfer stations, there was a weak to distinct level of odour observed within the TTB. A photo of the waste on the floor as found during the Odour Audit visit is shown in **Photo 2.1**.

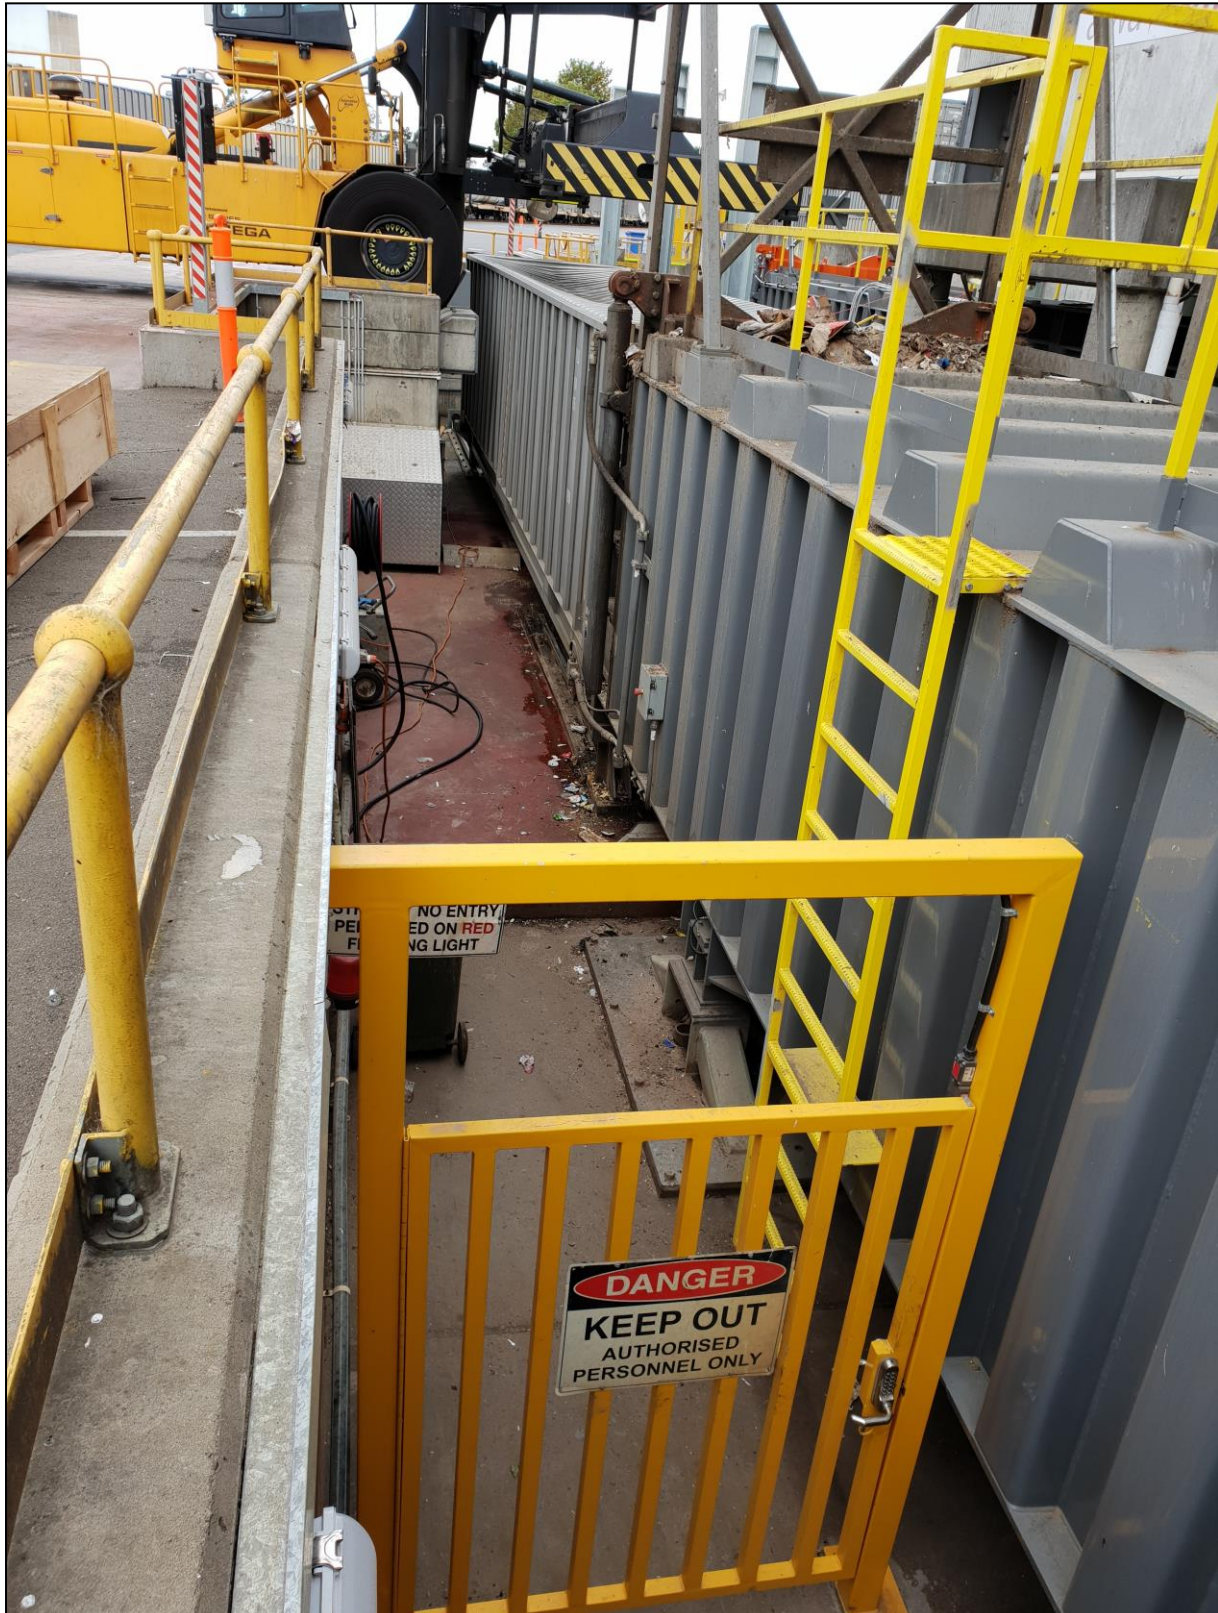
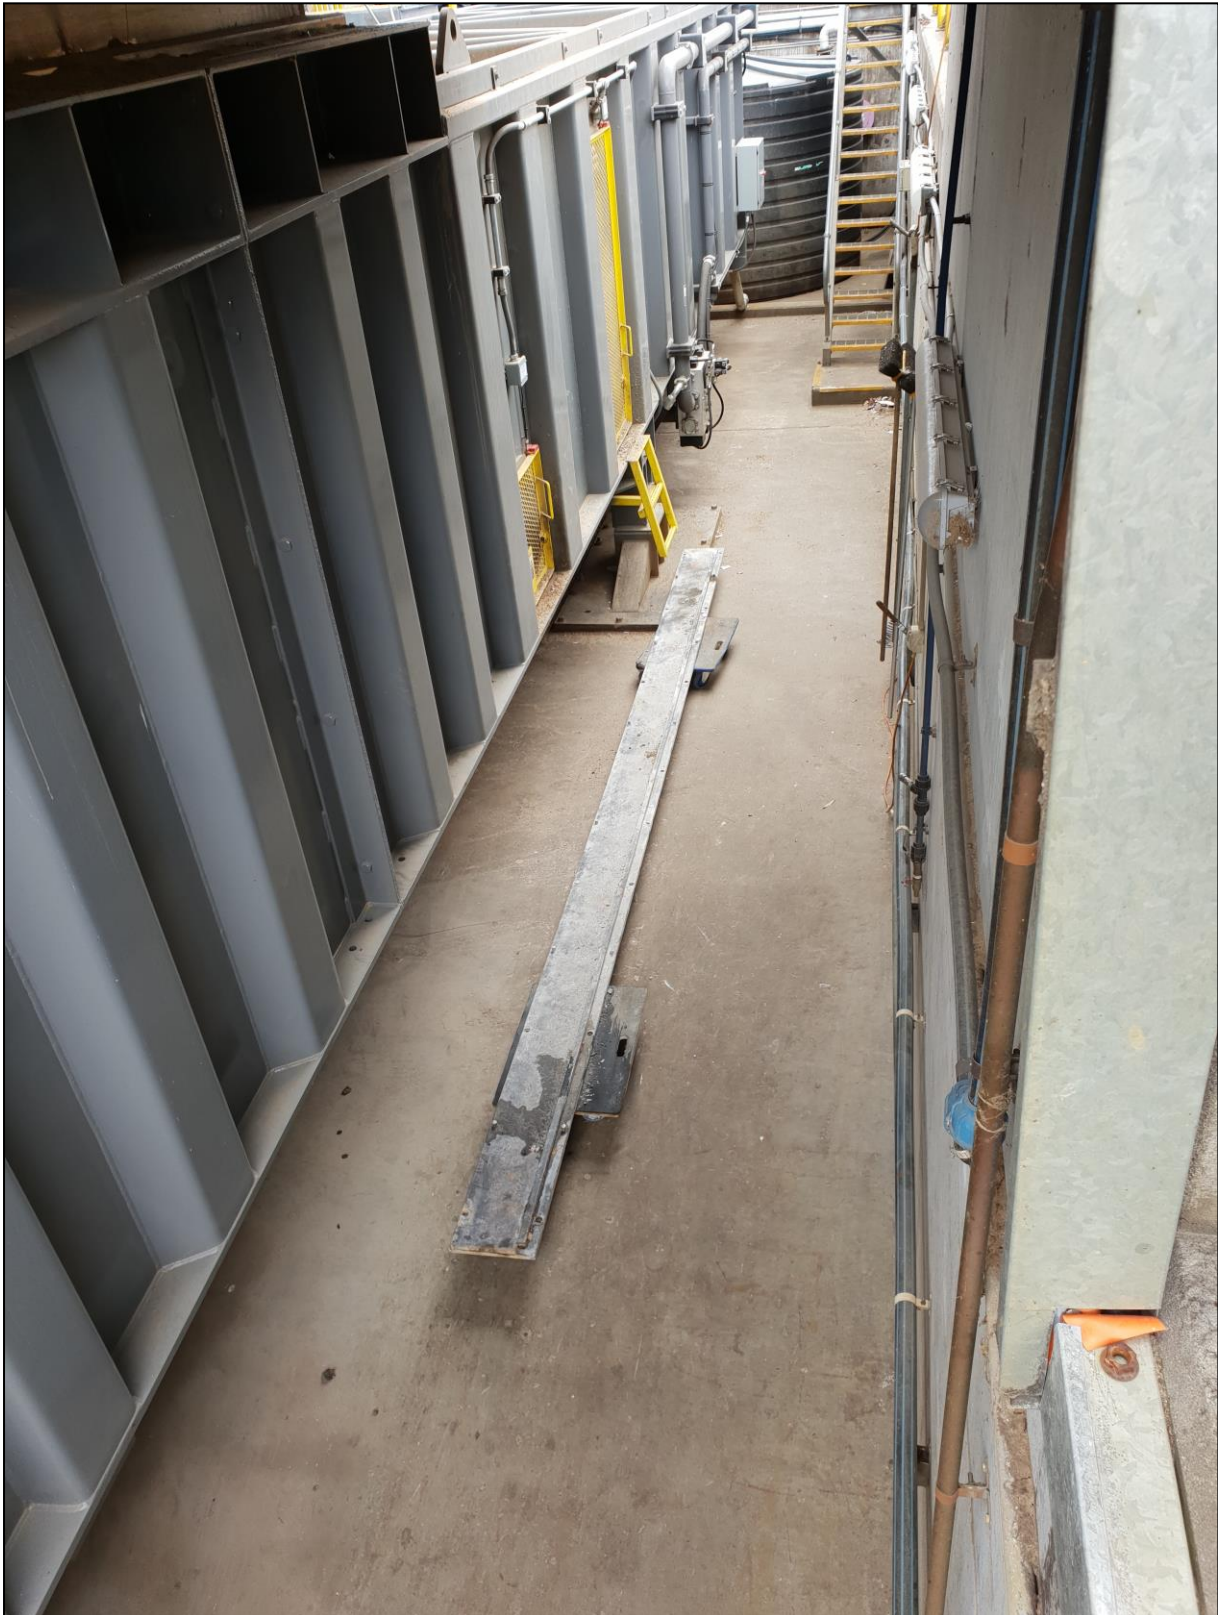
The container packing area and site roadways were found to be clean and well managed with no evidence of waste or exposed leachate. Like previous Odour Audits, the container compacting/train packing area had a weak to distinct odour that was intermittently detectable but was confined to this area only (see **Appendix C** for Field Ambient Odour Assessment Survey results). It appeared during the Odour Audit visit that both compactors were in operation. The general house-keeping around this area was observed to be of high quality, with no evidence to suggest otherwise. The condition of the compactor area as found on 15 November 2018 is shown in **Photo 2.2** and **Photo 2.3**.

Photo 2.2 – Compactor area as found on 15 November 2018 (1 of 2)

**Photo 2.3 – Compactor area as found on 15 November 2018 (2 of 2)**

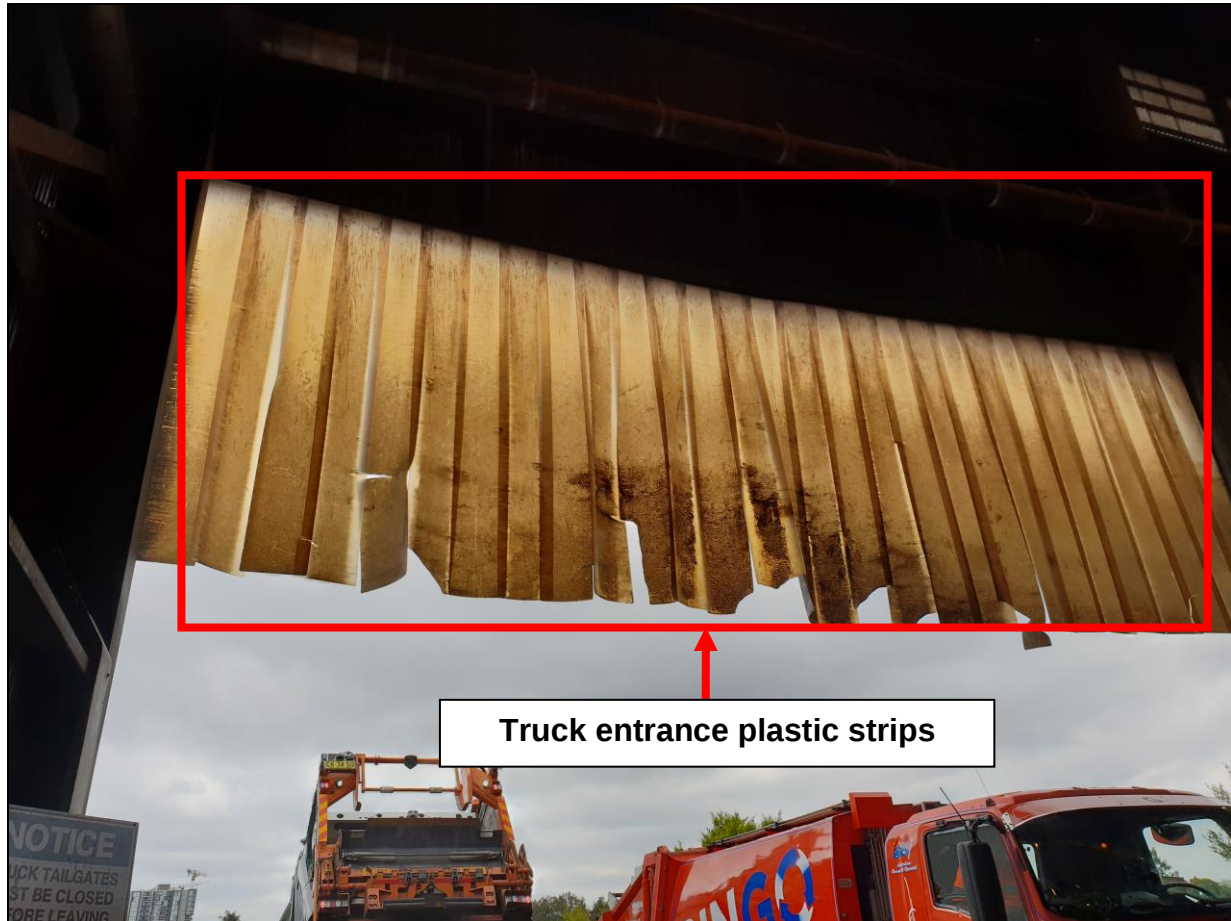
**Photo 2.4** –Truck entrance plastic strips as found on 15 November 2018

The truck entrance plastic strips of the TTB, used to reduce odour escaping through the opening, were found to be intact and in good condition (see **Photo 2.4**).

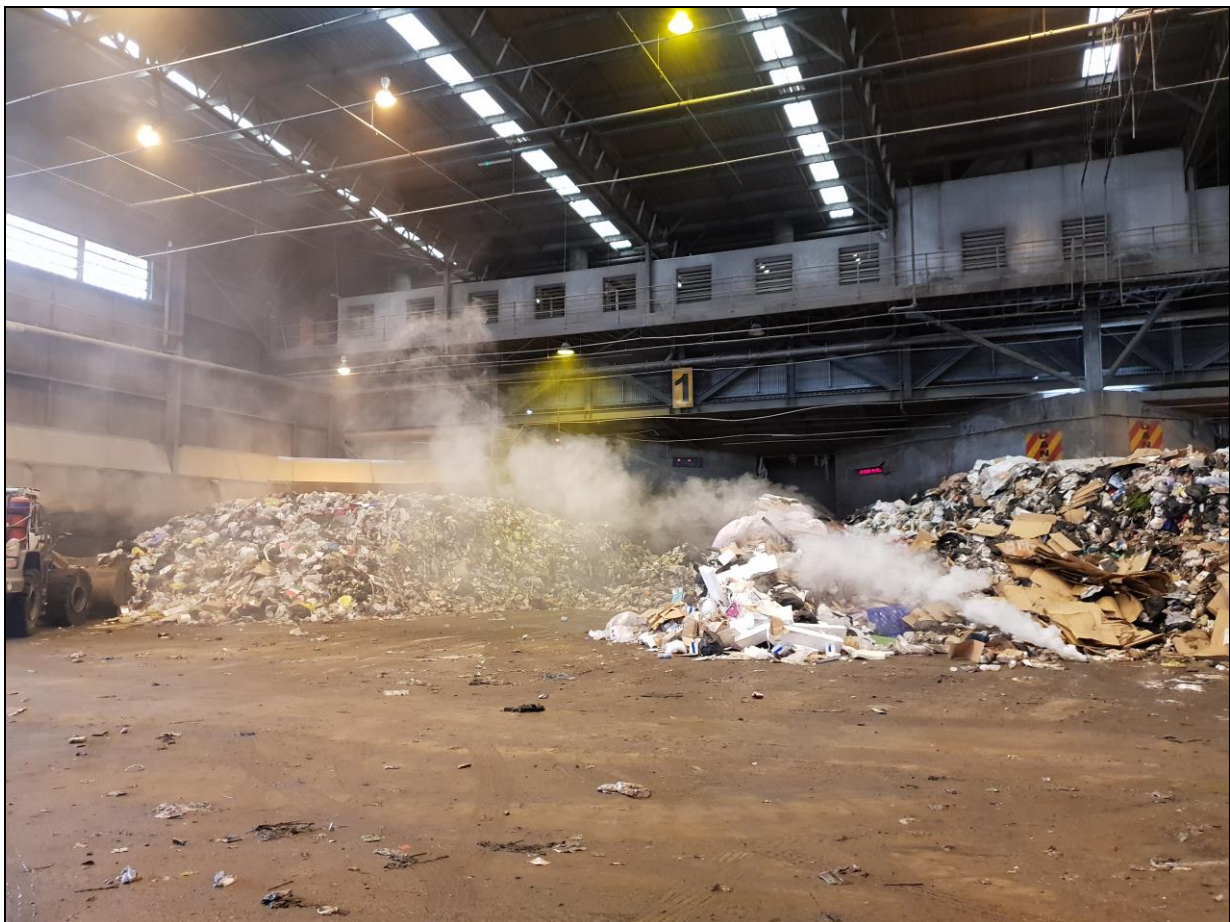
As per previous audits, smoke testing was carried out within the TTB to assist in determining the effectiveness of the forced air extraction system, as well as the extent to which the TTB has been sealed from leaks. As per previous audits, smoke was released from within the TTB at three points within the TTB. **Figure 2.1** shows the three points where the smoke was released within the TTB. **Photo 2.5** shows smoke testing at one of the test locations (Smoke Testing Point #2) as occurred on 15 November 2018.

**Photo 2.5** – Smoke testing within the TTB on 15 November 2018

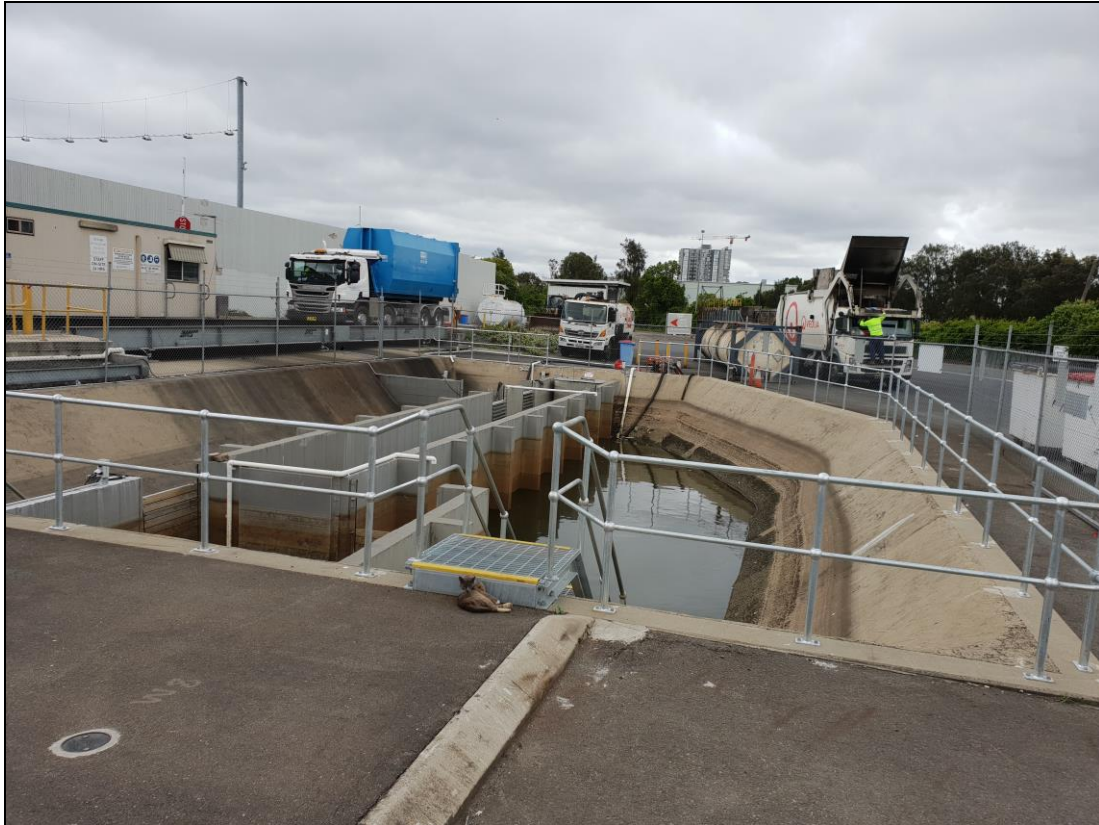
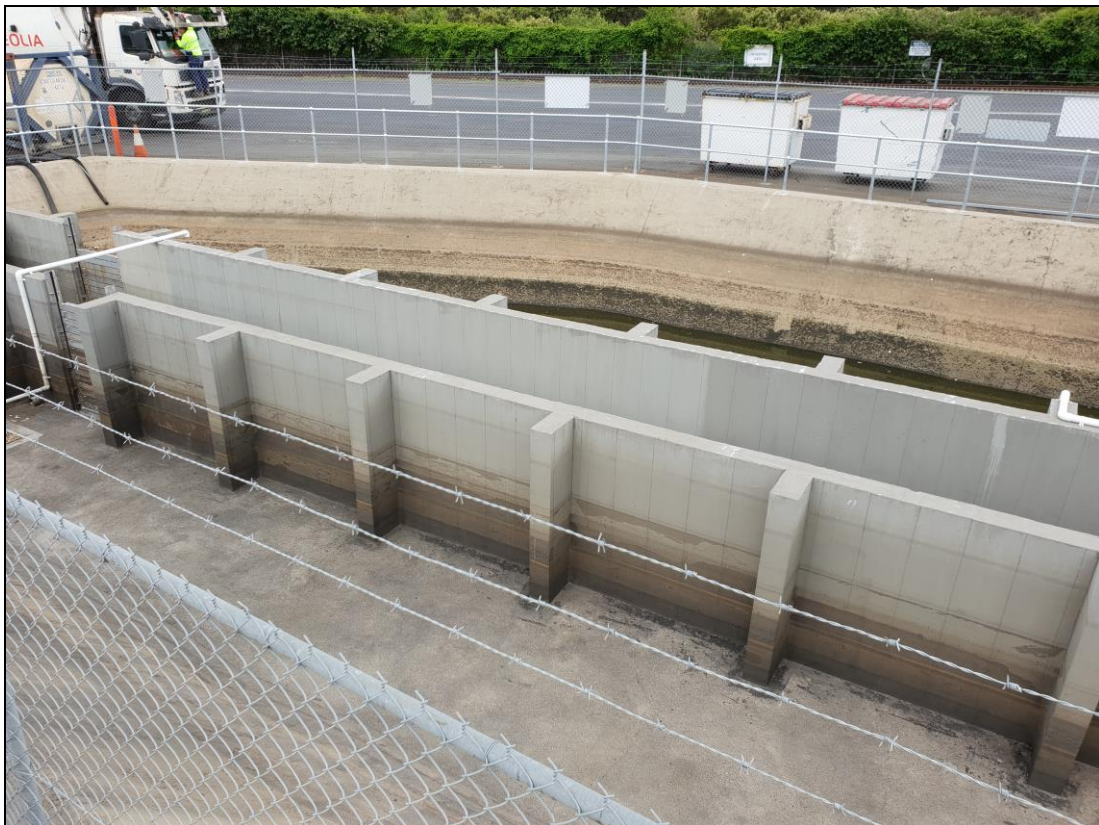
The auditor observed that there was a very low level of effluent in this pond at the time of the Odour Audit visit. Notwithstanding this observation, there was no odour detectable during the Odour Audit visit that could be linked directly back to the stormwater retention pond. **Photo 2.6** and **Photo 2.7** shows the state of the pond as found on 15 November 2018.

**Photo 2.6** – Stormwater retention pond as found on 15 November 2018

**Photo 2.7** – Stormwater retention pond as found on 15 November 2018
