# Annual Environmental Management Report - Banksmeadow Transfer Terminal 2018-2019

**NSW / Banksmeadow AEMR 2019**

Issue Date 16/08/2019

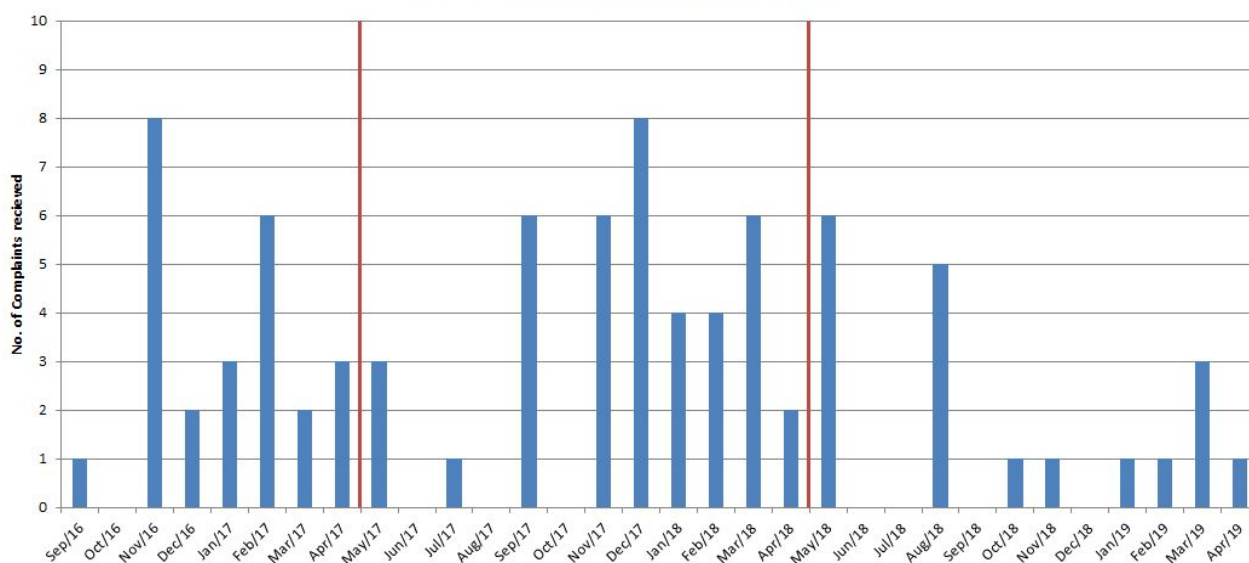
**Figure 2.4** - Number of odour complaints received each month at the Terminal

The odour performance of the Terminal has significantly improved in this reporting period compared to previous reporting periods.

- Results of odour sampling collected during this reporting period indicate there has been a significant reduction (by a factor of six) in the odour emission rate compared to the results from the previous reporting period.
- Following a series of improvement works in the waste shed, smoke testing results conducted throughout this reporting period have consistently indicated that there are no other potential fugitive emission release pathways from the waste shed area, apart from the entrance doorway.
- These positive results have been further validated through a significant reduction in the number of odour complaints received at the Terminal this reporting period, compared to previous reporting periods. The number of odour complaints received each month since the commencement of operations is illustrated in Figure 2.4 below (See Section 3.4 for further details).

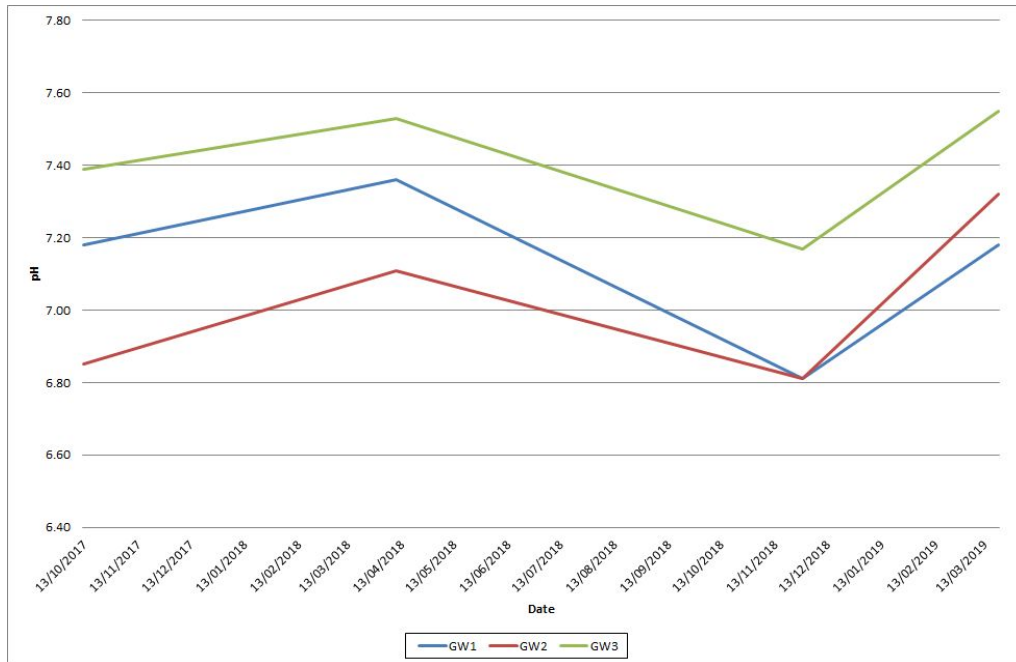
**Figure 2.5** - pH trends in groundwater

pH remained fairly consistent with baseline levels with fluctuating trends noted in all three wells (GW1, GW2 and GW3).

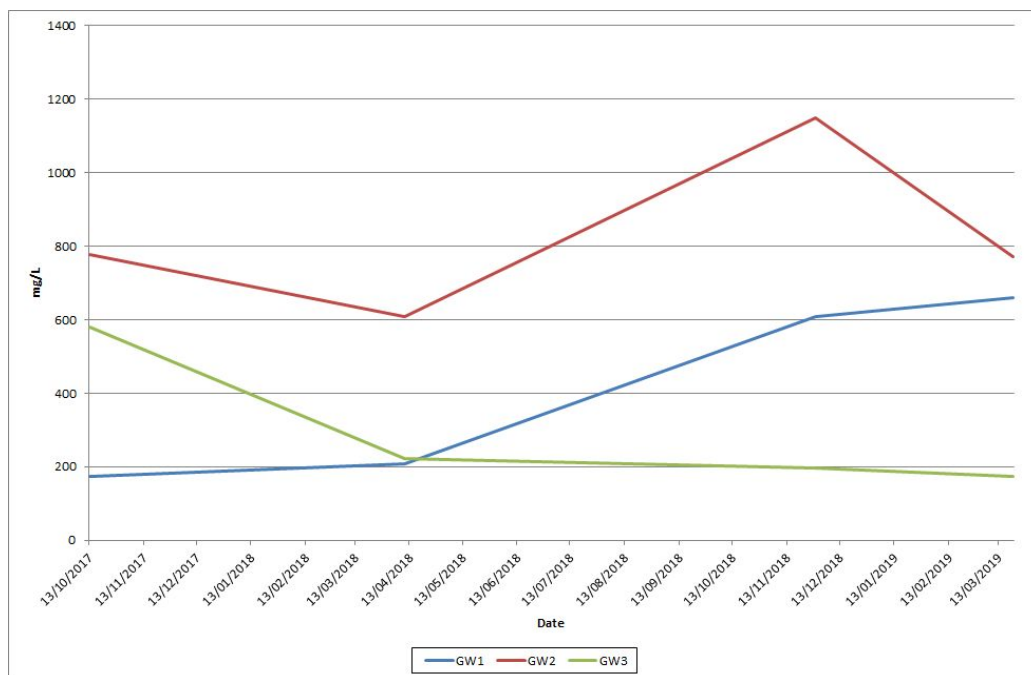
**Figure 2.6** - TDS trends in groundwater

- Groundwater quality in all three wells remains fairly consistent with historical trends and baseline levels.
- TDS and EC showed an increasing trend in GW1 since the previous reporting period, however this trend stabilised in the latter part of this reporting period. Conversely ammonia and BOD have showed a decreasing trend in GW1 this reporting period which does not indicate the presence of leachate migration. This trend will continue to be monitored to assess potential leachate migration.

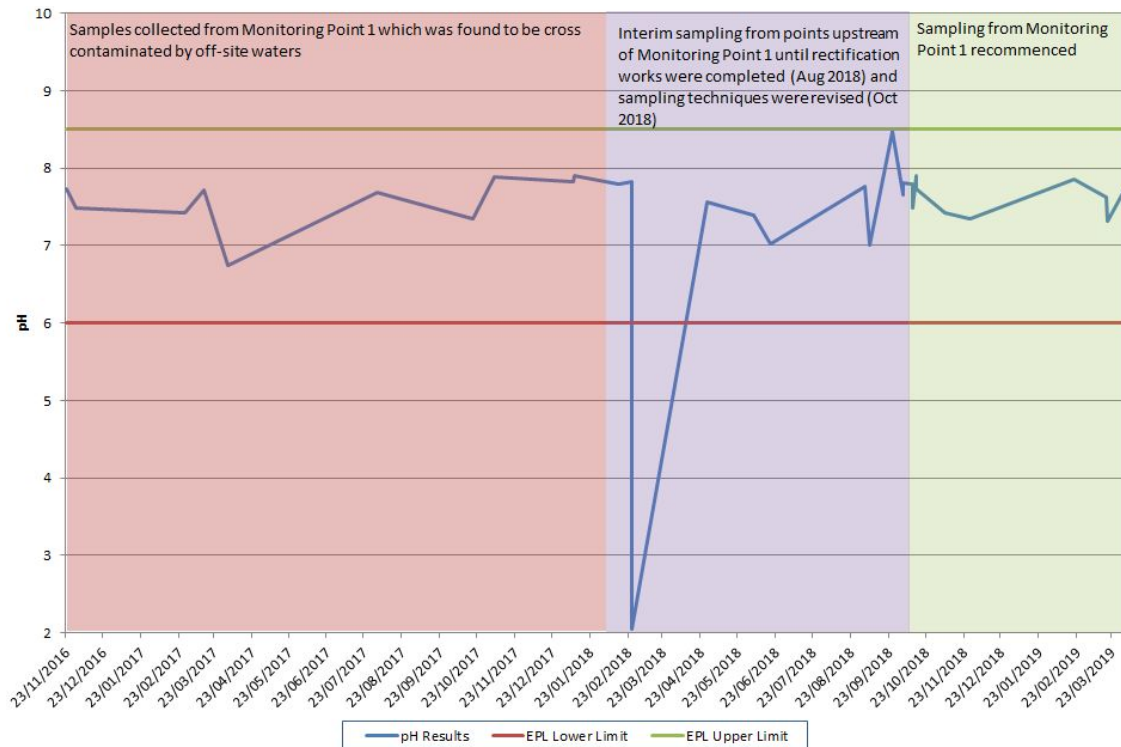
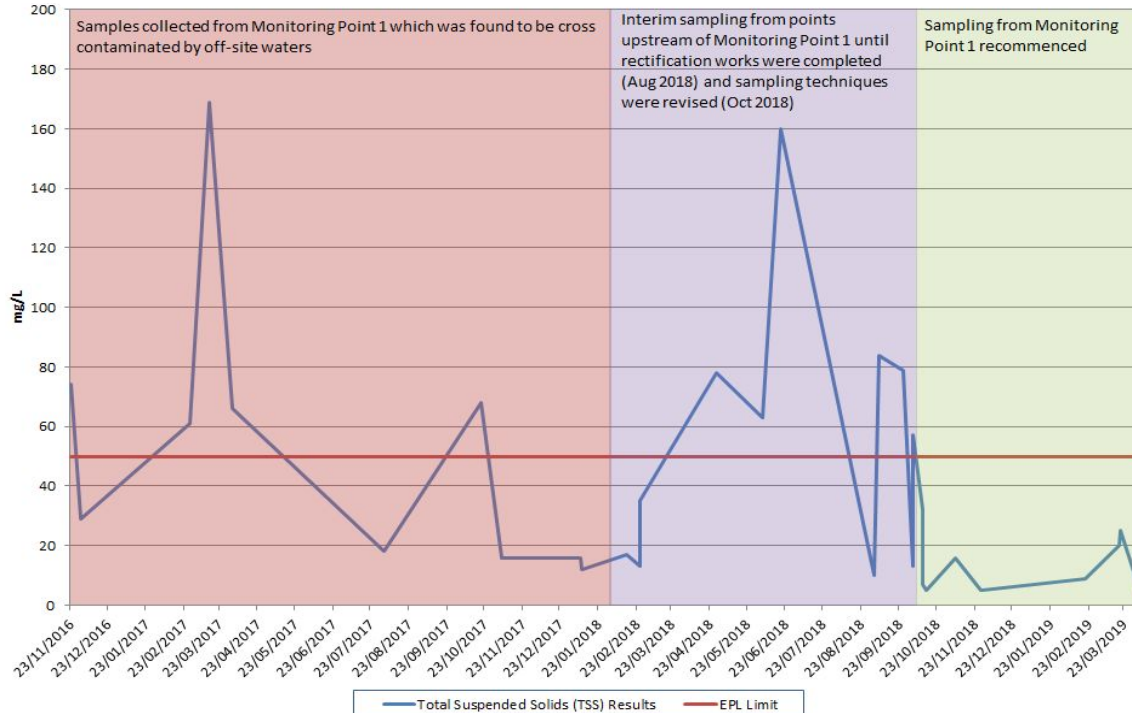
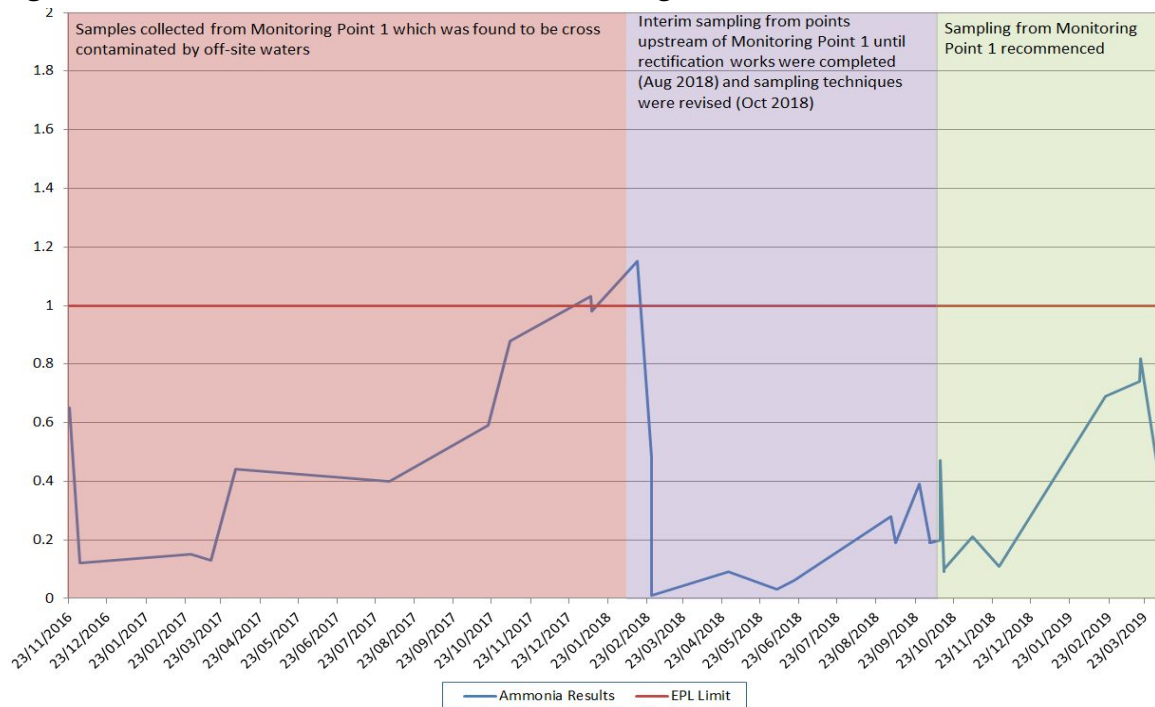
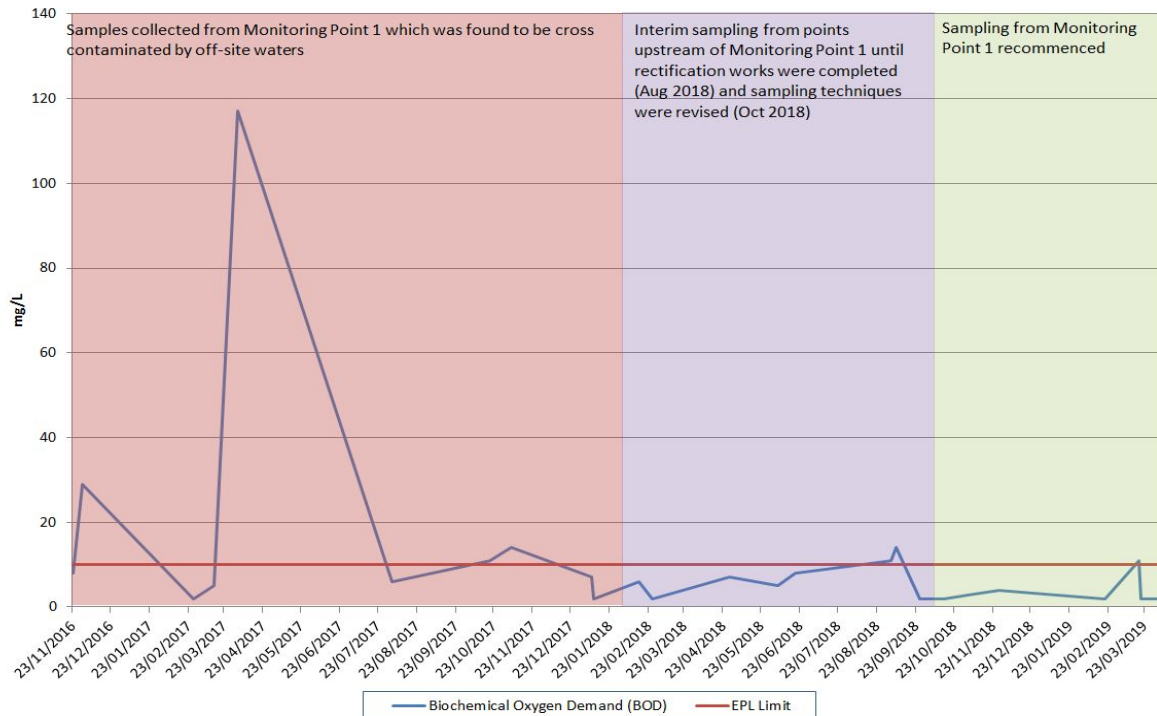
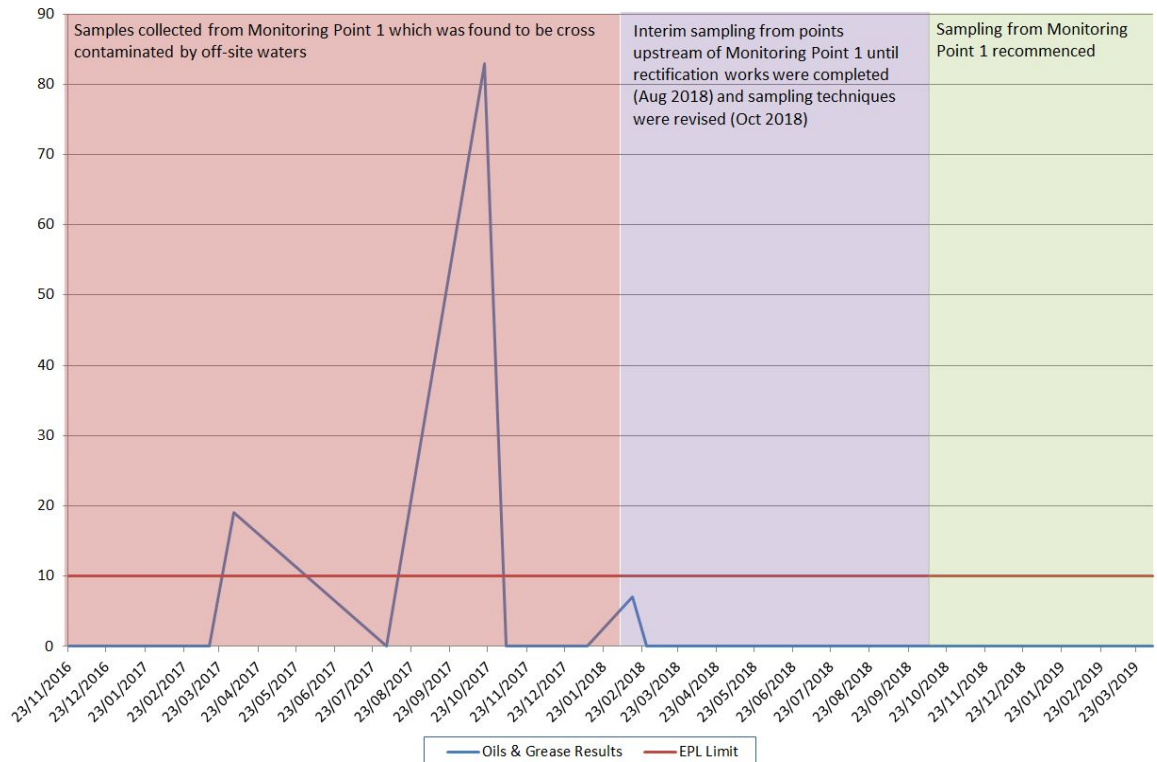
During the reporting period, stormwater discharge quality from the EPL Monitoring Point 1 has vastly improved in all parameters compared to the last two reporting periods based on corrective actions implemented to rectify off-site cross contamination issues at Monitoring Point 1.

Since sampling recommenced in EPL Monitoring Point 1 in October 2018, the stormwater discharge quality generally did not exceed the concentration limits stipulated in the EPL 20581, with the exception at a slight exceedance for BOD of 11 mg/L on the 19th March 2019.
