Clyde Waste Transfer Terminal

Odour Audit XXXV

Final Report

May 2020

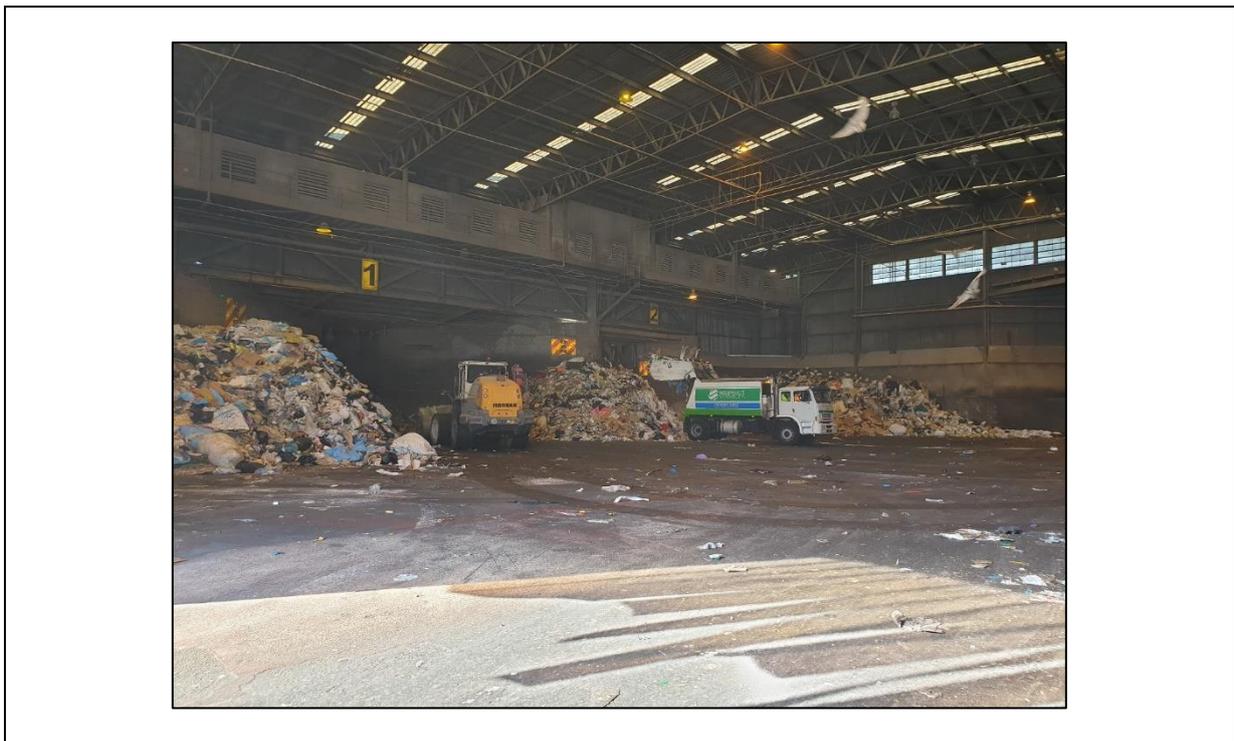
During the Odour Audit visit, there were approximately 250 to 300 tonnes of waste on the floor. This tonnage is considered to be within the normal operating range of the Transfer Terminal Building (TTB). The TTB floor area not covered by waste material was observed to be reasonably clean, with little evidence of leachate or aged material. General housekeeping procedures of the TTB were good, as found during several truck-unloading sequences. It was also observed that the TTB's front-end loaders cleared the floor area of waste on a regular basis, minimising the exposed area of waste.

As with previous audits, and consistent with TOU's experience at other waste transfer stations, there was a weak to distinct level of odour observed within the TTB. A photo of the waste on the floor as found during the Odour Audit visit is shown in **Photo 2.1**.

Photo 2.1 – TTB waste on-floor as found on 6 May 2020

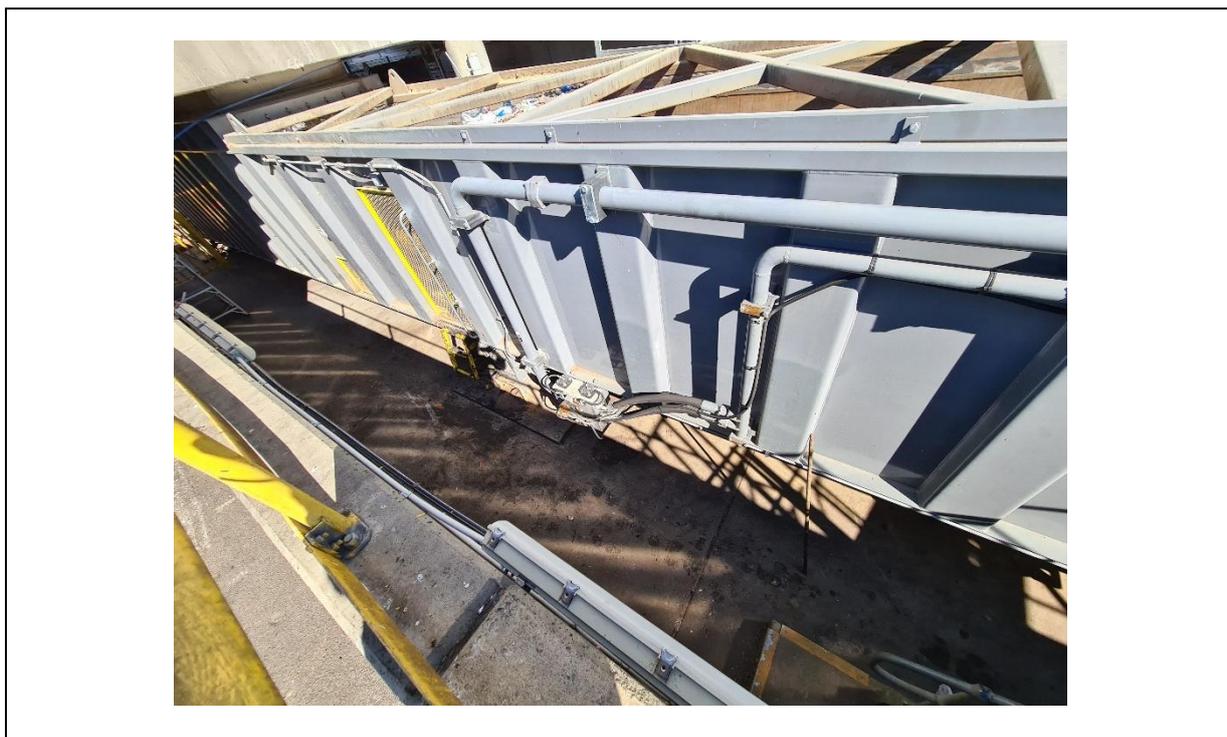
The container packing area and site roadways were found to be clean and well managed with no evidence of waste or exposed leachate (see **Photo 2.2**). Like previous odour audits, the container compacting/train packing area had a weak to distinct odour that was intermittently detectable but was confined to this area only (see **Appendix C** for Field Ambient Odour Assessment Survey results). It appeared during the Odour Audit visit that both compactors were in operation. The general

housekeeping around this area was observed to be of high quality, with no evidence to suggest otherwise.

Photo 2.2 – A view of the container compacting/packing area as found on 6 May 2020

- **No further action is required at this stage.**

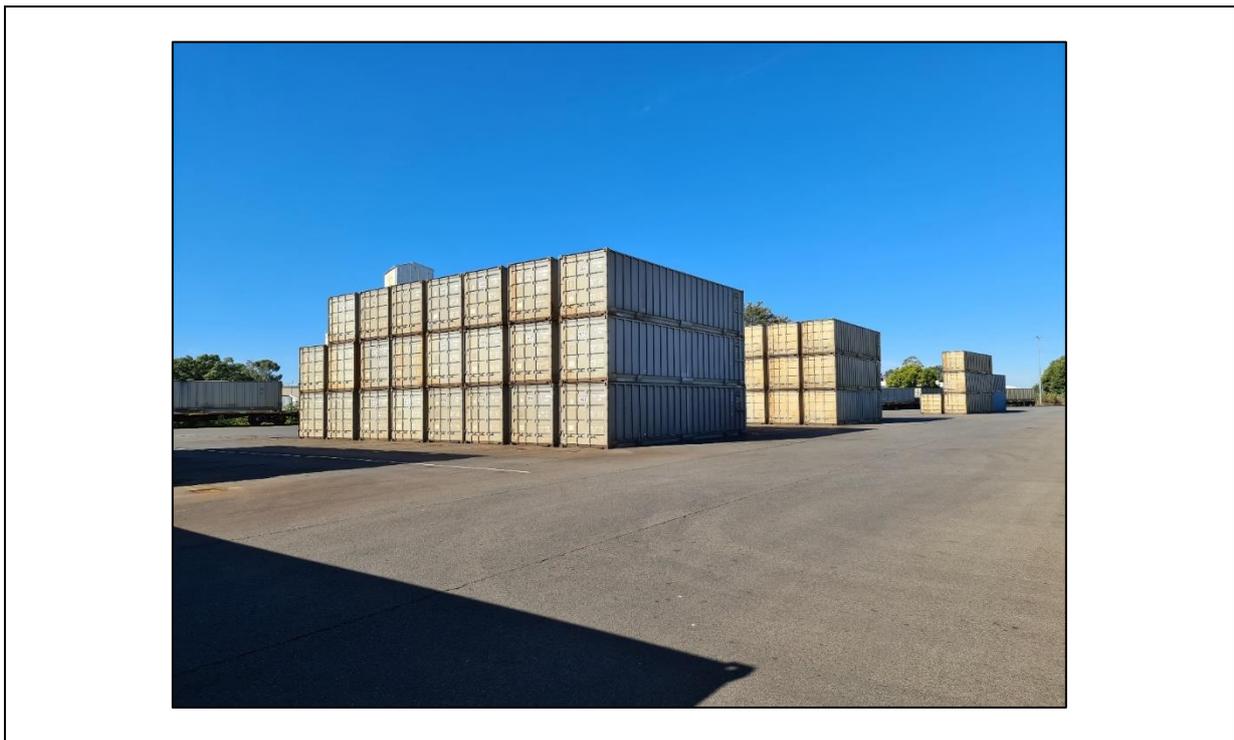
As per the Odour Management Plan dated February 2010 (**the February 2010 OMP**) for the Site, following the compaction of waste, all filled containers are entirely sealed and remain so while at the Site. All containers used are required to be in good condition, and unused/returned containers adequately clean. The Odour Audit finds that this continues to be current practice at the Site. A view of the condition of the compactor area as found on 6 May 2020 is shown in **Photo 2.3**.

Photo 2.3 – A view of the container area as found on 6 May 2020

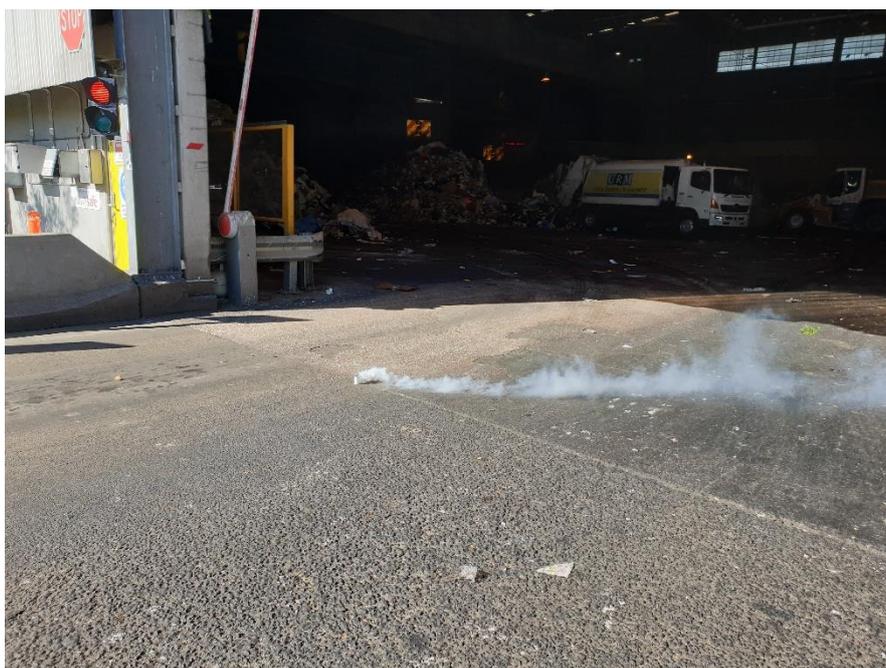
The truck entrance plastic strips of the TTB, used to reduce odour escaping through the opening, were found to be intact and in good condition (see **Photo 2.4**).

Photo 2.4 – A view of the truck entrance plastic strips as found on 6 May 2020

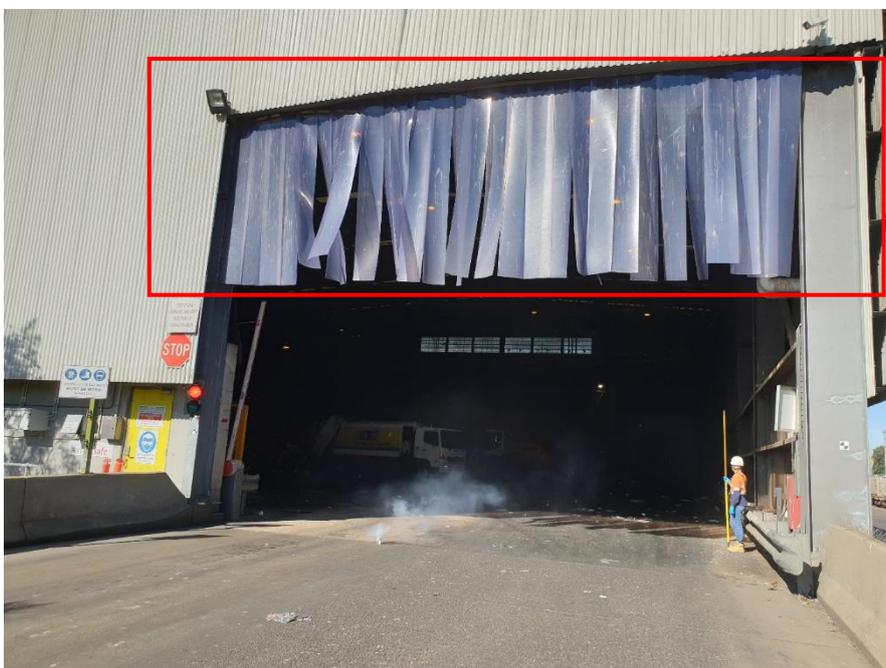
Photo 2.5 – A view of the truck entrance plastic strips during smoke testing on 6 May 2020

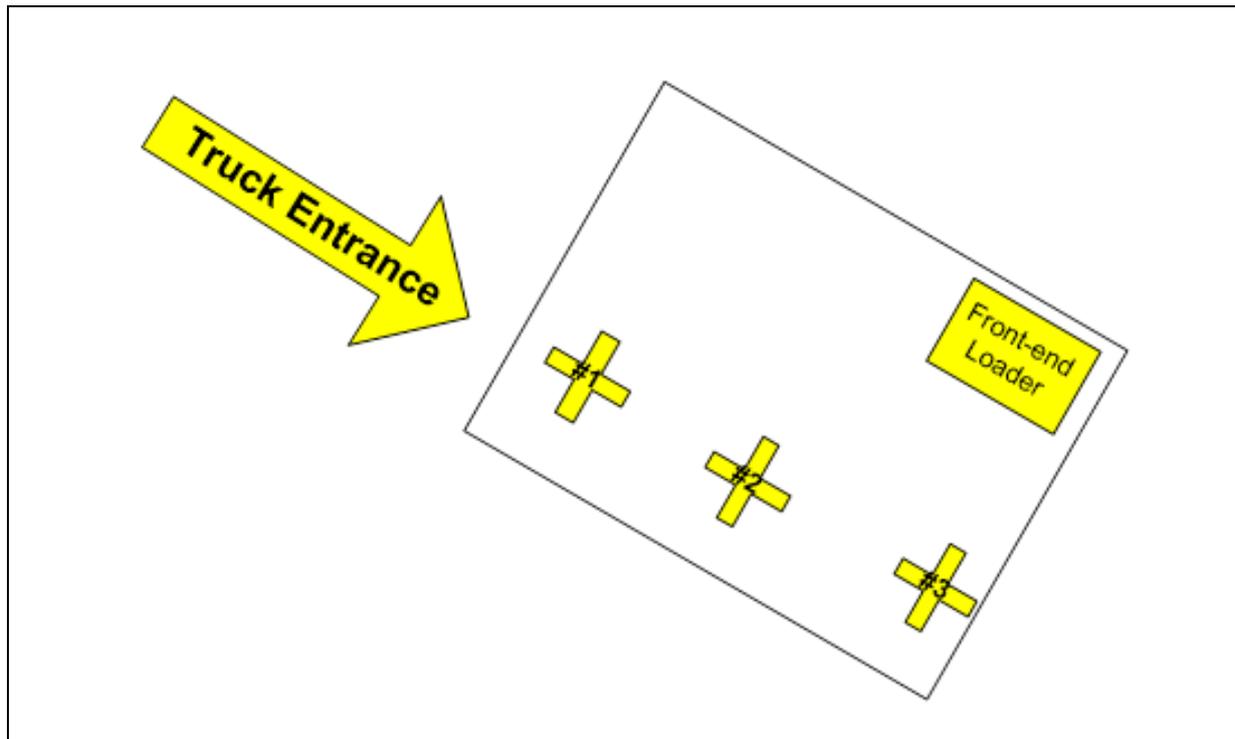
Figure 2.1 - Smoke testing release points within the TTB on 6 May 2020

The smoke released at this point initially rose gradually moving towards the truck entrance before rising to the roof and moving slowly towards the extraction system. Visible smoke extraction at the overhead capture points was evident during the smoke testing at this point. Any smoke that continued towards the truck entrance was drawn back into the building (see shown in **Photo 2.5**). However, TOU did visibly observe a slight bias in distribution at the overhead capture points closet to the truck entrance door compared with the other overhead capture points, suggesting that the balance for the odour extraction system may require checking, cleaning and balancing.

The smoke released at this point revealed a similar result to that documented for smoke testing point #1.

- **Action 1 – All stack discharge velocity and airflow measurements collected during a service visit should be reported in future service logs; and**
- **Action 2 - The odour extraction system to be checked, cleaned and balanced.**

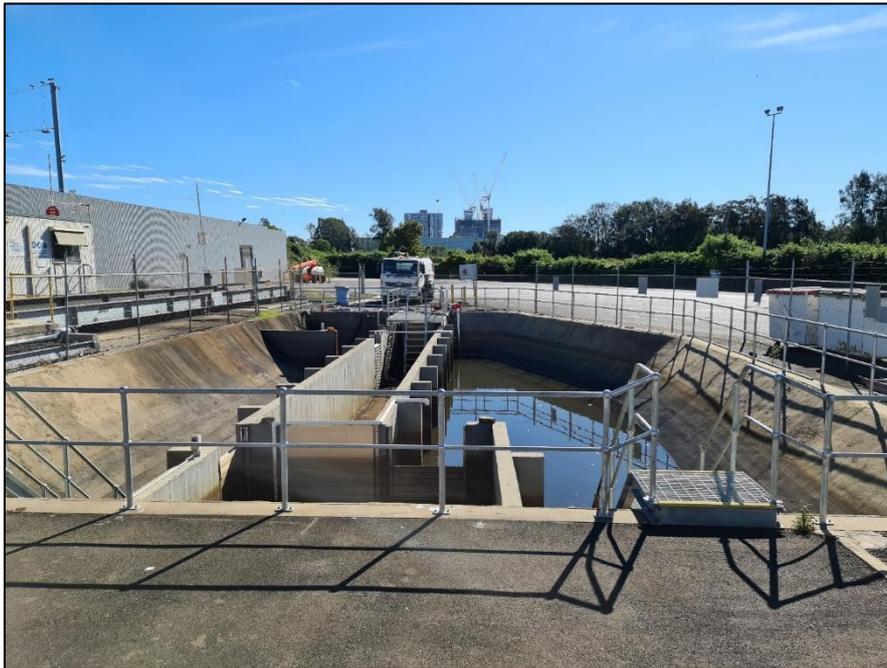
The auditor observed that there was effluent in this pond at the time of the Odour Audit visit. **Photo 2.6** shows the state of the pond as found on 6 May 2020.

Photo 2.6 – Stormwater retention pond as seen on 6 May 2020

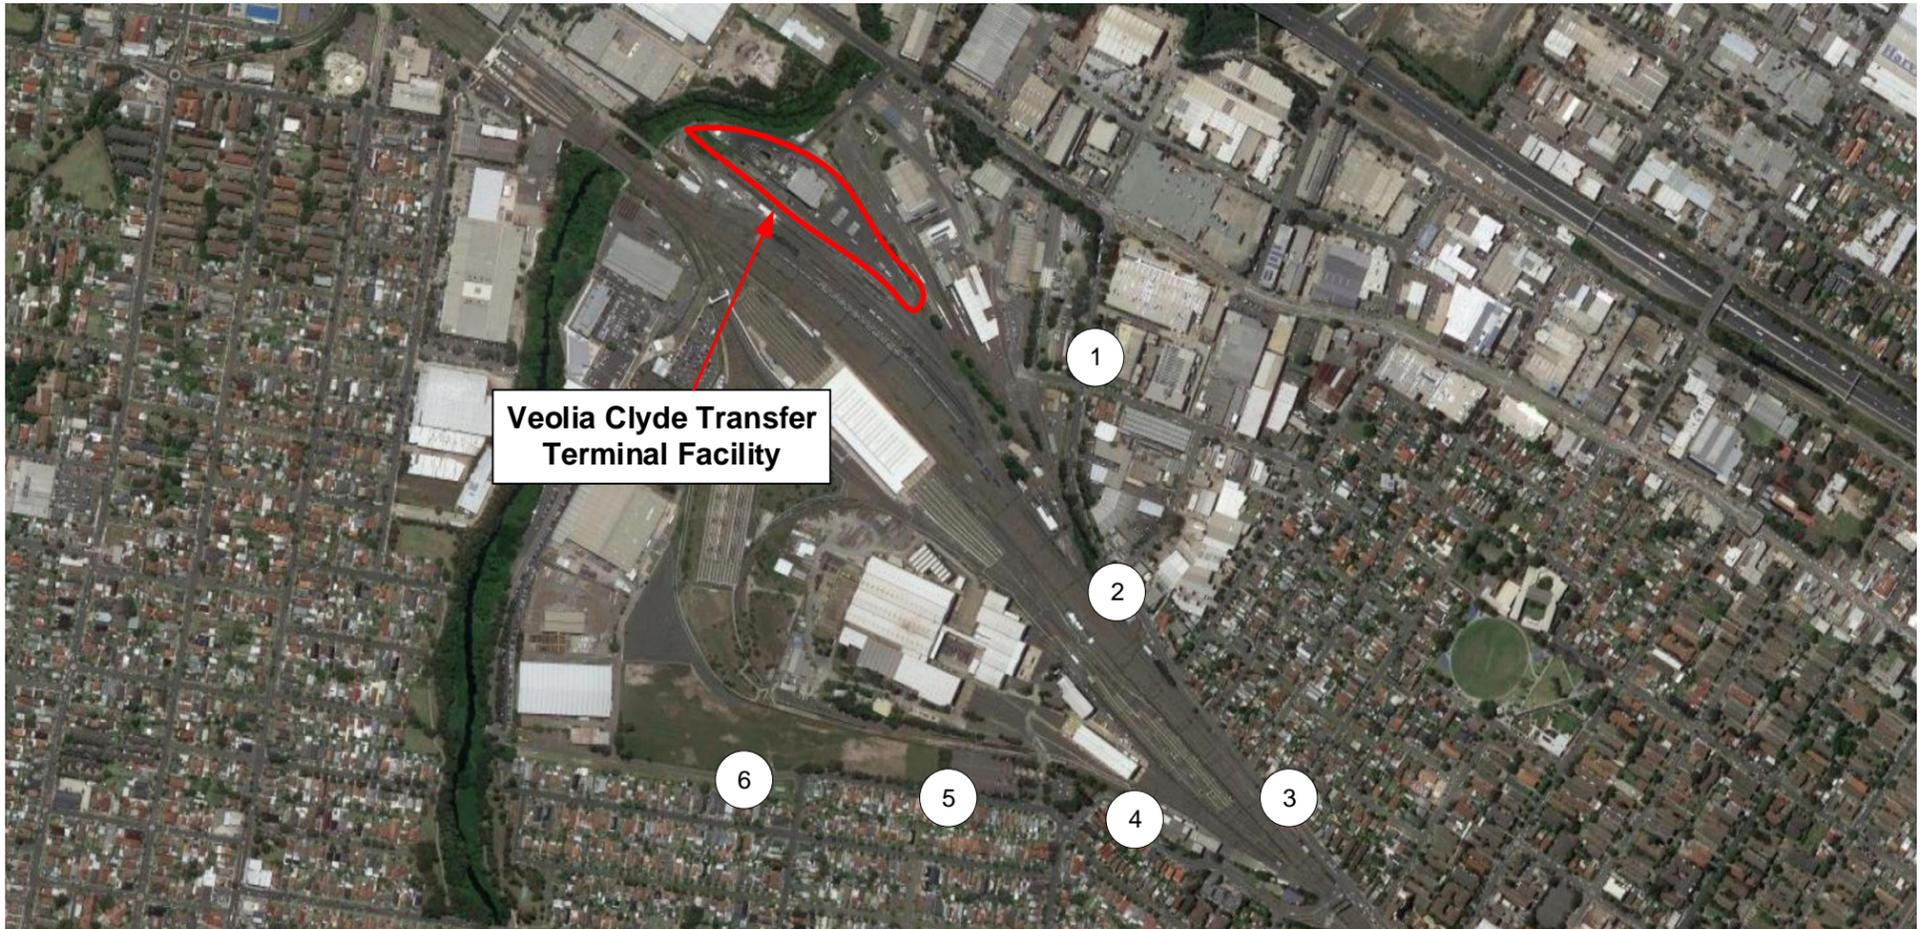
The results of the FAOA survey conducted during the Odour Audit found that whilst intermittent odours were detected on-site, no odours were detectable off-site that could be linked back to the Site and its activities.

Local wind conditions Light to moderate (0.5 m/s – 2 m/s), with winds blowing from the north-west. No rainfall observed. Refer to FAOA Logsheet N1473L-XXXV for details on recorded odour detections
