Clyde Waste Transfer Terminal

Odour Audit XXXX

Final Report

December 2022

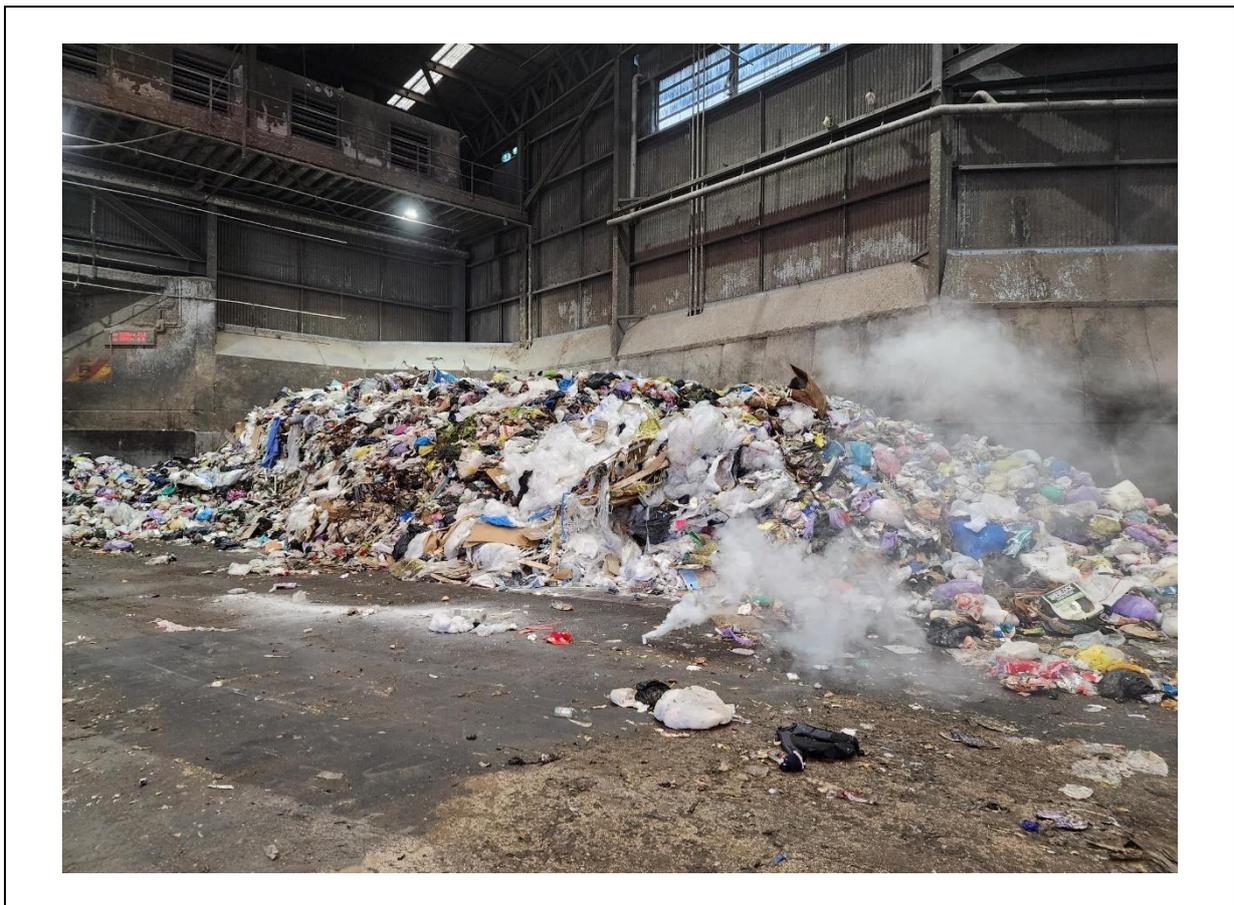
During the Odour Audit visit, there were approximately 140 tonnes of waste on the floor. This tonnage is within the normal operating range of the Transfer Terminal Building (TTB). The TTB floor area not covered by waste material was observed to be reasonably clean, with little evidence of leachate or aged material. The general housekeeping procedures of the TTB were good, as found during several truck-unloading sequences. It was also observed that the TTB's front-end loaders cleared the floor area of waste on a regular basis, minimising the exposed area of waste.

As with previous audits, and consistent with TOU's experience at other waste transfer stations, there was a weak to distinct level of odour observed within the TTB. A photo of the waste on the floor as found during the Odour Audit visit is shown in Photo 2.1.

Photo 2.1 – TTB waste on-floor as found on 21 December 2022 (during a smoke test)

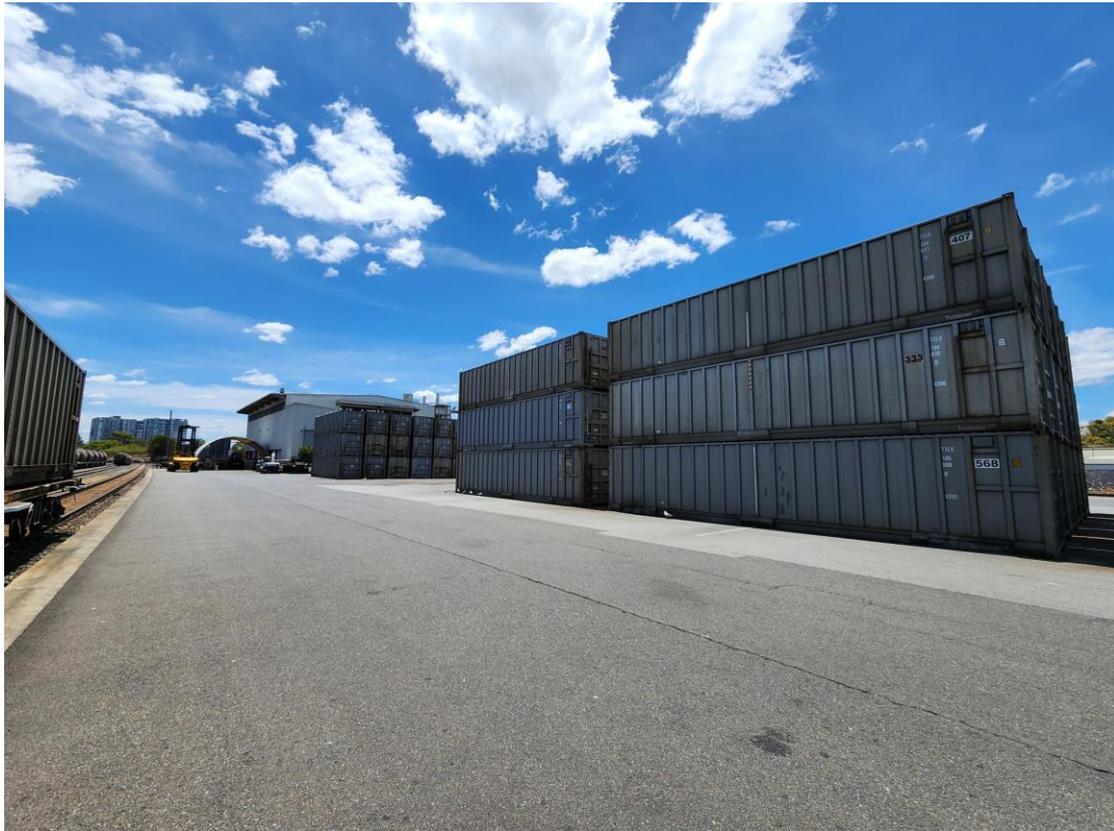
As per the Odour Management Plan dated February 2010 (the **February 2010 OMP**) for the Site, following the compaction of waste, all filled containers are entirely sealed and remain so while at the Site. All containers used are required to be in good condition, and unused/returned containers adequately clean. The Odour Audit finds that this continues to be current practice at the Site. A view of the condition of the container area as found on 21 December 2022 is shown in **Photo 2.2**.

Photo 2.2 – A view of the container area as found on 21 December 2022

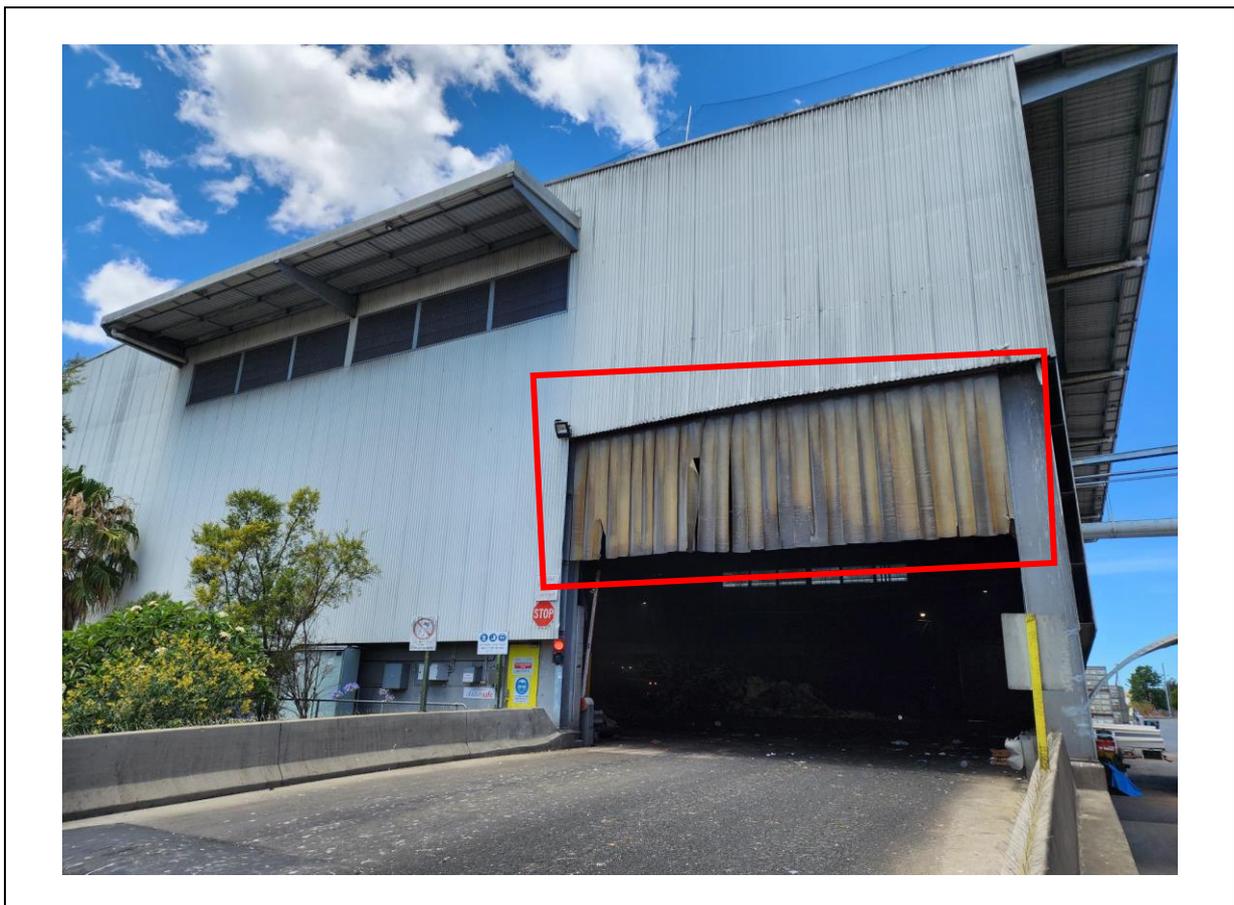
The truck entrance plastic strips of the TTB, used to reduce odour escaping through the opening, were found to be superficially damaged and in a state to function and effectively reduce air movement at the top section of the truck entrance (refer to **Photo 2.3**).

Photo 2.3 – A view of the truck entrance plastic strips as found on 21 December 2022

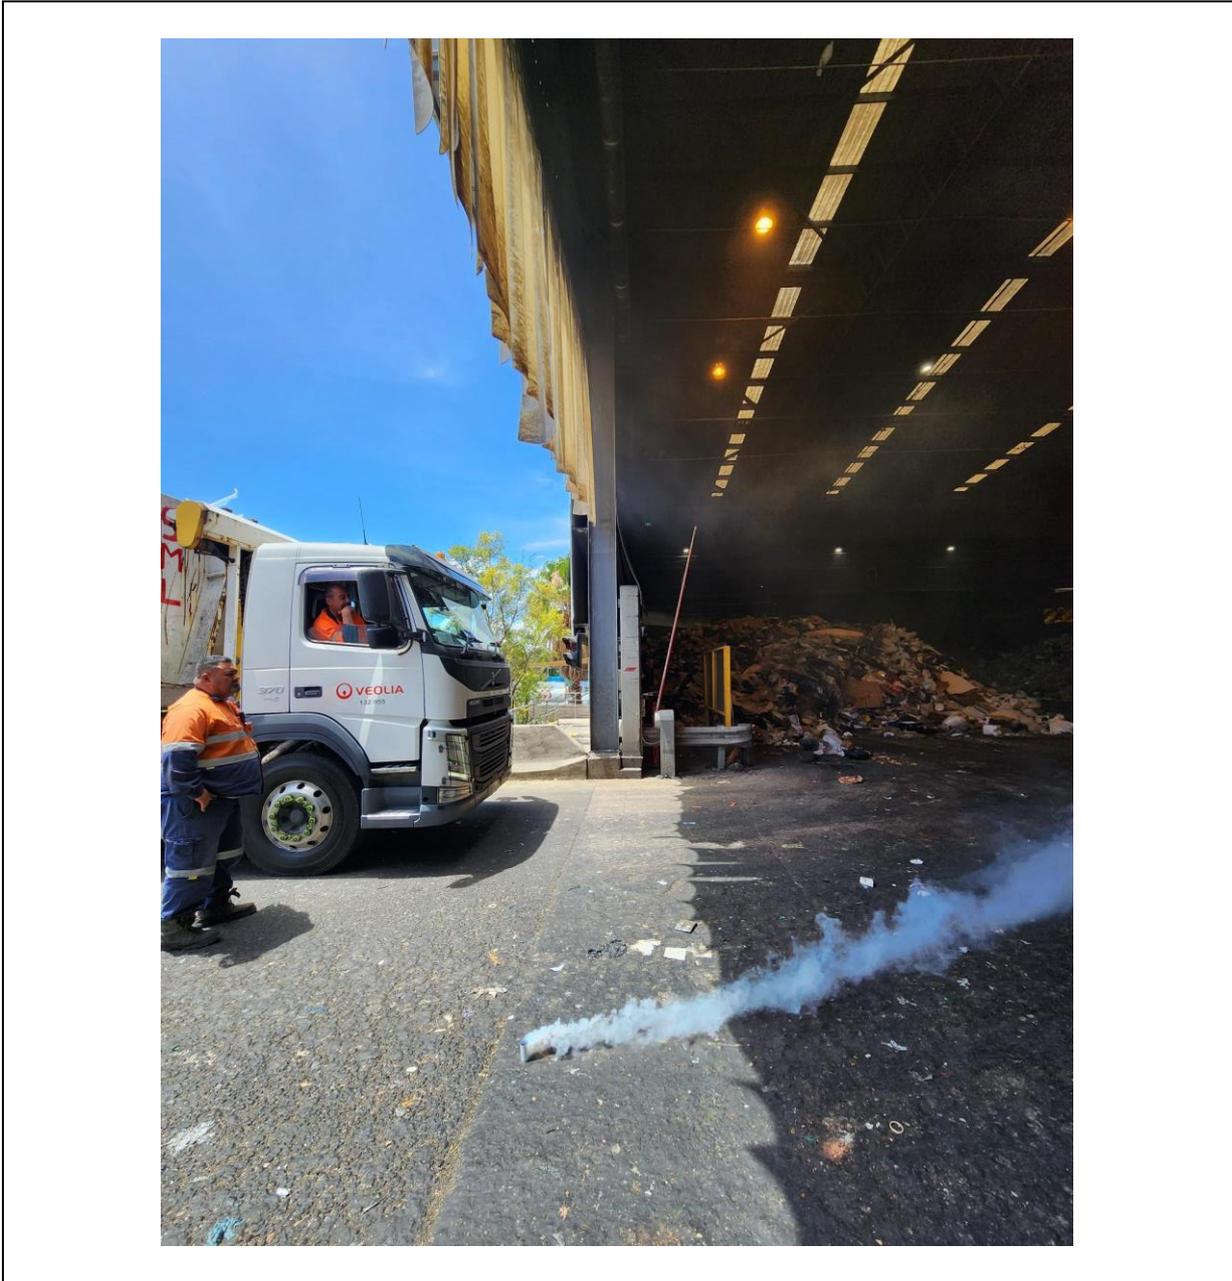
Photo 2.4 – A view of the truck entrance plastic strips during smoke testing on 21 December 2022

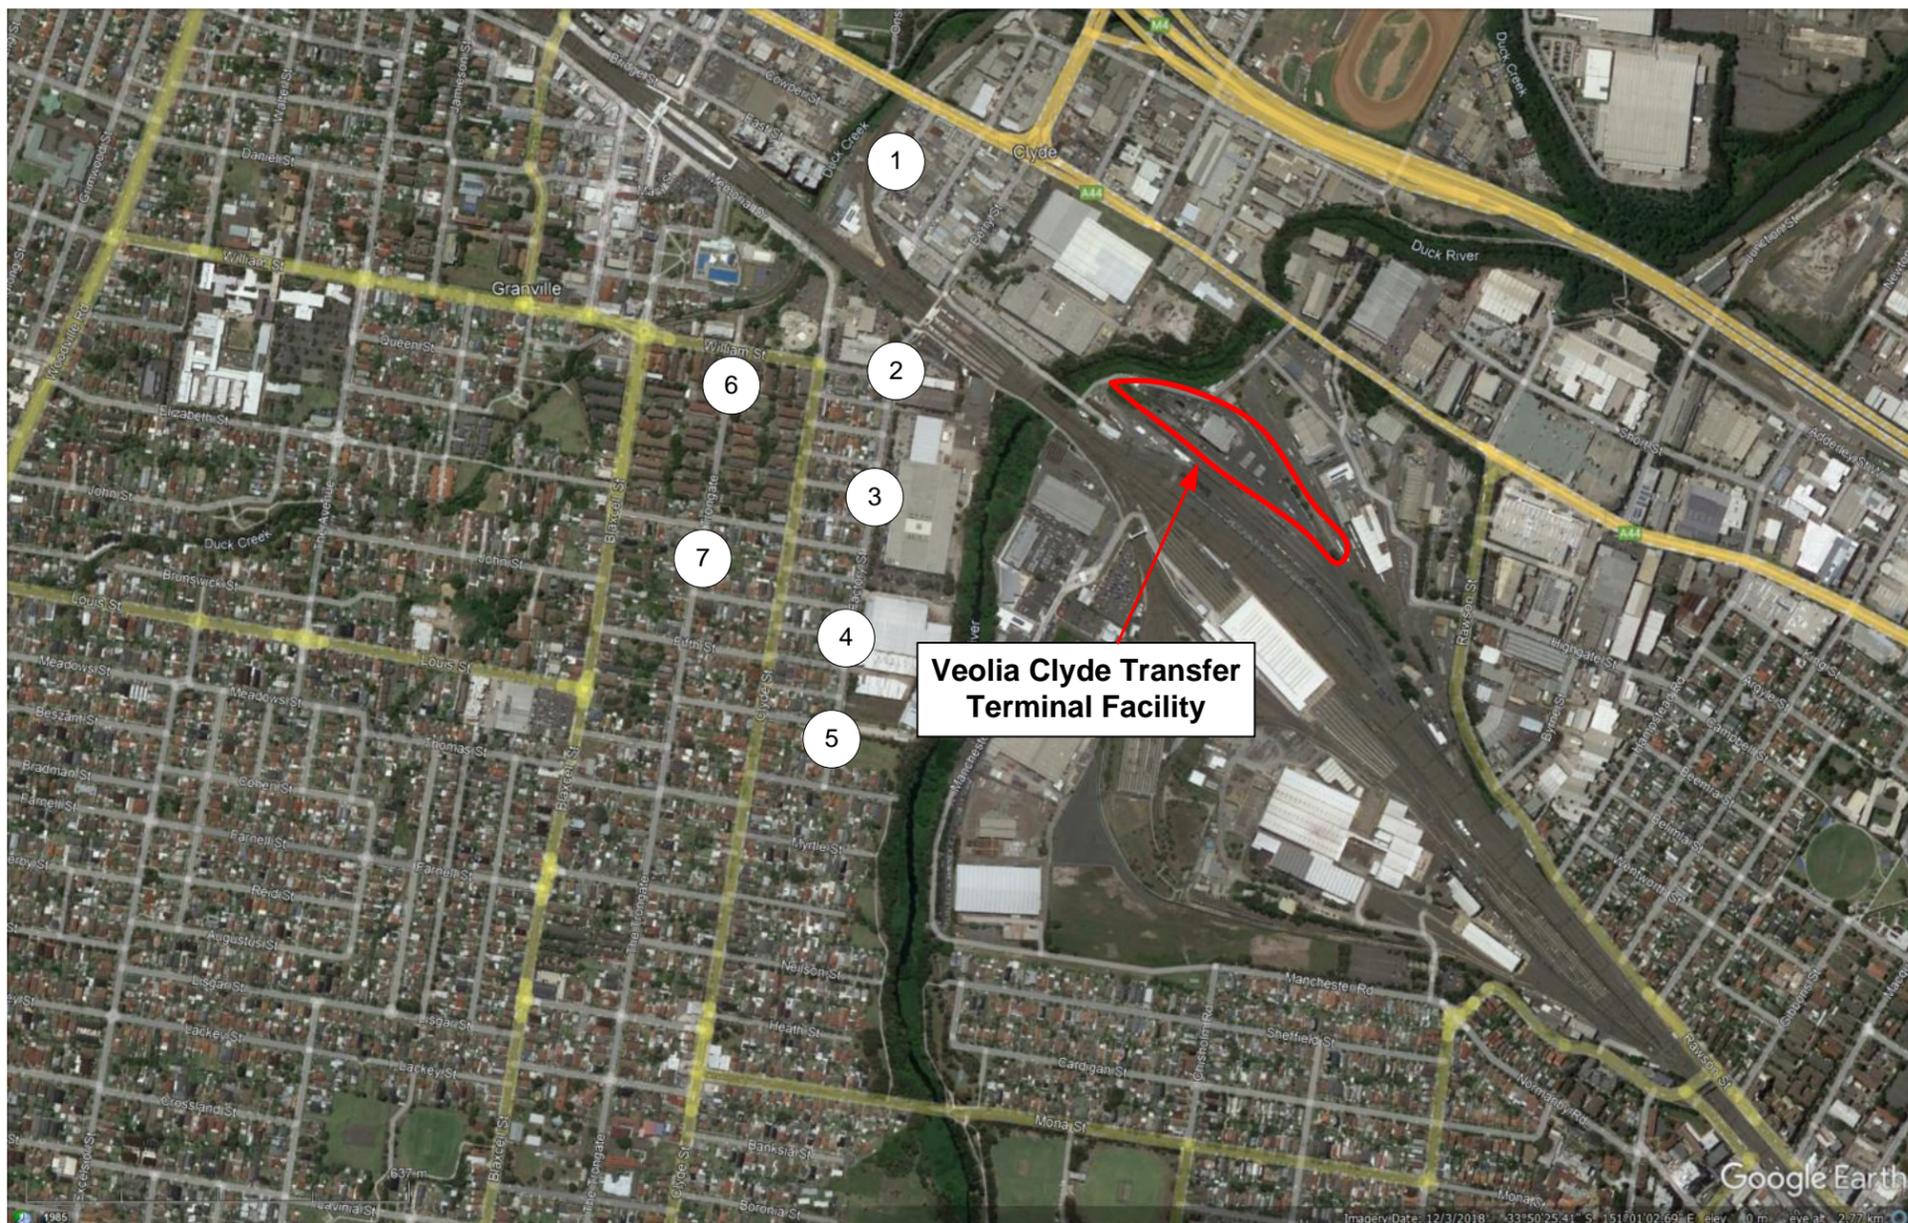
FIELD AMBIENT ODOUR ASSESSMENT PLOT AND FIELD SHEET

The results of the FAOA survey conducted during the Odour Audit found that whilst intermittent odours were detected on-site, no odours were detectable off-site that could be linked back to the Site and its activities. This is a good outcome and reflects the findings from previous odour audits. The field log sheets, and visual survey plot are appended as **Appendix C**.
