**TO: ANAE RESSOS**  
**COMPANY: VEOLIA (AUSTRALIA) PTY LTD**  
**FROM: ISAAC FARRUGIA & MICHAEL ASSAL**  
**DATE: 11 FEBRUARY 2024**  
**JOB NO: N1906**  
**SUBJECT: BANKSMEADOW WASTE TRANSFER TERMINAL FACILITY – ON-GOING ODOUR AUDIT PROGRAM: JULY 2023**

The following technical memorandum documents the findings and recommendations from an on-going, six-monthly odour audit program (the **Audit**) being conducted by The Odour Unit Pty Ltd (**TOU**) at the Veolia (Australia) Pty Ltd (**Veolia**) Waste Transfer Terminal Facility, 34/36 McPherson Street, Banksmeadow, New South Wales (**BTT Facility**). The Audit documented in this memorandum report covers the outcome of the visit conducted by TOU at the BTT Facility on 4 & 5 July 2023. This report for the Audit documents the following:

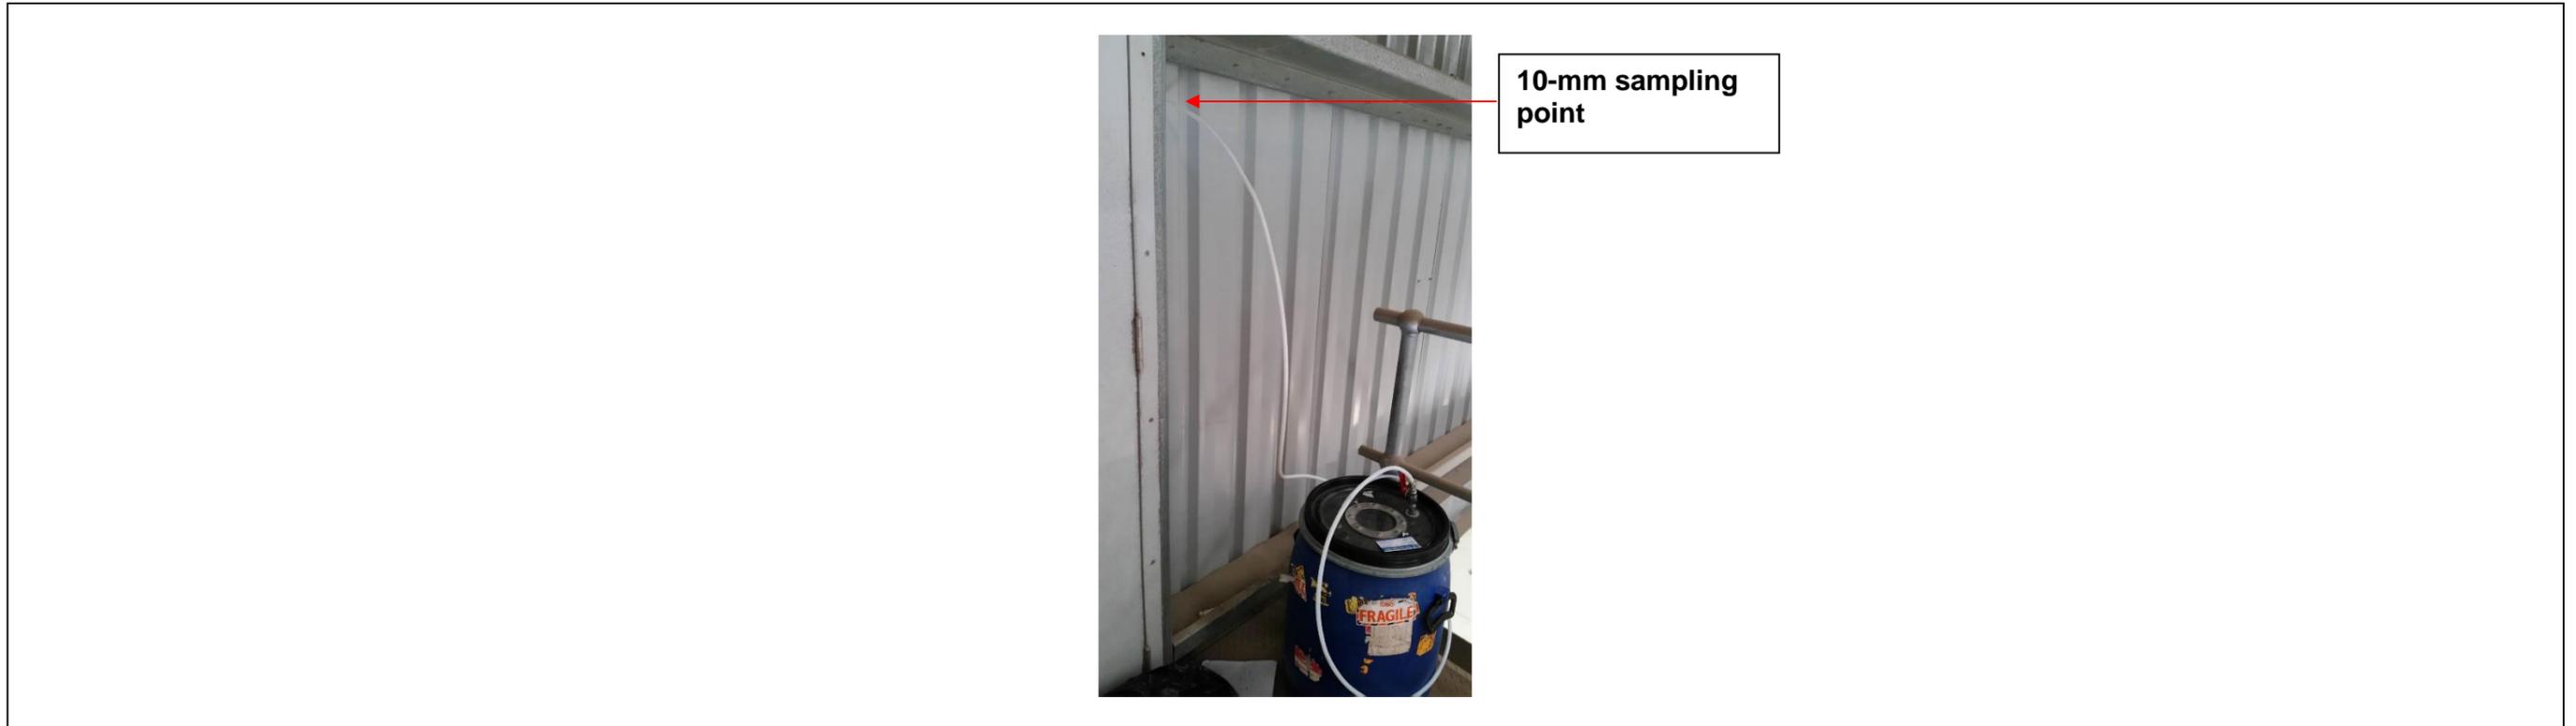
The point source sampling method was utilised to collect samples from a 10-millimetre (**mm**) tap point created in the common plenum chamber of the two fan modules servicing the building ventilation extraction system at the BTT Facility. An illustration of the location and sampling technique is presented in **Photo 1**.

**Photo 1** – An example of the roof discharge stack odour sampling point at the BTT Facility

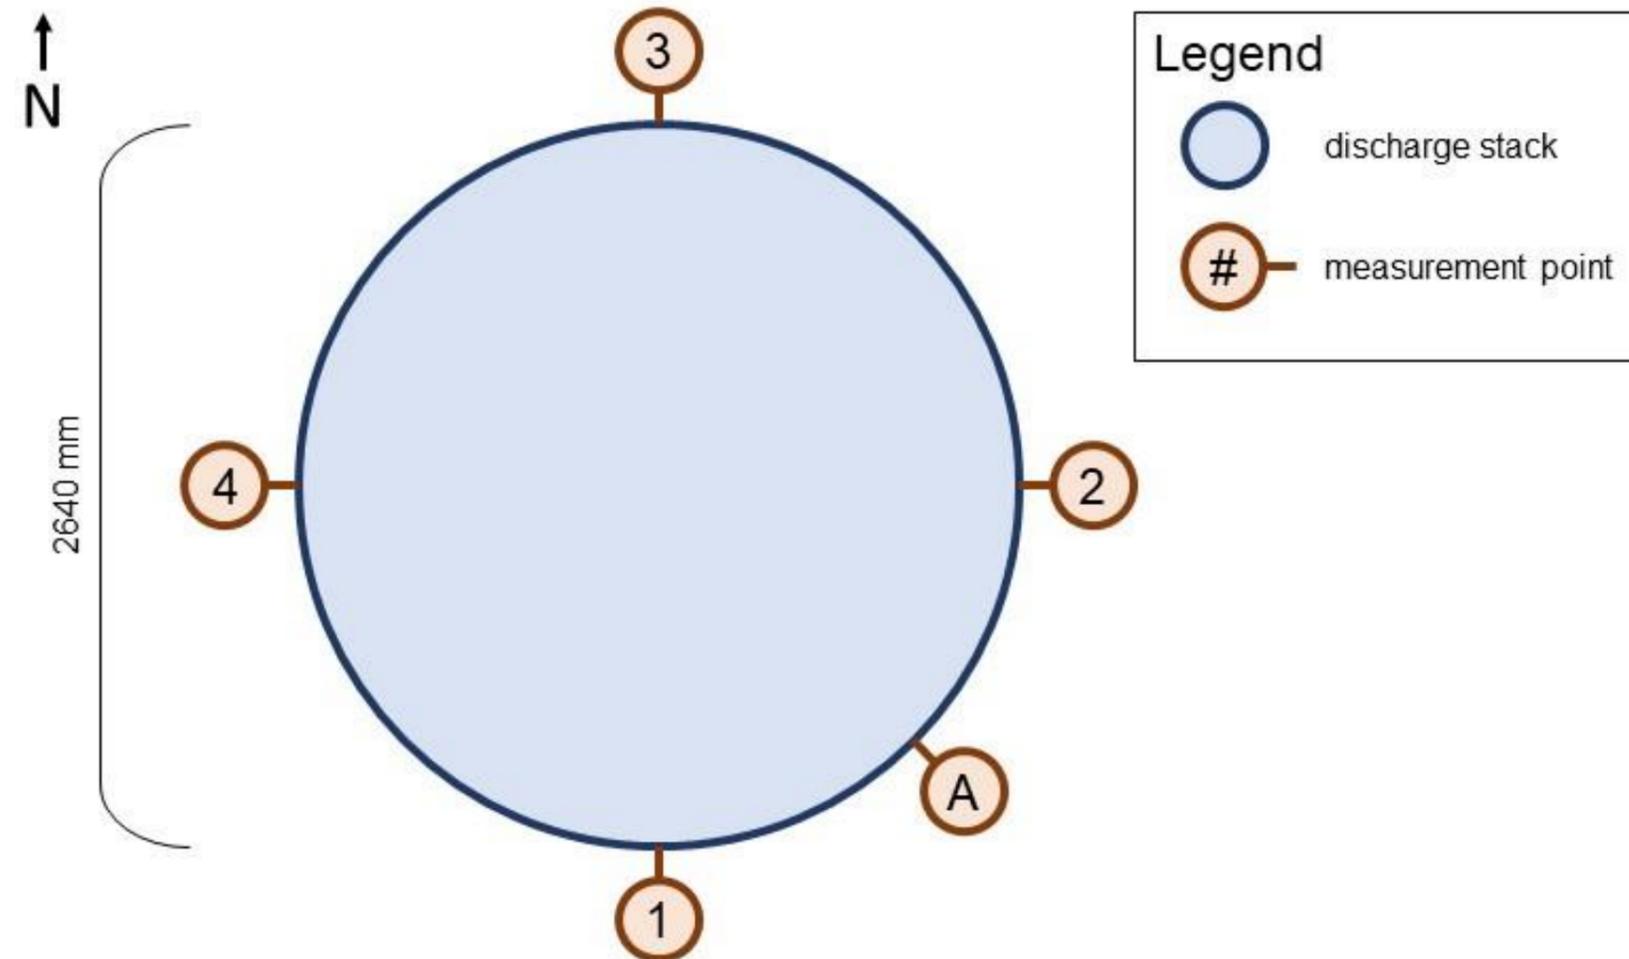
The methodology used to measure the airflow from the roof discharge stack was via a hot-wire anemometer at four (4) pre-drilled measurement locations, as illustrated in **Figure 2**. Notably, measurement point A is the location of the velocity sensor probe. These measurements were compared against the airflow sensor readings to determine the accuracy of the airflow sensor (refer to **Table 3**).

Figure 2 – Diagram displaying a cross-sectional view of the roof discharge stack and location of measurement points

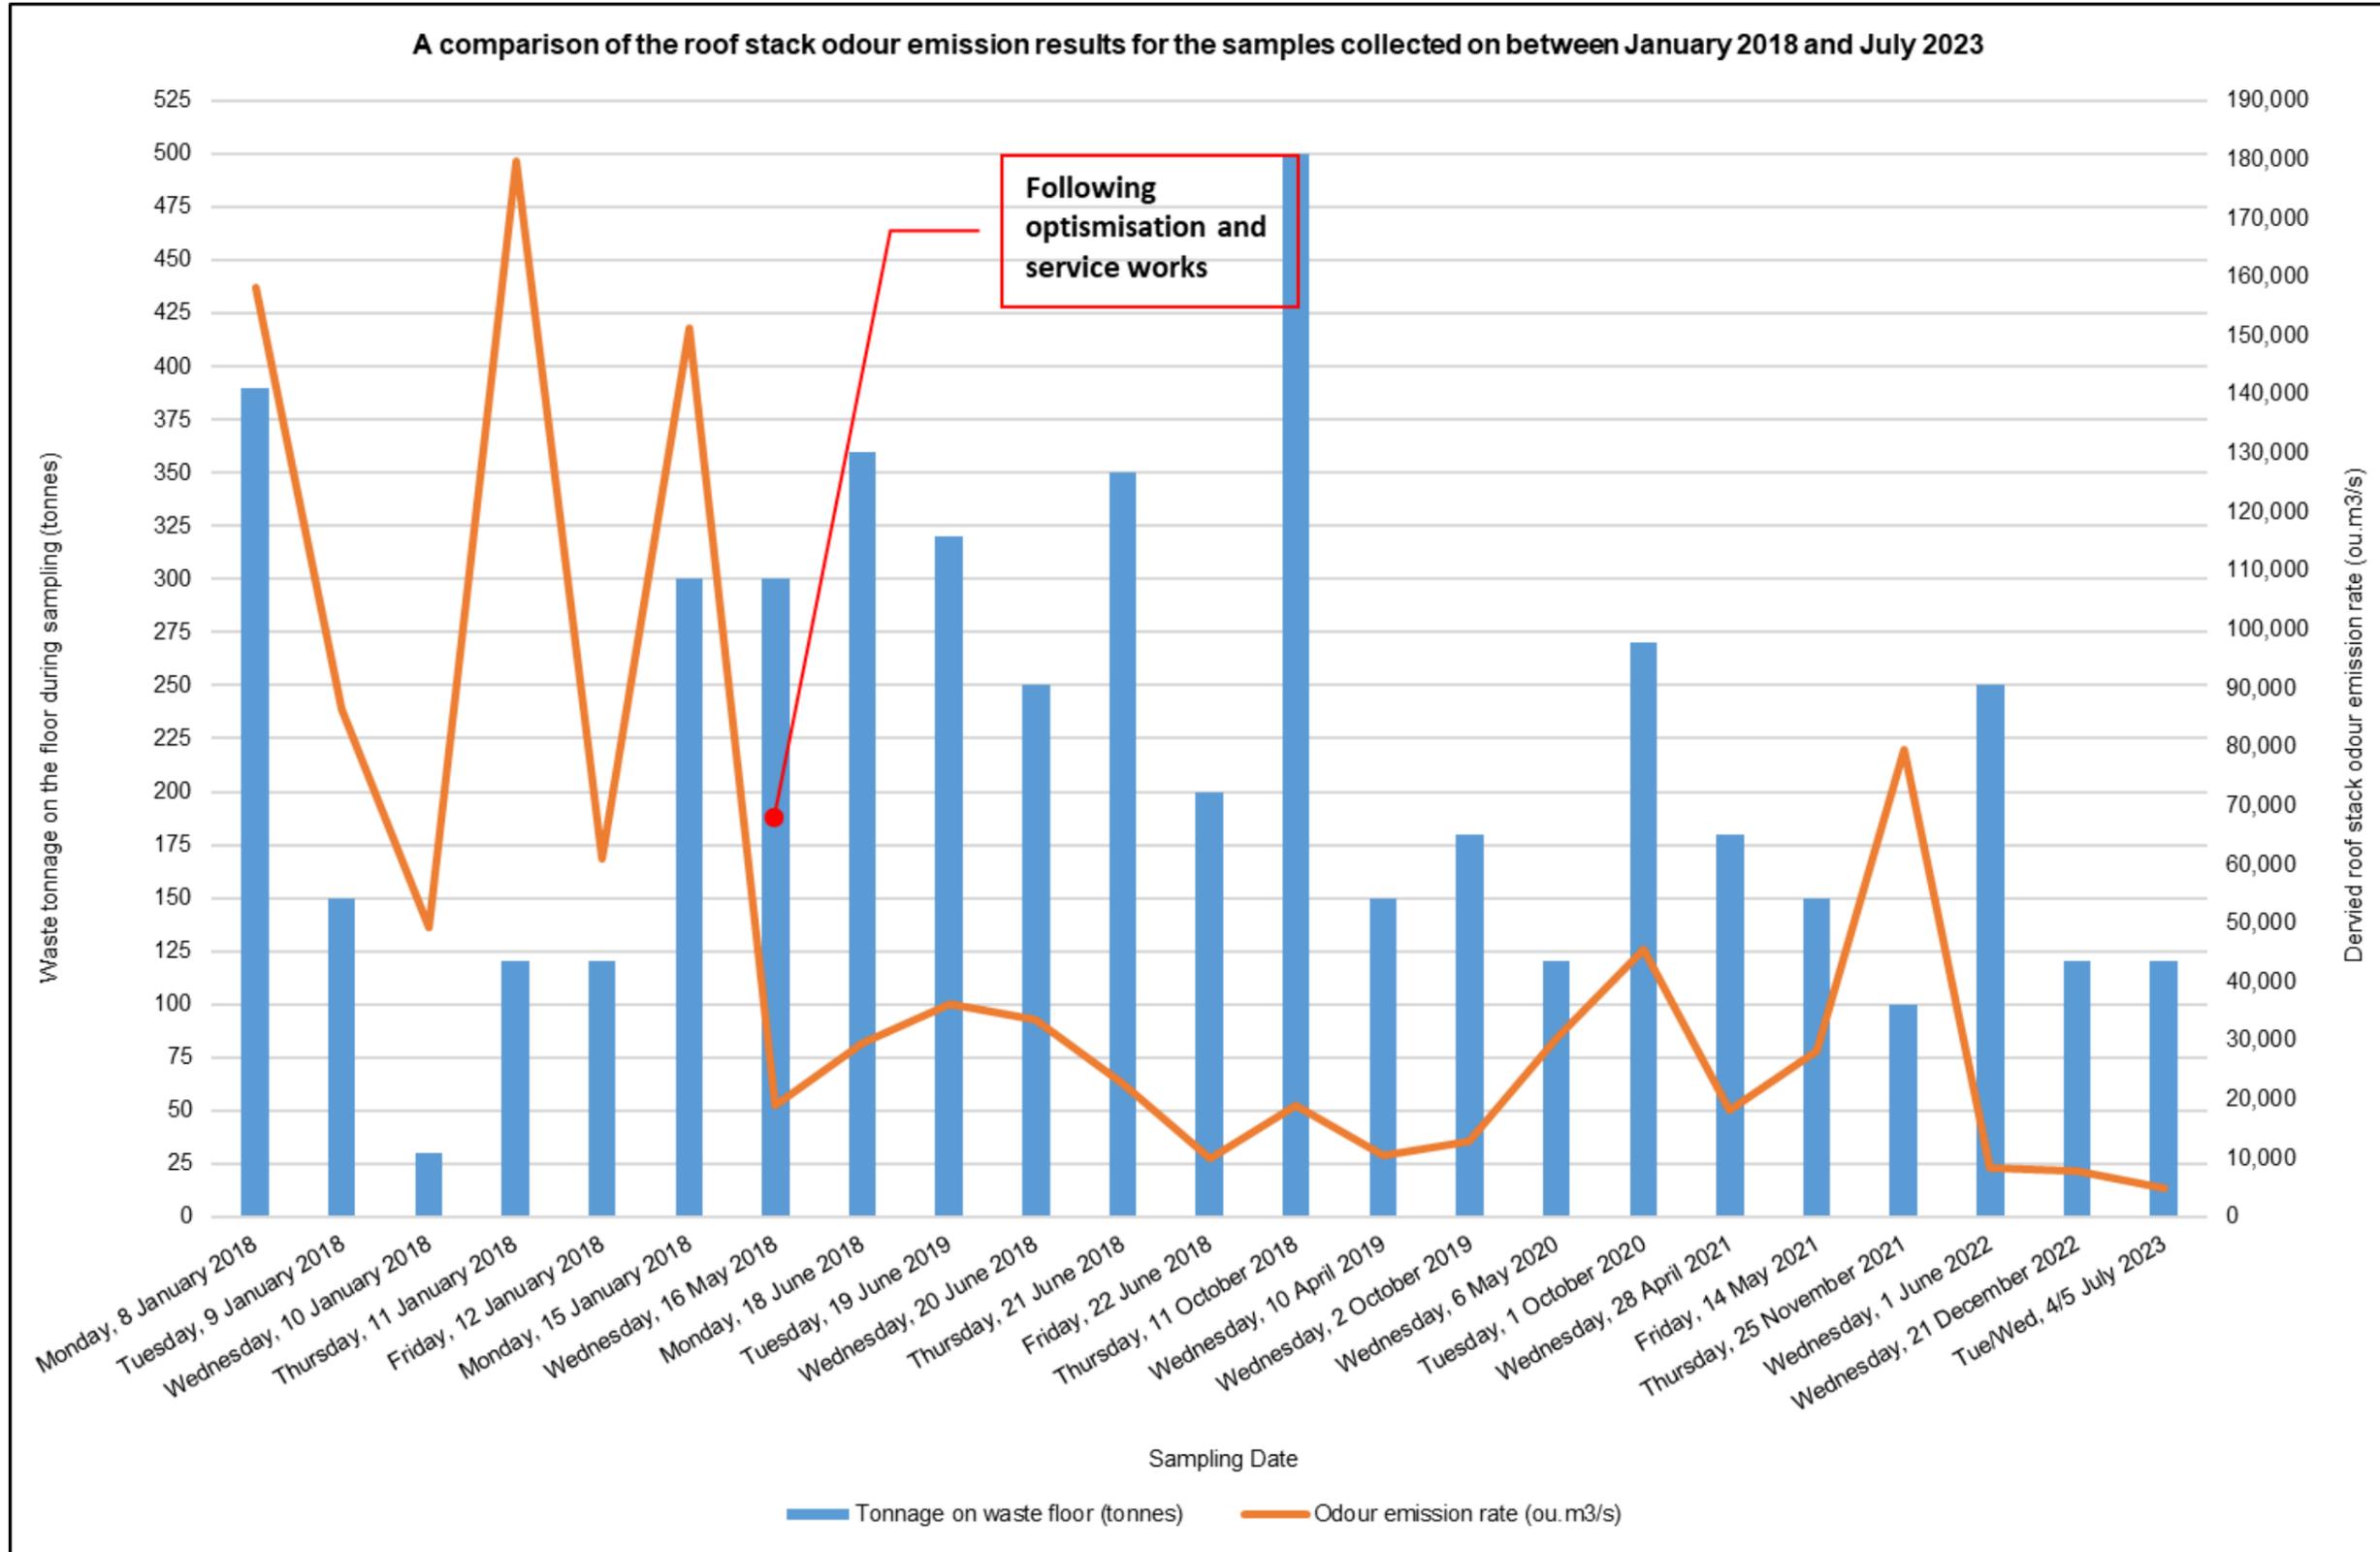
The roof discharge stack odour emission results are presented in **Table 1**. The historical trend between waste tonnage on the floor and the stack odour emission rate at the BTT Facility until 4 & 5 July 2023 is presented in **Figure 3**.

Figure 3 – Comparison of the roof stack odour emission rate between December 2022 and July 2023

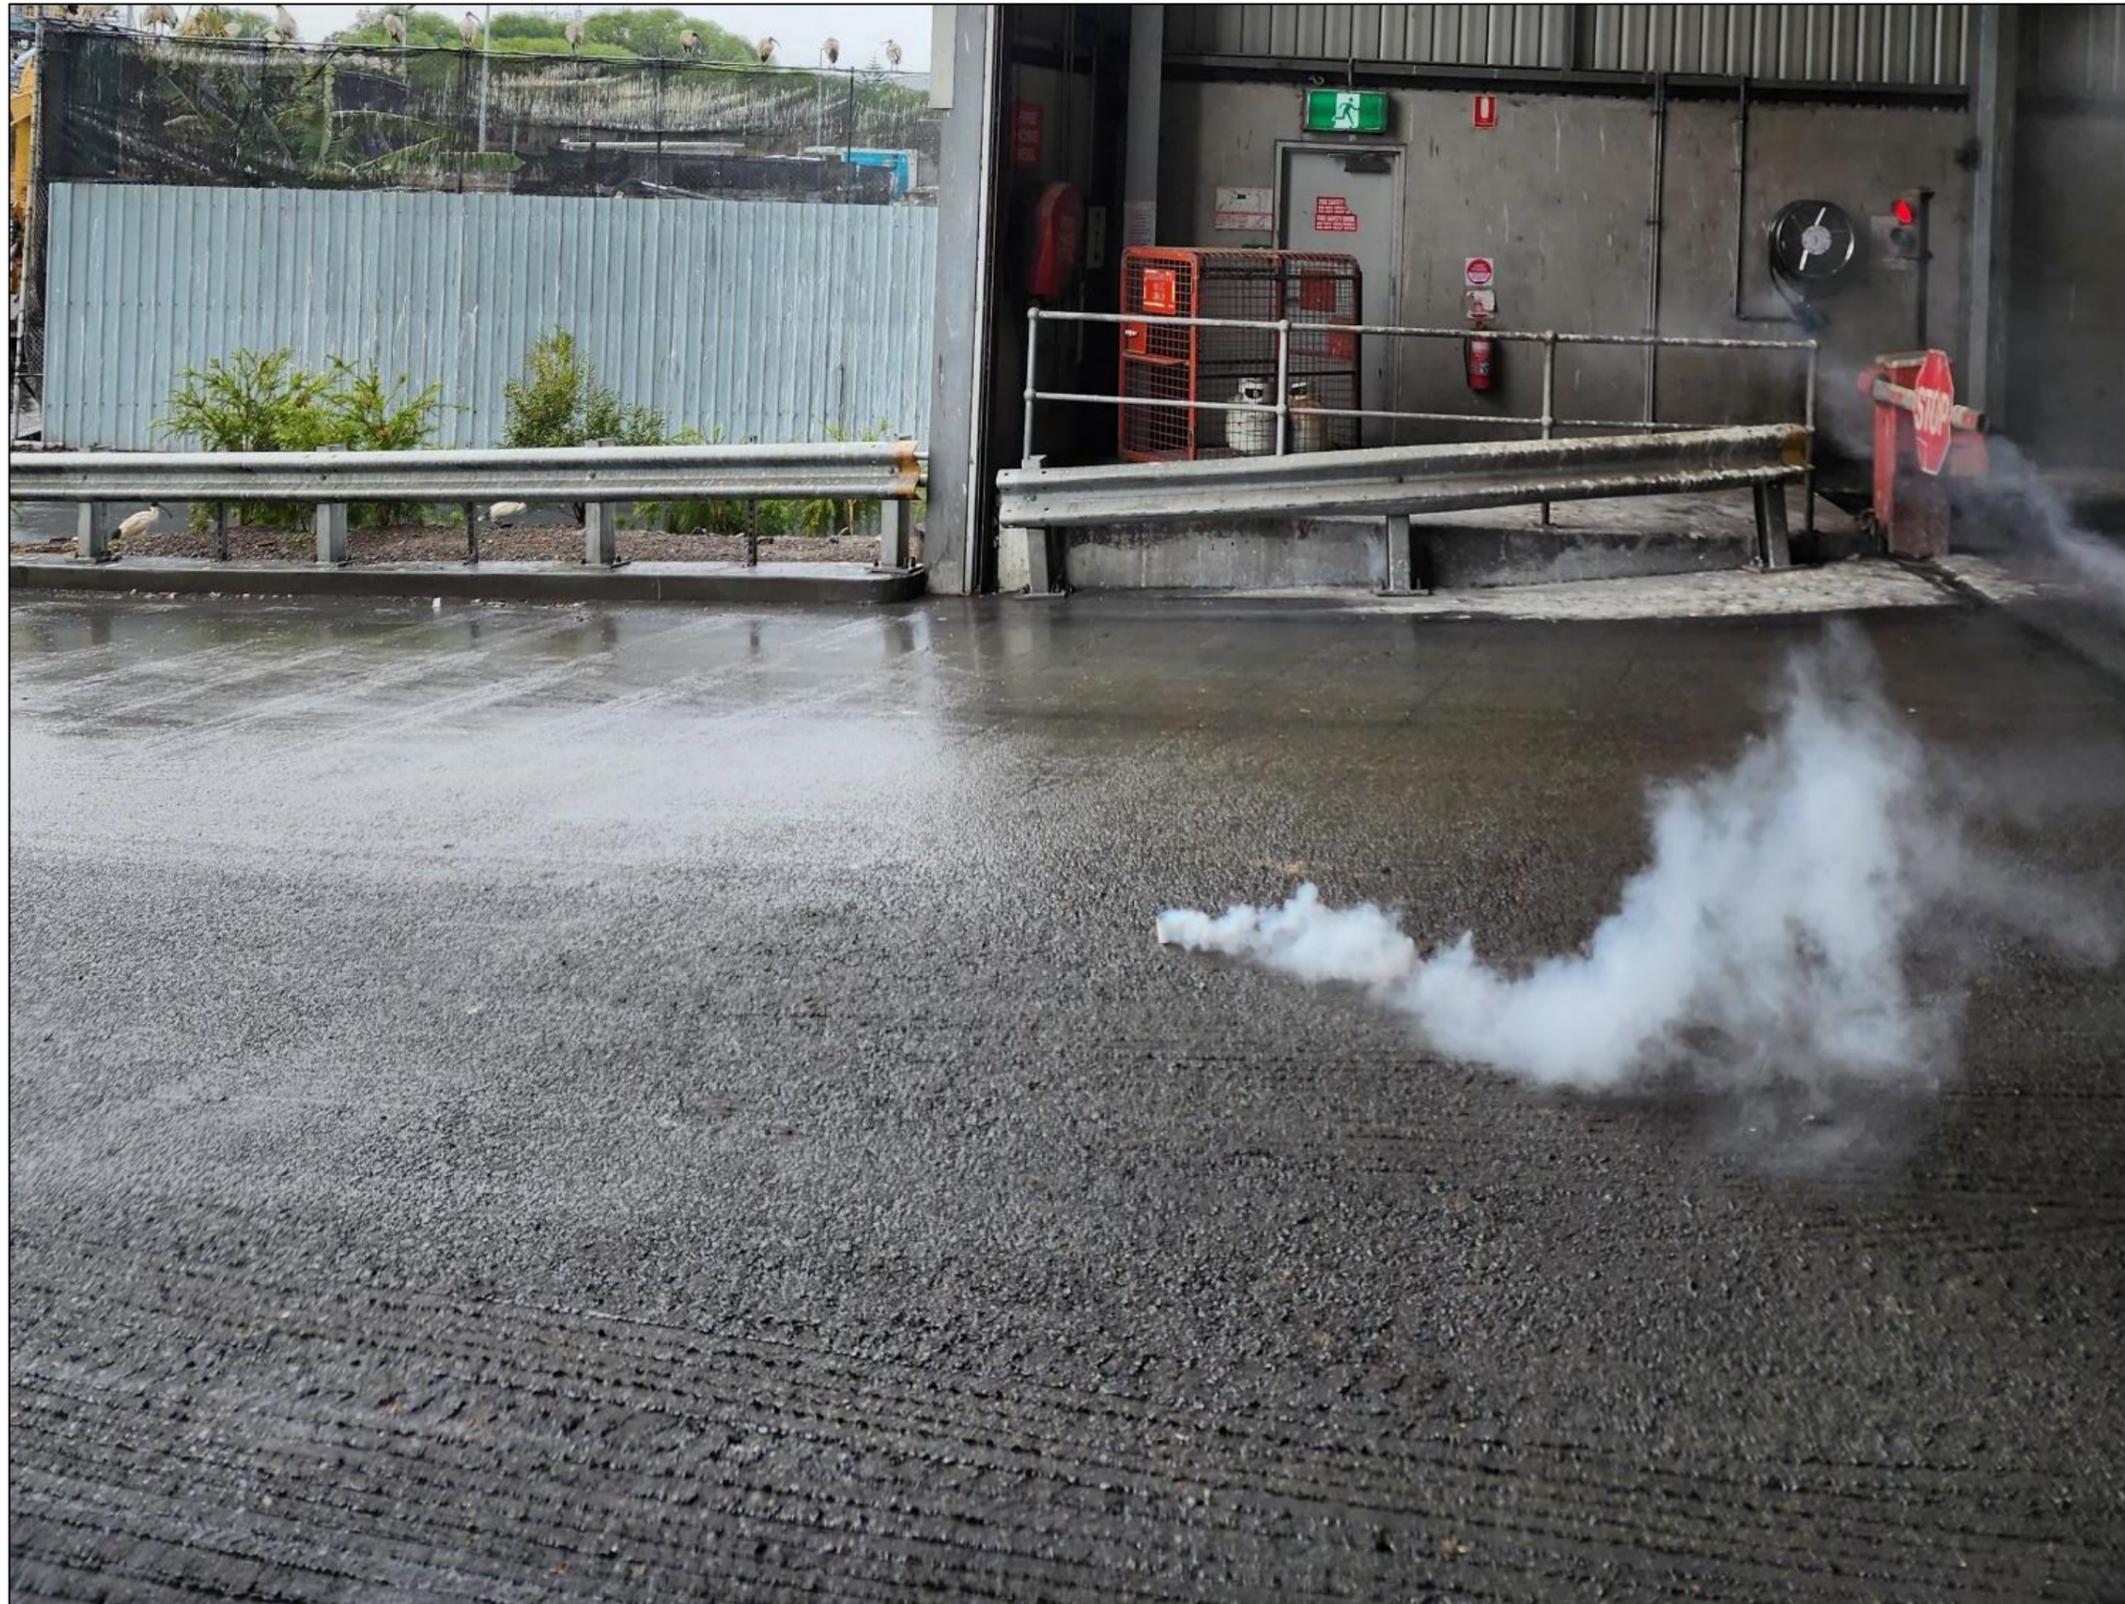
Several smoke release points were undertaken to evaluate airflow patterns and fugitive emission release within the BTT Facility building enclosure. The smoke release points included the northern, middle, and southern areas of the BTT Facility building enclosure. A photo of a smoke testing point at the truck entry point of the BTT Facility, as occurred on 4 July 2023, is shown in **Photo 2**. A photo of the smoke testing within the BTT Facility building enclosure is shown in **Photo 3**. The observations made during smoke testing are as follows:

- No smoke was found to be emanating from the sealed breezeways around the perimeter of the BTT Facility building;
- The released smoke was found to be well-contained within the BTT Facility building enclosure, suggesting that odour release at ground level is minimal; and
- The released smoke was found to dissipate over time gradually. This indicates that there is a very good level of air exchange turnover within the BTT Facility building enclosure.

**Photo 2** – Smoke testing at the truck entry point of the BTT Facility building enclosure on 4 July 2023

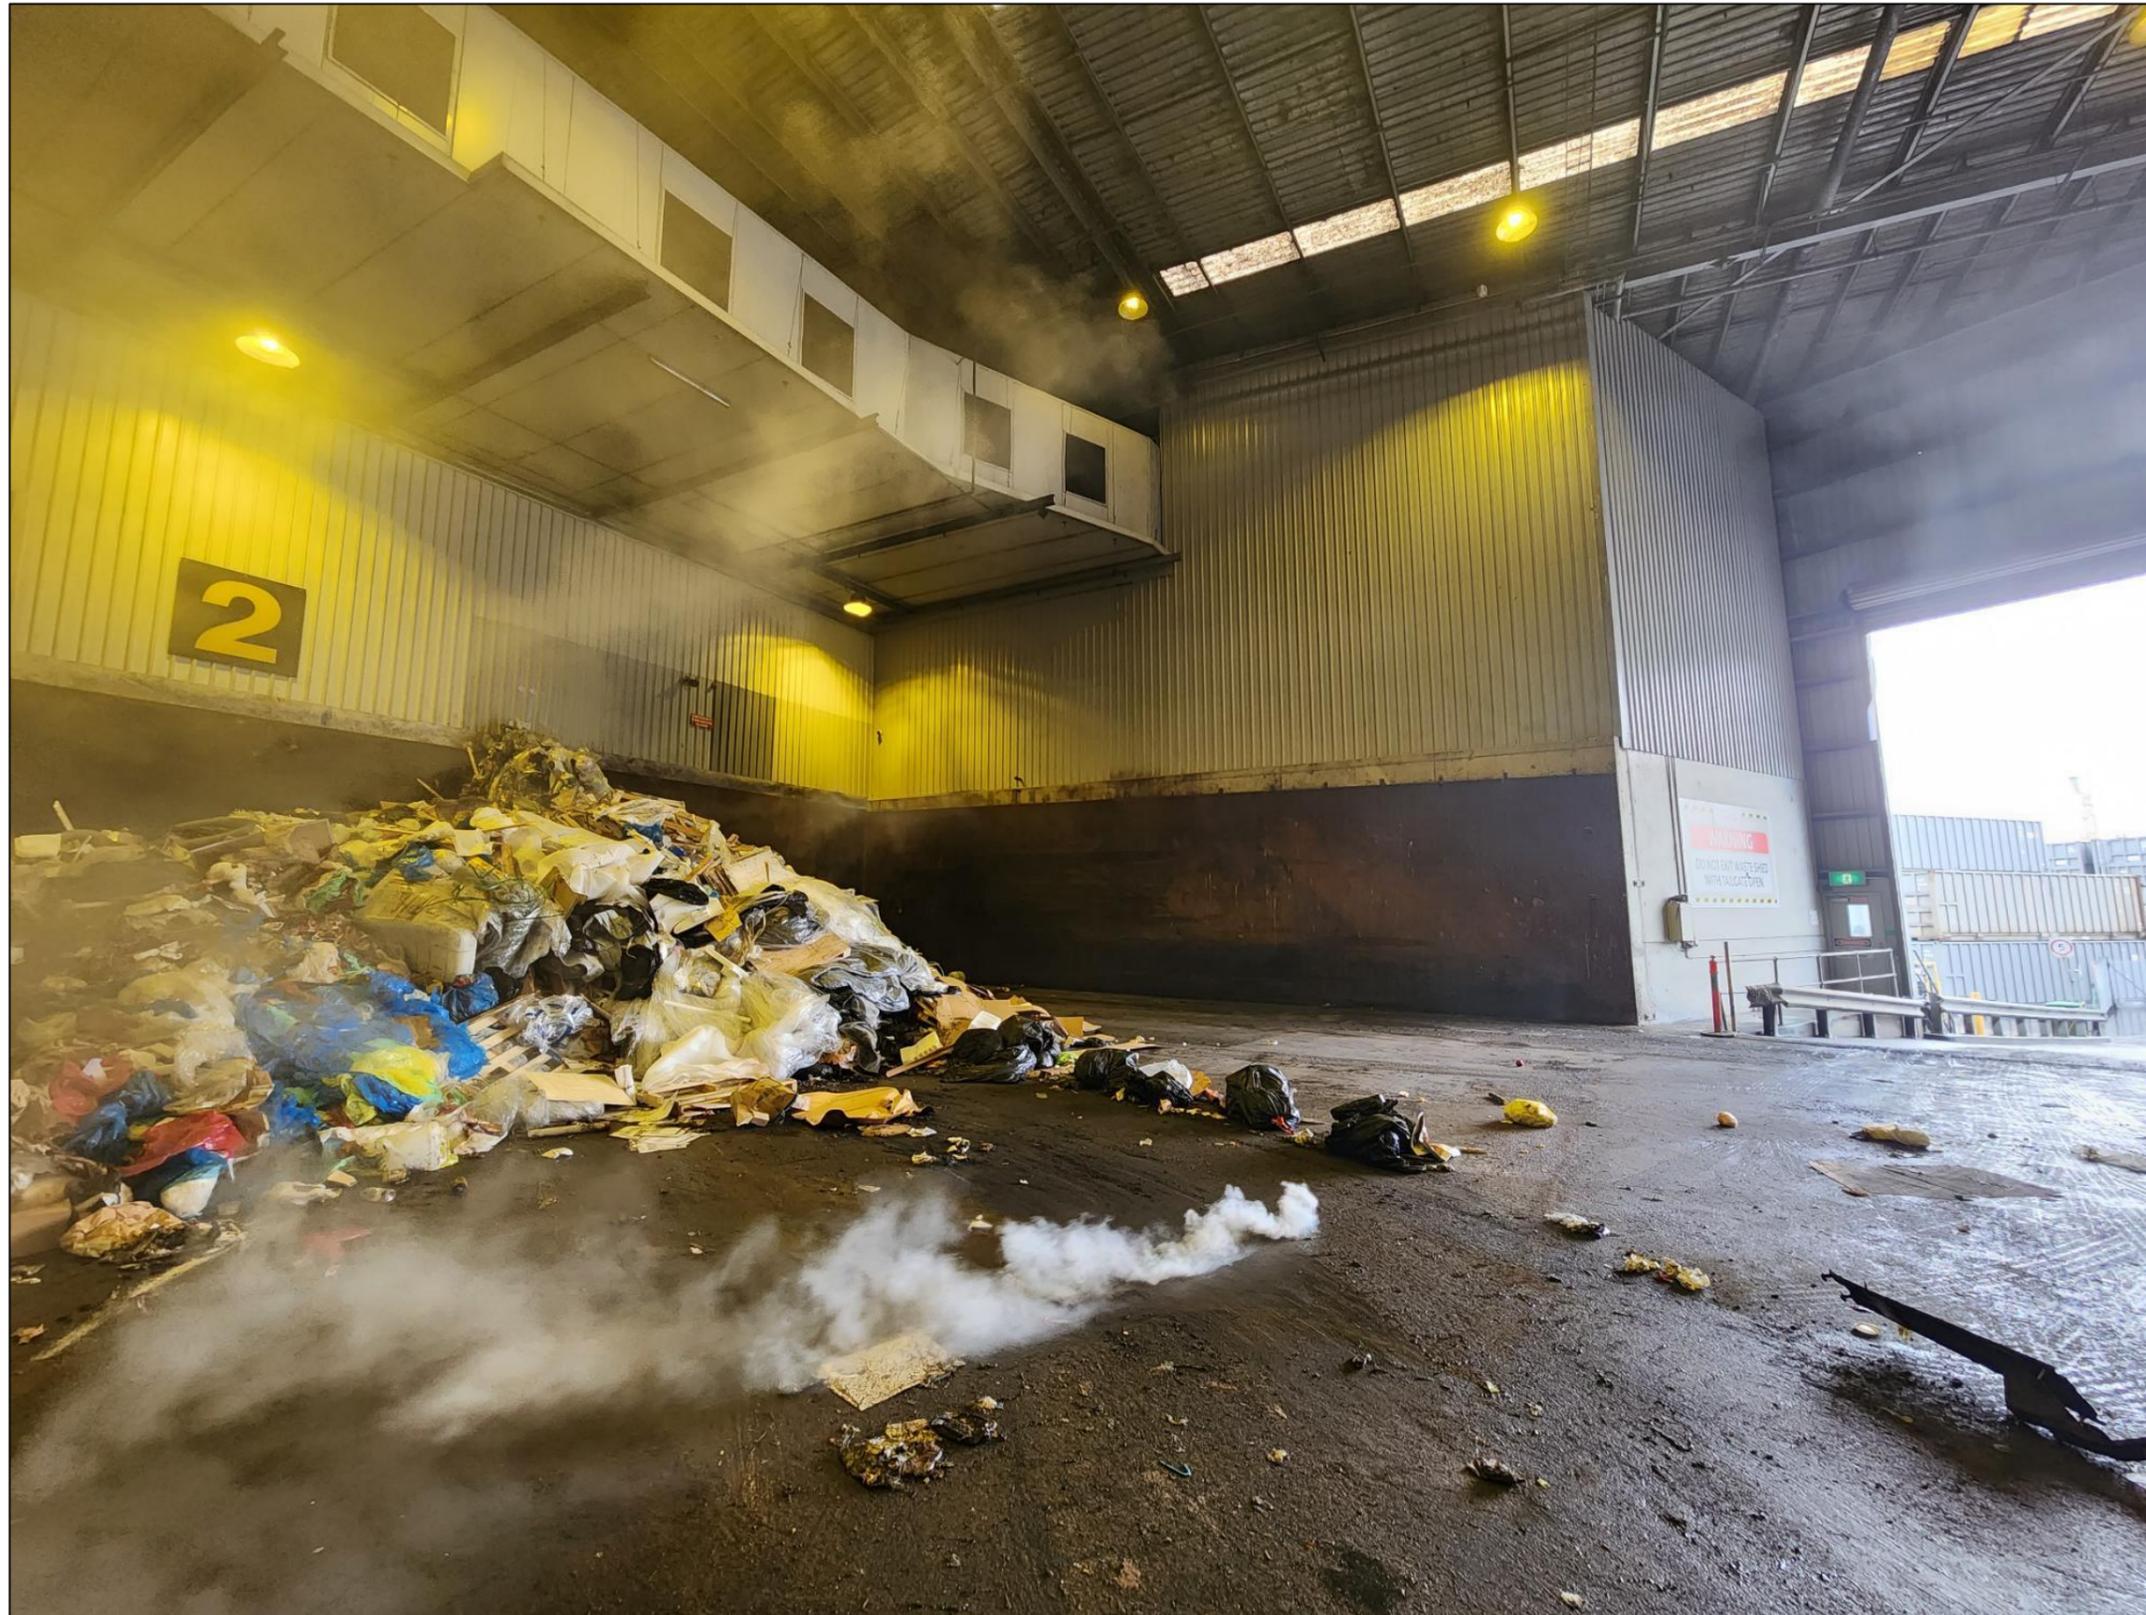
**Photo 3** – A picture of the BTT Facility waste floor area during smoke testing on 4 July 2023

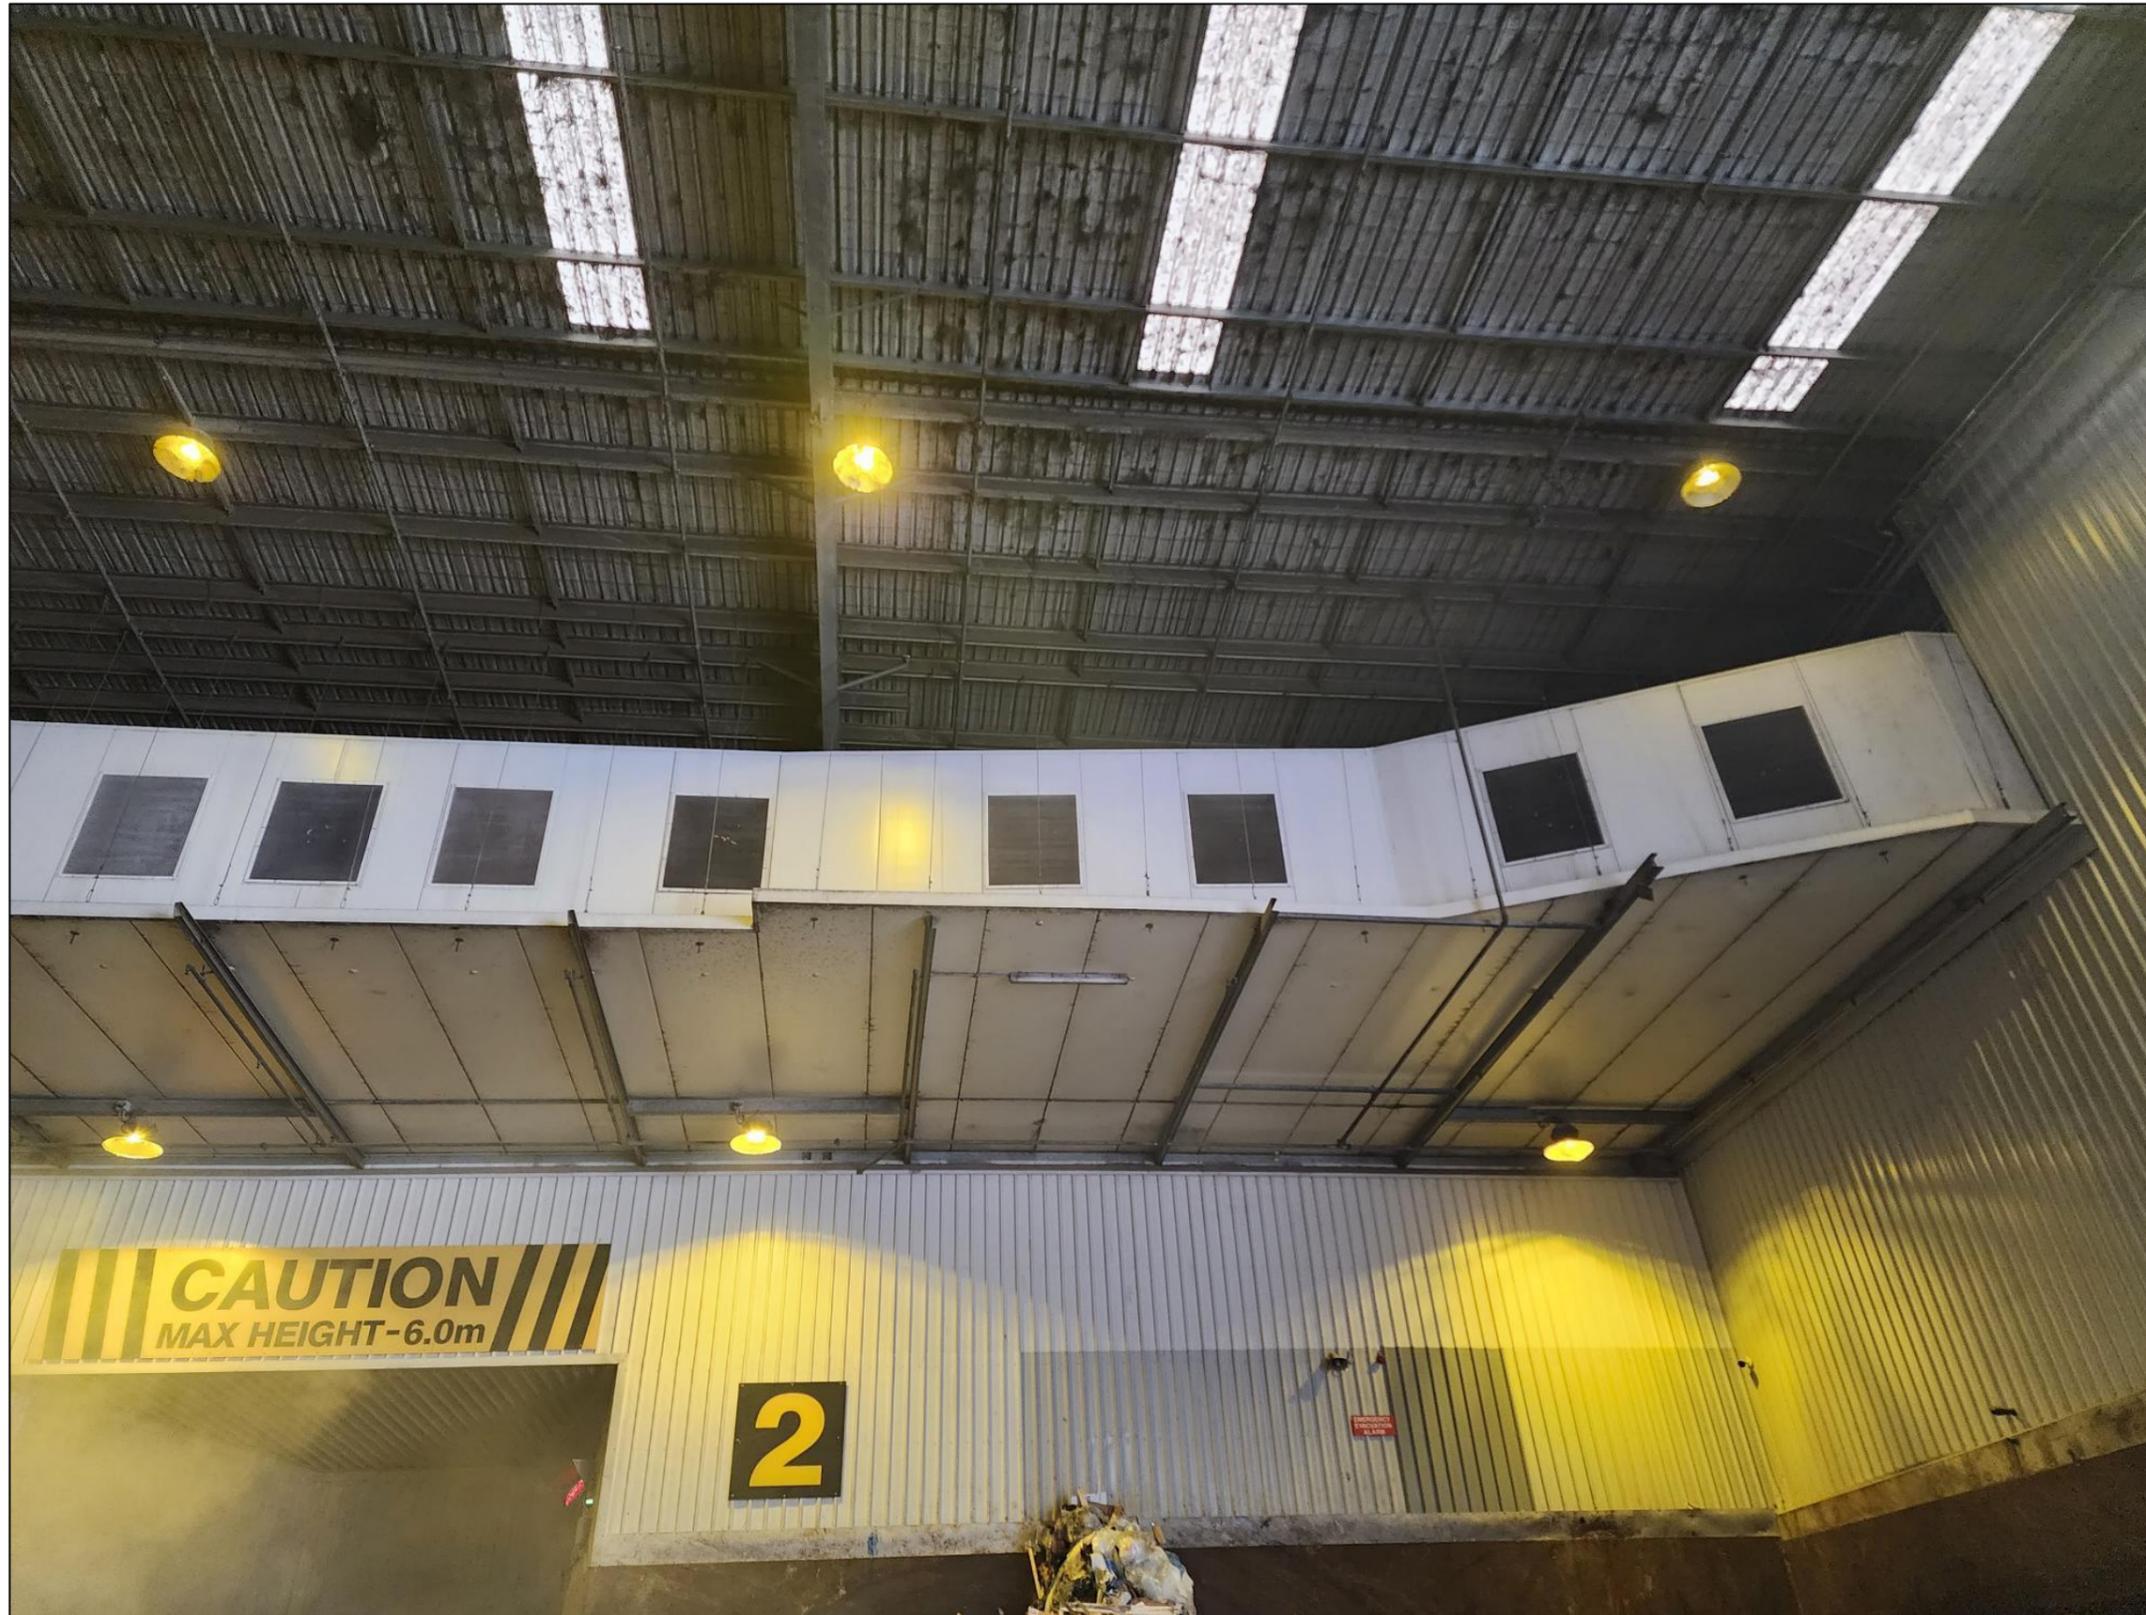
The walls and air collection grilles of the BTT Facility building have been cleaned since the December 2022 Report (refer to **Photo 4**). The truck entrance plastic strips were found to be in good condition at the time of the Audit (refer to **Photo 5**). The storage container area was found to be well-maintained at the time of the Audit (refer to **Photo 6**).

**Photo 4** – A view of the ventilation collection points: 4 July 2023 (Note: The walls and collection grilles have been cleaned since the December 2022 Audit)

- The smoke testing conducted within the BTT Facility building enclosure indicated positive results and suggested that the building ventilation air extraction system at the BTT Facility is operating effectively. It was noted that the collection grilles for the ventilation collection system (refer to **Photo 4**) and internal building walls have been cleaned since the December 2022 Audit;

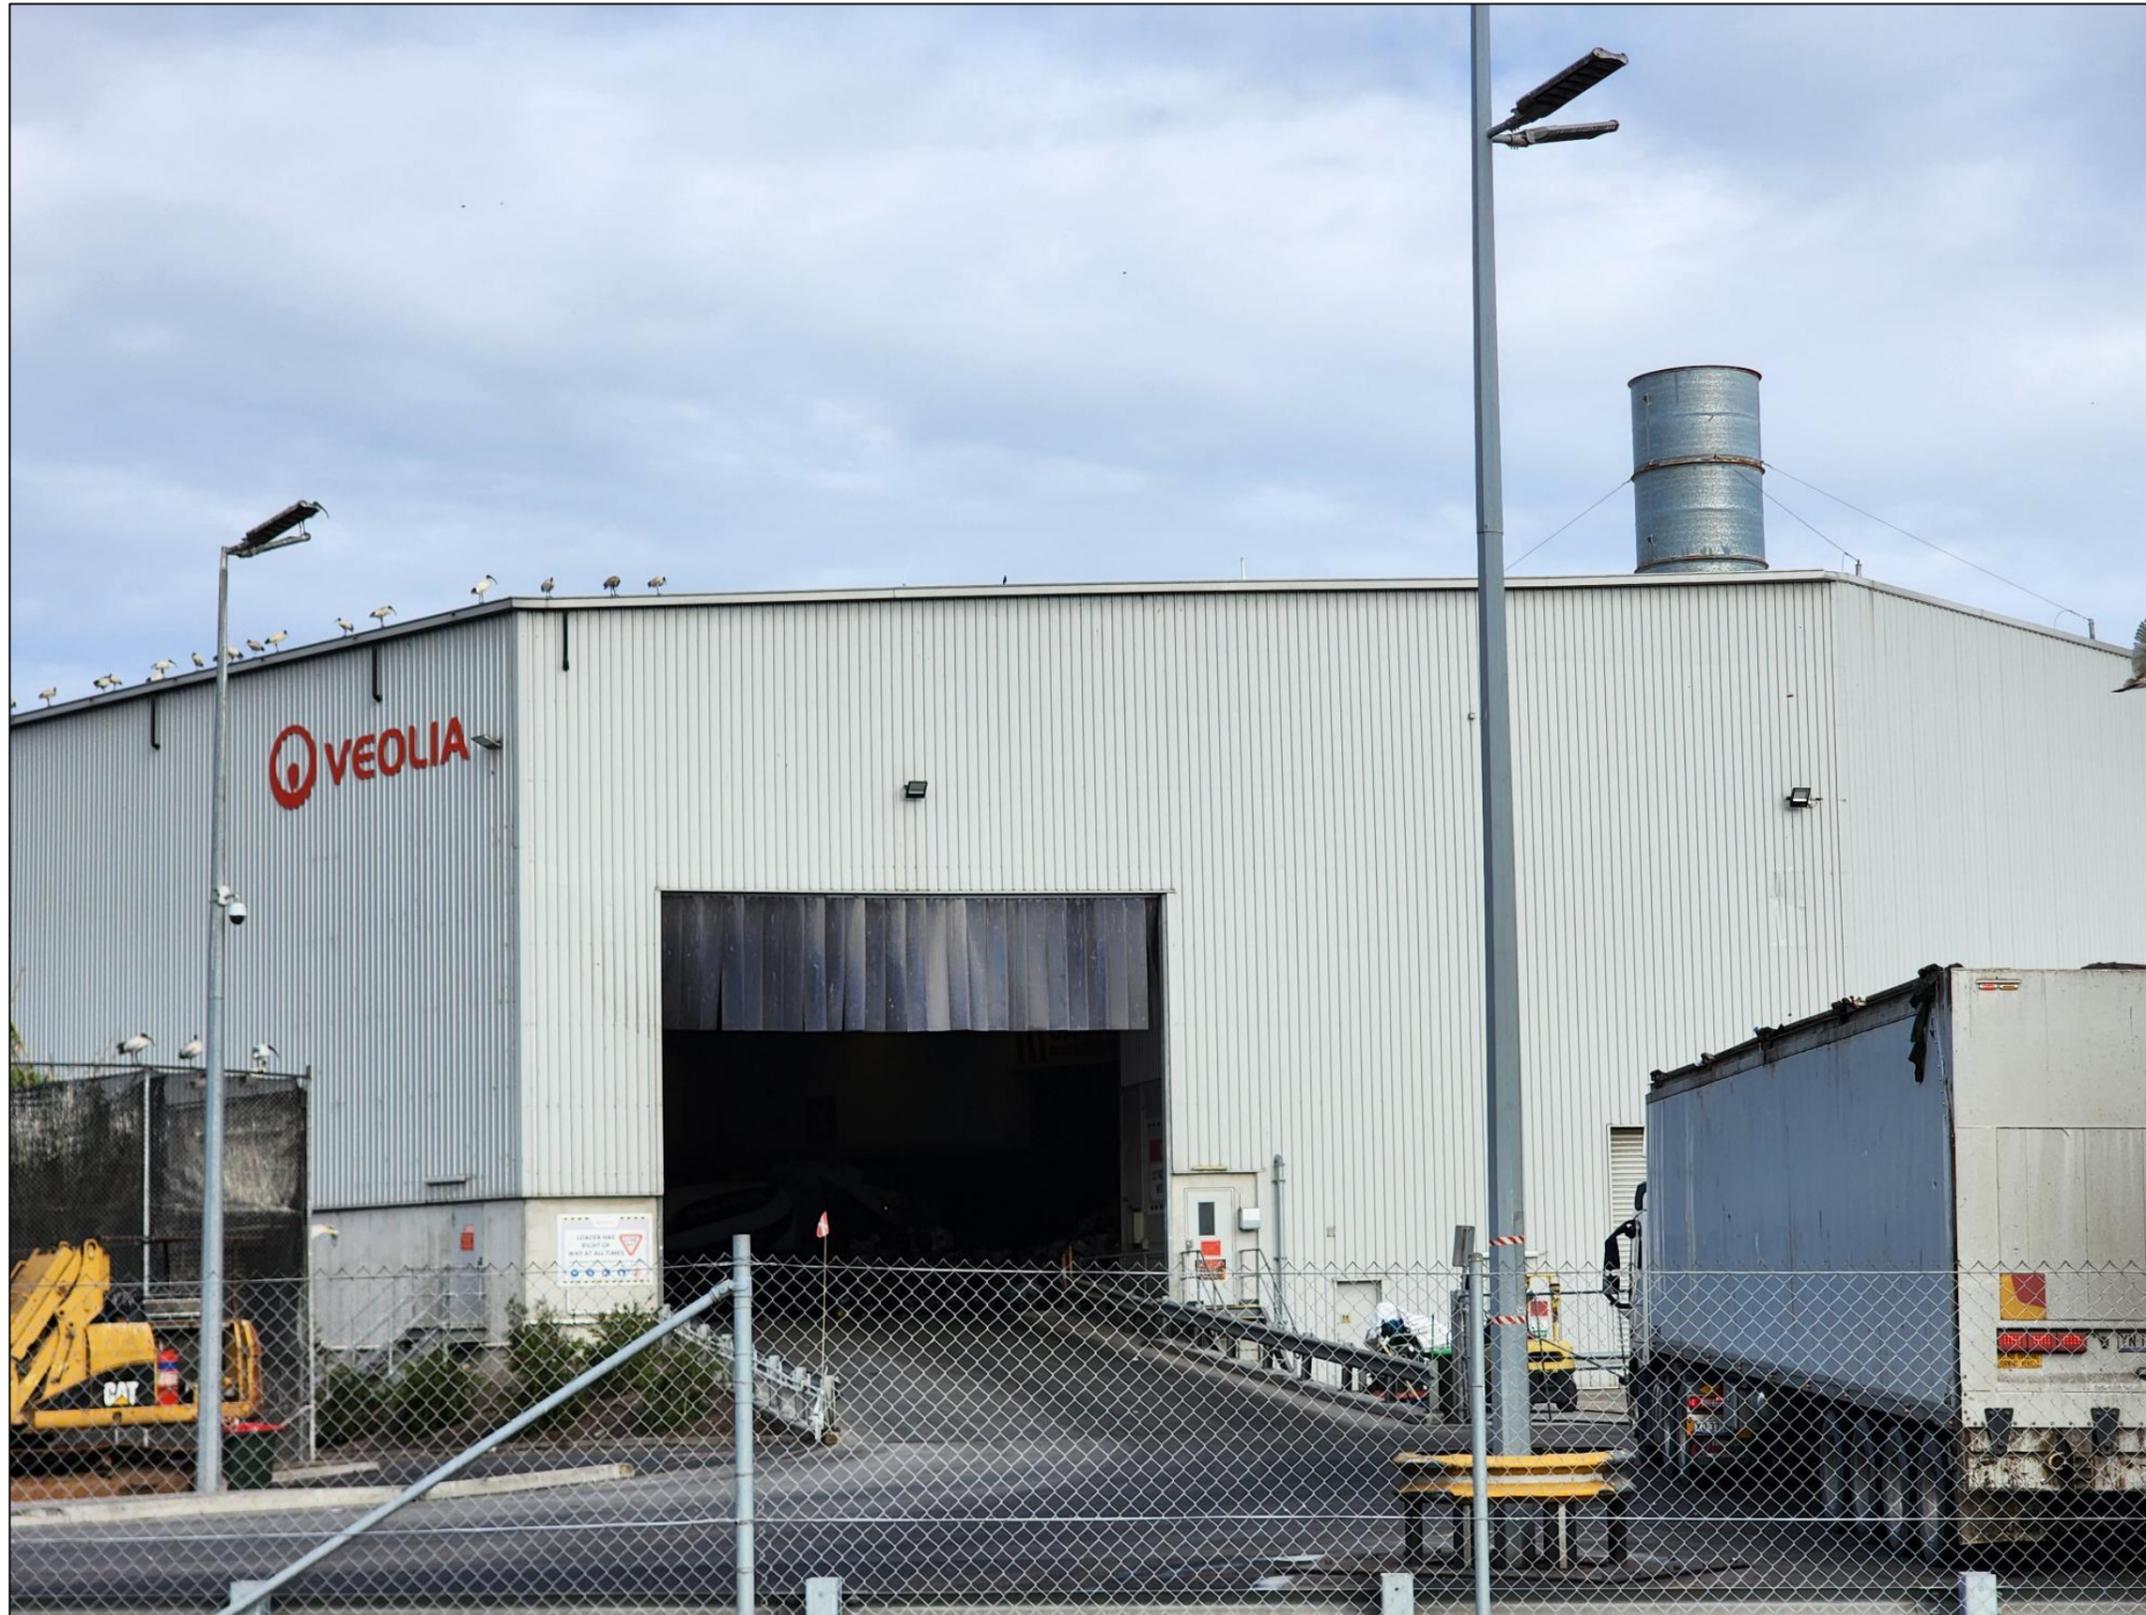
Photo 5 – A view of the truck entrance & plastic strips: 5 July 2023

- The plastic panels at the truck entry point of the BTT Facility building enclosure were intact and in good condition, and the storage container area was well maintained.
