**TO: ANAE RESSOS**  
**COMPANY: VEOLIA (AUSTRALIA) PTY LTD**  
**FROM: ISAAC FARRUGIA & MICHAEL ASSAL**  
**DATE: 11 FEBRUARY 2024**  
**JOB NO: N1906**  
**SUBJECT: BANKSMEADOW WASTE TRANSFER TERMINAL FACILITY – ON-GOING ODOUR AUDIT PROGRAM: JULY 2023**

The following technical memorandum documents the findings and recommendations from an on-going, six-monthly odour audit program (the **Audit**) being conducted by The Odour Unit Pty Ltd (**TOU**) at the Veolia (Australia) Pty Ltd (**Veolia**) Waste Transfer Terminal Facility, 34/36 McPherson Street, Banksmeadow, New South Wales (**BTT Facility**). The Audit documented in this memorandum report covers the outcome of the visit conducted by TOU at the BTT Facility on 4 & 5 July 2023. This report for the Audit documents the following:

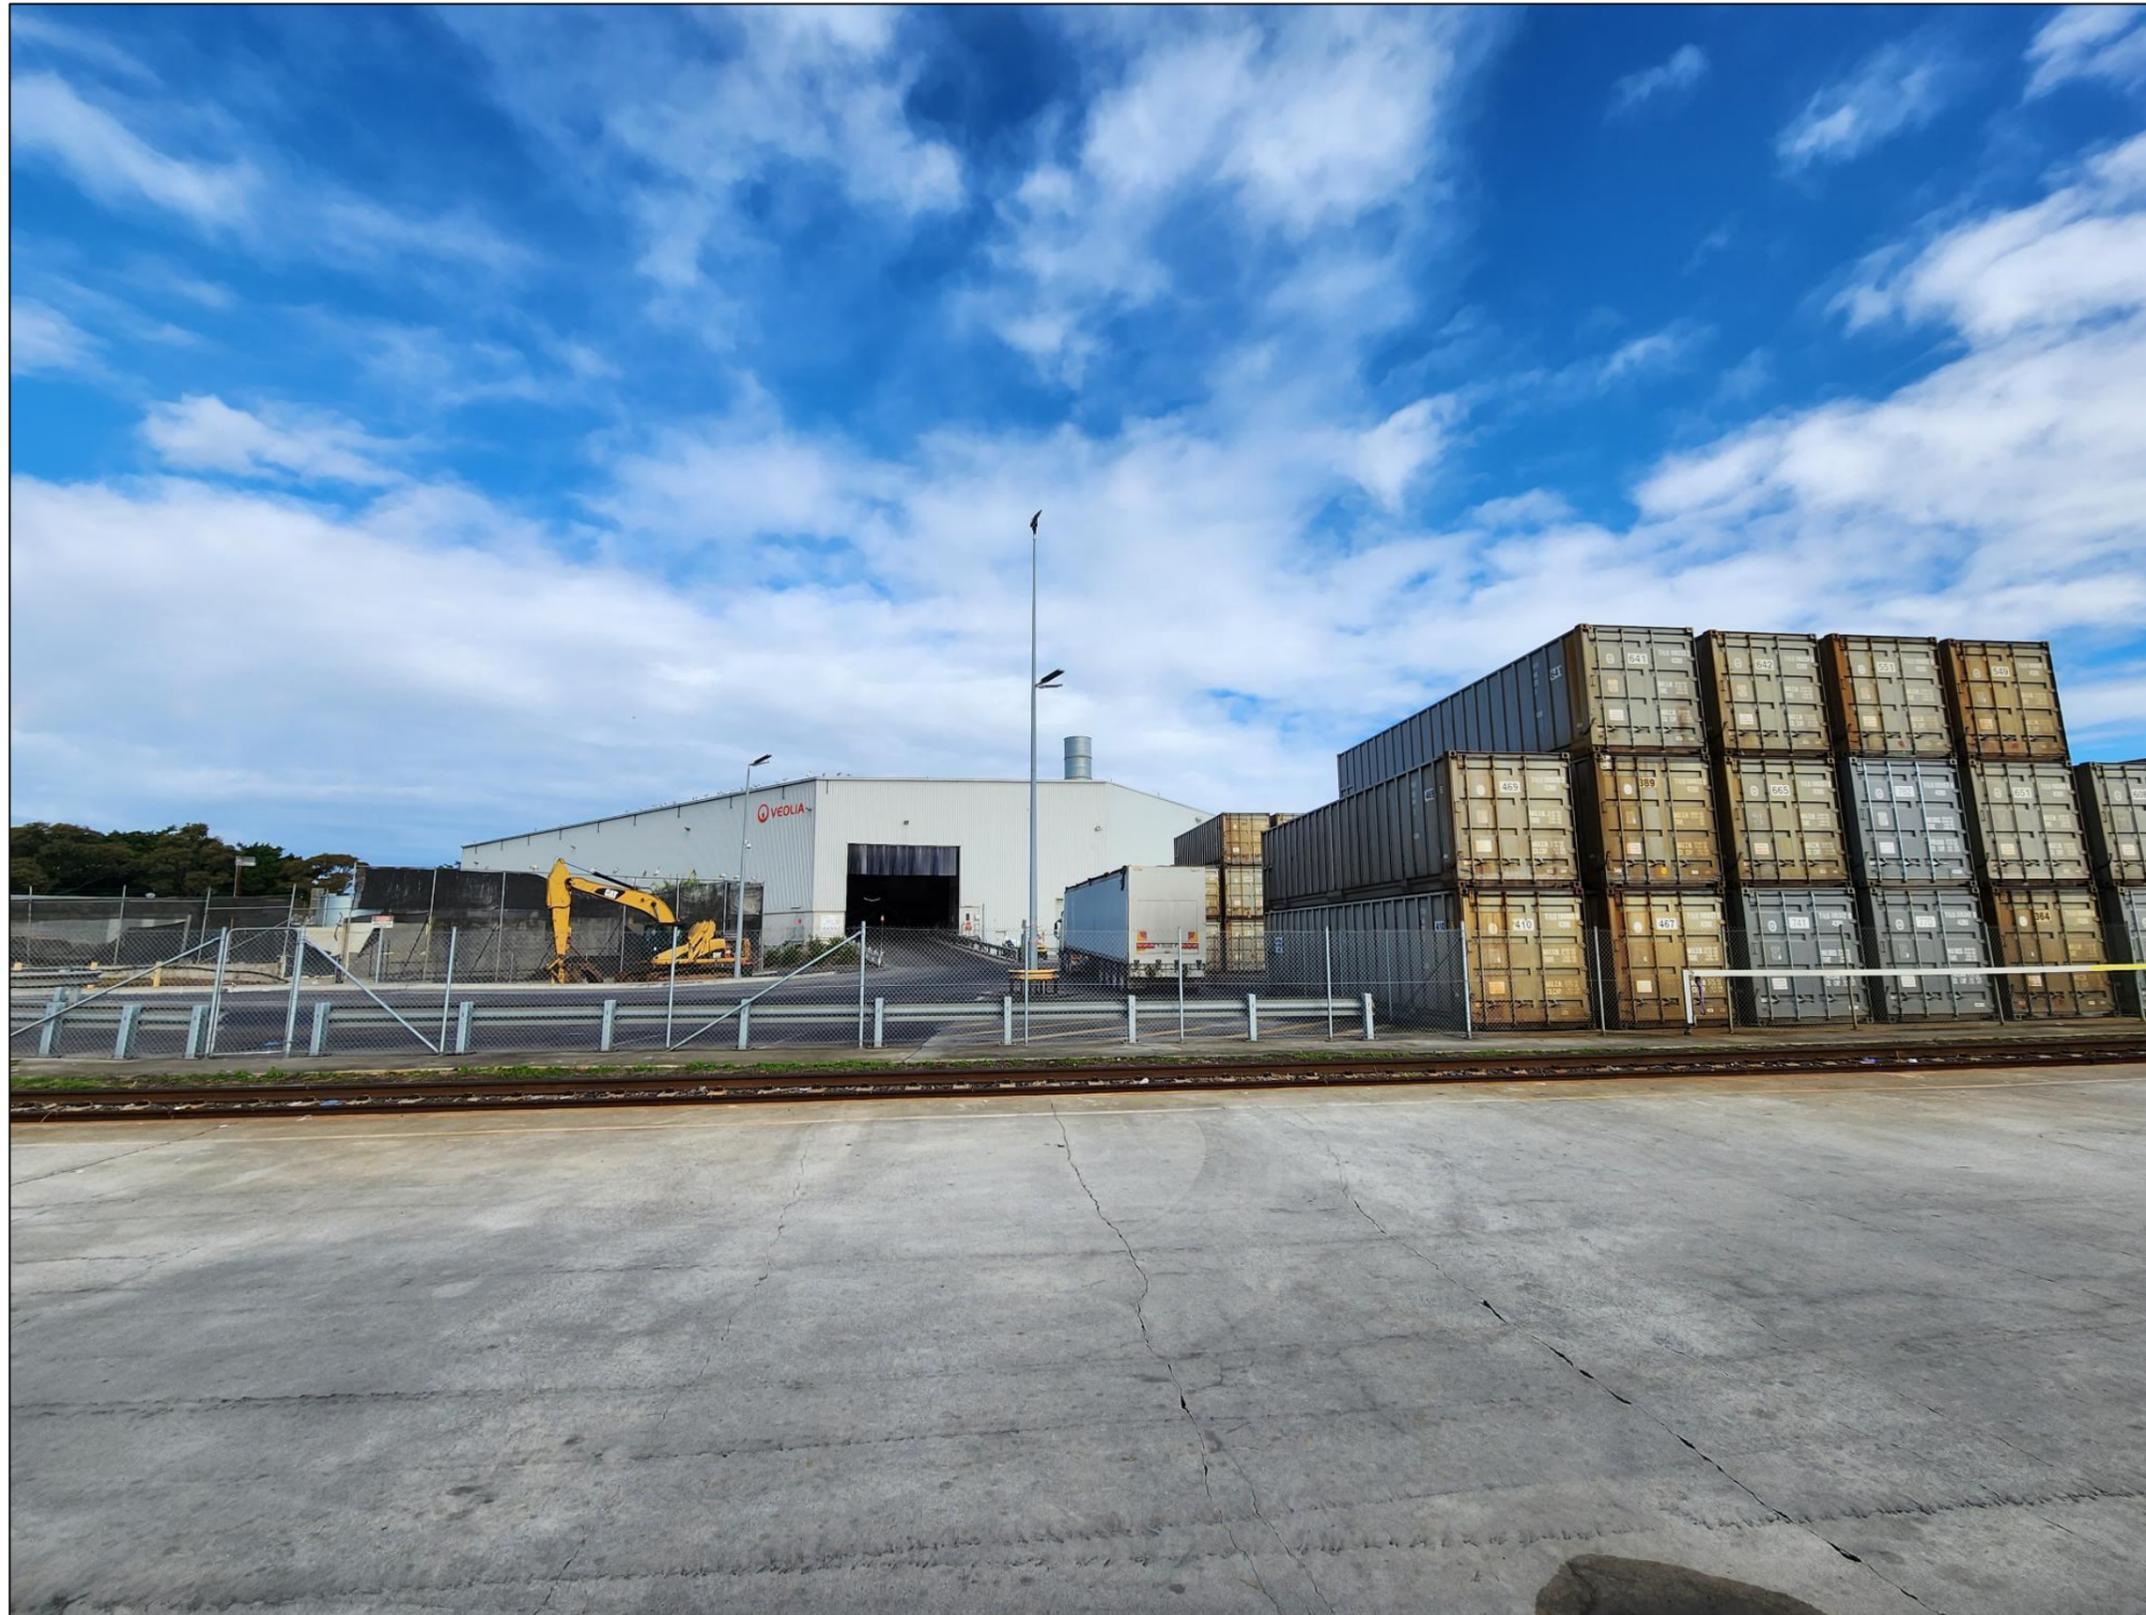
Photo 6 – A view of the storage container area: 5 July 2023

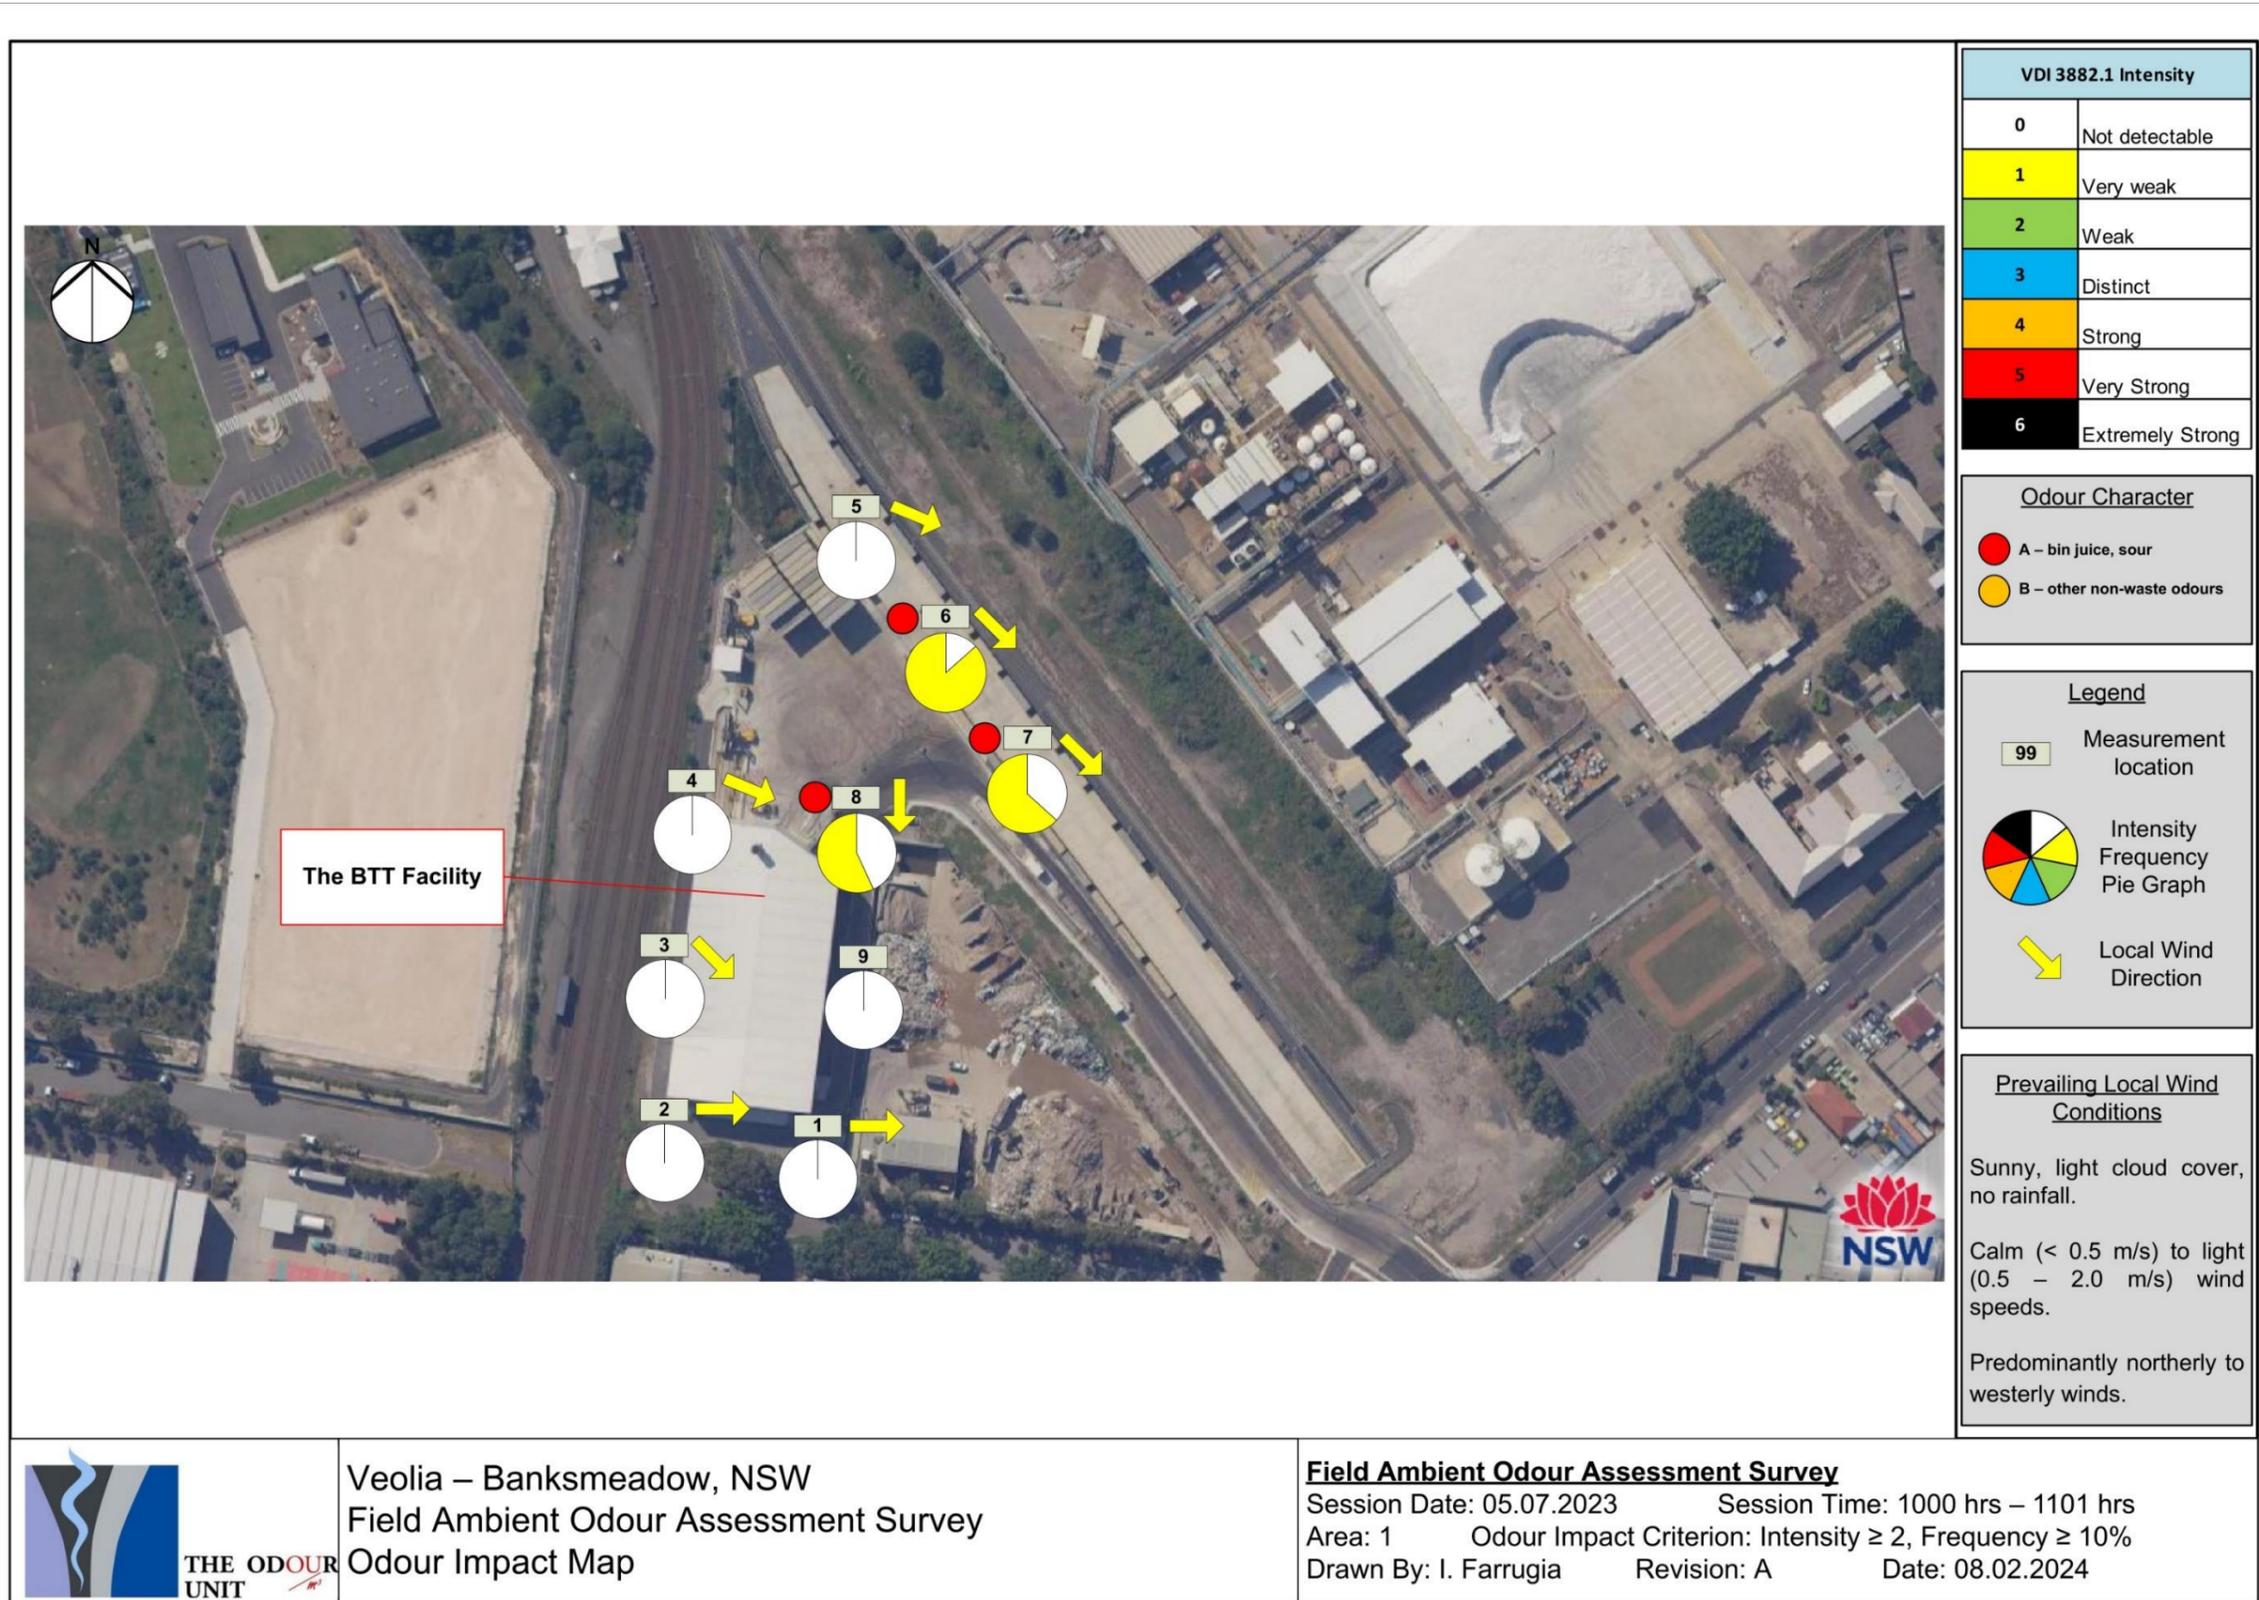
Figure 5 – FAOA survey odour impact map as conducted on 5 July 2023 between 1000 hrs and 1101 hrs (refer to Table 4 for details)

- A localised Very Weak (Odour Intensity of 1) was detectable within the boundary of the BTT Facility at several measurement location points (refer to **Figure 5**) during the FAOA survey. The odour character was 'bin juice, sour' and the likely source was the activities at the BTT Facility occurring at the time;
