Annual Environmental Management Report - Clyde Transfer Terminal 2023-2024

Name of operation	Clyde Transfer Terminal
Name of operator	Veolia Environmental Services
Development consent / project approval #	DA 205-08-01
Name of holder of development consent / project approval	Veolia Environmental Services
Mining lease #	NA
Name of holder of mining lease	NA
Water licence #	NA
Name of holder of the water licence	NA
MOP/RMP start date	NA
MOP/RMP end date	NA
Annual Review start date	15th of January 2023
Annual Review end date	14th of January 2024
<p>I, Anae Ressos, certify that this audit report is a true and accurate record of the compliance status of Clyde Transfer Terminal for the period 15 January 2023-14 January 2024 and that I am authorised to make this statement on behalf of Veolia Environmental Services.</p> <p>Note:</p> <p>a) <i>The Annual Review is an 'environmental audit' for the purposes of section 122B(2) of the Environmental Planning and Assessment Act 1979. Section 122E provides that a person must not include false or misleading information (or provide information for inclusion in) an audit report produced to the Minister in connection with an environmental audit if the p

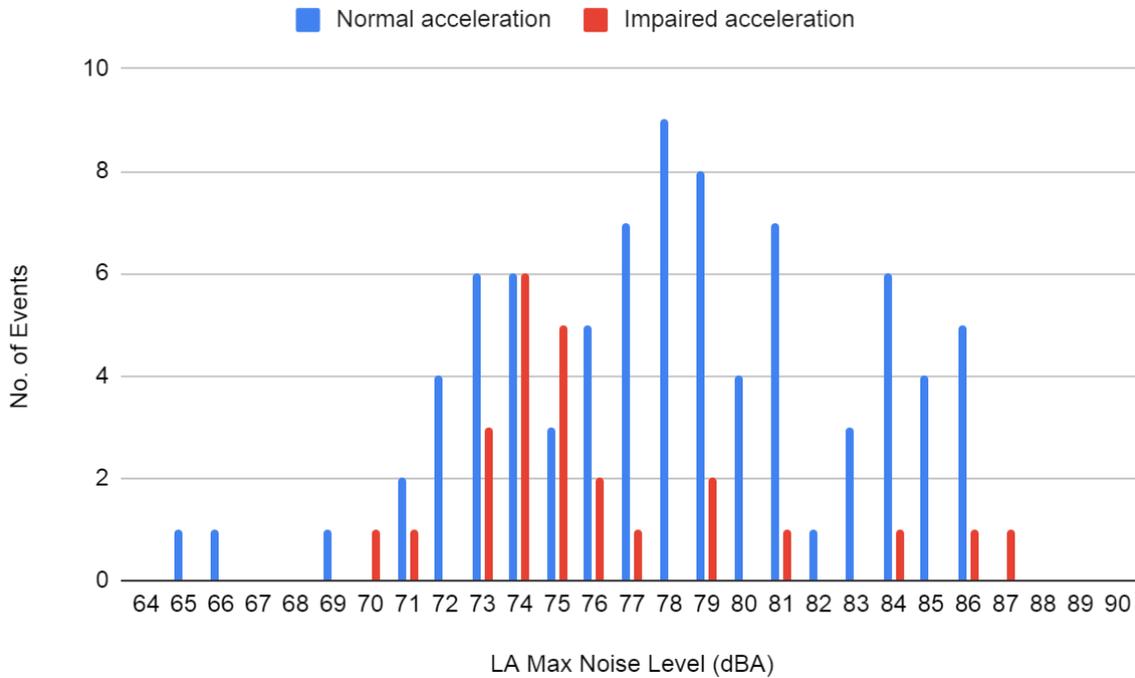
Figure 2.3. Noise level distribution from truck noise monitoring conducted on 7th of September 2023

Trucks monitored on 7 September 2023 were measured between 65.8dBA to 87.0dBA, and fell within or below the thresholds of 81dBA to 87dBA for Heavy Goods Vehicles with a GVM > 12 tonne in accordance with the Australian Design Rules (ADR) 28/01. Although there were no exceedances of the threshold, one truck was measured at 87.0dBA which reaches the 87dBA threshold.

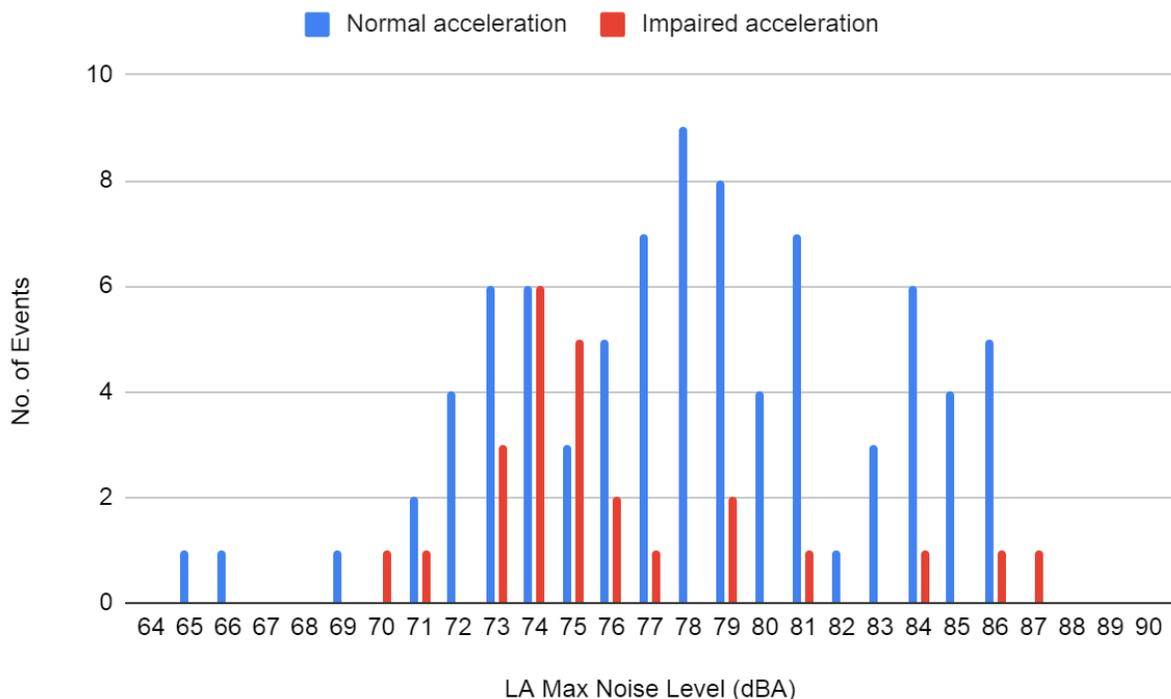
Figure 1: Noise level distribution from Truck Noise Monitoring – 7th of September 2023

Measurements of 'normal' truck acceleration ranged from 65.8dBA to 86.9dBA with the highest frequency occurring between 77 - 79dBA. Impaired acceleration readings due to the impeded traffic conditions ranged from 60dBA to 87dBA, with the highest frequency occurring between 73-75dBA. Impaired acceleration readings were plotted separately from the normal accelerating vehicles on Figure 1.
