**Clyde Waste Transfer Terminal**

**Odour Audit XLI**

**Final Report**

**July 2023**

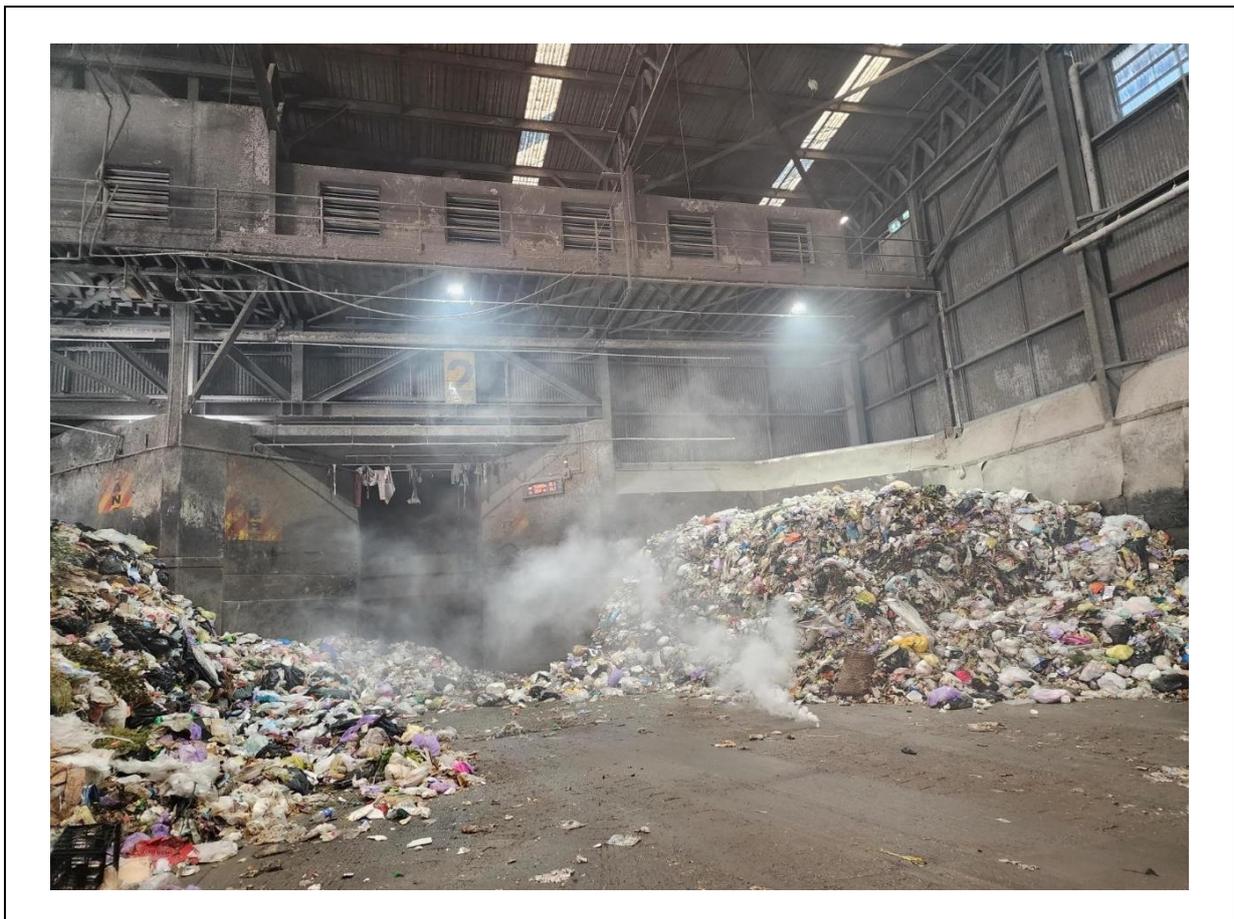
During the Odour Audit visit, there were approximately 140 tonnes of waste on the floor. This tonnage is within the normal operating range of the Transfer Terminal Building (TTB). The TTB floor area not covered by waste material was observed to be reasonably clean, with little evidence of leachate or aged material. The general housekeeping procedures of the TTB were good, as found during several truck-unloading sequences. It was also observed that the TTB's front-end loaders cleared the floor area of waste on a regular basis, minimising the exposed area of waste.

As with previous audits, and consistent with TOU's experience at other waste transfer stations, there was a weak to distinct level of odour observed within the TTB. A photo of the waste on the floor as found during the Odour Audit visit is shown in Photo 2.1.

**Photo 2.1** – TTB waste on-floor as found on 5 July 2023 (during a smoke test)

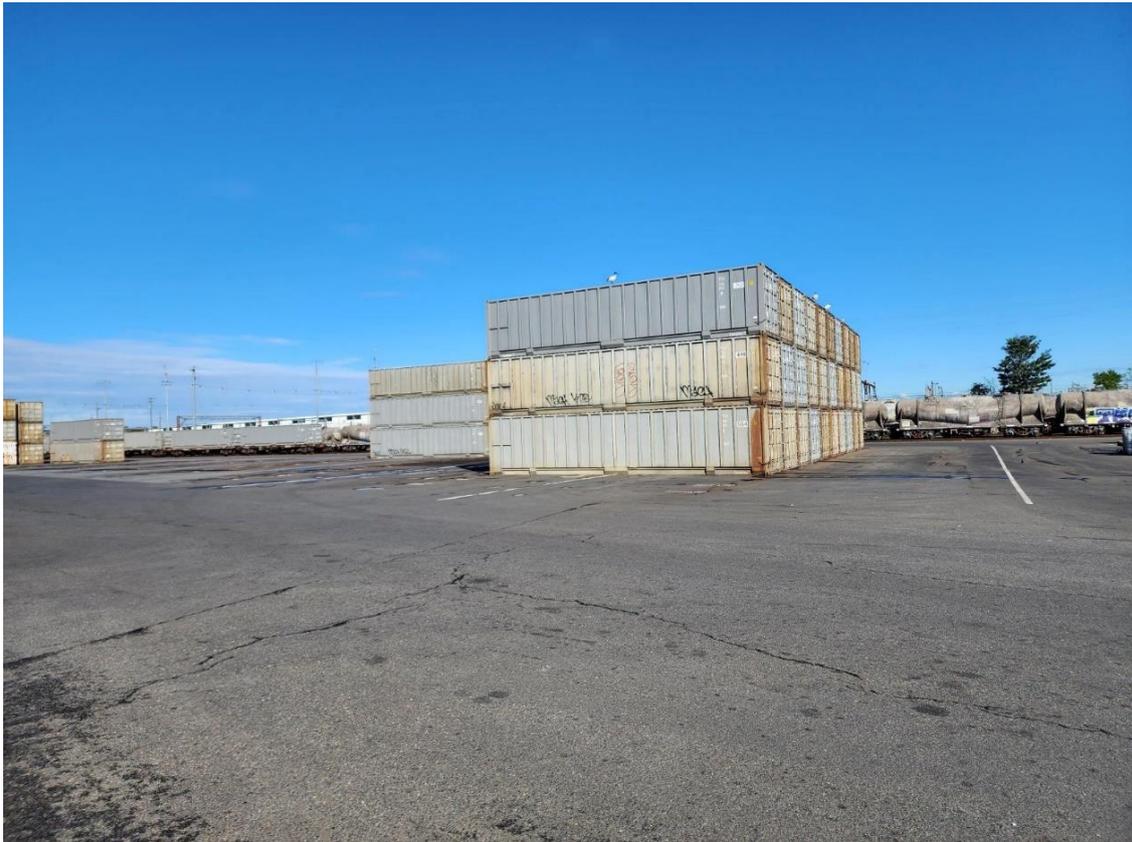
As per the Odour Management Plan dated February 2010 (the **February 2010 OMP**) for the Clyde TT, following the compaction of waste, all filled containers are entirely sealed and remain so while at the Clyde TT. All containers used are required to be in good condition, and unused/returned containers adequately clean. The Odour Audit finds that this continues to be current practice at the Clyde TT. A view of the condition of the container area as found on 21 December 2022 is shown in **Photo 2.2**.

**Photo 2.2** – A view of the container area as found on 5 July 2023

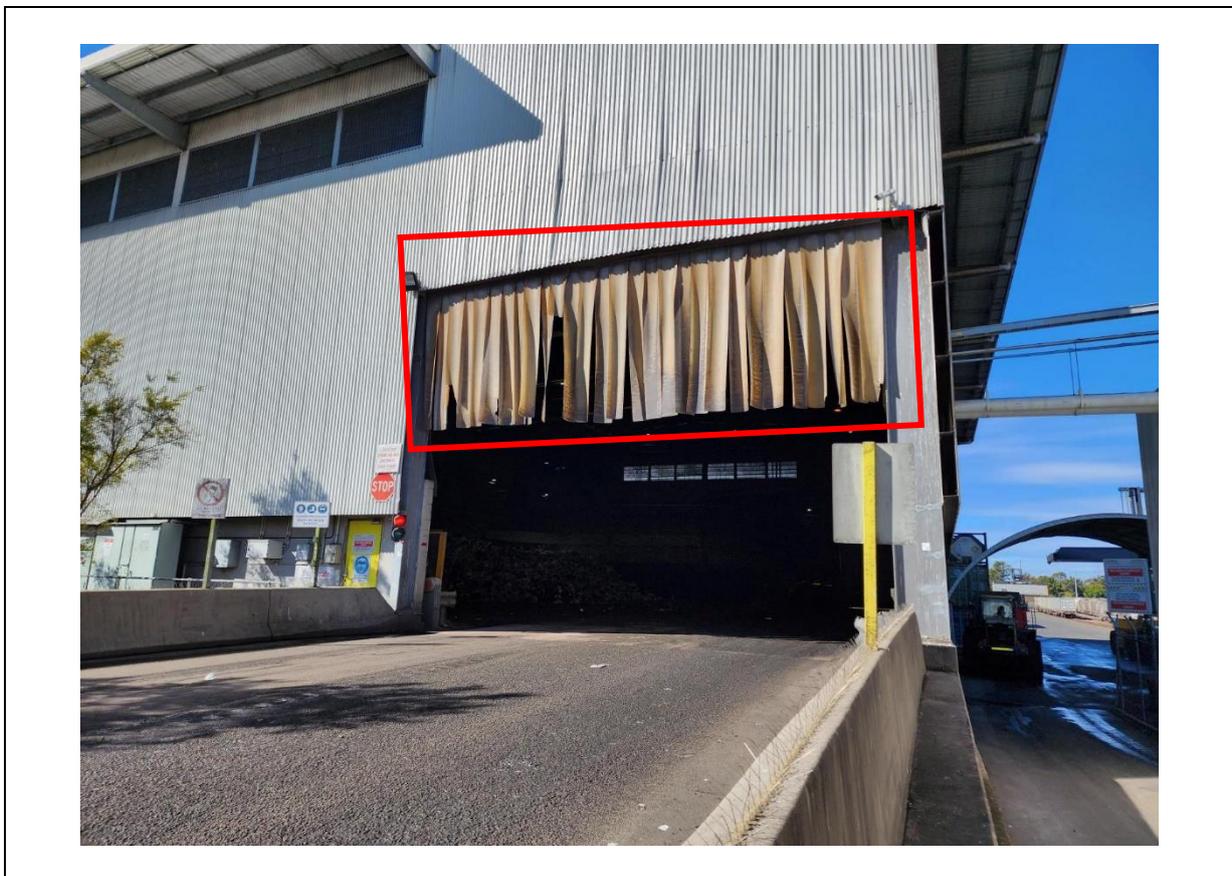
The truck entrance plastic strips of the TTB, used to reduce odour escaping through the opening, were found to be superficially damaged and in a state to function and effectively reduce air movement at the top section of the truck entrance (refer to **Photo 2.3**).

**Photo 2.3** – A view of the truck entrance plastic strips as found on 5 July 2023

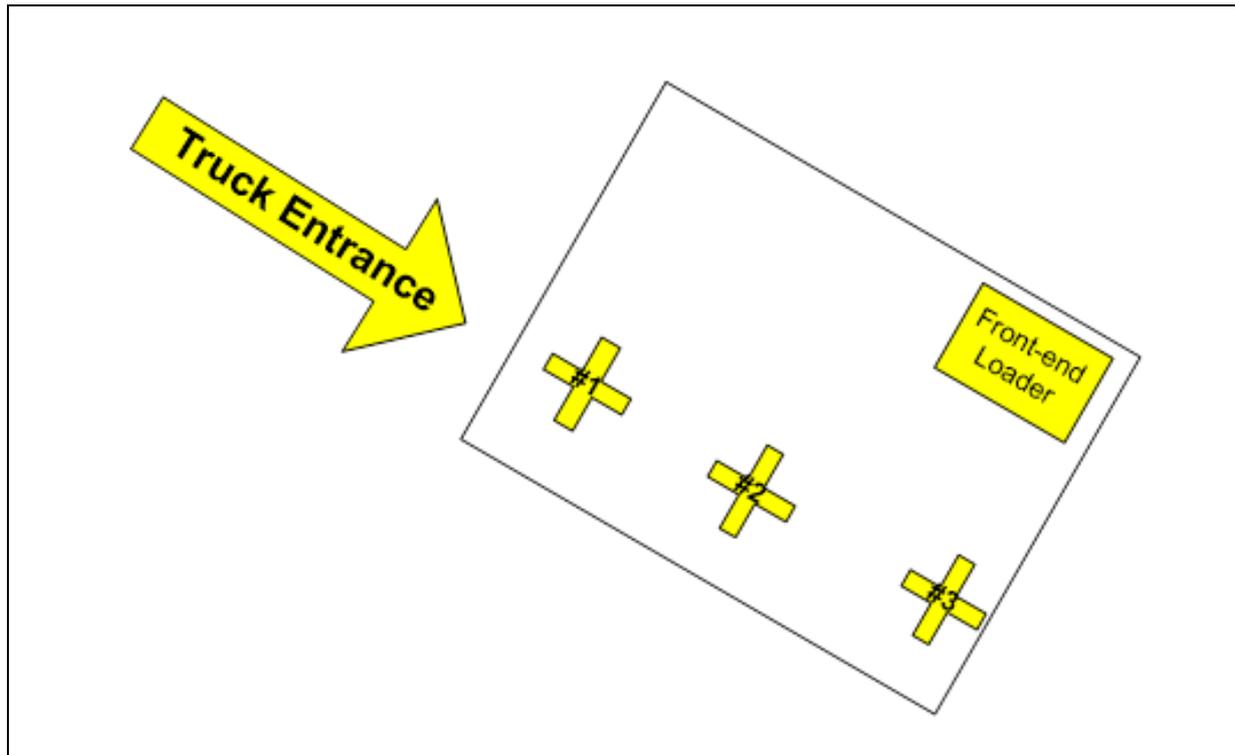
As per previous audits, smoke testing was carried out within the TTB to assist in determining the effectiveness of the forced air extraction system, as well as the extent to which the TTB has been sealed from leaks. As per previous audits, smoke was released from within the TTB at three points within the TTB. **Figure 2.1** shows the three points where the smoke was released within the TTB. **Photo 2.4** shows smoke testing at the truck entrance of the TTB, which reflects an additional test location to the normal smoke testing release points shown in **Figure 2.1**.

**Figure 2.1** – Smoke testing release points within the TTB on 5 July 2023

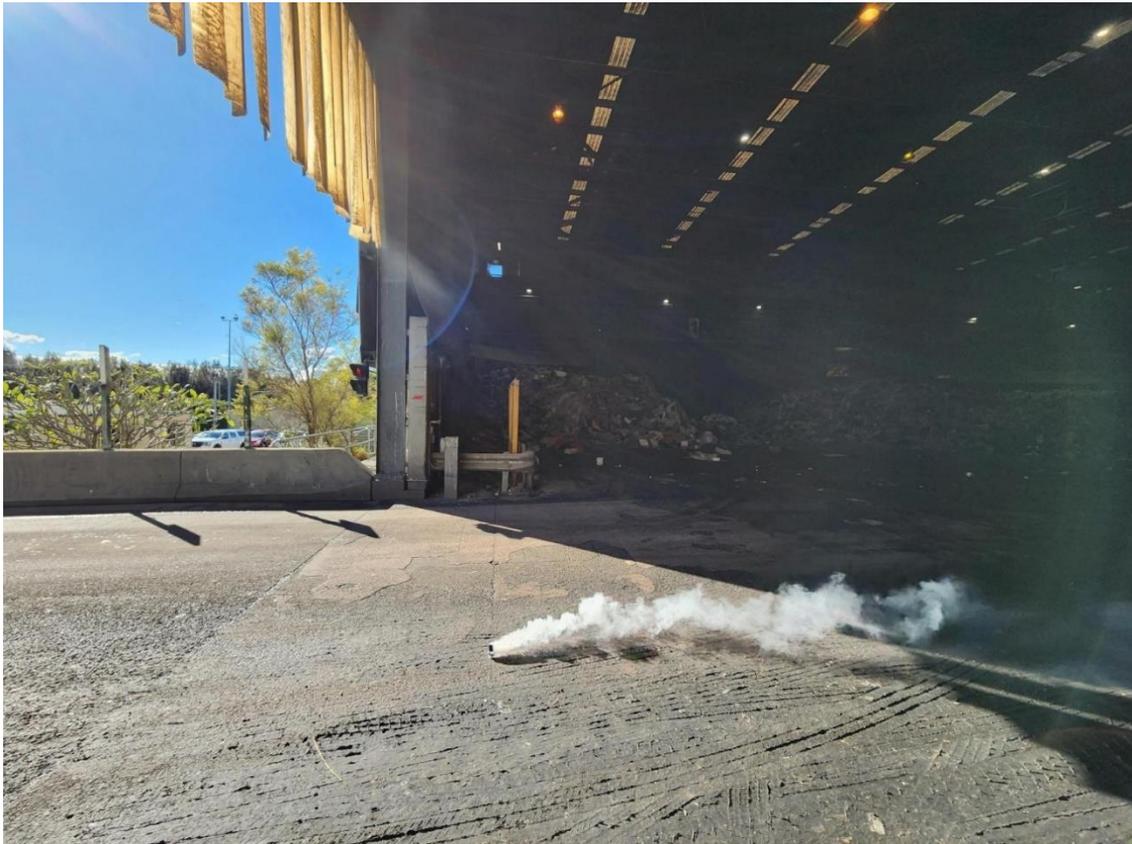
**Photo 2.4** – A view of the truck entrance plastic strips during smoke testing on 5 July 2023
