# **Veolia Environmental Services (Australia) Pty Limited**

## **Woodlawn Bioreactor Expansion Project**

### **Independent Odour Audit #2**

**January 2014**

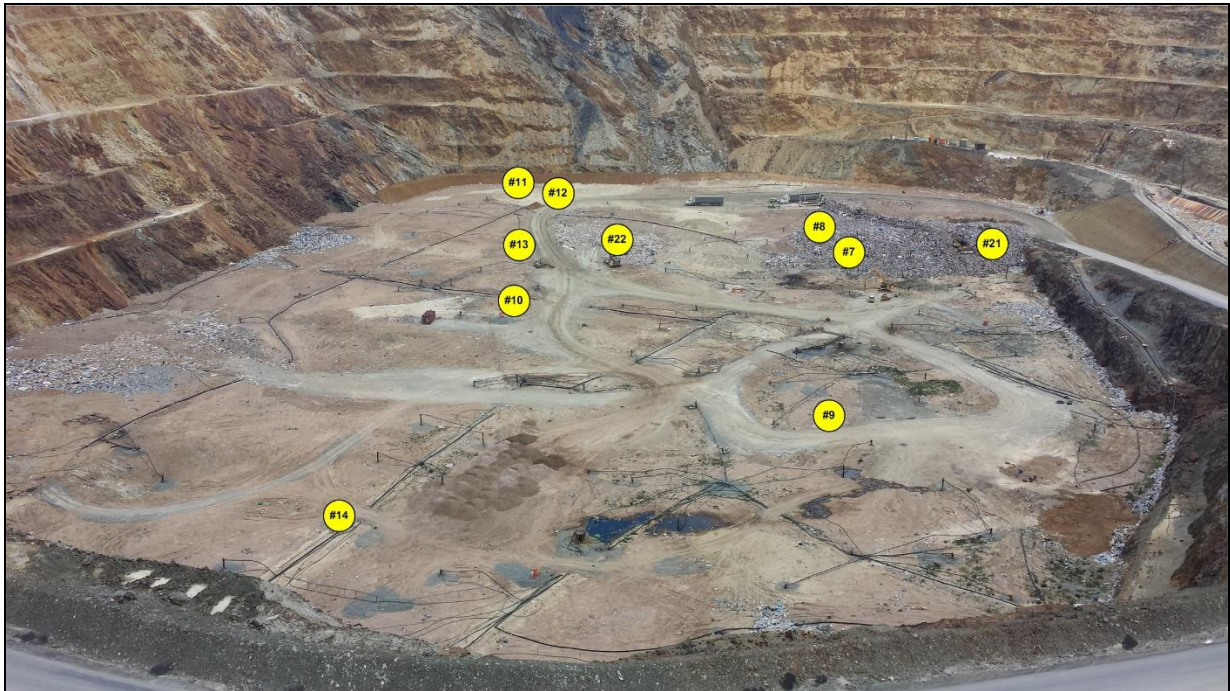
**Figure 6.2 – Nominal locations within the Void**

- The areas sampled within the Void included:
  - Gas/sump well extraction points (TOUSC13600 & TOUSC13602);
  - Waste Covered Area with visible surface cracks (TOUSC13601);

- The collected sample locations inside the Void have been nominally shown in **Figure 6.2**. The sample numbers shown below correspond with **Table 6.1**.

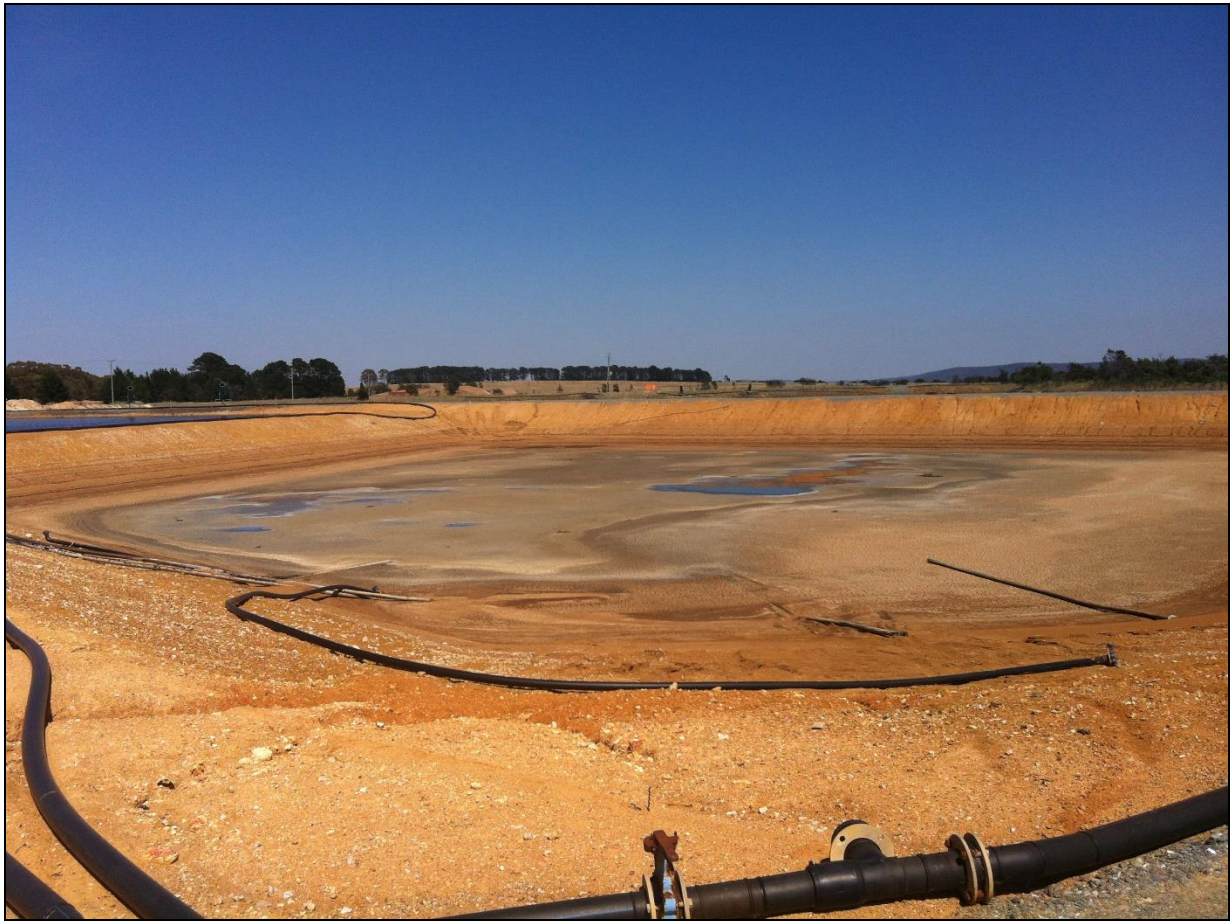
Since the 2012 IOA, the Audit has found that VES had encountered a number of operational issues during the development of the continuous leachate treatment system (see VES correspondence to EPA in **Appendix C**). As a result, VES was unable to meet the EPA's deadline of removing all leachate from ED3N-1 by 30 June 2013. This had a flow-on effect on the need to store partially treated leachate in ED3N-2 until the LMS could be restarted and returned to operational capacity. As shown in **Section 6**, this was reflected in the odour testing results for ED3N-2 with a mean SOER of 20.1 ou.m<sup>3</sup>/m<sup>2</sup>/s and peak of 46.1 ou.m<sup>3</sup>/m<sup>2</sup>/s. In the lead up to this Audit report, VES have advised that all ED3N-2 contents have now been drained (see **Photo 7.1**) and no sub-optimal quality treated leachate remains stored in any of the ED3N lagoons. On this basis, and for the purposes of this Audit, no further action is required by VES in regards to mitigating odour emissions from ED3N-2.

**Photo 7.1** – Photographic evidence of ED3N-2 fully drained: 18 December 2013

ED3N-2 & 3 odour emissions have increased since the last Audit, with the increase of emissions originating from ED3N-2. The Audit was advised that VES had identified the contents of ED3N-2 as partially treated leachate remaining from the previous batch leachate treatment system and that the conditions in this dam were turning anoxic. This explains the observed increase in odour emissions from this pond source seen in the odour testing results (see **Section 6 – Table 6.1**). The Audit did note that VES were in the process of returning this sub-optimal quality leachate to the LAD for treatment. As shown in **Section 7 - Photo 7.1**, all partially untreated leachate in ED3N-2 sampled during the Audit has undergone treatment, and no sub-optimal quality treated leachate remains stored in any of the ED3N lagoons. On this basis, and for the purposes of this Audit, no further action is required by VES in regards to mitigating odour emissions from ED3N-2.

If there are future operational issues with the LMS, VES should take the precautionary measures of notifying the EPA, neighbouring residents and other necessary external parties. As previously mentioned in **Section 7.2.1.1**, the Audit understands that with the current continuous leachate treatment configuration, untreated leachate will not be stored in the ED3N lagoons and instead flow directly from the Void and into the LAD.

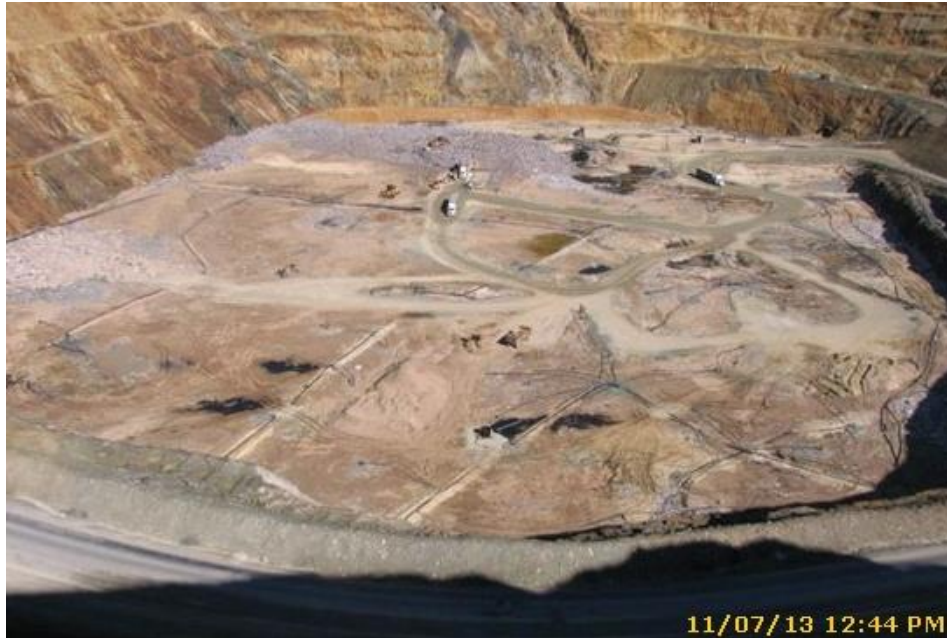
*Diagram: Picture of the landfill cell on 11<sup>th</sup> of July 2013 on the Woodlawn Bioreactor viewing platform*

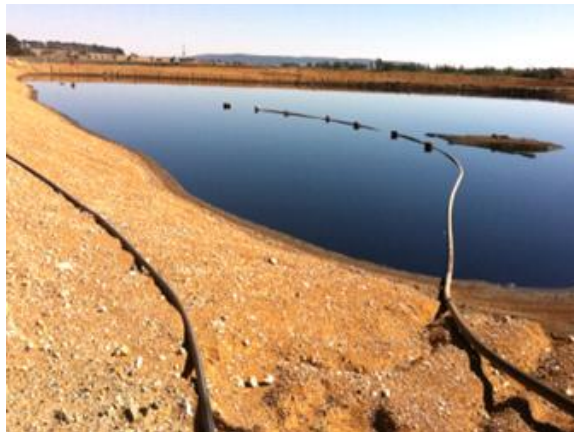
The deadline that the EPA set for treating all of the raw leachate in ED3N-1 is the 30<sup>th</sup> of June 2013. There is still approximately 5.24 ML of raw leachate left in ED3N-1. The raw leachate in ED3N-1 was considered as a main odour emission point at the premises, but since the liquid level has dropped from 17.5 ML (see Figure 1) to 5.24 ML (see Figure 2) over the last 2 months.

*Figure 1: ED3N-1 Volume on 6<sup>th</sup> of may 2013 (17.5 ML)*

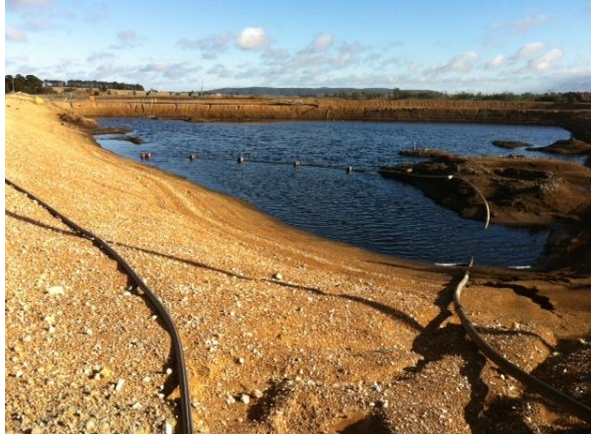
Figure 2: Estimated ED3N-1 Volume on 5<sup>th</sup> of July 2013 (5.24 ML)
