## Re: EPL– Annual Assessment of Woodlawn Bioreactor & Intermodal Facility Monitoring Data.

Report – 8 April 2010.

**Client: Veolia Environmental Services (Australia) Pty Ltd**

**Project: EPL - Annual Assessment of  
Woodlawn Bioreactor and Intermodal Facility Monitoring Data**

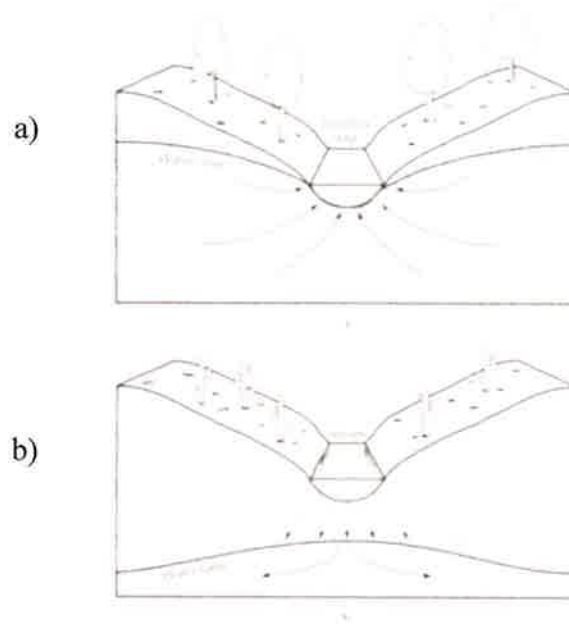
Figure 4.6: Gaining (a) and losing streams (b) typically associated with wet and dry seasons.

E2W interpret that Crisps Creek (one of two primary receptors) is ephemeral and generally a losing stream (in text Figure 4.6b) during dry seasons. The stream would revert to a gaining stream (in text Figure 4.6a) during wet seasons. The type of creek system will determine the discharge regime, fate and transport of groundwater pollution.

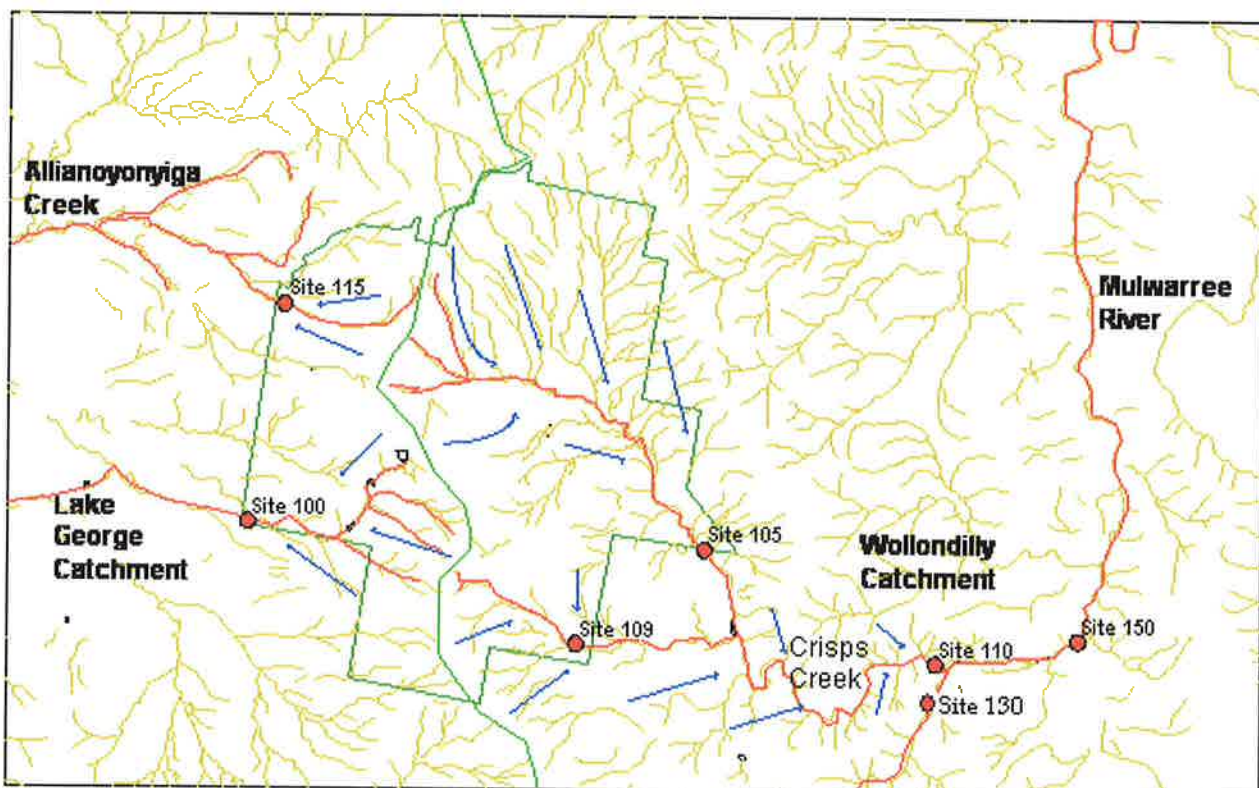
Figure 4.7: Hydrology at Woodlawn. Arrows indicate flow directions, while the light green line represents the GDR and the dark green line the site boundary. *Source: Veolia AEMR, 2006/07.*

Allianoyonyiga and Crisps Creek are considered to be the primary receptors for discharges occurring from the Woodlawn site. The GDR bisects the void and diverts flows to south (via Allianoyonyiga Creek) to Lake George catchment and north (via Crisps Creek) to Wollondilly catchment (Figure 1 and in text Figure 4.7).

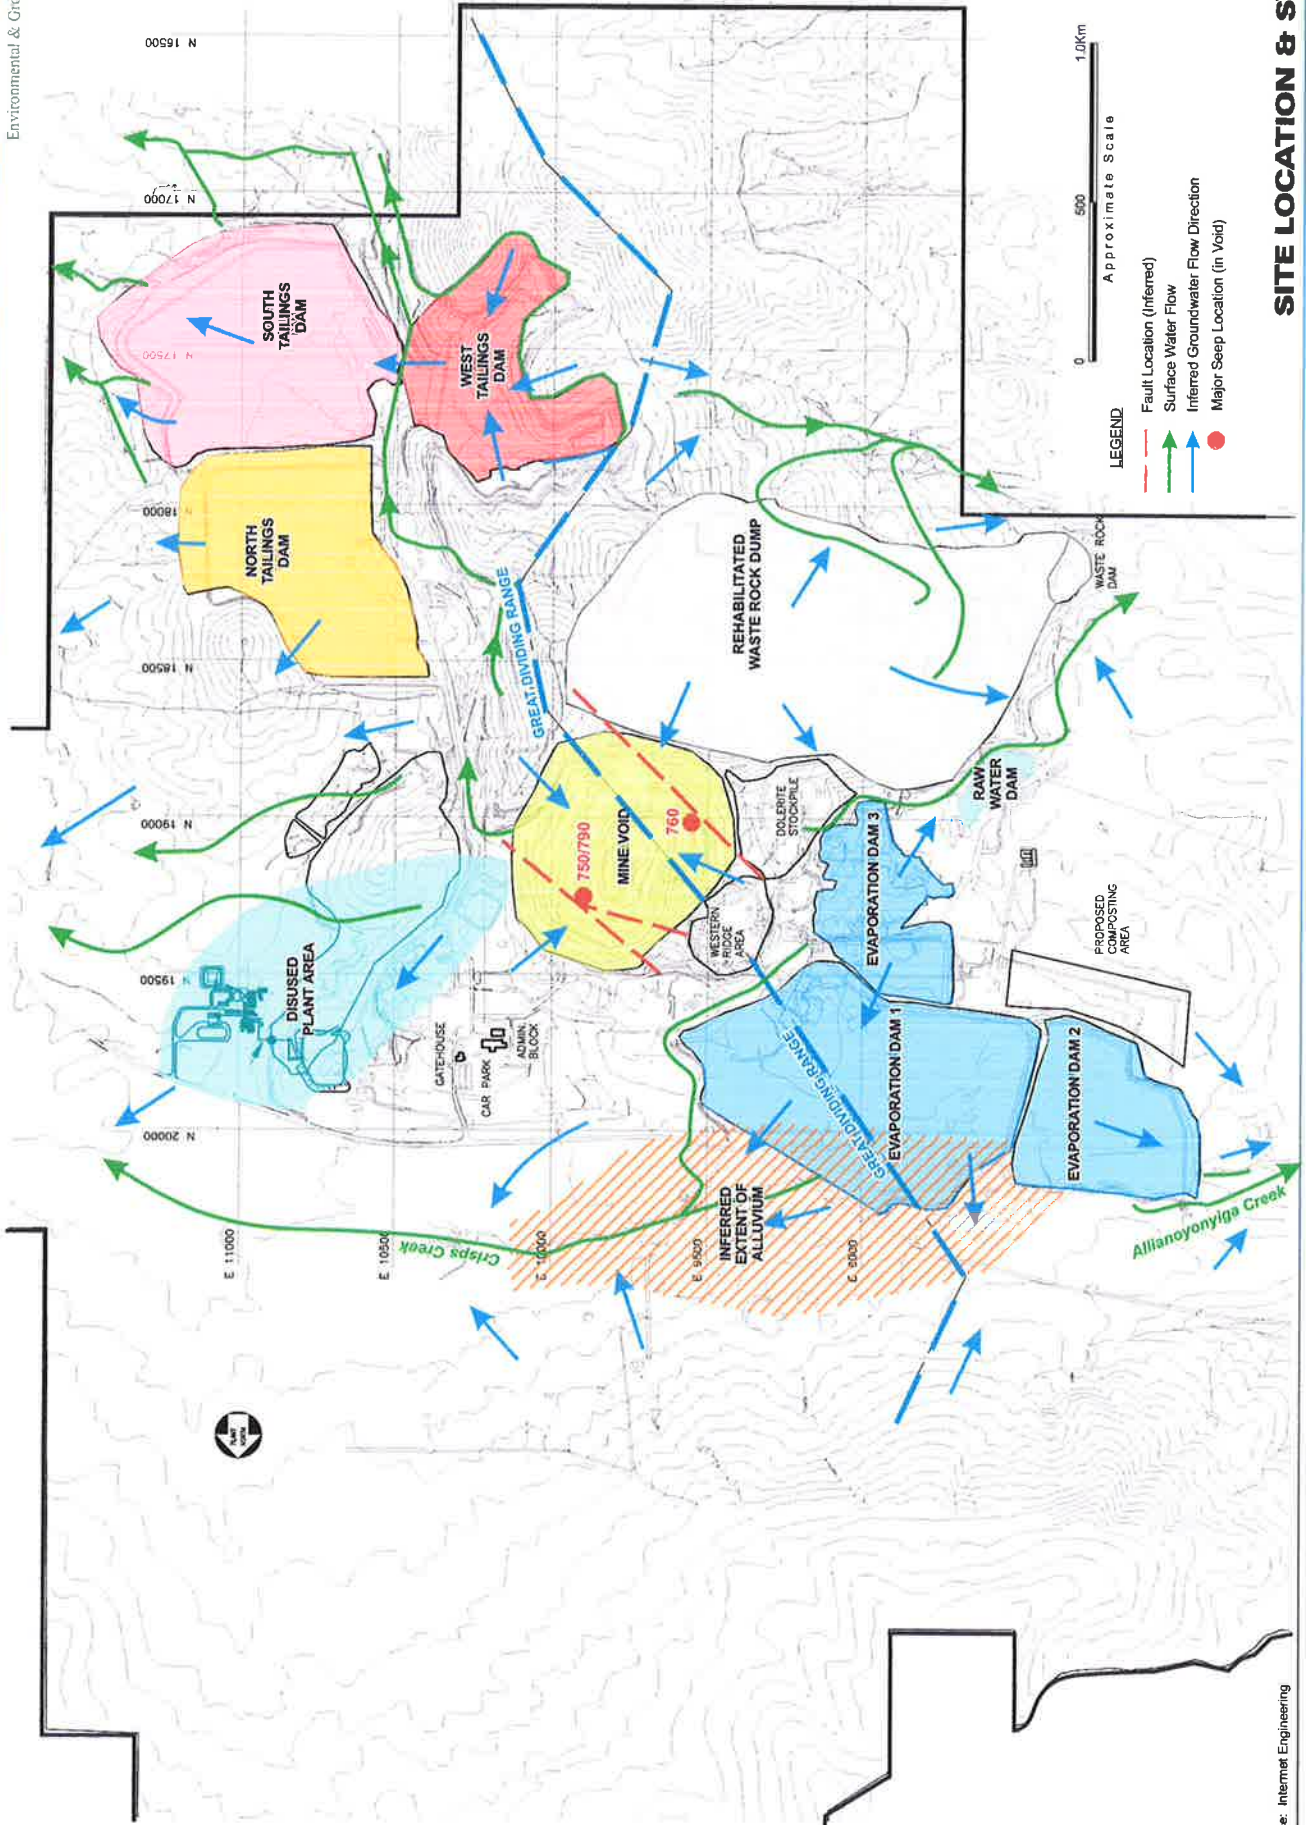
Figure 1

VEOLIA ENVIRONMENTAL SERVICES - WOODLAWN BIOREACTOR

The piezometers P44A and P58B show a pronounced (>10 m over time, Appendix D) water level change from rainfall recharge and are interpreted to intersect localized faulting/fracturing. Fault planes and increased rainfall recharge are interpreted to cause the fluctuating water levels in the wells and piezometers (Figure 1).

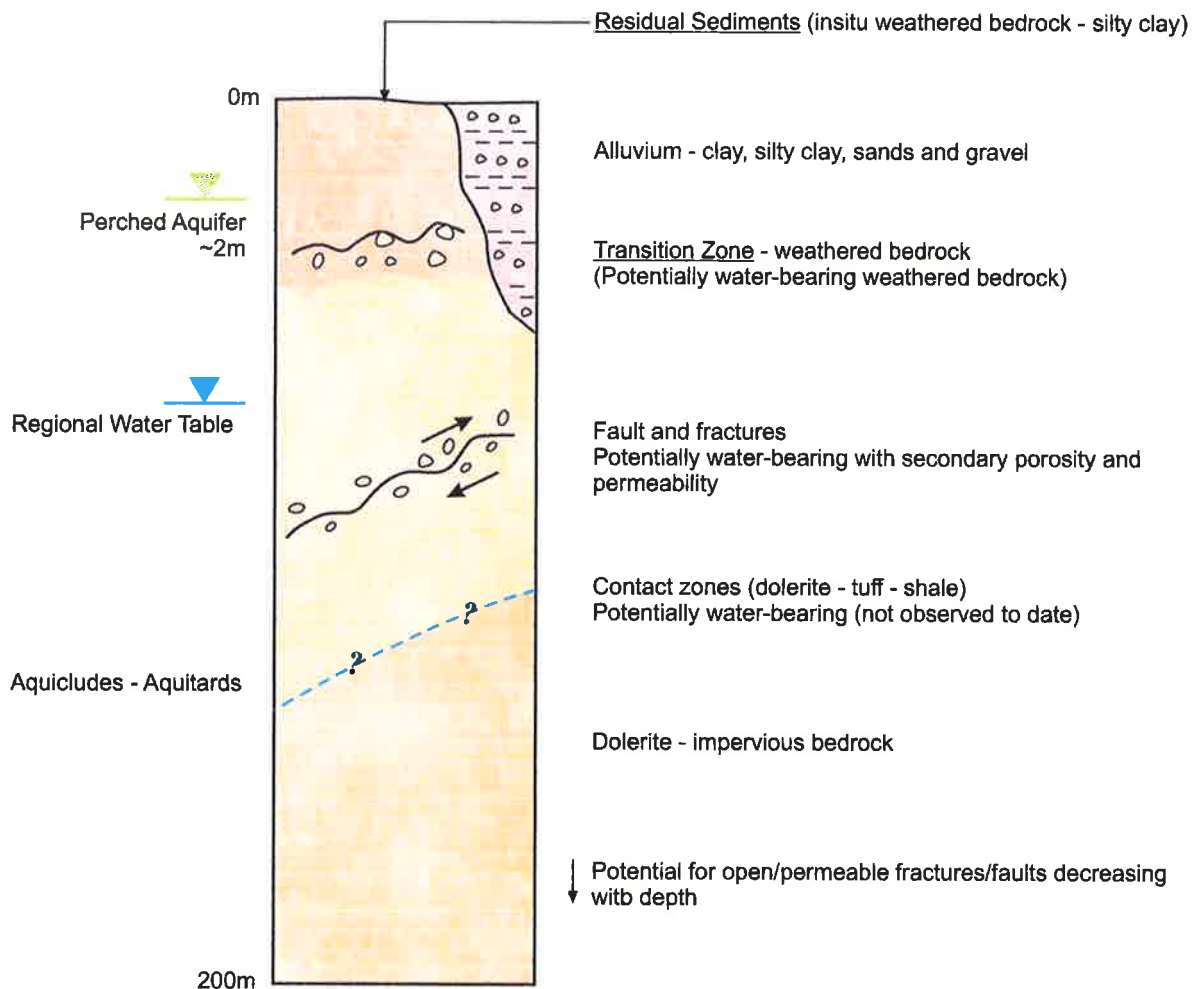
## SUMMARY OF AQUIFER UNITS AT BIOREACTOR SITE
