**ANNUAL ENVIRONMENTAL  
MANAGEMENT REPORT**

WOODLAWN BIOREACTOR  
AND  
CRISPS CREEK INTERMODAL FACILITY

November 2013

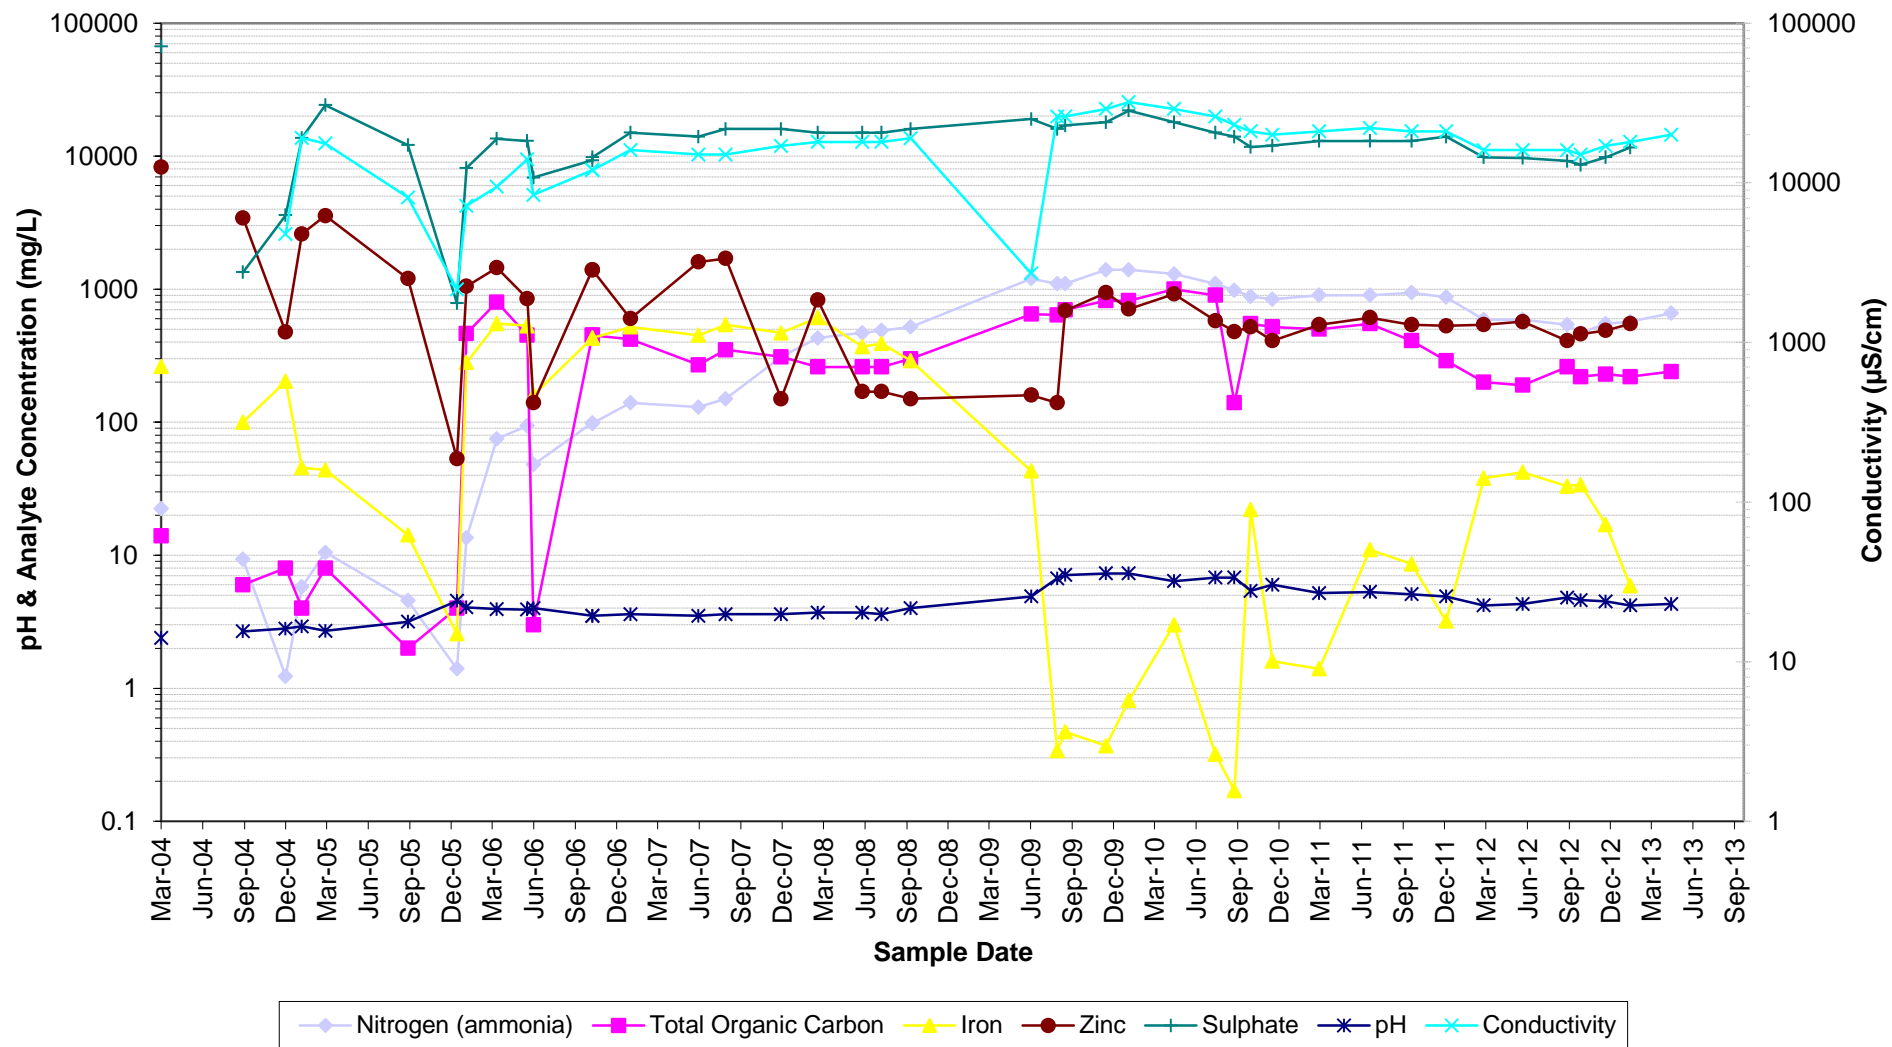
Figure 11 - Surface Water Trends - WM203

Evaporation Dam 3 North is a storage point to manage AMD/leachate by evaporation. Quarterly monitoring events were undertaken in accordance with EPL conditions (refer to Table T8.7 and Figure 11).
