Soil Water & Leachate Management Plan

For Woodlawn Mechanical Biological Treatment Facility

Document Code: PLA-NSW-XXX-XXX-1

Date: 19.01.2017

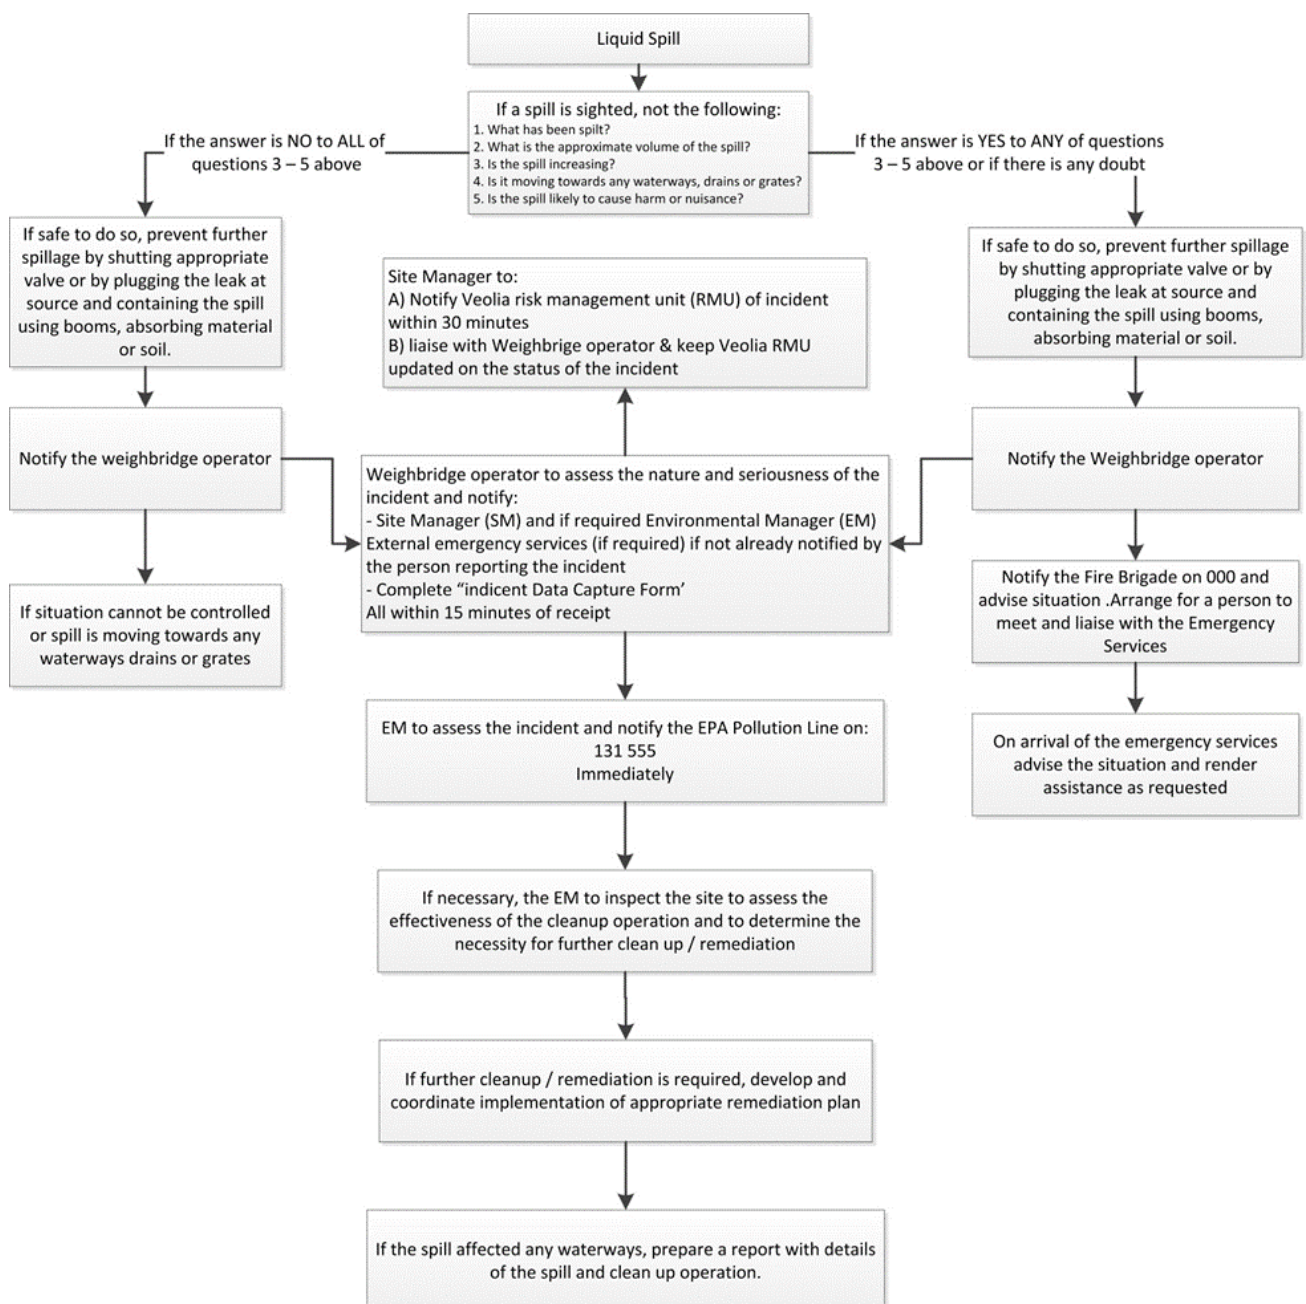
Figure 6.2 Typical Spill Response Flow Chart

A typical spill response procedure to be followed by Veolia personnel is summarised in Figure 6.2 below.

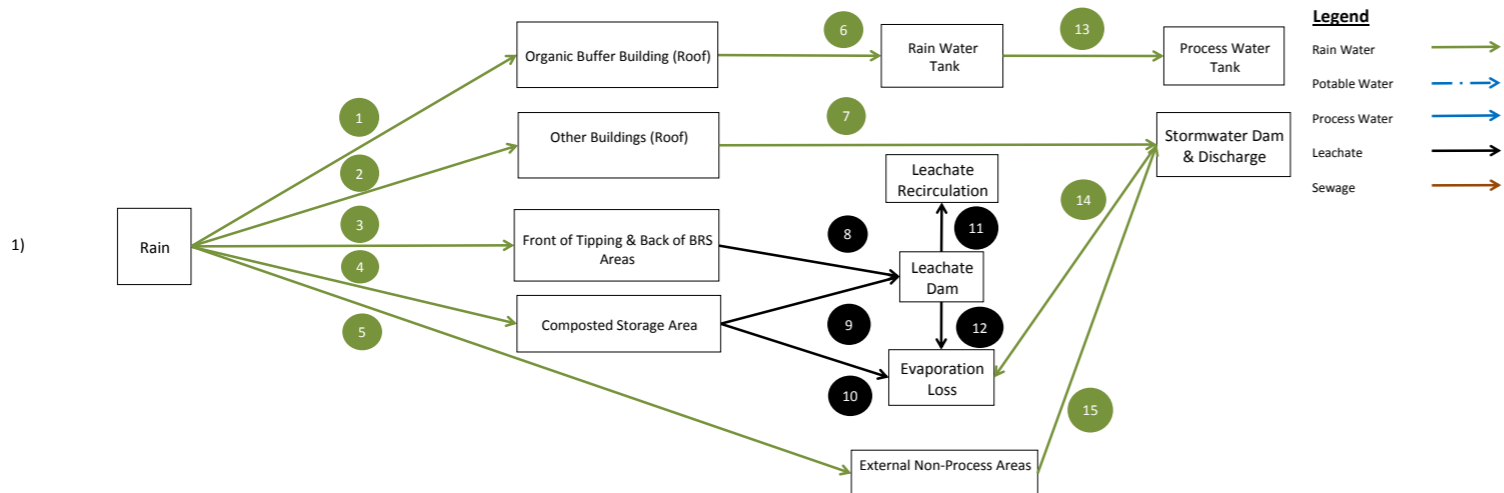
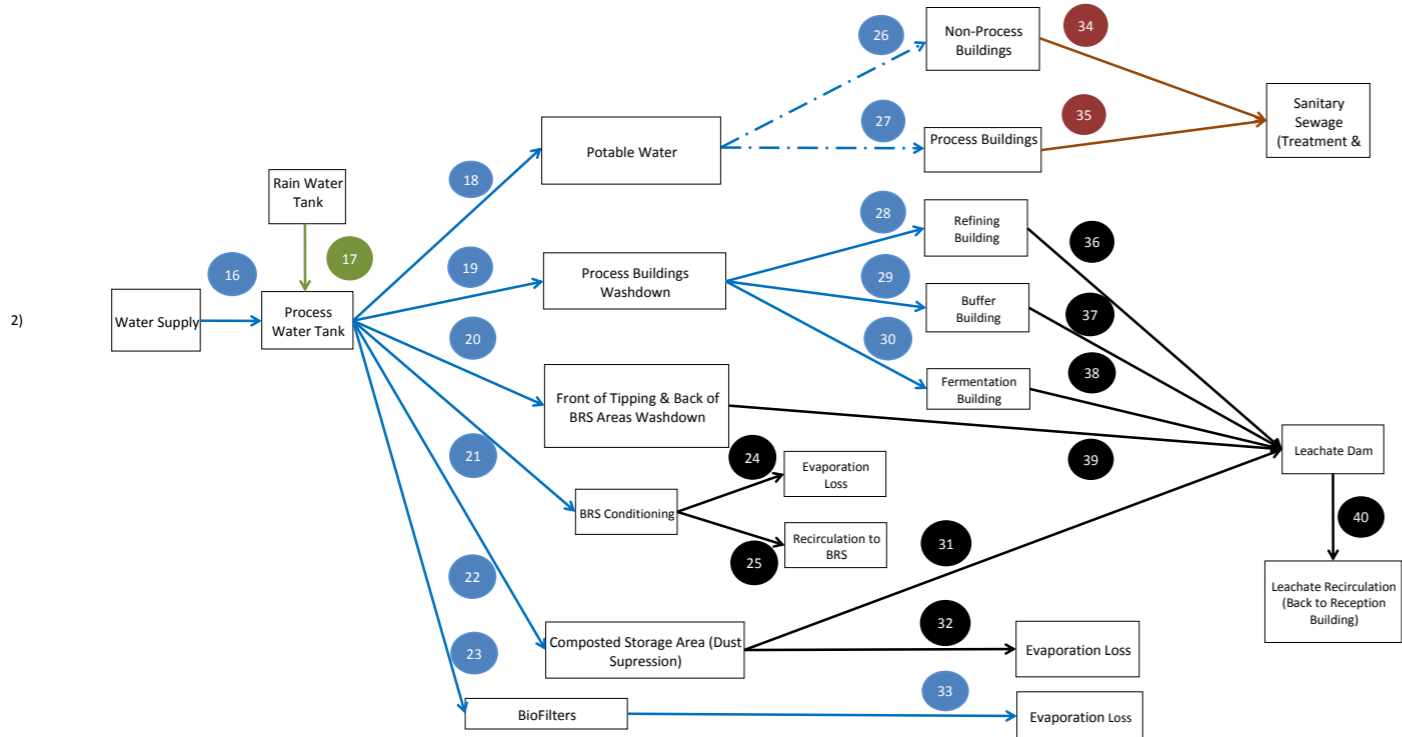
Appendix D1.1 Detailed Water Balance

Water Balance Calculation					
From	Descriptions	To	Code	Hourly	m3/d
Rain		Organic Buffer Building (Roof)	1	0.10	2.5
Rain		Other Buildings (Roof)	2	0.95	22.8
Rain		External Process Areas (Reception/BRS)	3	0.04	0.9
Rain		Composted Storage Area	4	2.17	52.2
Rain		To External Non-Process Areas	5	4.33	104.0
Organic Buffer Building (Roof)		Rain Water Tank	6	0.10	2.5
Other Buildings (Roof)		Stormwater Dam & Discharge	7	0.95	22.8
Front of Tipping & Back of BRS Areas		Leachate Dam	8	0.04	0.9
Composted Storage Area		Leachate Dam	9	0.43	10.4
Composted Storage Area		Evaporation	10	1.74	41.8
Leachate Dam		Leachate Recirculation	11	0.30	7.2
Leachate Dam		Evaporation	12	0.17	4.0
Rain Water Tank		Process Water Tank	13	0.10	2.50
Stormwater Dam		Evaporation	14	4.82	115.7
External Non-Process Areas		Stormwater Dam & Discharge	15	4.33	104
Water Supply		Process Water Tank	16	4.63	85.68
Rain Water Tank		Process Water Tank	17	0.10	2.50

Process Water Tank		Potable Water	18	0.11	1.9
Process Water Tank		Process Buildings Washdown	19	0.17	3.04
Process Water Tank		Front of Tipping & Back of BRS Areas Washdown	20	0.04	0.96
Process Water Tank		BRS Conditioning	21	1.92	46
Process Water Tank		Composted Storage Area (Dust Suppression)	22	2.19	39.4
Process Water Tank		OCs	23	2.13	38.1
BRS Conditioning		Evaporation	24	0.19	4.6
BRS Conditioning		Recirculation to BRS	25	1.73	41.5
Potable Water		Non-Process Water Buildings	26	0.05	1
Potable Water		Process Water Buildings	27	0.05	1
Process Buildings Washdown		Refining Building	28	0.11	2
Process Buildings Washdown		Buffer Building	29	0.01	0.24
Process Buildings Washdown		Fermentation Building	30	0.04	0.8
Composted Storage Area (Dust Suppression)		Leachate Dam	31	0	0
Composted Storage Area (Dust Suppression)		Evaporation	32	2.19	39
OCs		Evaporation	33	2.13	38.30
Non-Process Water Buildings		Sanitary Sewage (Treatment & Irrigation)	34	0.05	0.95

Process Water Buildings		Sanitary Sewage (Treatment & Irrigation)	35	0.05	1
Refining Building		Leachate Dam	36	0.11	2.00
Buffer Building		Leachate Dam	37	0.01	0.24
Fermentation Building		Leachate Dam	38	0.04	0.80
Front of Tipping & Back of BRS Areas Washdown		Leachate Dam	39	0.04	0.96
Leachate Dam		Leachate Recirculation (Back to Reception Building)	40	0.17	4.0

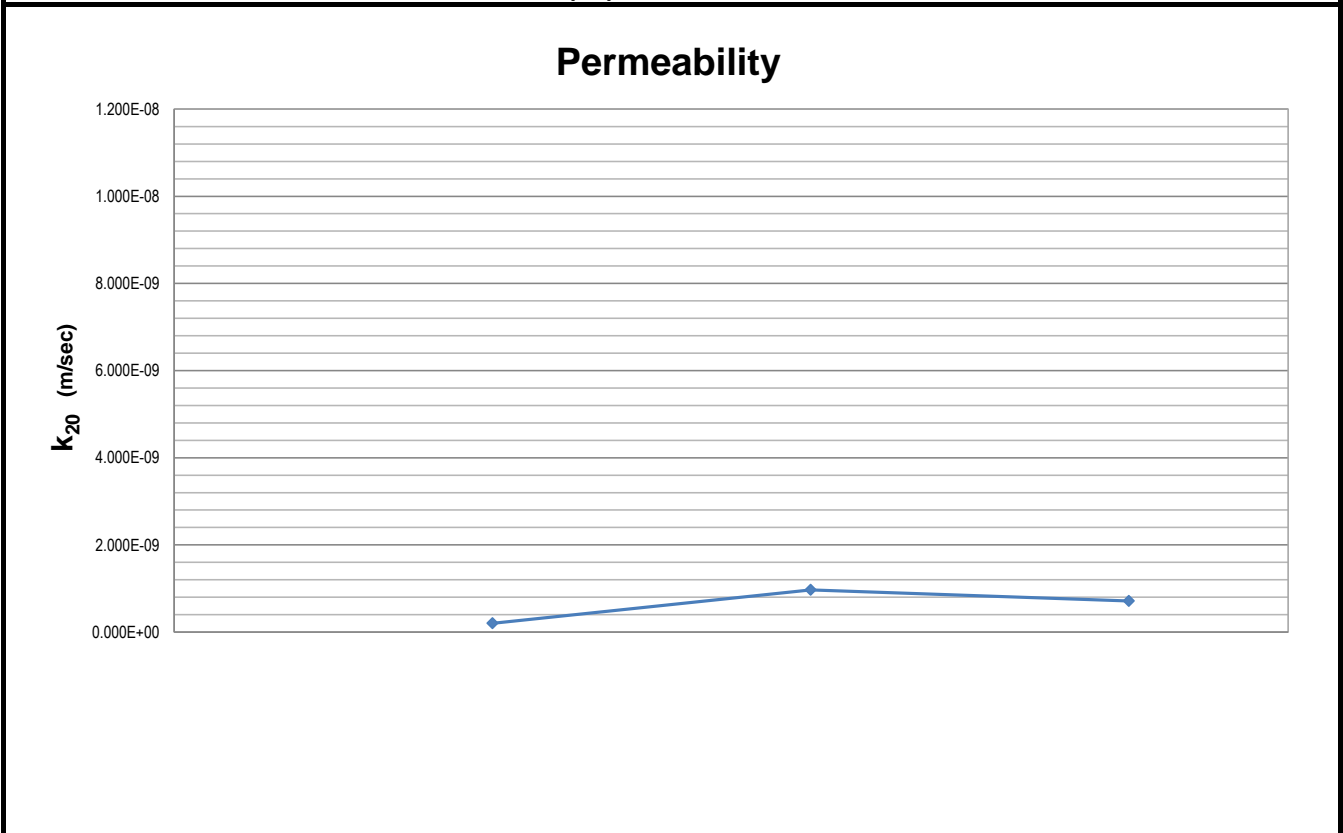
RESULTS			
Standard Maximum Dry Density (t/m ³)	1.67	Hydraulic Gradient	0.0
Optimum Moisture Content (%)	20.0	Surcharge (kPa)	0.0
Placement Moisture Content (%)	20.2	Head Pressure Applied (kPa)	0.0
Moisture Ratio (%)	101.2	Standard Compaction	Standard
Placement Dry Density (t/m ³)	1.67	Percentage Material Retained/Sieve Size (mm)	0 % on 9.5
Density Ratio (%)	99.8	Sample Height and Diameter (mm)	103.4 x 98.4

PERMEABILITY $k_{(20)} = 7.11E-10 \text{ (m/sec)}$

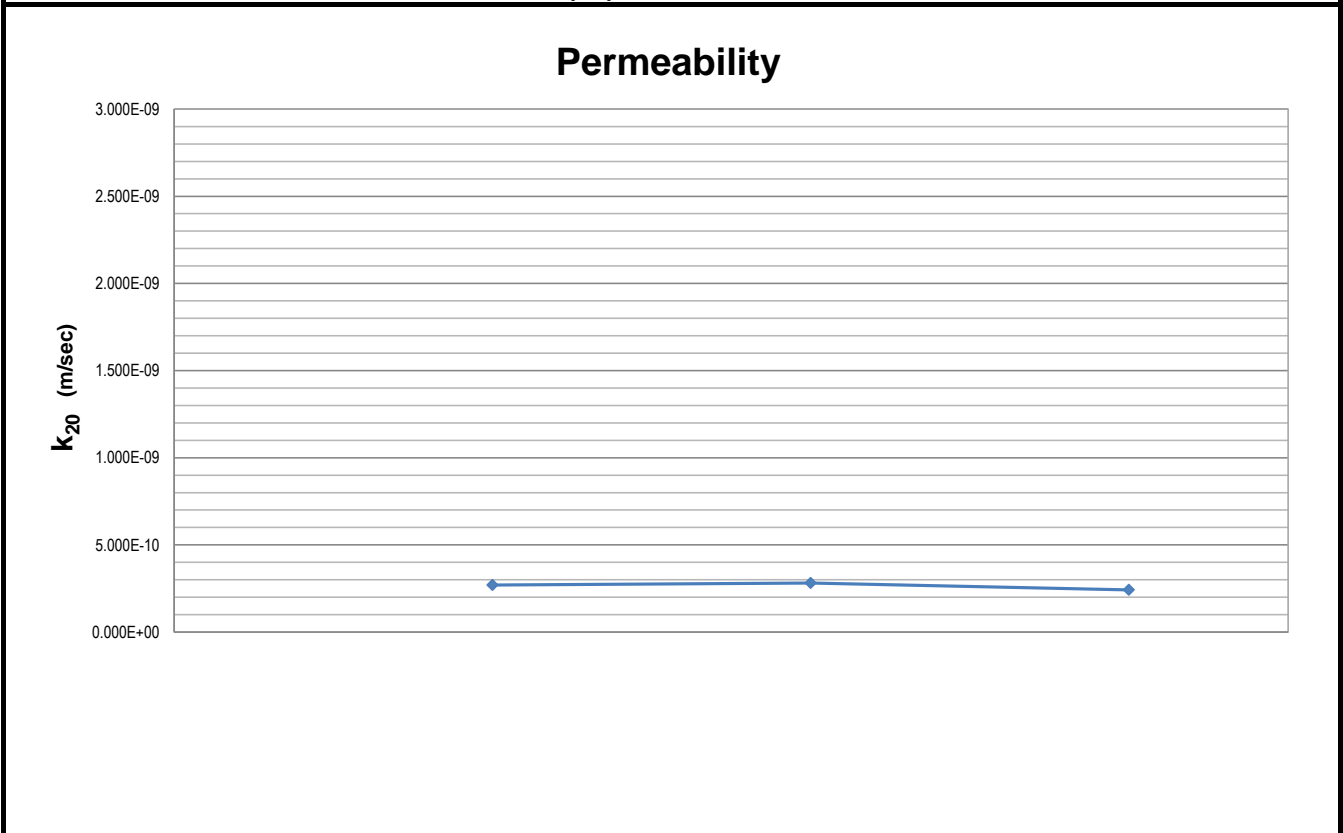
RESULTS			
Standard Maximum Dry Density (t/m ³)	1.70	Hydraulic Gradient	0.0
Optimum Moisture Content (%)	19.0	Surcharge (kPa)	0.0
Placement Moisture Content (%)	19.0	Head Pressure Applied (kPa)	0.0
Moisture Ratio (%)	99.9	Standard Compaction	Standard
Placement Dry Density (t/m ³)	1.70	Percentage Material Retained/Sieve Size (mm)	0 % on 9.5
Density Ratio (%)	100.0	Sample Height and Diameter (mm)	104 x 97.9

PERMEABILITY $k_{(20)} = 2.42E-10$ (m/sec)

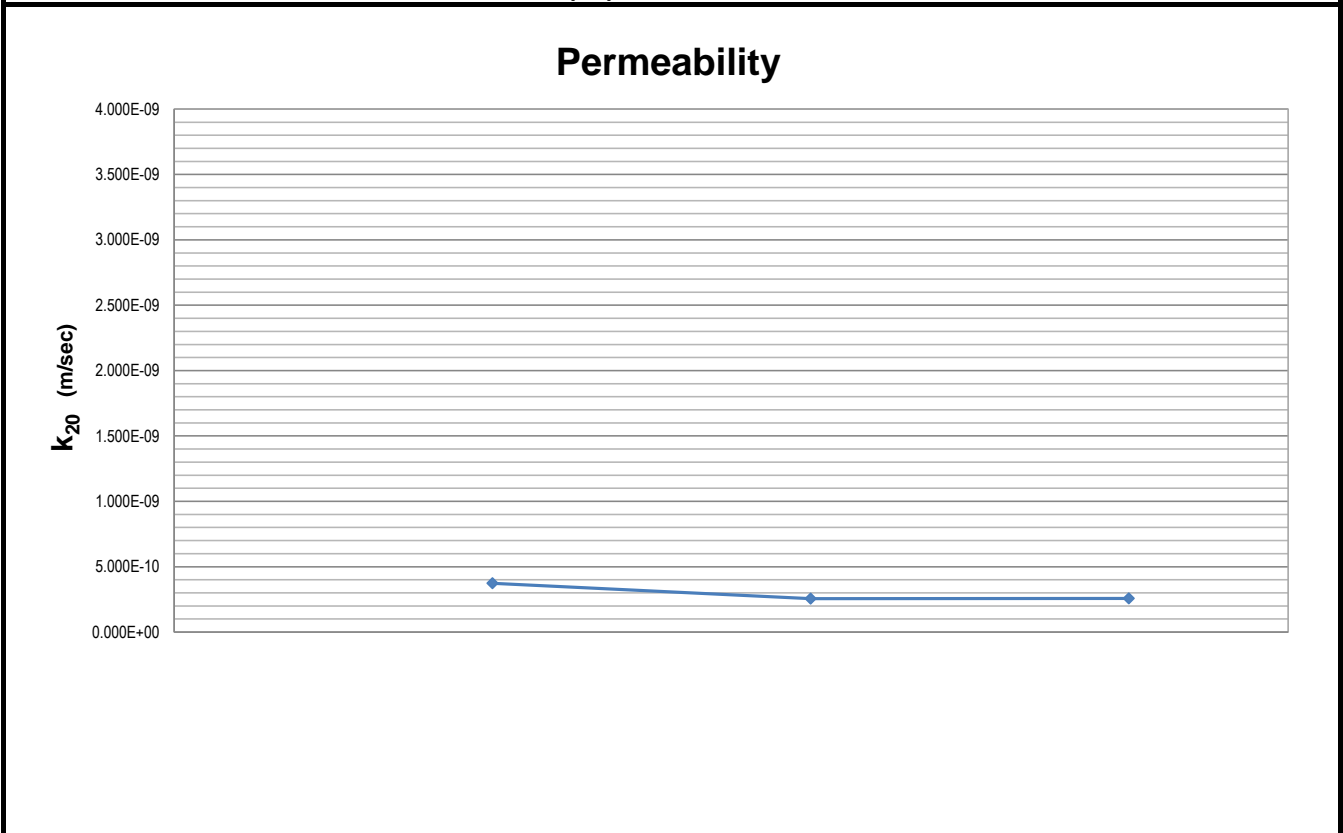
RESULTS			
Standard Maximum Dry Density (t/m ³)	1.64	Hydraulic Gradient	0.0
Optimum Moisture Content (%)	19.0	Surcharge (kPa)	0.0
Placement Moisture Content (%)	18.9	Head Pressure Applied (kPa)	0.0
Moisture Ratio (%)	99.5	Standard Compaction	Standard
Placement Dry Density (t/m ³)	1.64	Percentage Material Retained/Sieve Size (mm)	0 % on 9.5
Density Ratio (%)	100.1	Sample Height and Diameter (mm)	103.3 x 98.3

PERMEABILITY $k_{(20)} = 2.57E-10$ (m/sec)

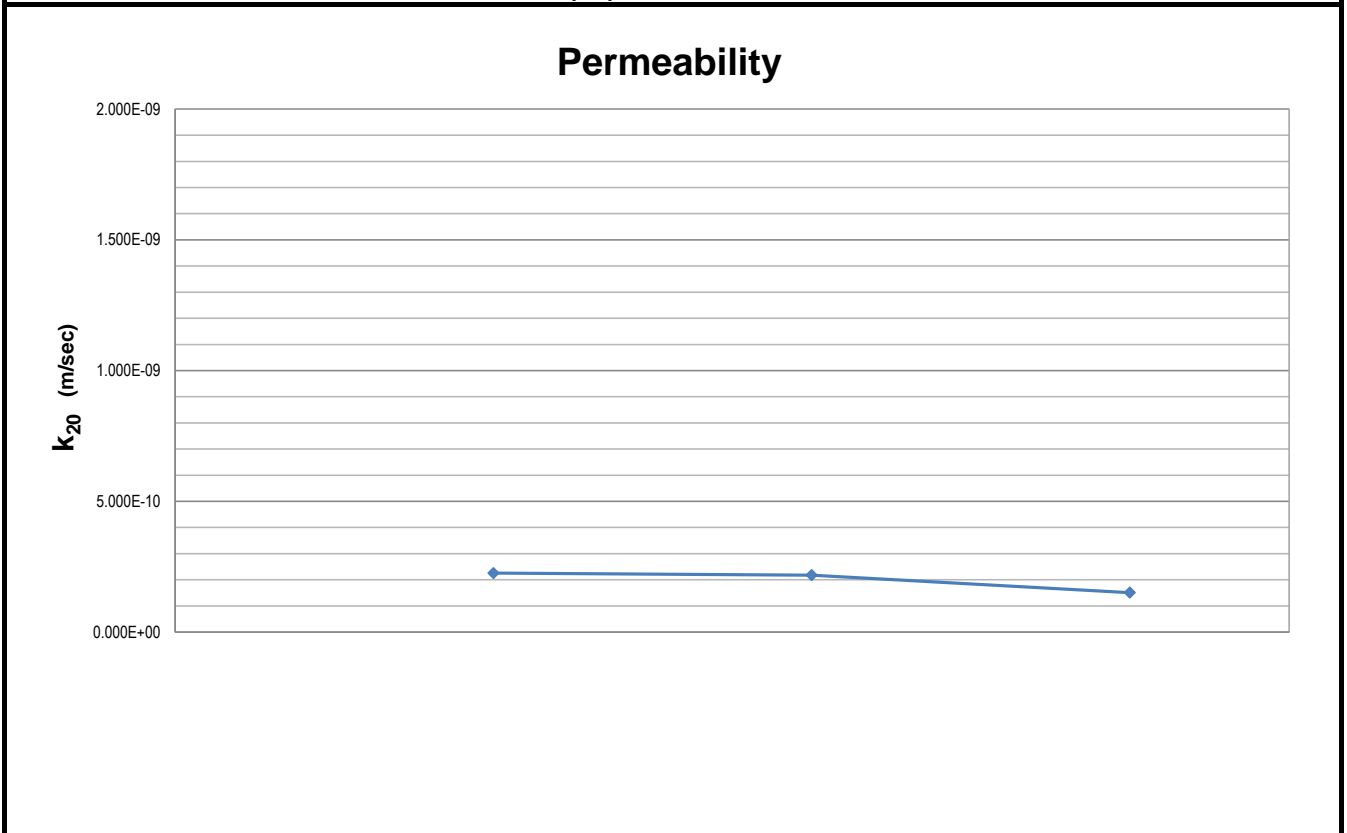
PERMEABILITY $k_{(20)} = 1.51E-10$ (m/sec)

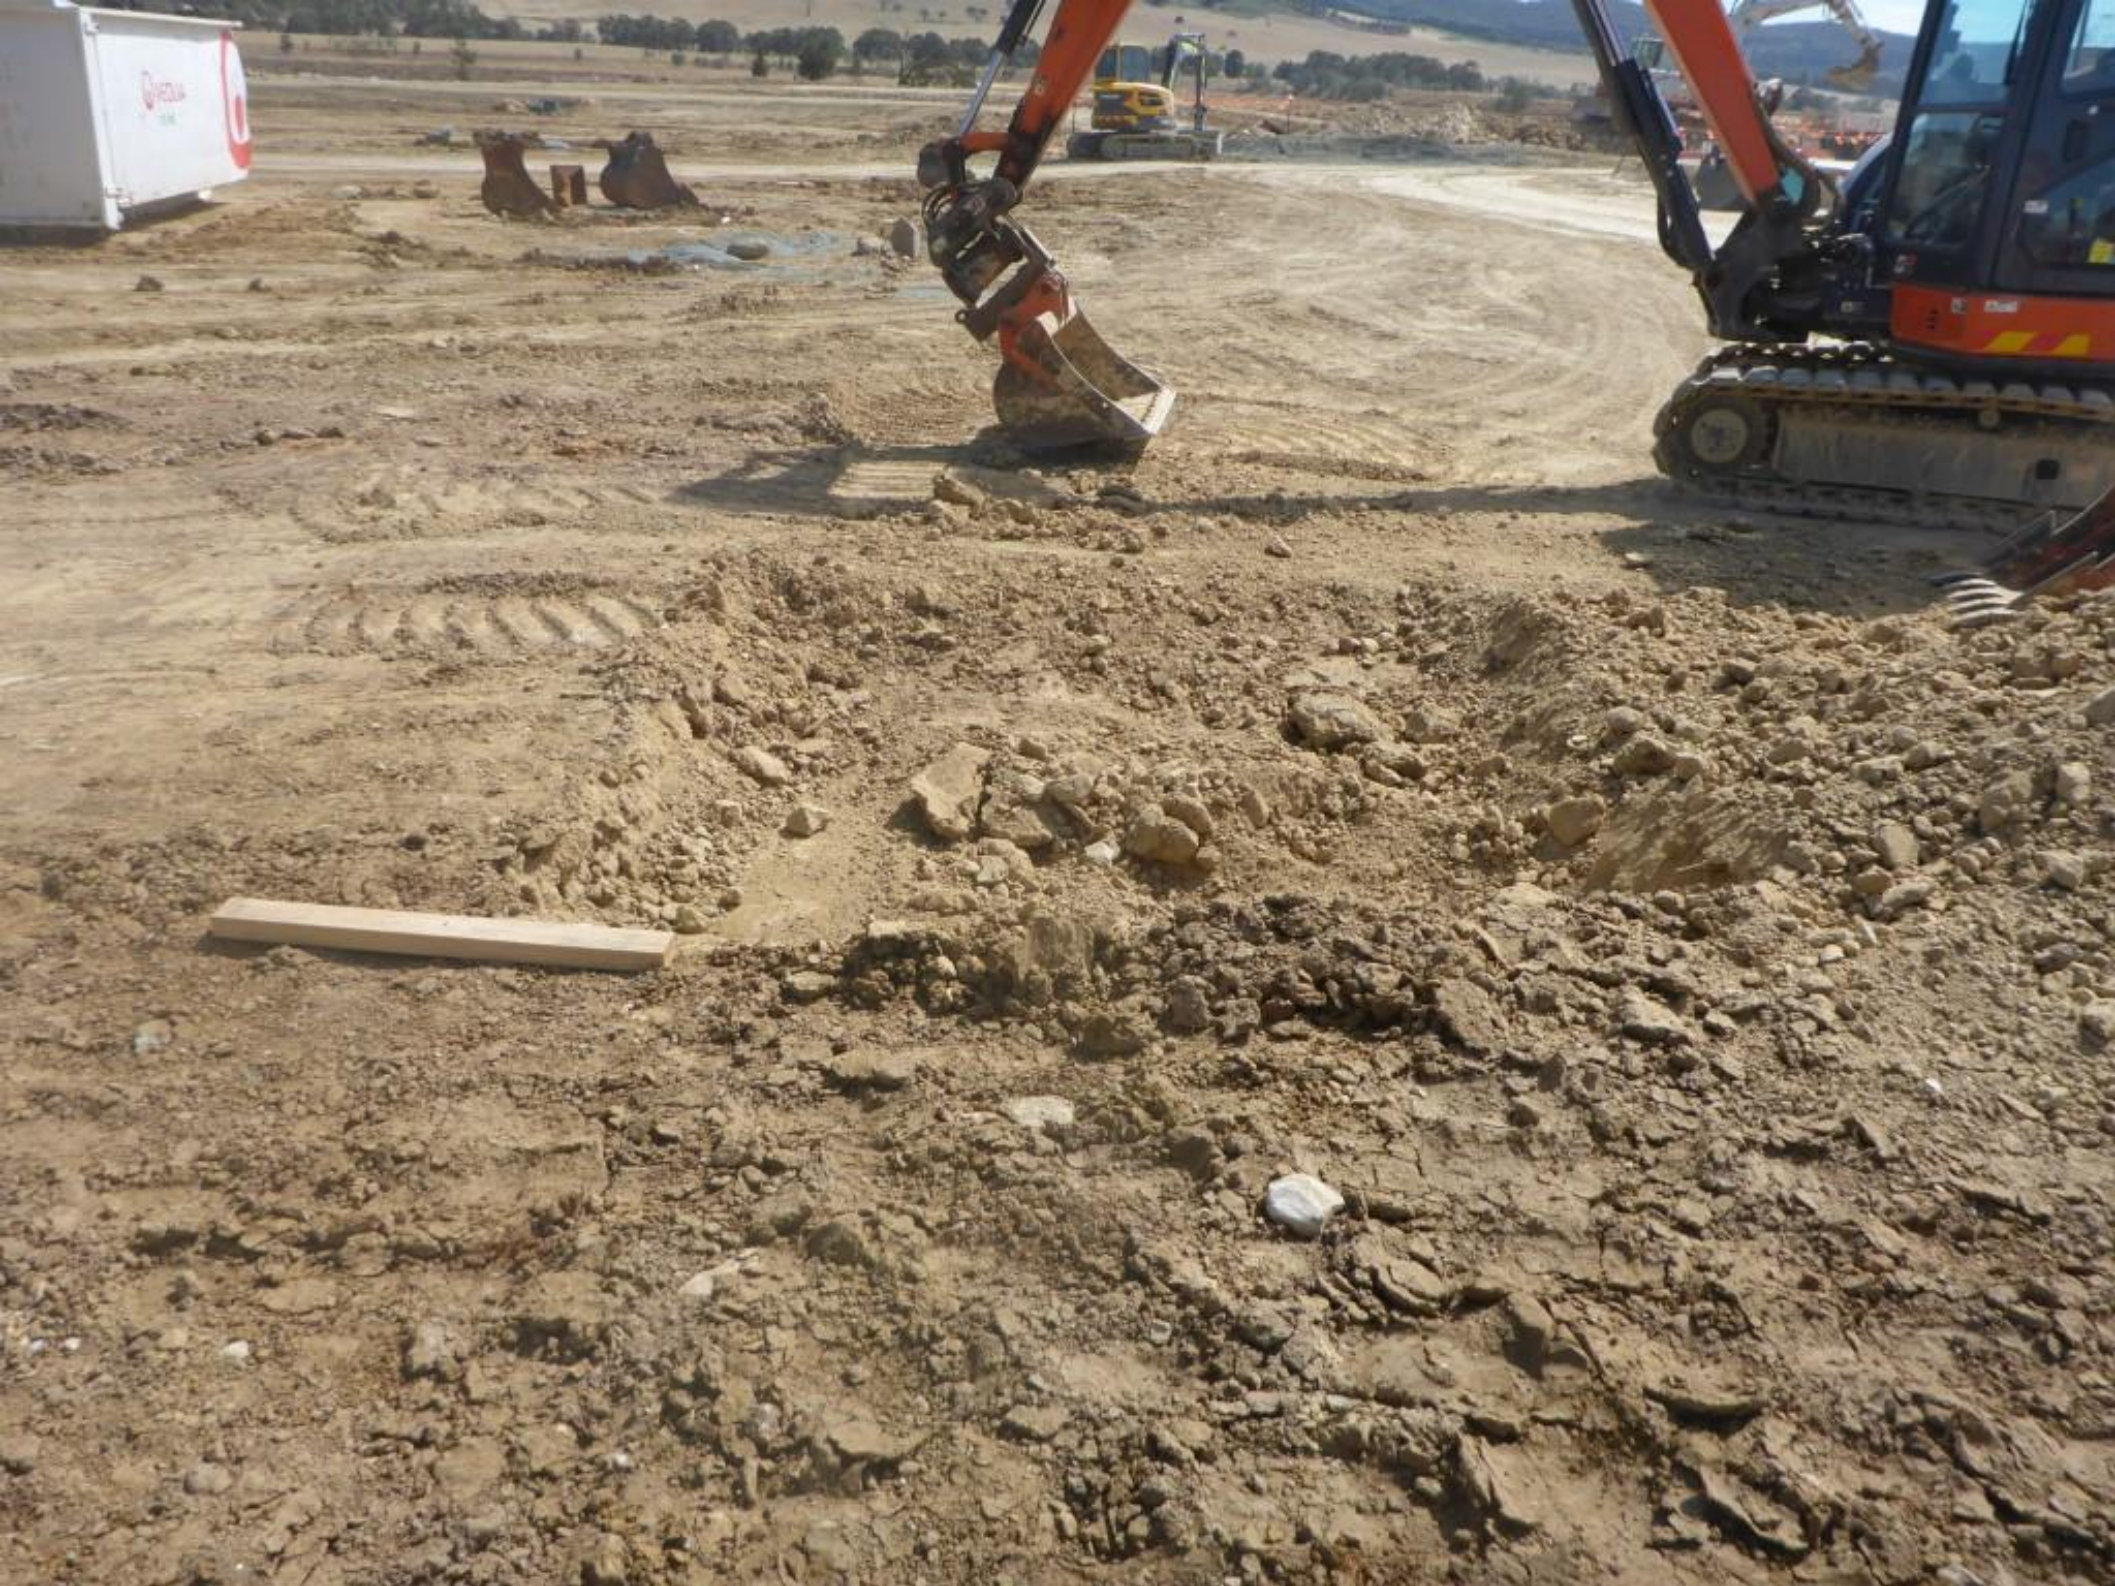
Field Log - Excavation

method	penet	support	notes	depth	USC	material	moisture	consist.	PP	structure and
1 2 3			samples, tests, etc	(m)		soil name, plasticity or particle characteristics, colour secondary components & minor components			kPa	additional observations
E				0		SILTY CLAY: Mp to Hp. BROWN, TRACE OF F-C SAND, TRACE OF F-C GRAVELS	D	M		FILL (CLAY LINER)
				0.5						
				0.7m		COLOUR TO PALE GREEN				7600
				0.8		XW MATERIAL				Residual
				1.0		TP01 TERMINATED @ 0.8m				
						TARGET DEPTH				
				1.5						
				2.0						
				2.5						
				3.0

☒ groundwater not observed ☐ groundwater inflow at: m ☐ standing water level m time: date:

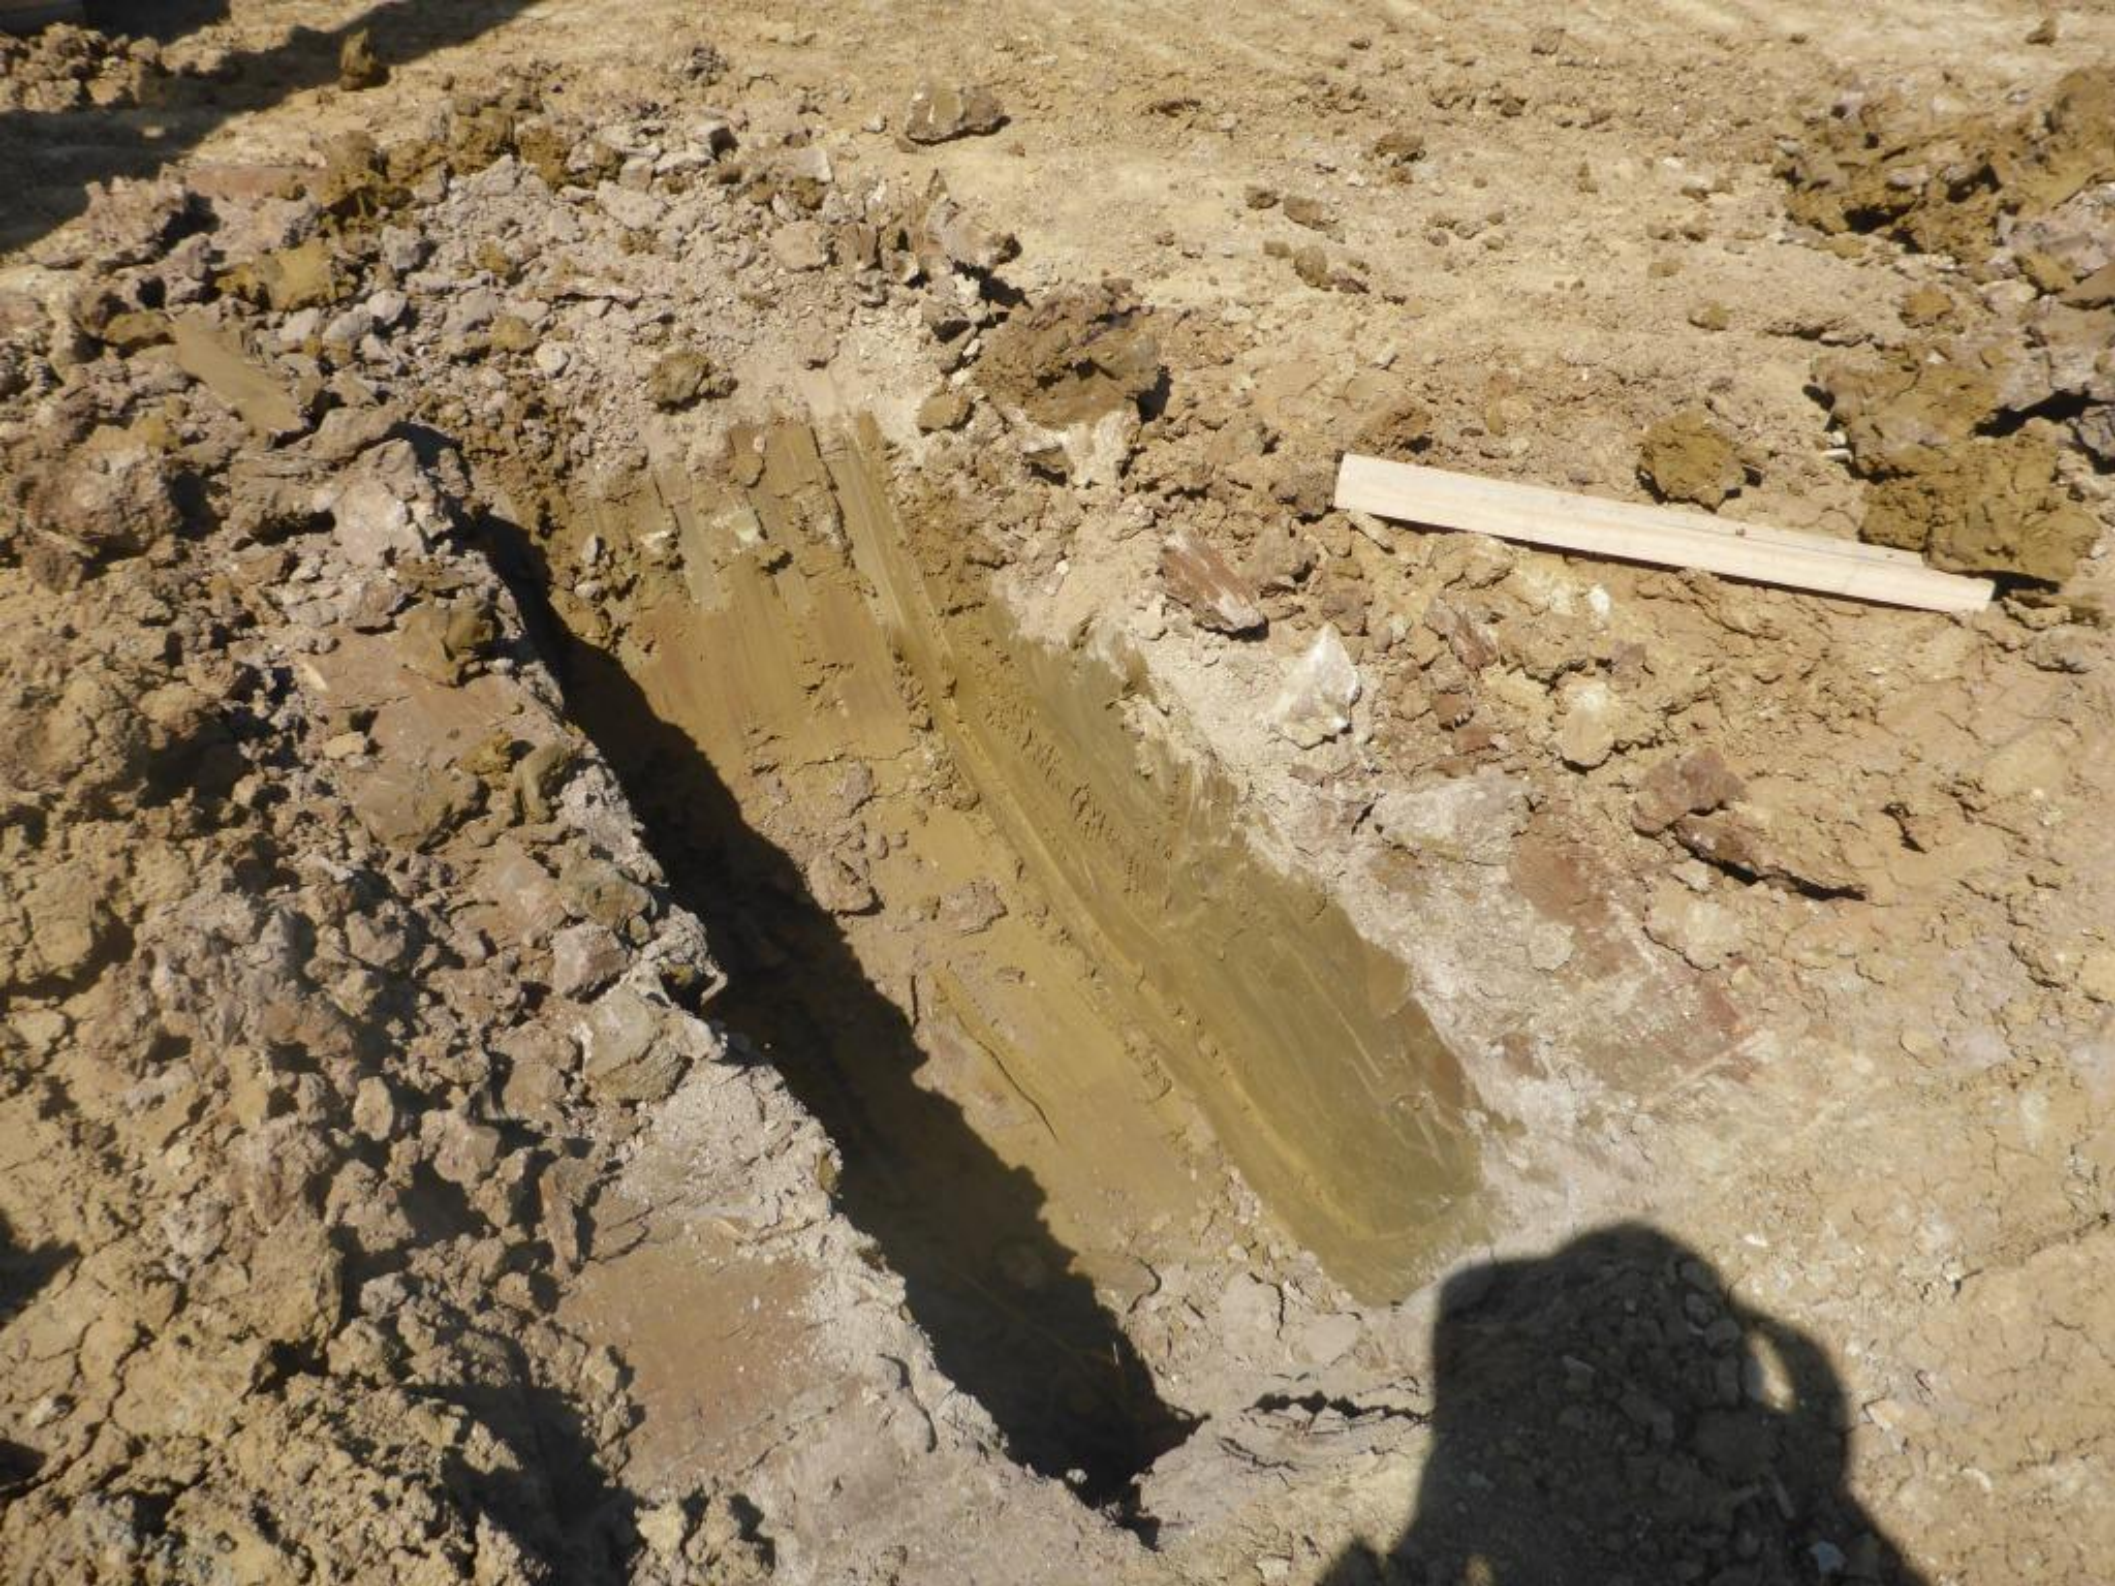
Field Log - Excavation

method	penet- 1 2 3	support	notes samples, tests, etc	depth (m)	USC	material soil name, plasticity or particle characteristics, colour secondary components & minor components	moisture	consist.	PP kPa 100 200 300 400	structure and additional observations
E				0		CLAY: Hp, PALE BROWN				Fill / Liner
				0.5		(CLAY > 0.6m)			X430 X300	
				1.0		TP02 TERMINATED @ 0.7m @ TARGET DEPTH				
				1.5						
				2.0

☒ groundwater not observed

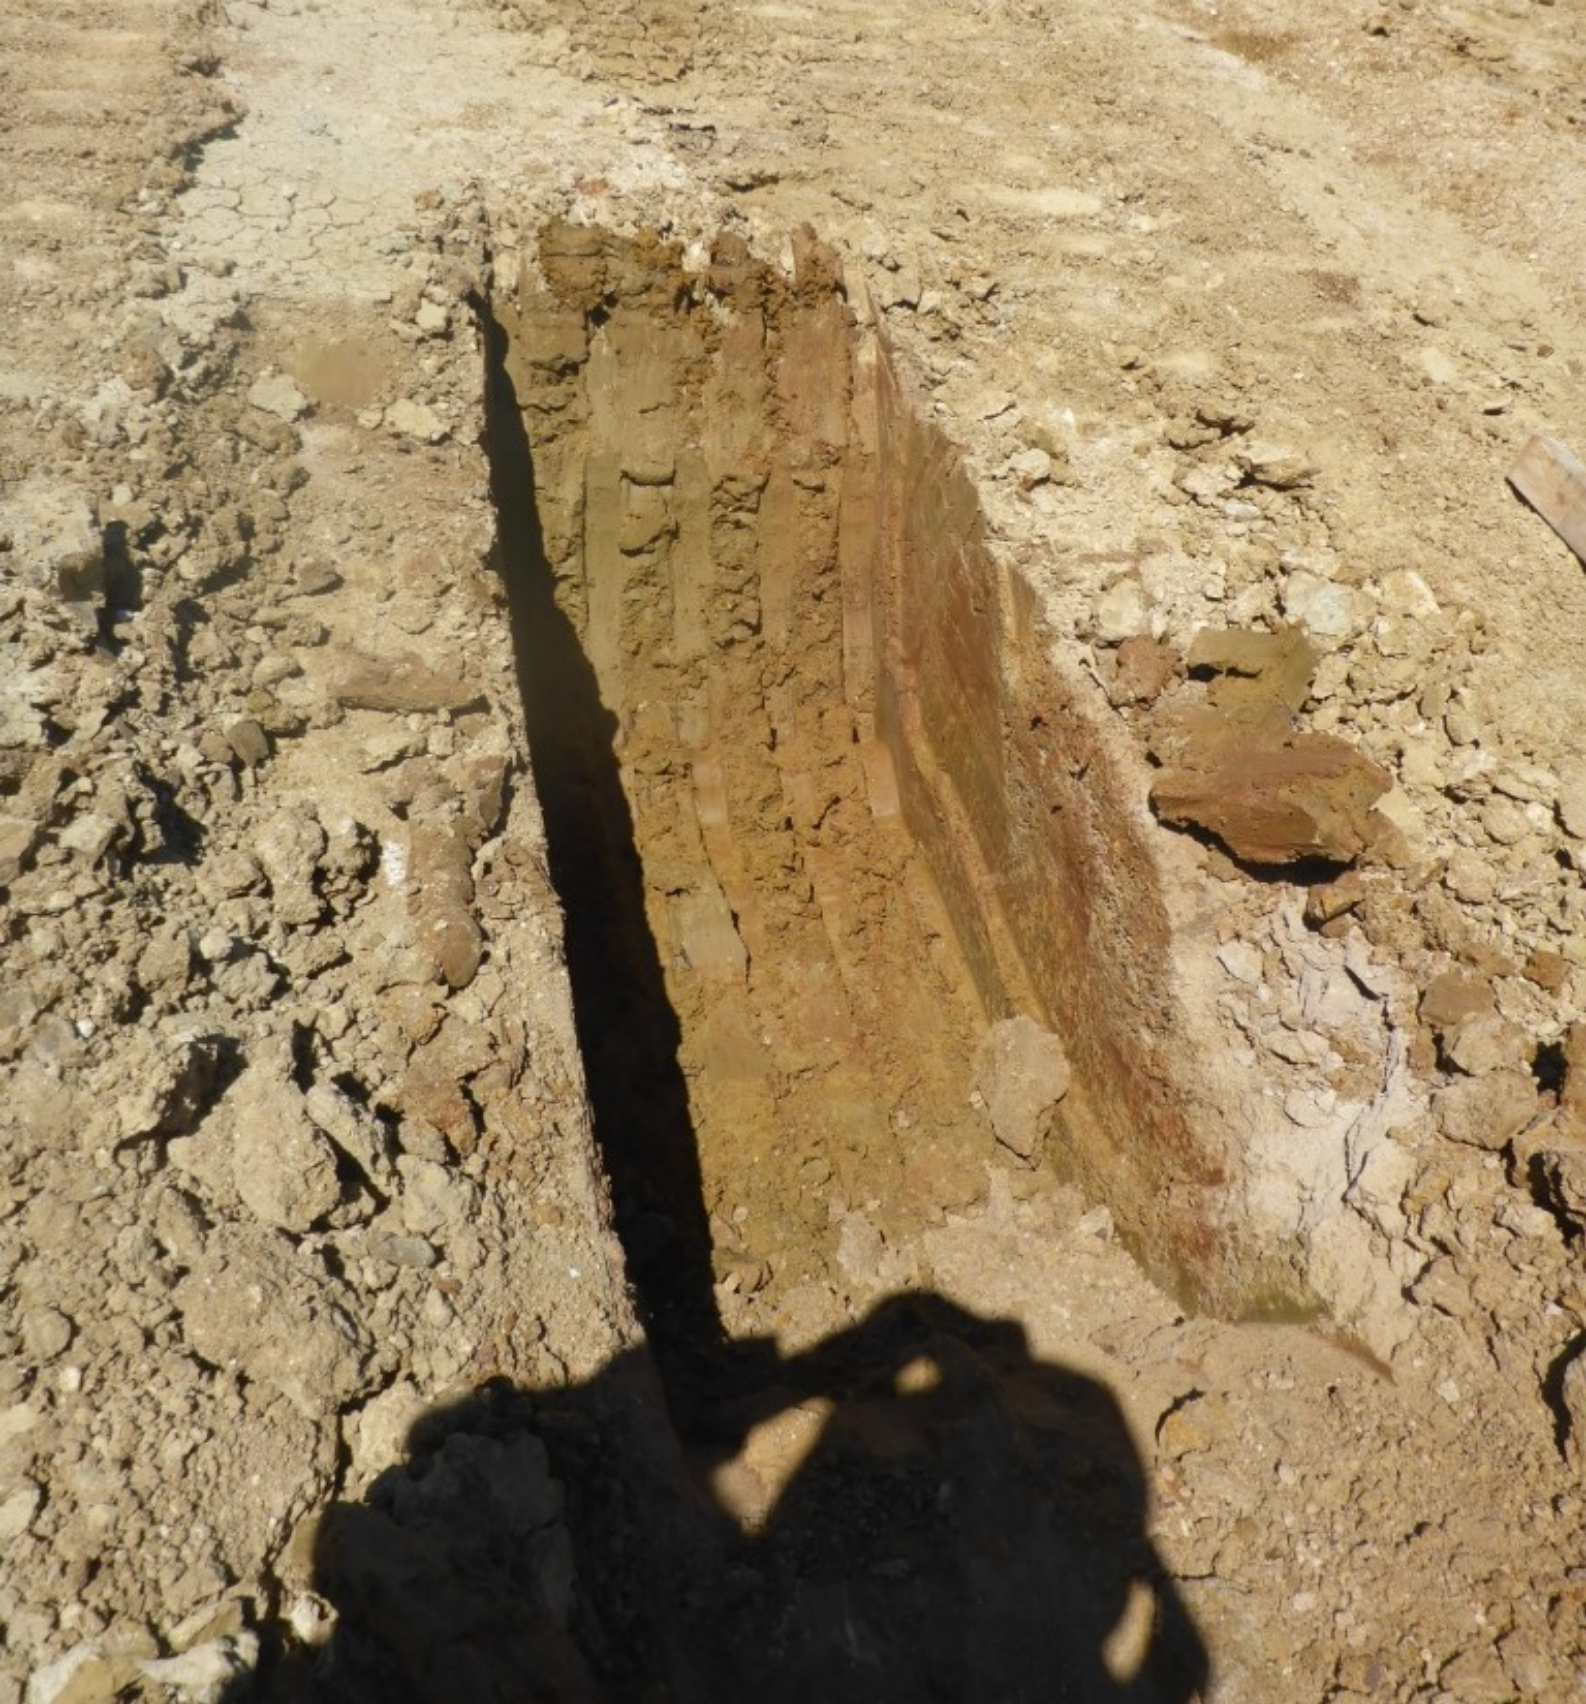
Field Log - Excavation

method	penet-	support	notes samples, tests, etc	depth (m)	USC	material soil name, plasticity or particle characteristics, colour secondary components & minor components	moisture	consist.	PP kPa	structure and additional observations
1	2	3							100 200 300 400 500	
E				0		CLAY: Hp, Pale Brown	Wp	VS/H	X500	Fill/Liner
				0.5					X500	
									X400	
									X300	
									X300	
				1.0		TP03 TERMINATED @ 0.6m on TARGET DEPTH				Liner Below

☒ groundwater not observed ☐ groundwater inflow at: m ☐ standing water level m time: date:

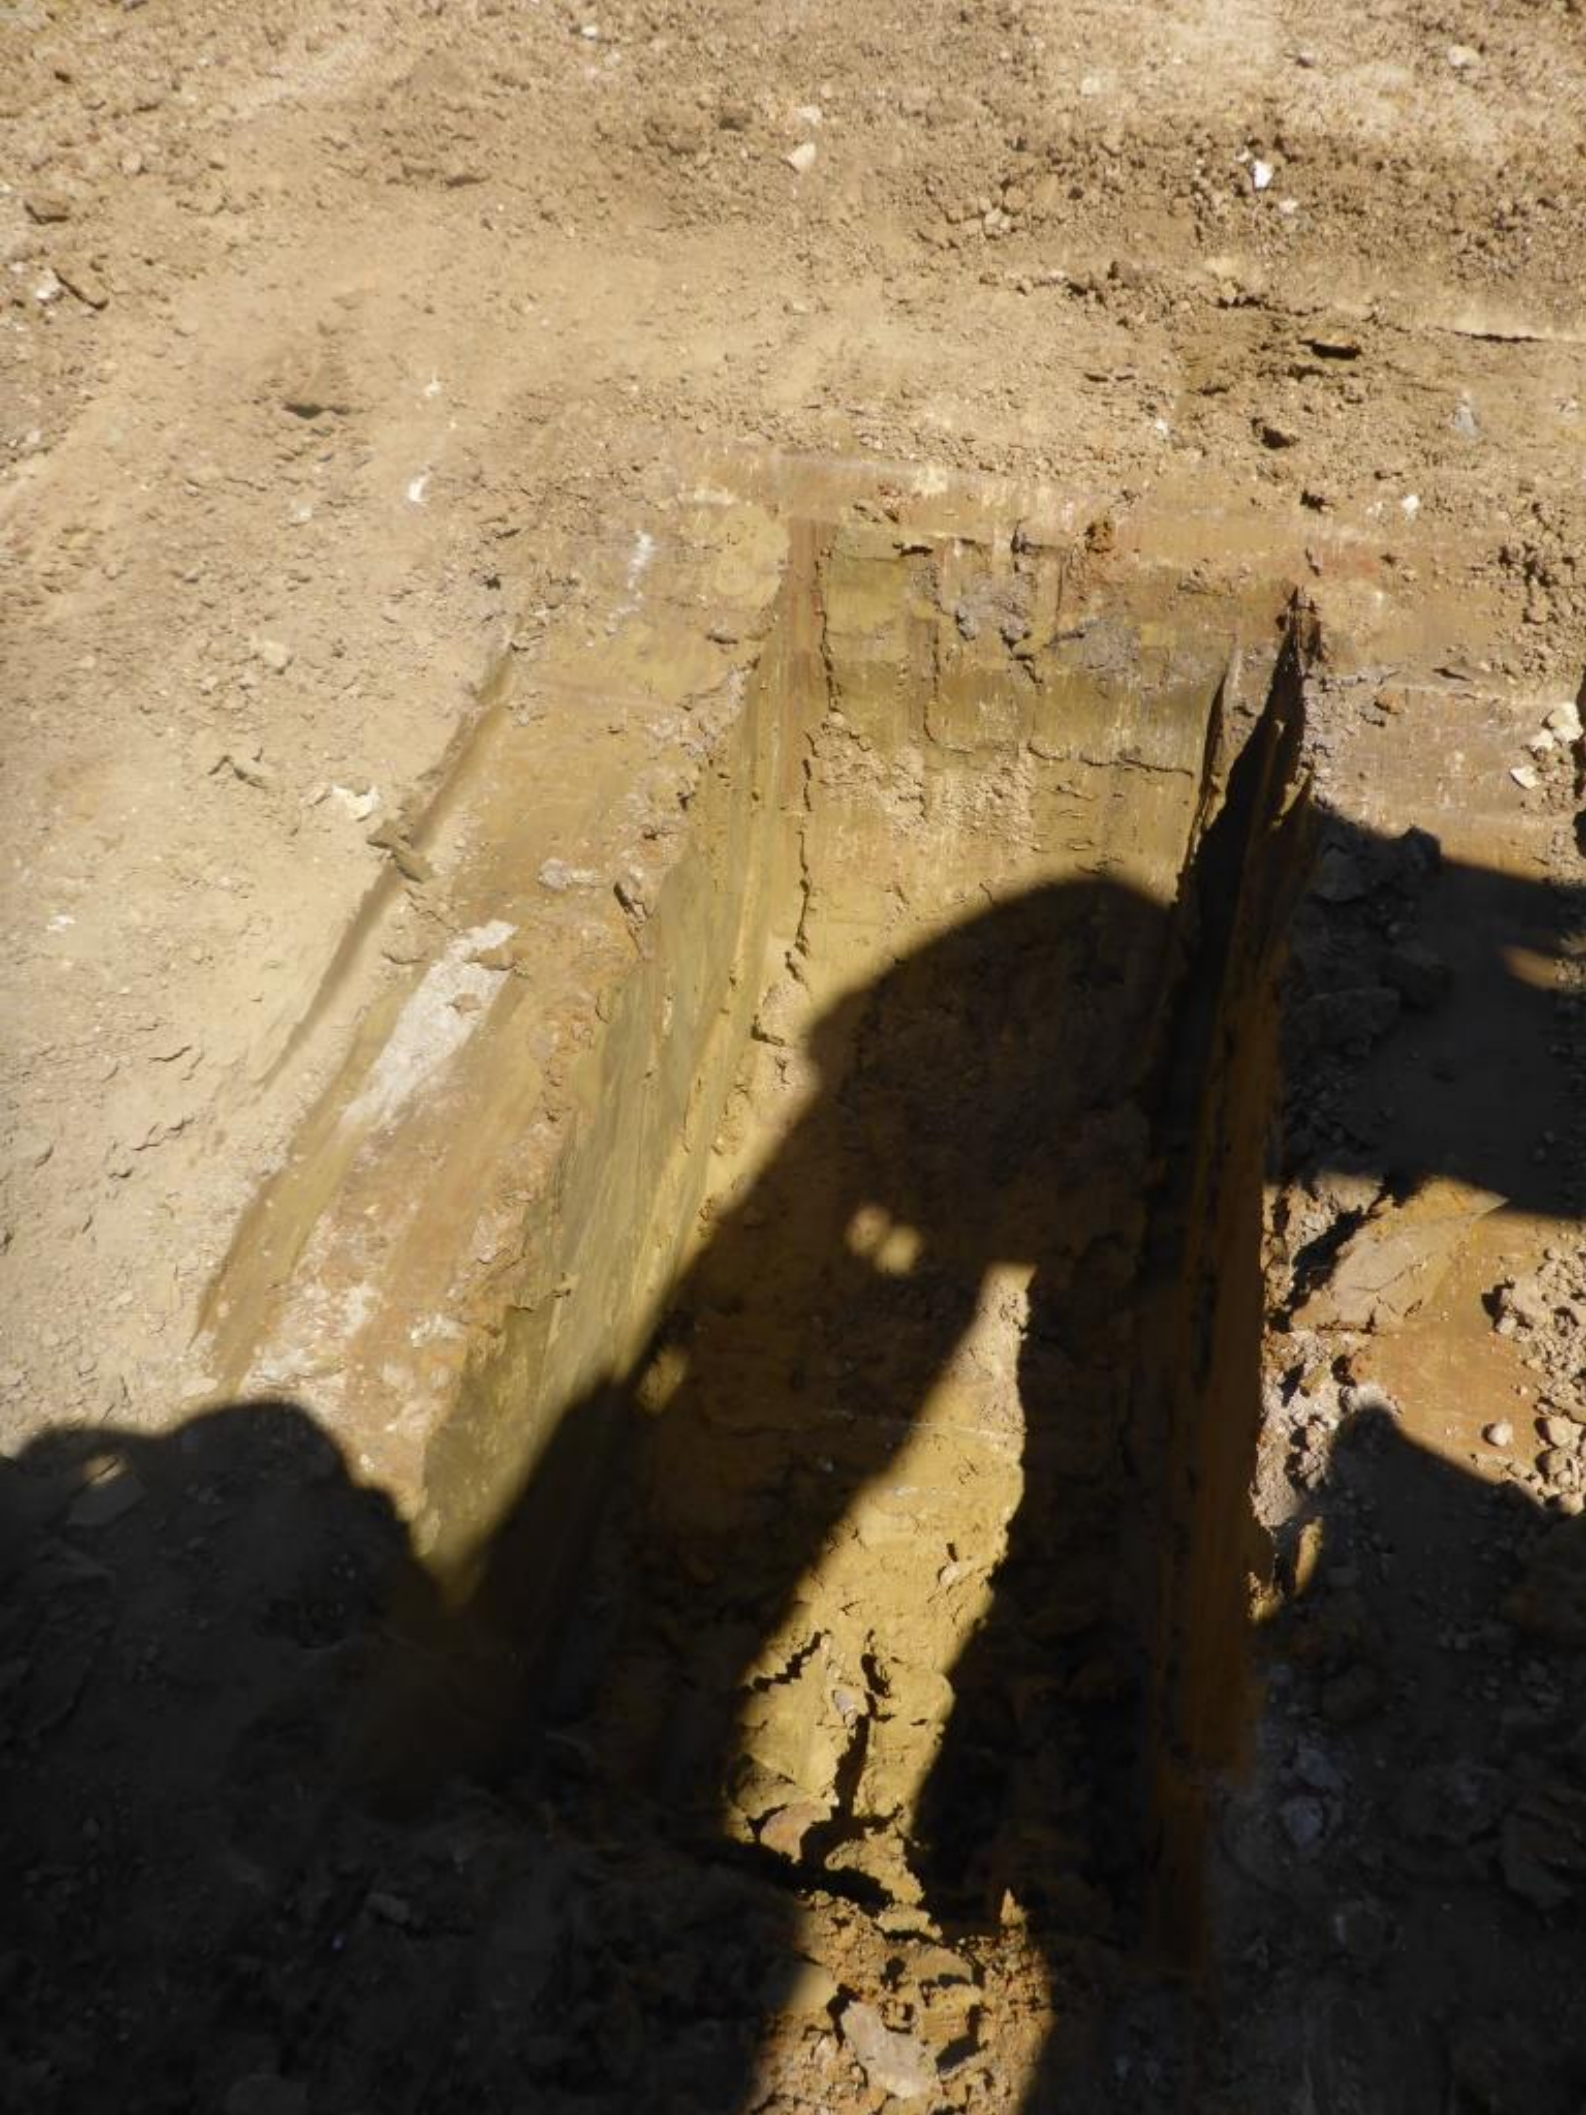
Field Log - Excavation

method	penet- 1 2 3	support	notes samples, tests, etc	depth (m)	USC	material soil name, plasticity or particle characteristics, colour secondary components & minor components	moisture	consist.	PP kPa 100 200 300 400 500	structure and additional observations
E				0		CLAY: HP, PALE BROWN	7wp		250	(CLAY LINER)
				0.5					200	FILL
				1.0		TP04 TERMINATED @ 0.65m			200	
				1.5		@ TARGET DEPTH			250	
				2.0

☐ groundwater not observed ☐ groundwater inflow at: m ☐ standing water level m time: date:
