Soil Water & Leachate Management Plan

For Woodlawn Mechanical Biological Treatment Facility

Document Code: PLA-NSW-XXX-XXX-1

Date: 19.01.2017

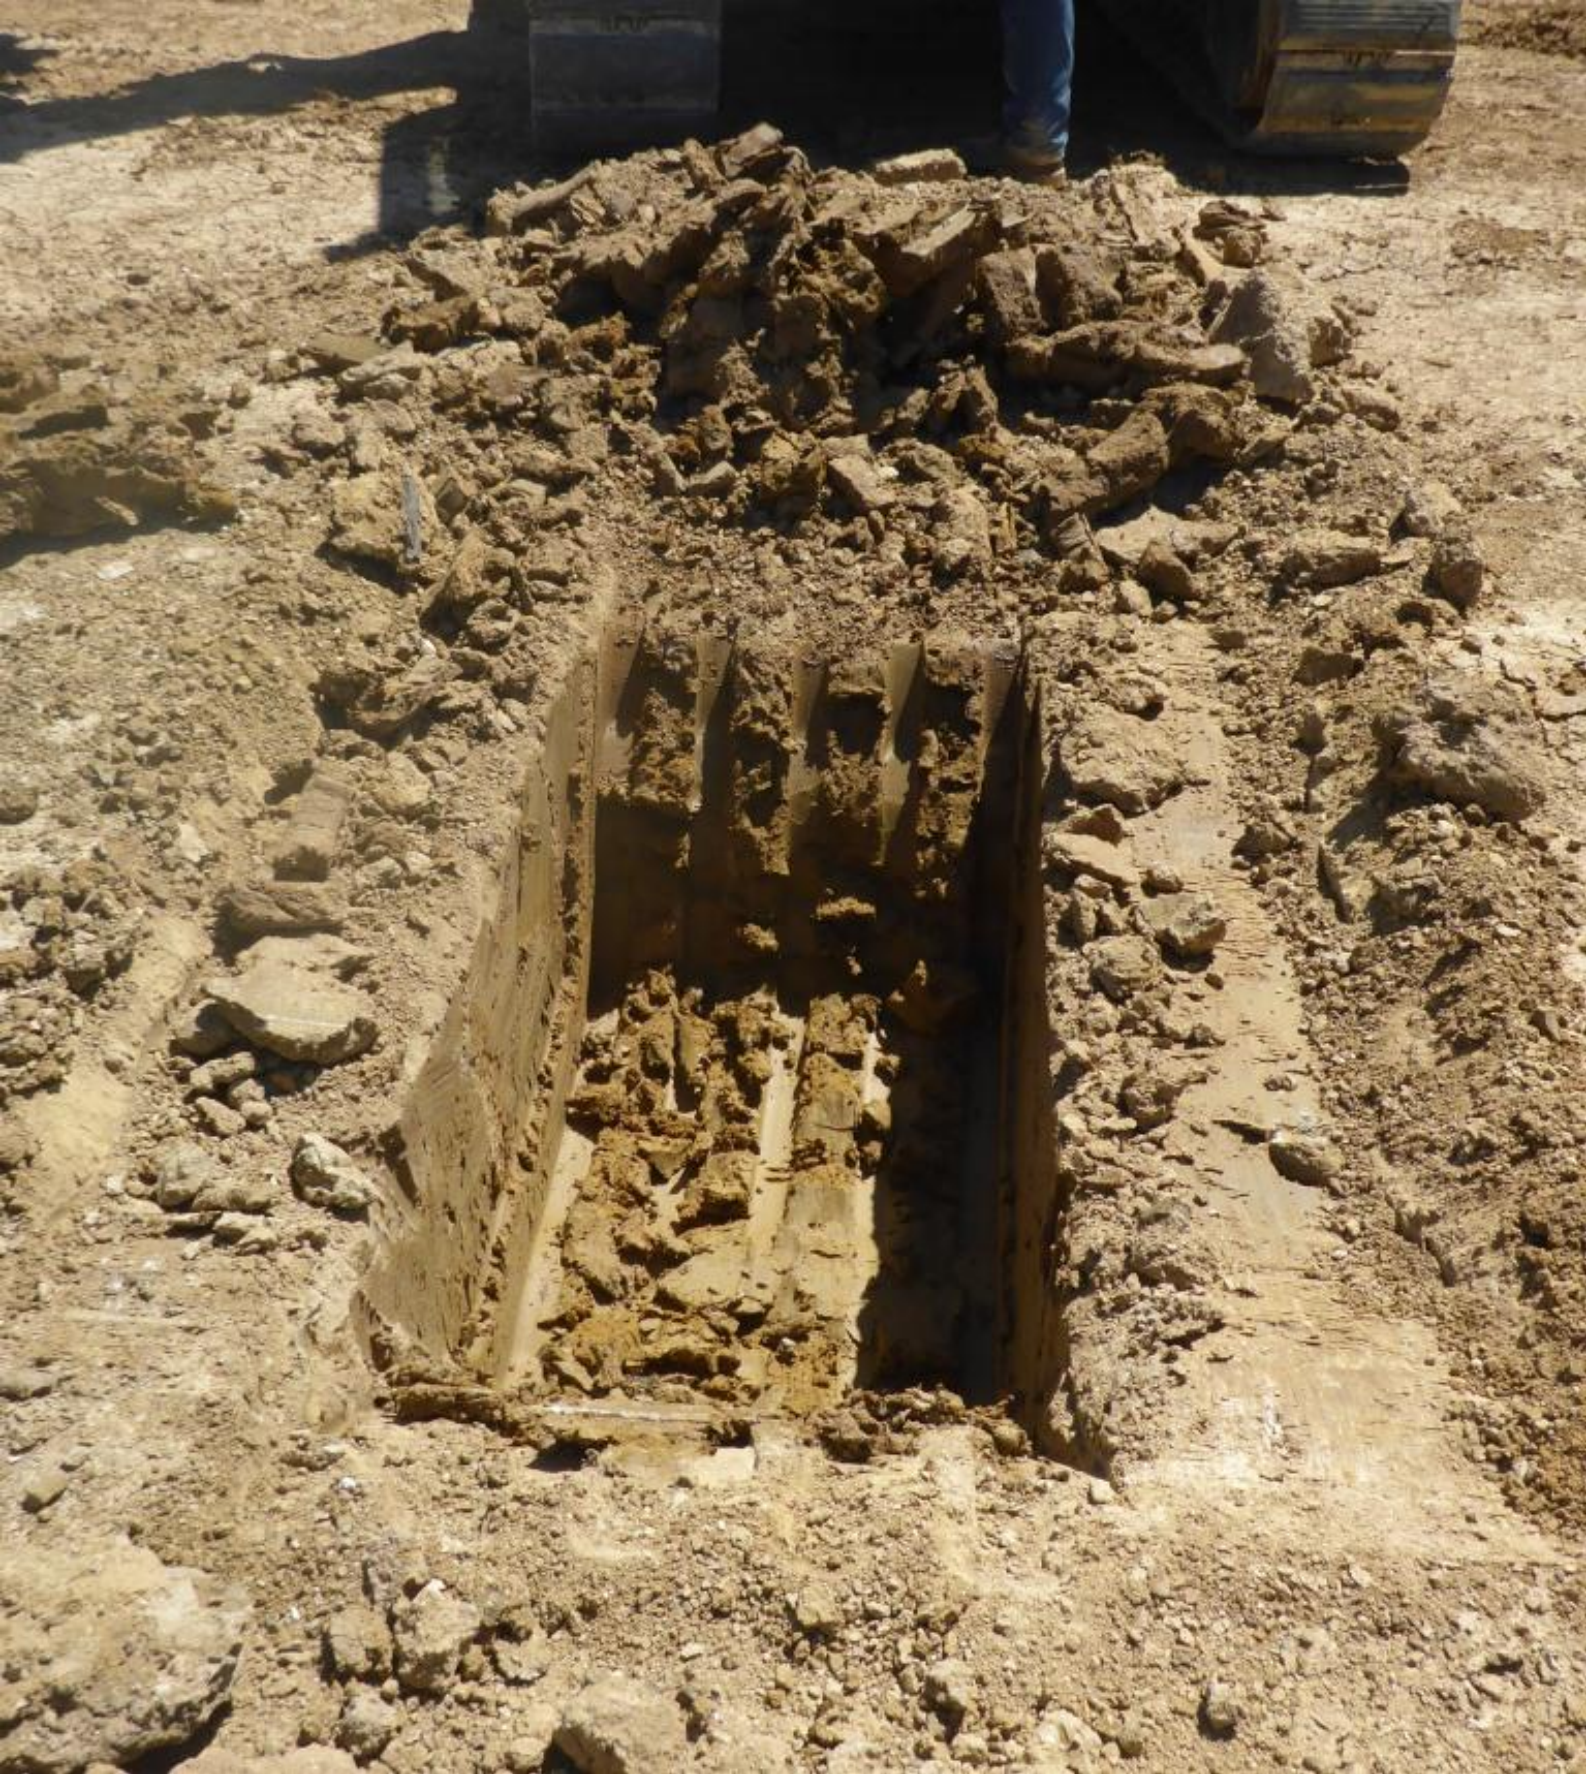
Field Log - Excavation

method	penet-	support	notes	depth	USC	material	moisture	consist.	PP	structure and
1 2 3			samples, tests, etc	(m)		soil name, plasticity or particle characteristics, colour secondary components & minor components			kPa	additional observations
				0		CLAY: Hp, Pale Brown	Kup	VS	400	Fill
				0.5					200	(Clay Liner)
				1.0		TP05 TERMINATED @ 0.7m @ TARGET DEPTH			250	
									300

☒ groundwater not observed ☐ groundwater inflow at: m ☐ standing water level m time: date:

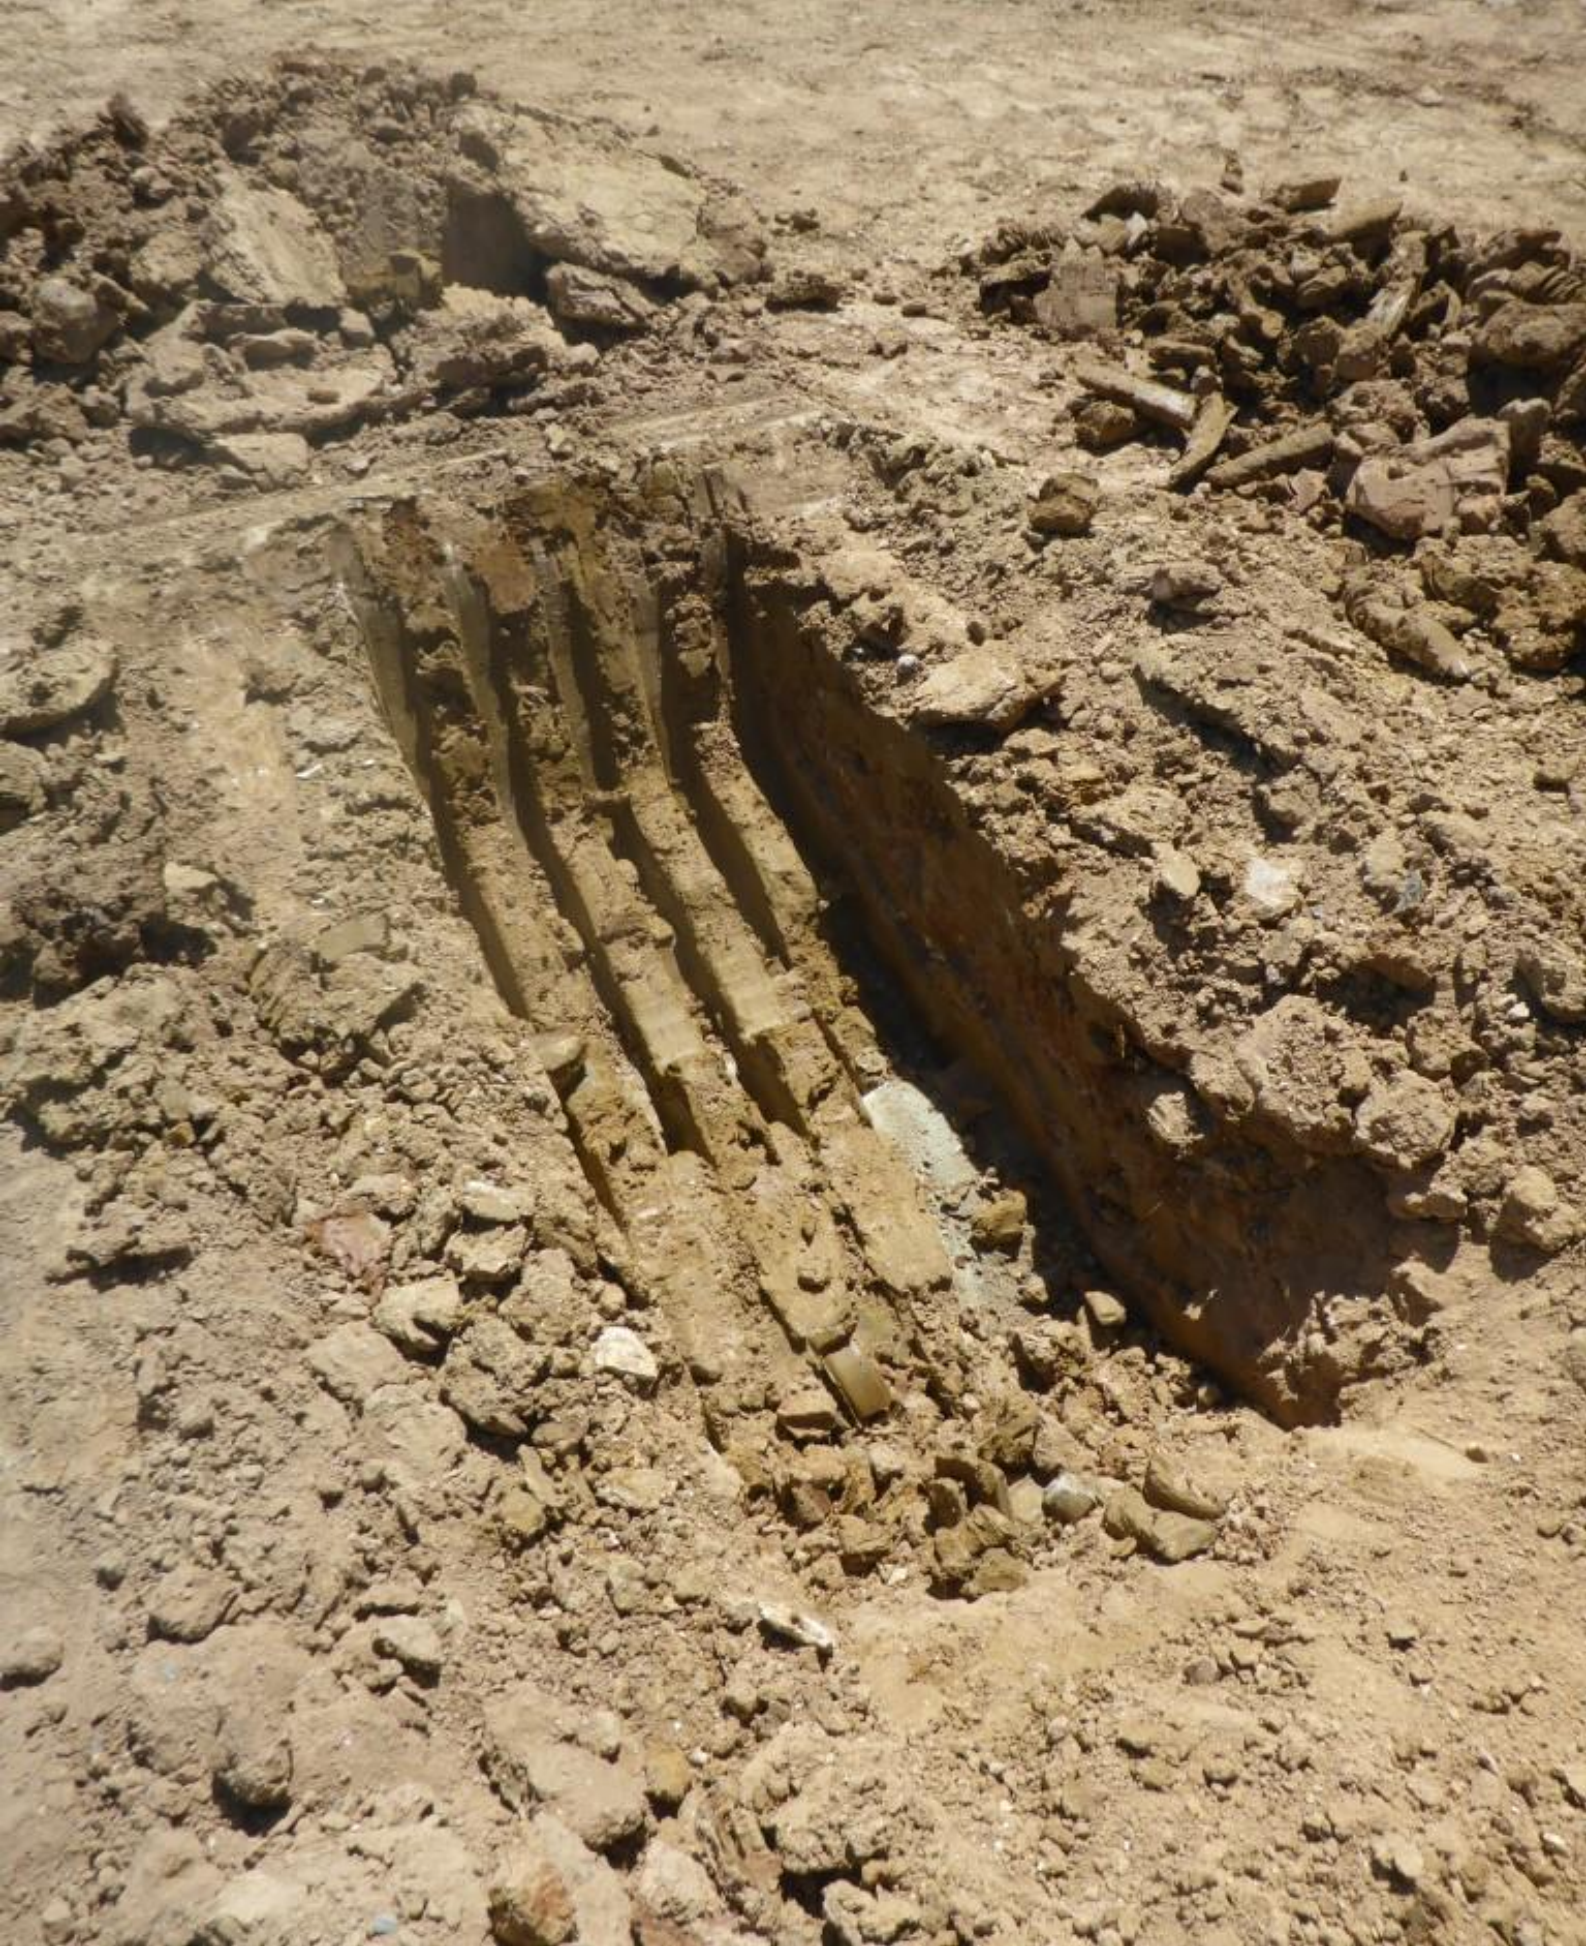
Field Log - Excavation

method	penet- support	notes samples, tests, etc	depth (m)	USC	material soil name, plasticity or particle characteristics, colour secondary components & minor components	moisture	consist.	PP kPa	structure and additional observations
E			0	CM	CLAY: 14p, Pale Brown, Trace of F-C quartz gravels	Wp	VS/H	x 600	FILL (CLAY LINER)
			0.5					x 416	
			1.0		TP06 TERMINATED @ 0.6m TARGET DEPTH			800	
			1.5

☒ groundwater not observed ☐ groundwater inflow at: m ☐ standing water level m time: date:

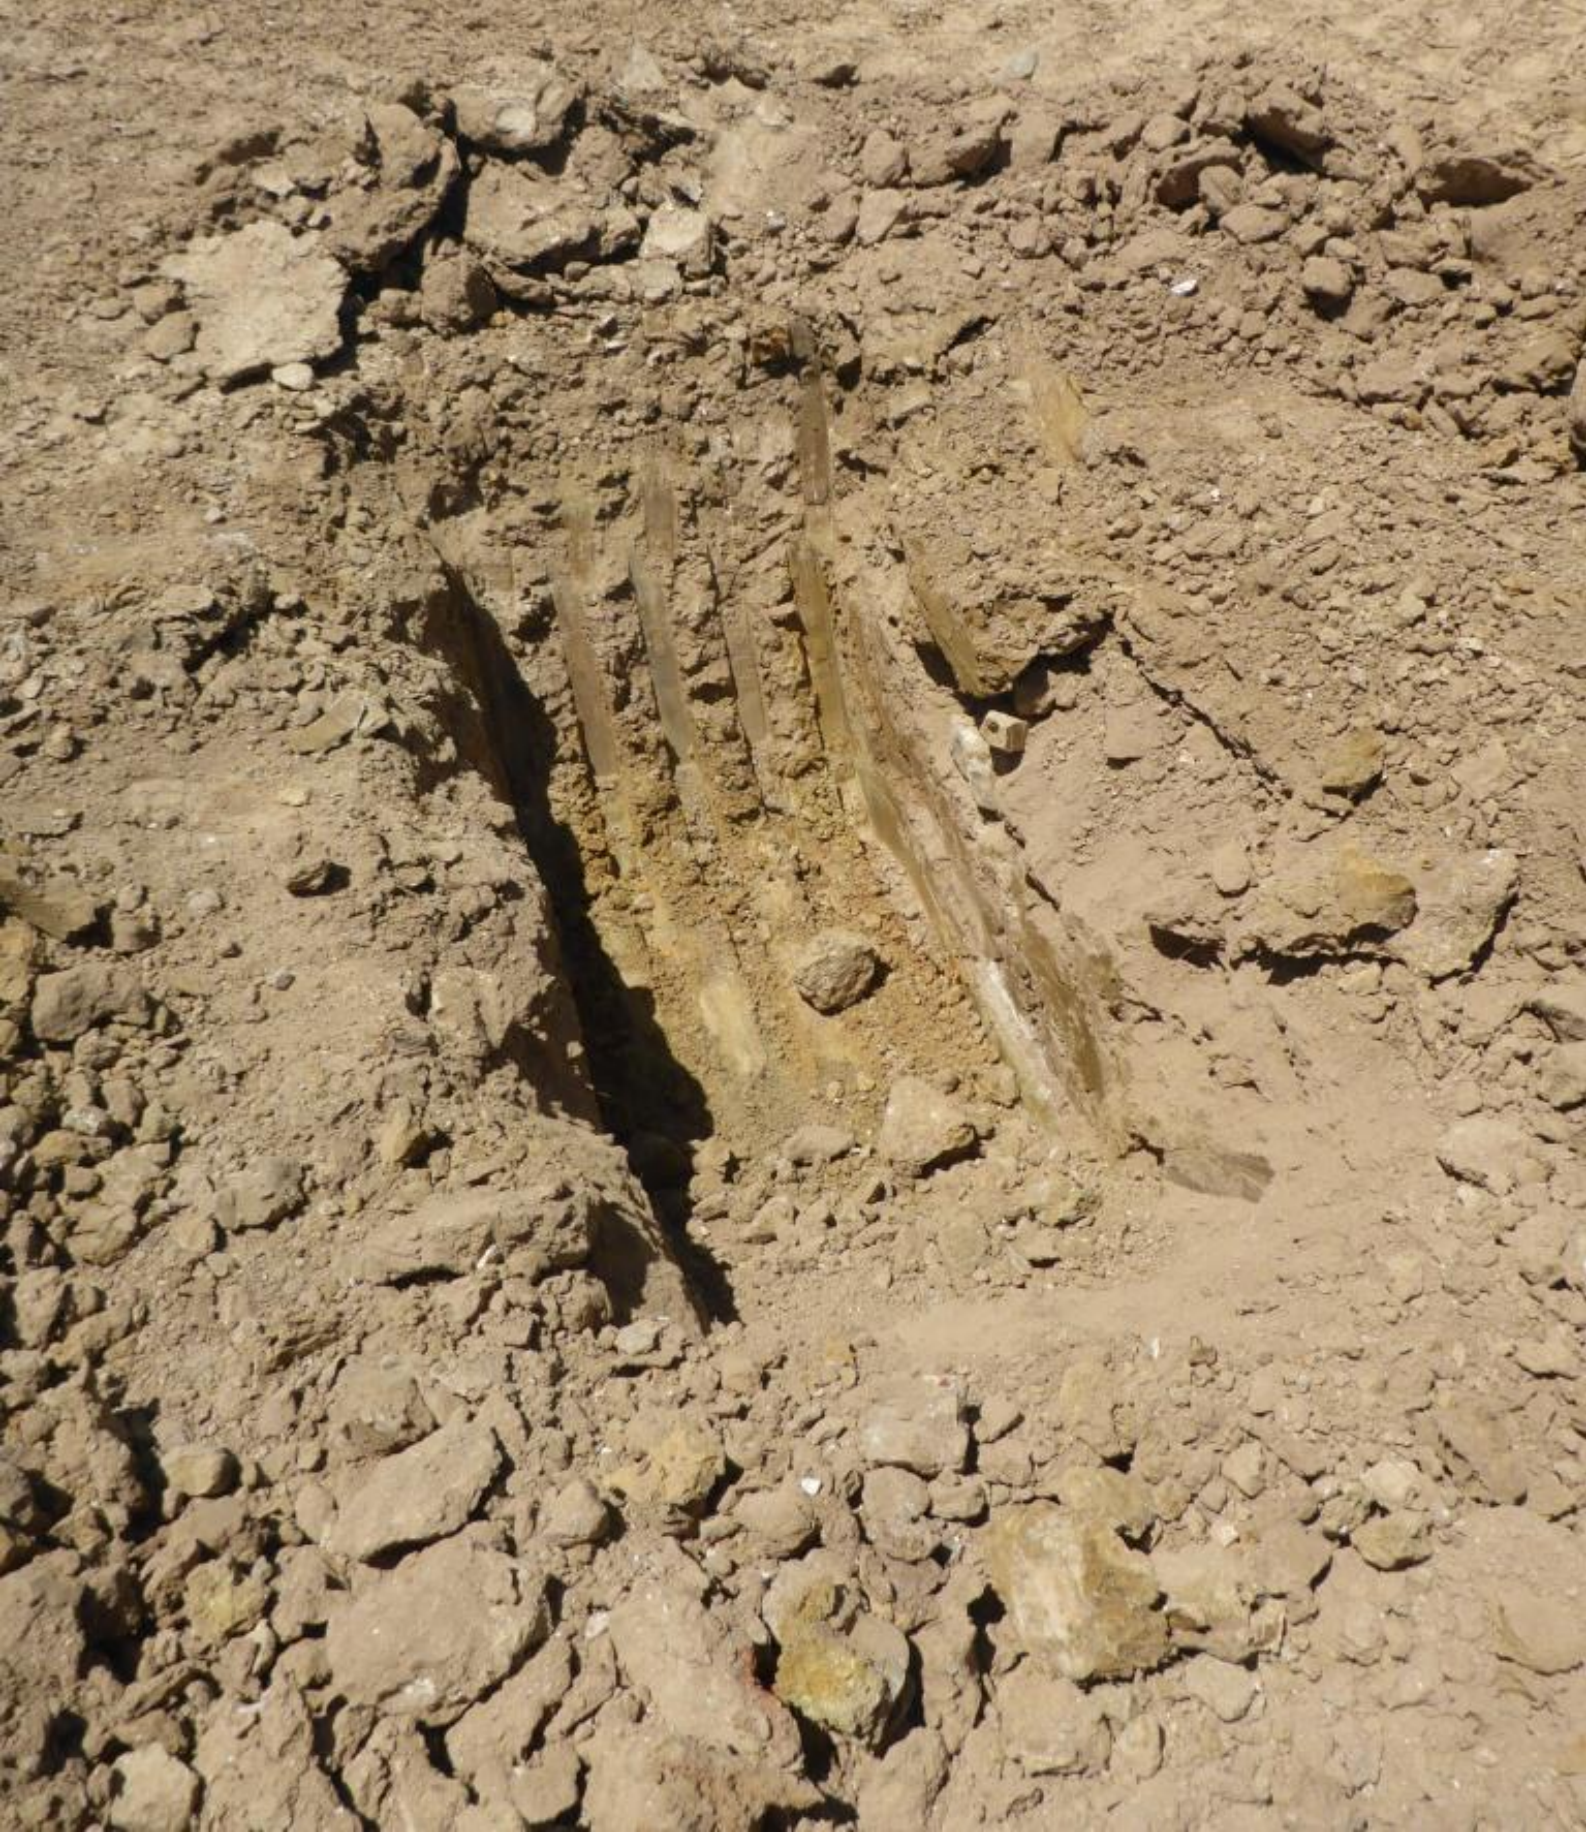
Field Log - Excavation

method	penet- 1 2 3	support	notes samples, tests, etc	depth (m)	USC	material soil name, plasticity or particle characteristics, colour secondary components & minor components	moisture	consist.	PP kPa	structure and additional observations
E				0.0		CLAY: H _p , Pale Brown, TRACE OF F-C GRAVELS, TRACE OF COBBLES	Wp	VS	>600	FILL (CLAY LINER)
				0.5					>600	
				1.0		TP07 TERMINATED @ 0.7m TARGET DEPTH			>600

☒ groundwater not observed ☐ groundwater inflow at: m ☐ standing water level m time: date:

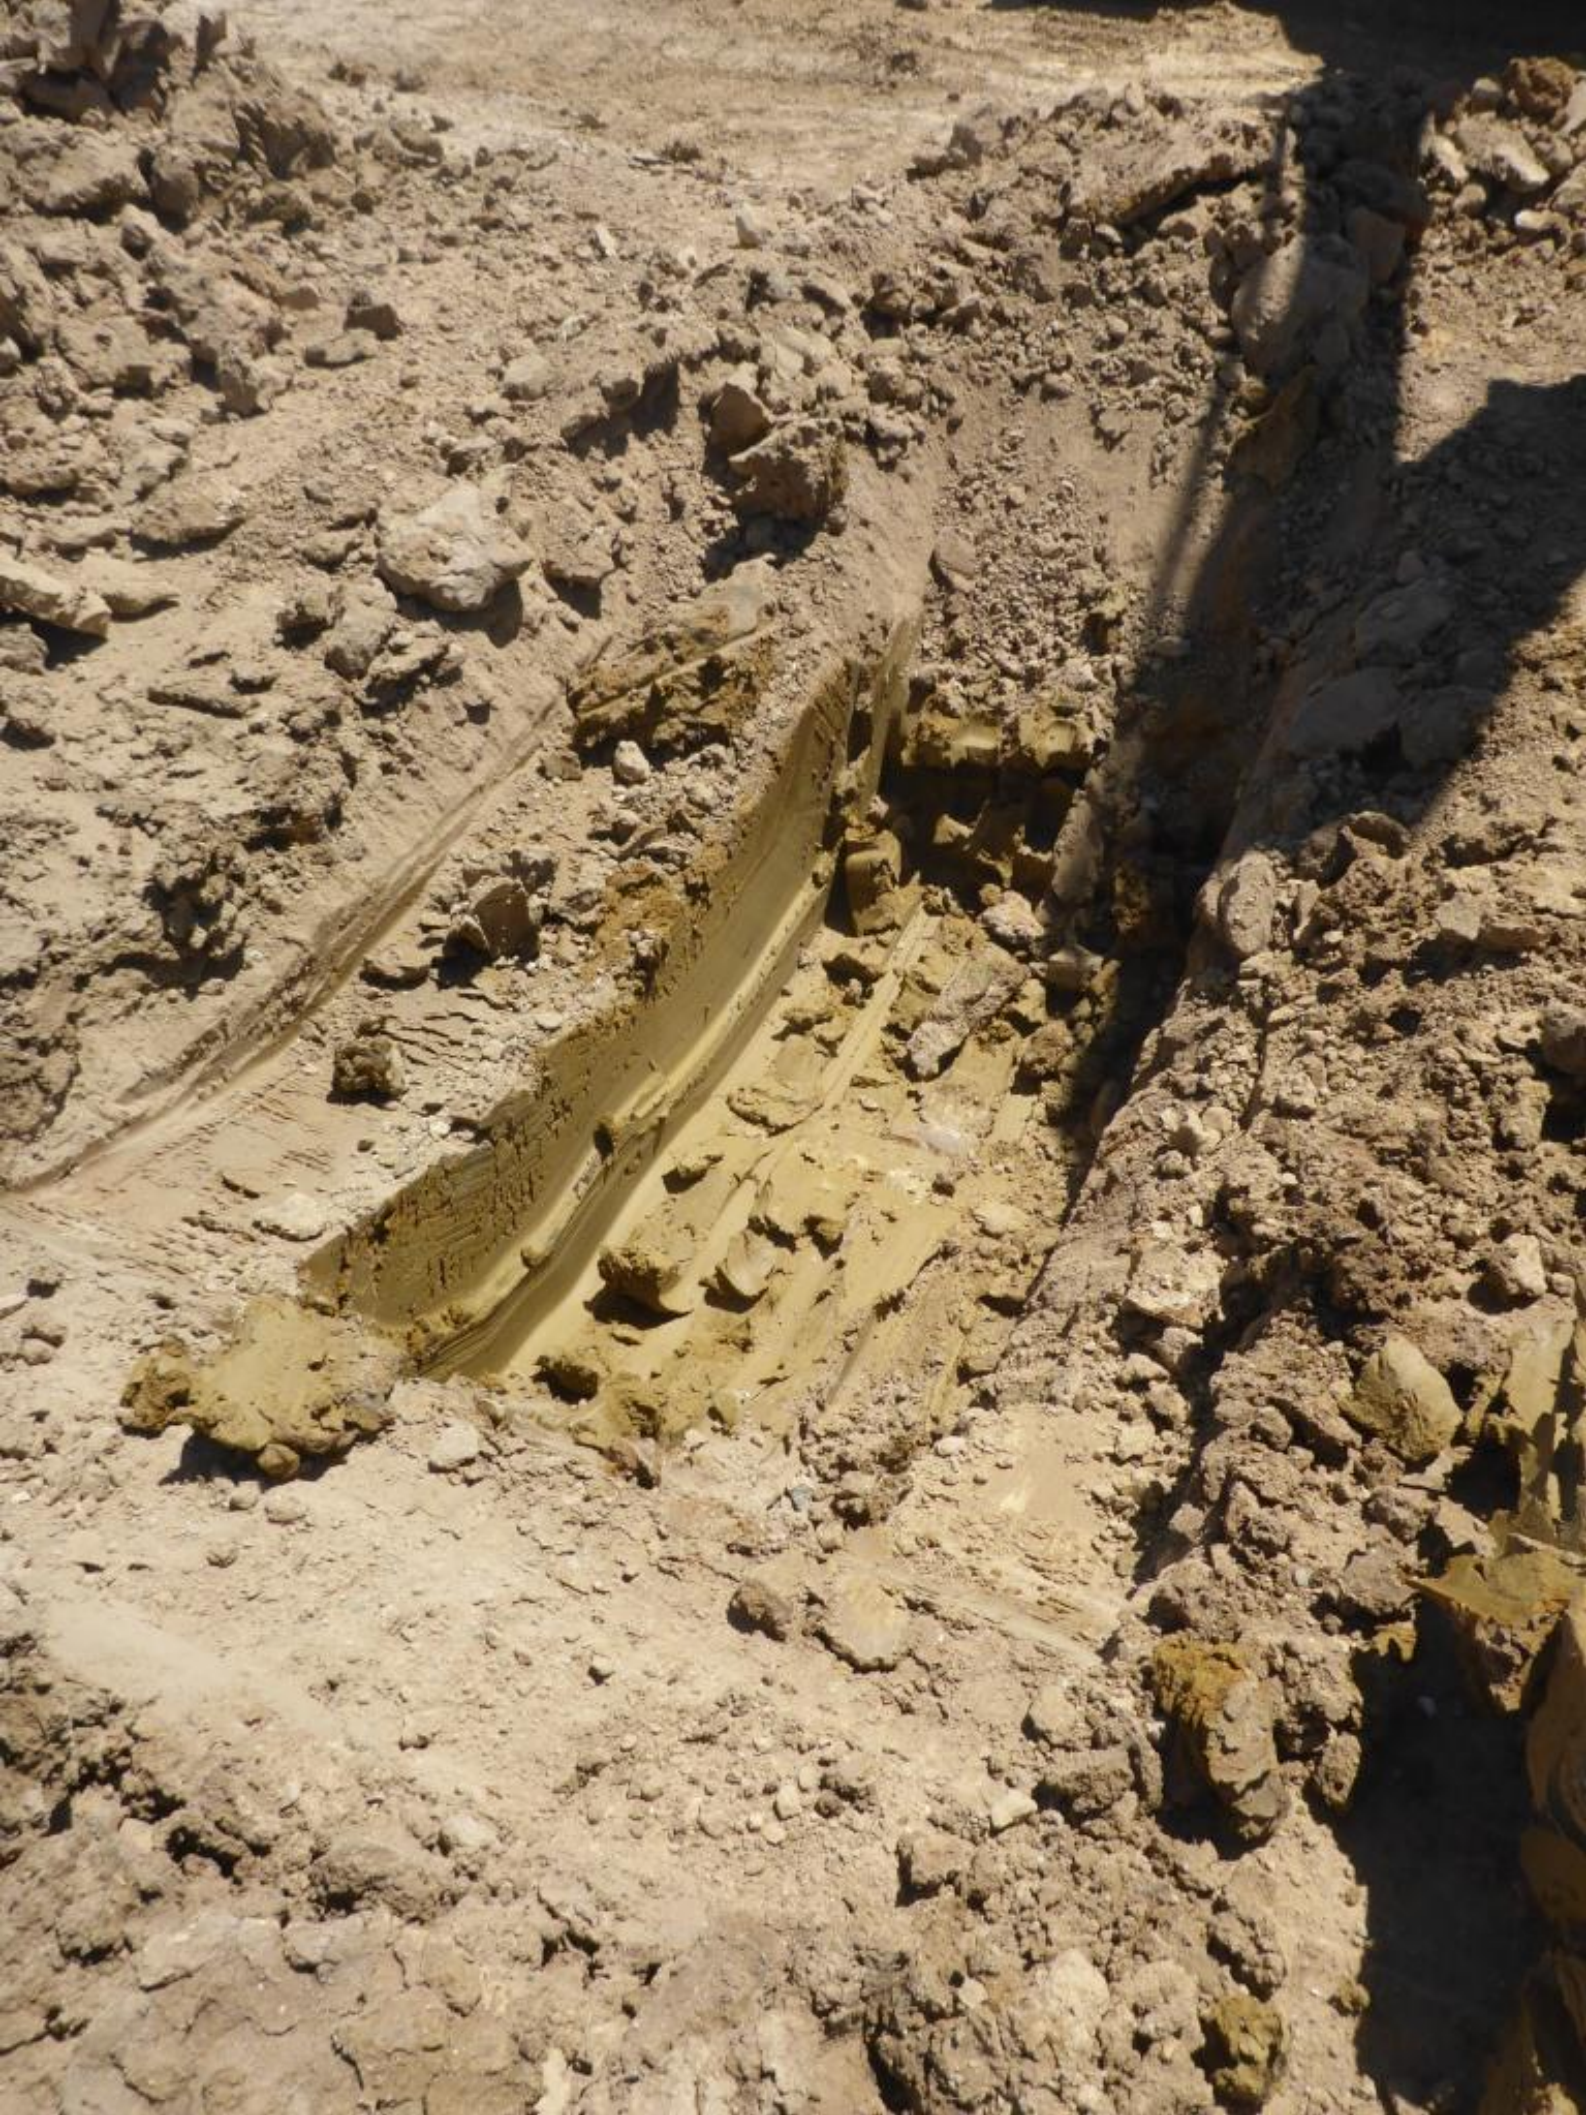
Field Log - Excavation

method	penet- 1 2 3	support	notes samples, tests, etc	depth (m)	USC	material soil name, plasticity or particle characteristics, colour secondary components & minor components	moisture	consist.	PP kPa	structure and additional observations
E				0		CLAY, HP, PALE BROWN	Wp	Vst/H	7600	FILL
				0.5			Wp		350	CLAY LINER
				1.0		TP08 TERMINATED @ 0.7m TARGET DEPTH			200	
				1.5					200	
				2.0						
				2.5						
				3.0

☒ groundwater not observed ☐ groundwater inflow at: m ☐ standing water level m time: date:

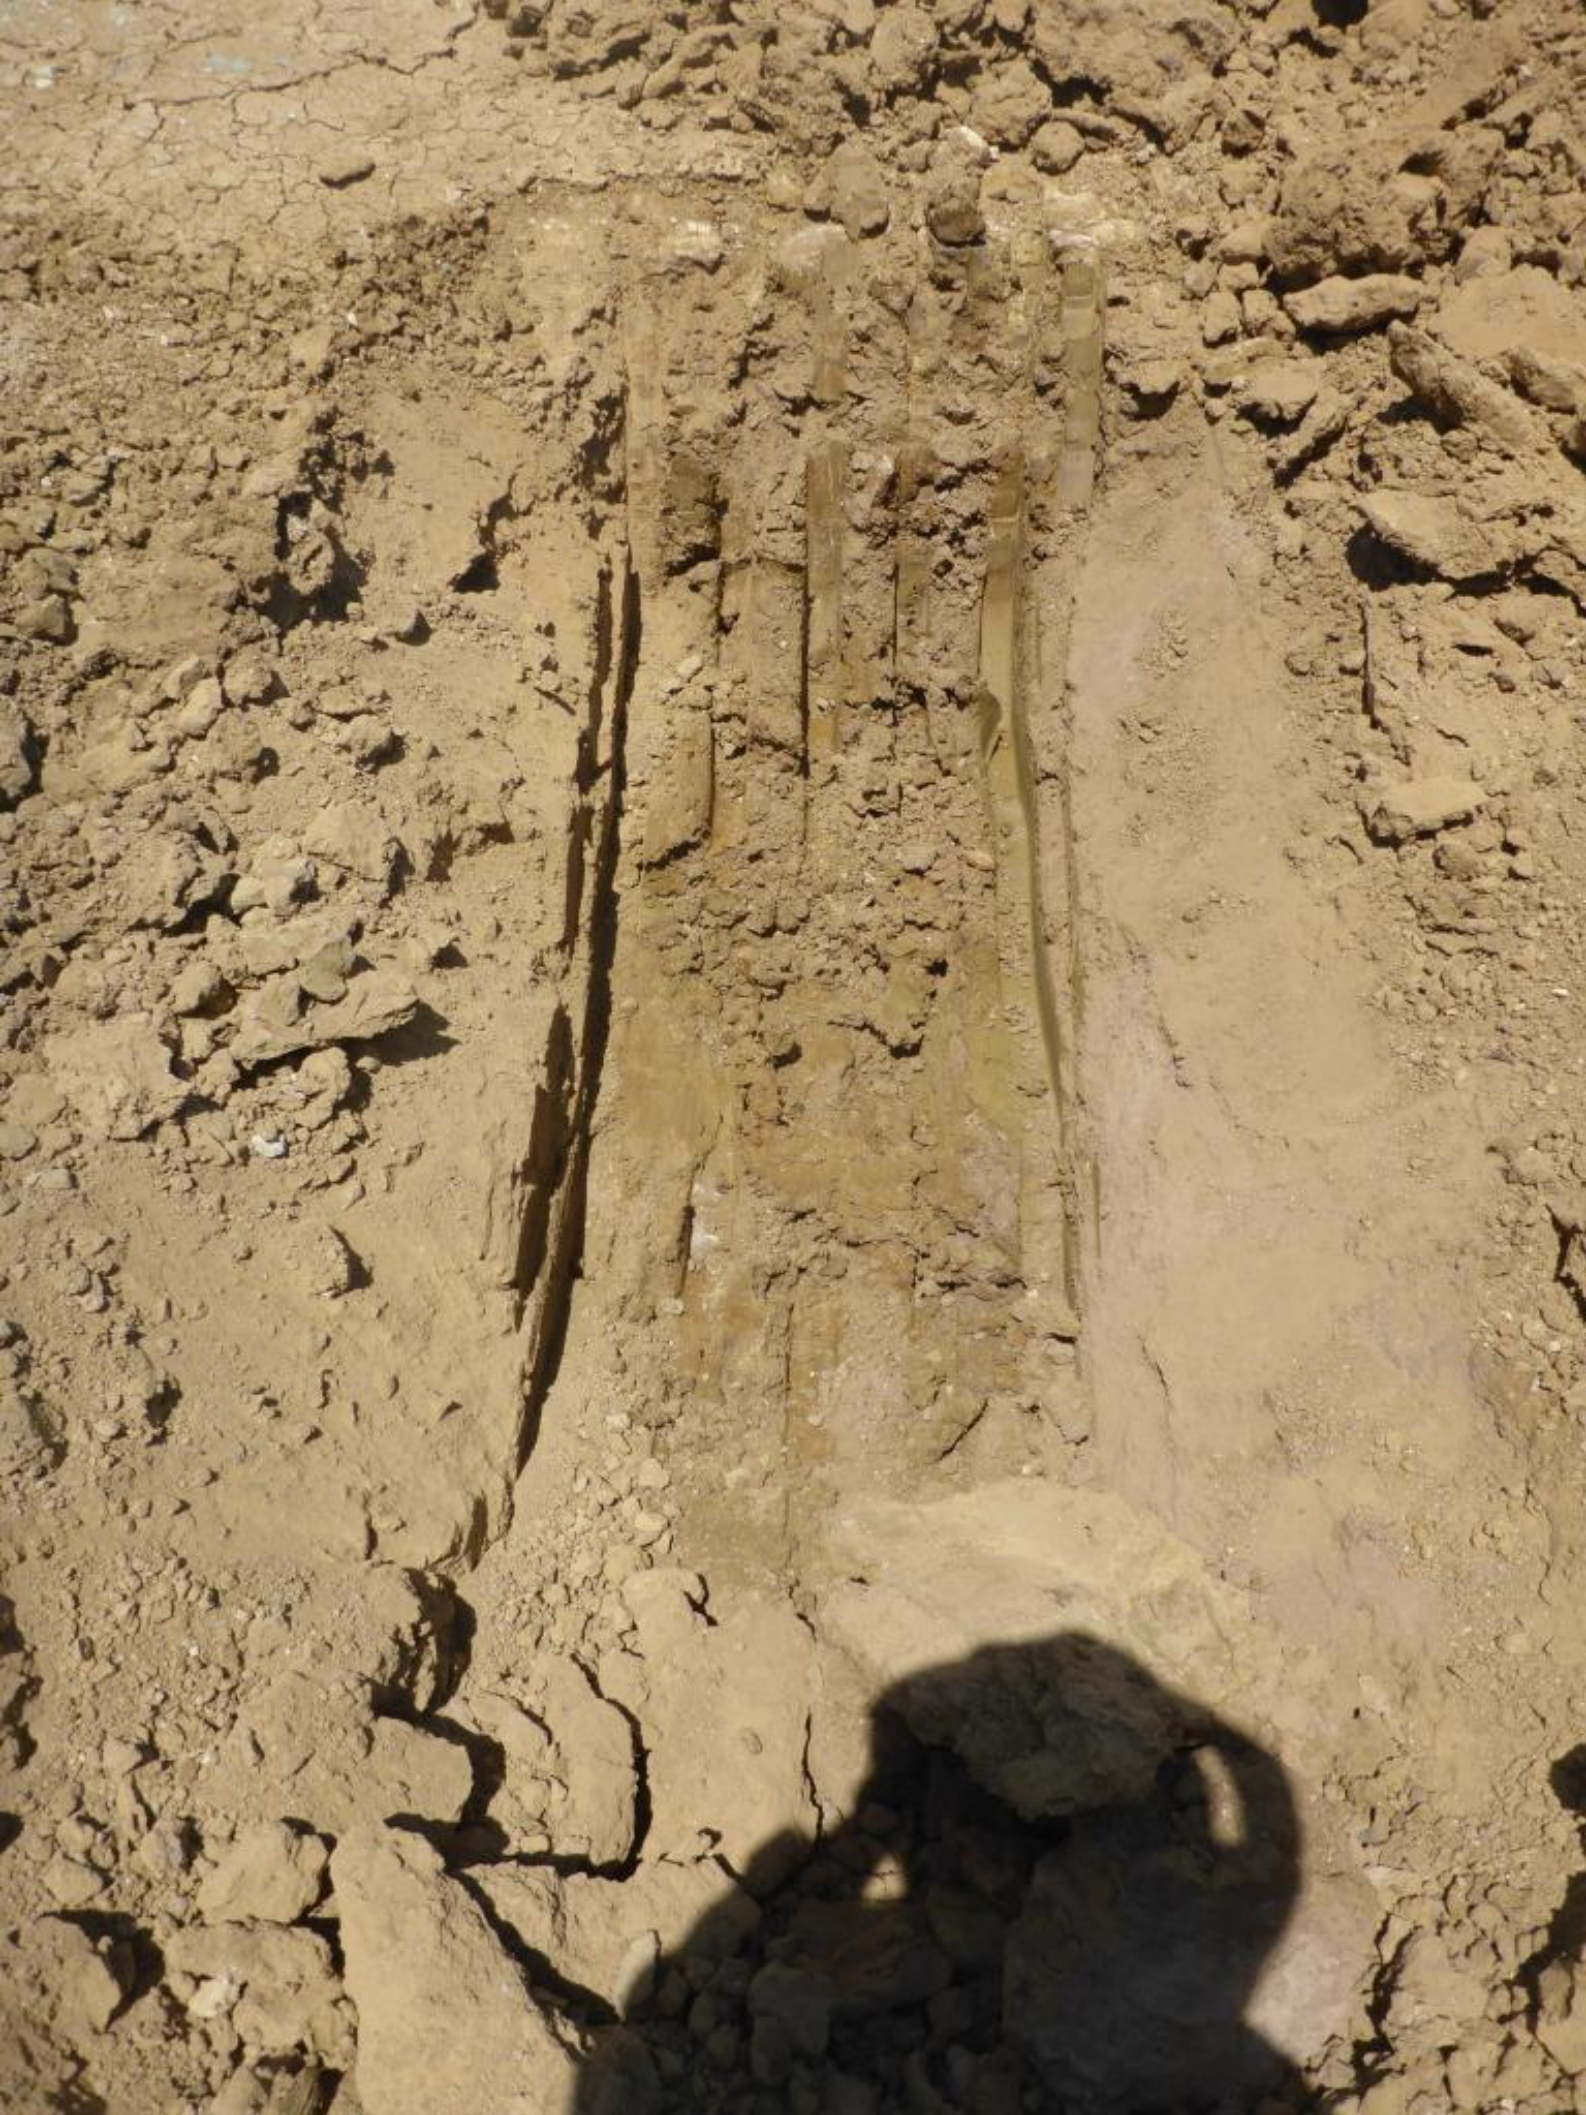
Field Log - Excavation

method	penet- support	notes samples, tests, etc	depth (m)	USC	material soil name, plasticity or particle characteristics, colour secondary components & minor components	moisture	consist.	PP kPa	structure and additional observations
1	2	3						100 200 300 400	
E			0		CLAY: HP, PALE BROWN, TRACE OF F-C GRAVEL	Wp	VS	>600	FILL (CLAY LINER)
			0.5					600	
			1.0		TP09 TERMINATED @ 0.7m TARGET DEPTH			300	
			1.5						
			2						
			2.5						
			3

☒ groundwater not observed ☐ groundwater inflow at: _____ m ☐ standing water level _____ m time: _____ date: _____

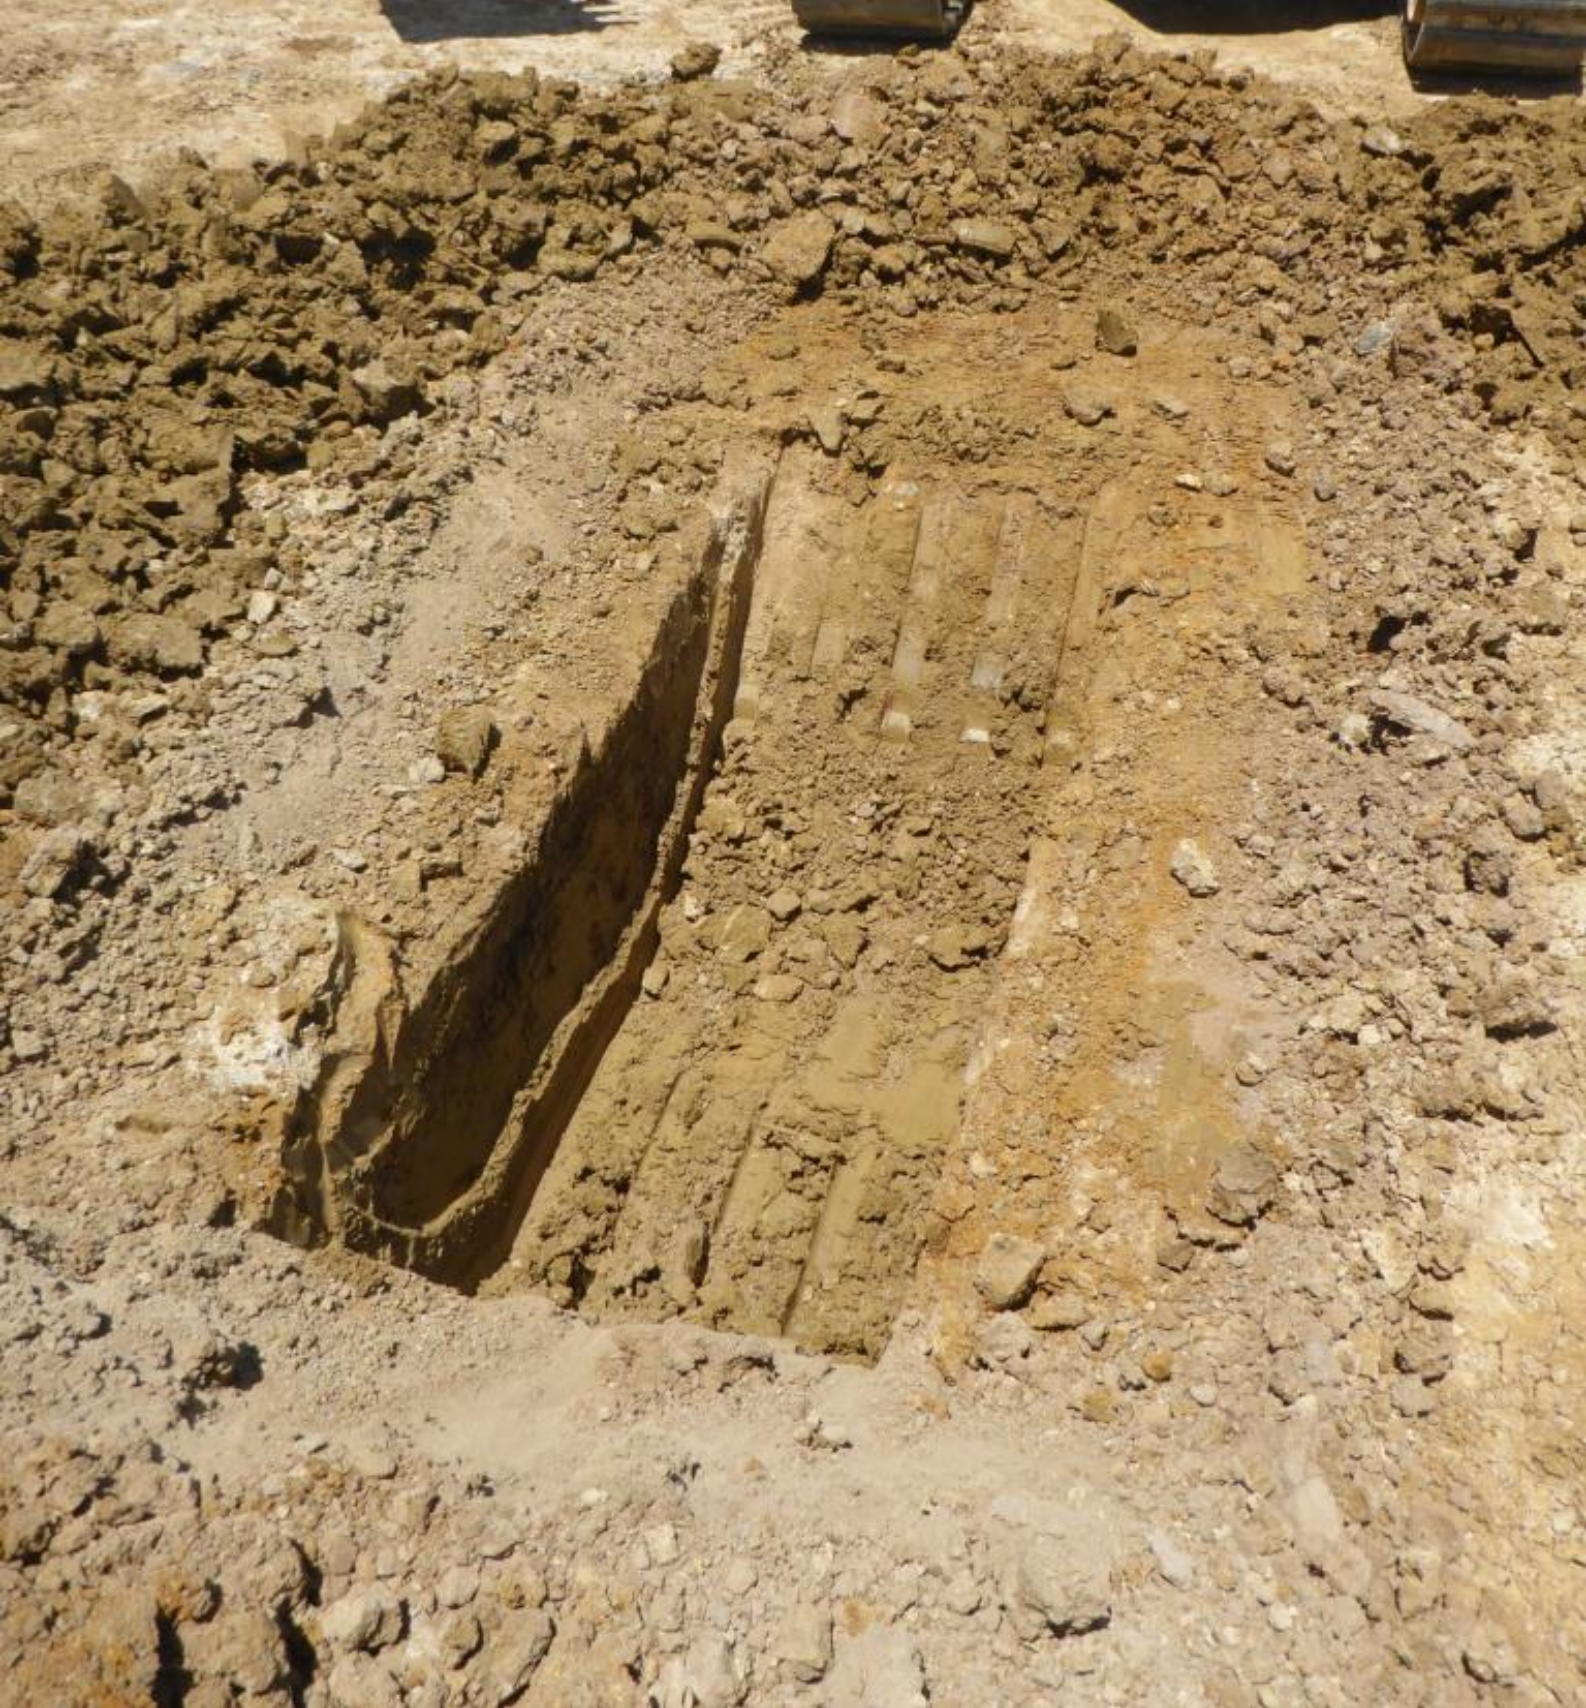
Field Log - Excavation

method	penet- support	notes samples, tests, etc	depth (m)	USC	material soil name, plasticity or particle characteristics, colour secondary components & minor components	moisture	consist.	PP kPa	structure and additional observations
E			0		CLAY: HP, Pale Brown, trace of f-c gravel	Kwp	H	>600	Fill (CLAY LINER)
			0.5					>600	
			1.0		TP10 TERMINATED @ 0.7m				
			1.5		TARGET DEPTH				
			2.0						
			2.5						
			3.0

☒ groundwater not observed ☐ groundwater inflow at: m ☐ standing water level m time: date:

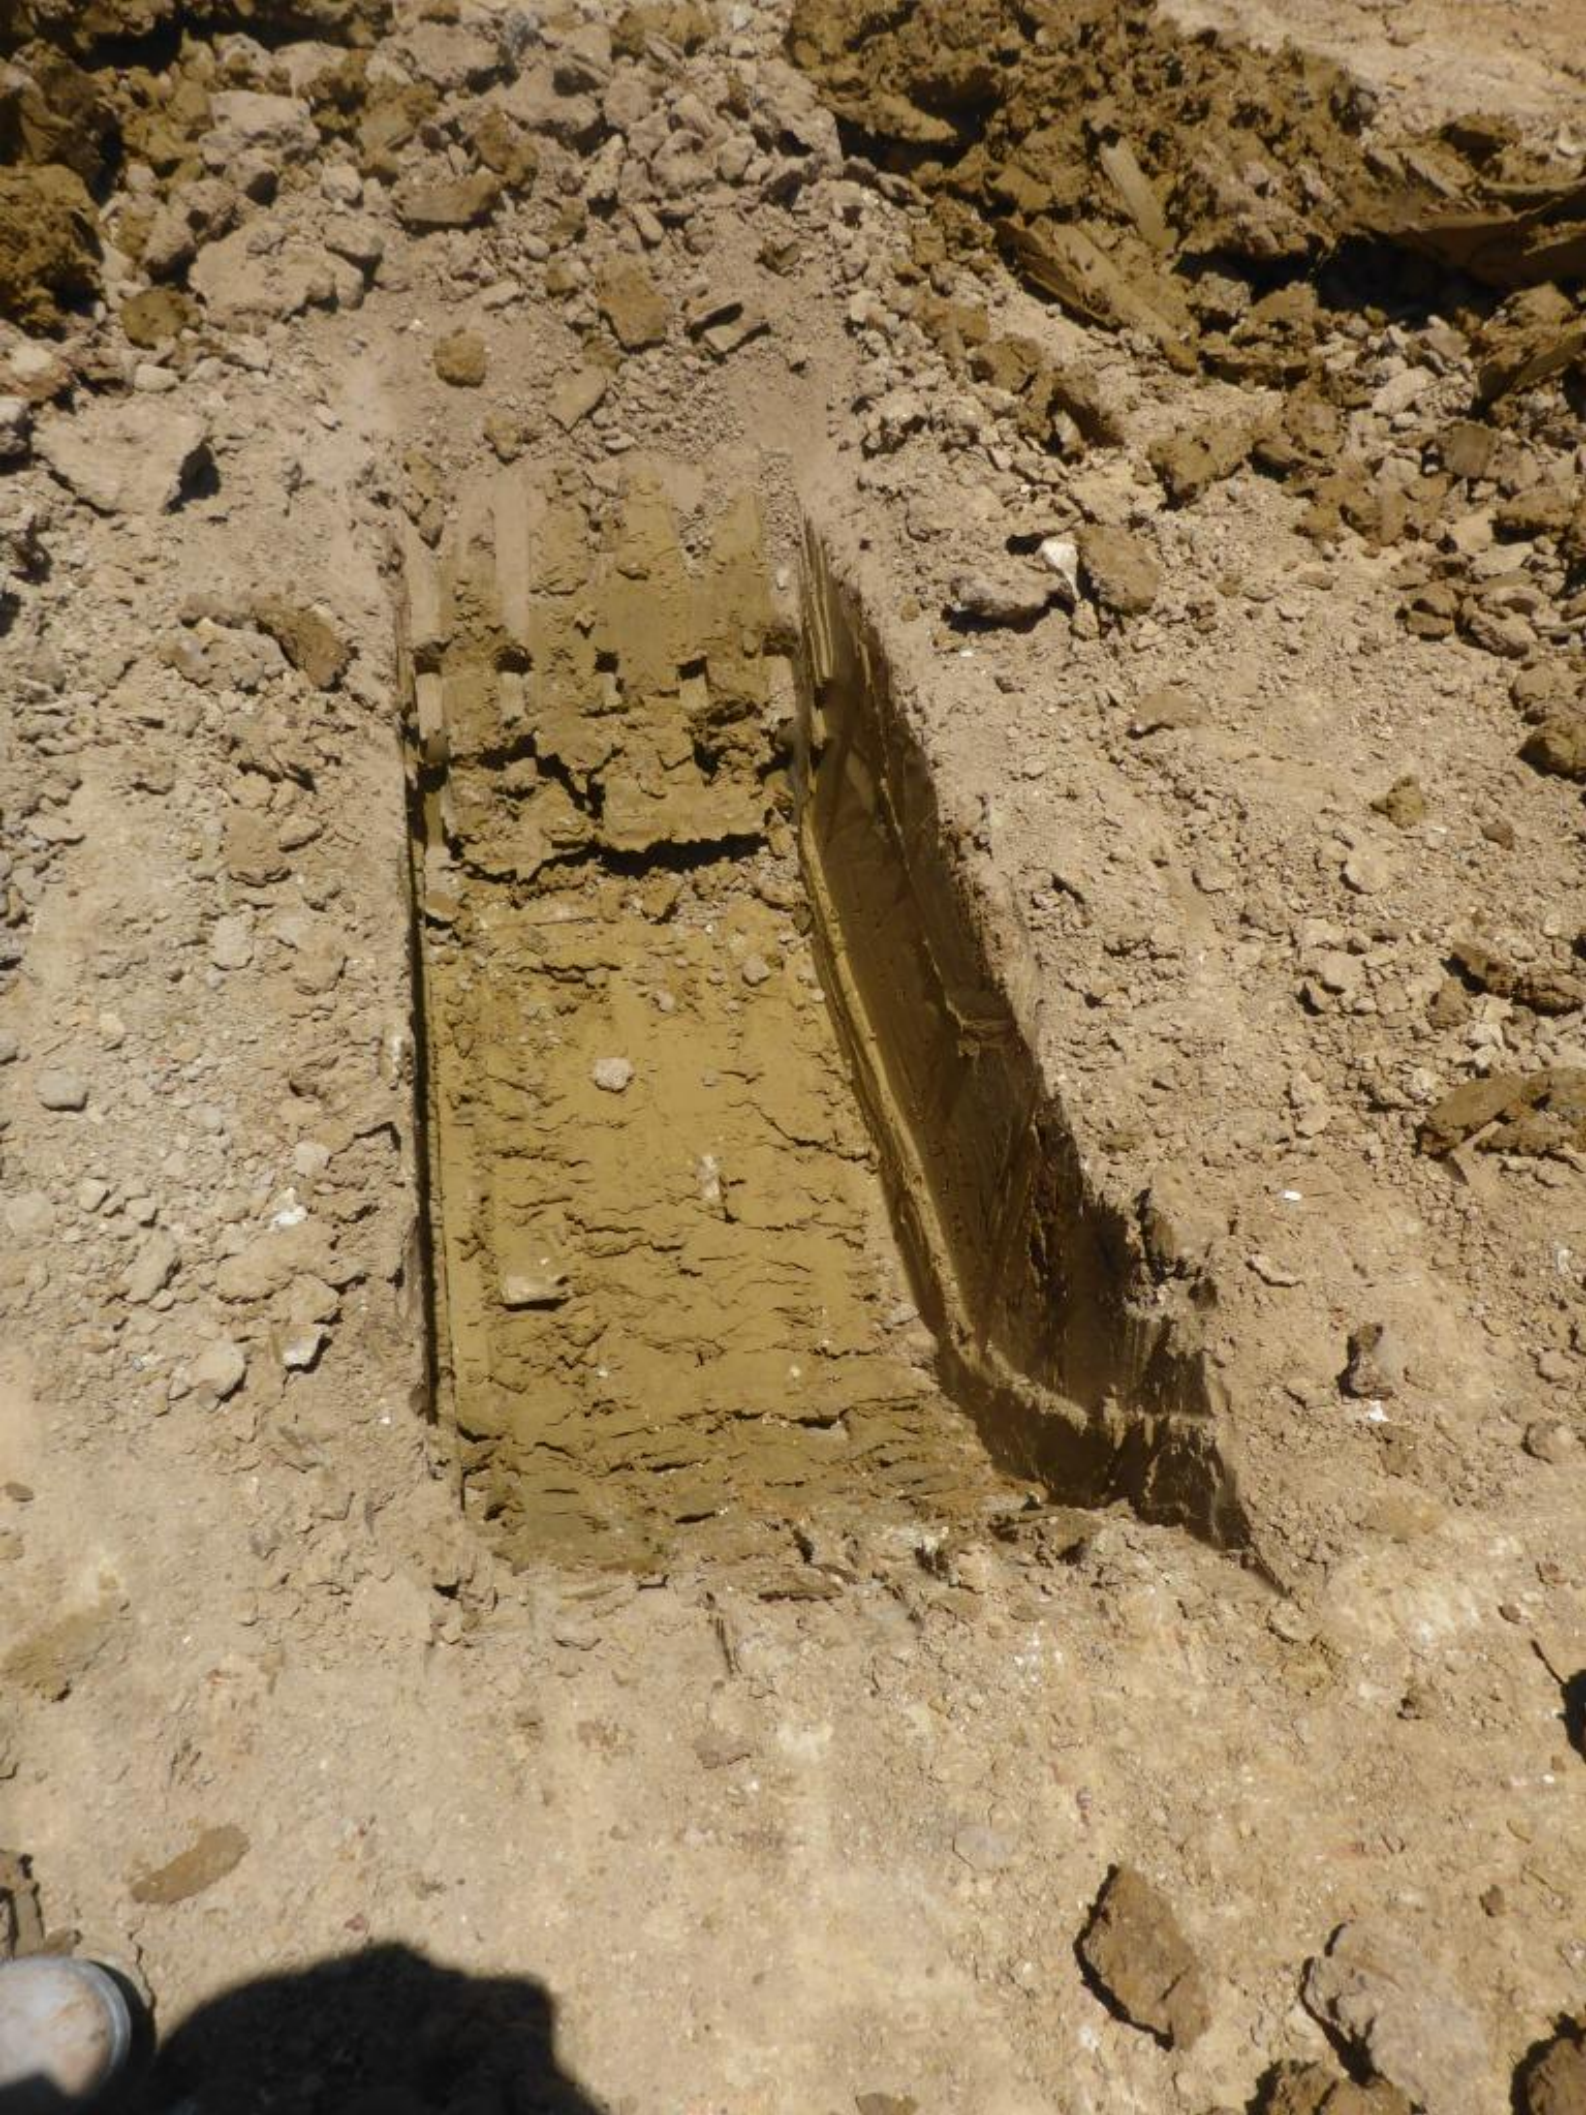
Field Log - Excavation

method	penet- support	notes samples, tests, etc	depth (m)	USC	material soil name, plasticity or particle characteristics, colour secondary components & minor components	moisture	consist.	PP kPa	structure and additional observations
1	2	3						100 200 300 400	
E			0		CLAY: Hp. trace of f-c gravel	cup H		2600	FILL
			0.5			Wp	VS	450	(CLAY Liner)
			1.0		TP11 TERMINATED @ 0.6m			450	
			1.5		TARGET DEPTH				
			2.0						
			2.5						
			3.0

☐ groundwater not observed ☐ groundwater inflow at: m ☐ standing water level m time: date:
