Soil Water & Leachate Management Plan

For Woodlawn Mechanical Biological Treatment Facility

Document Code: PLA-NSW-XXX-XXX-1

Date: 19.01.2017

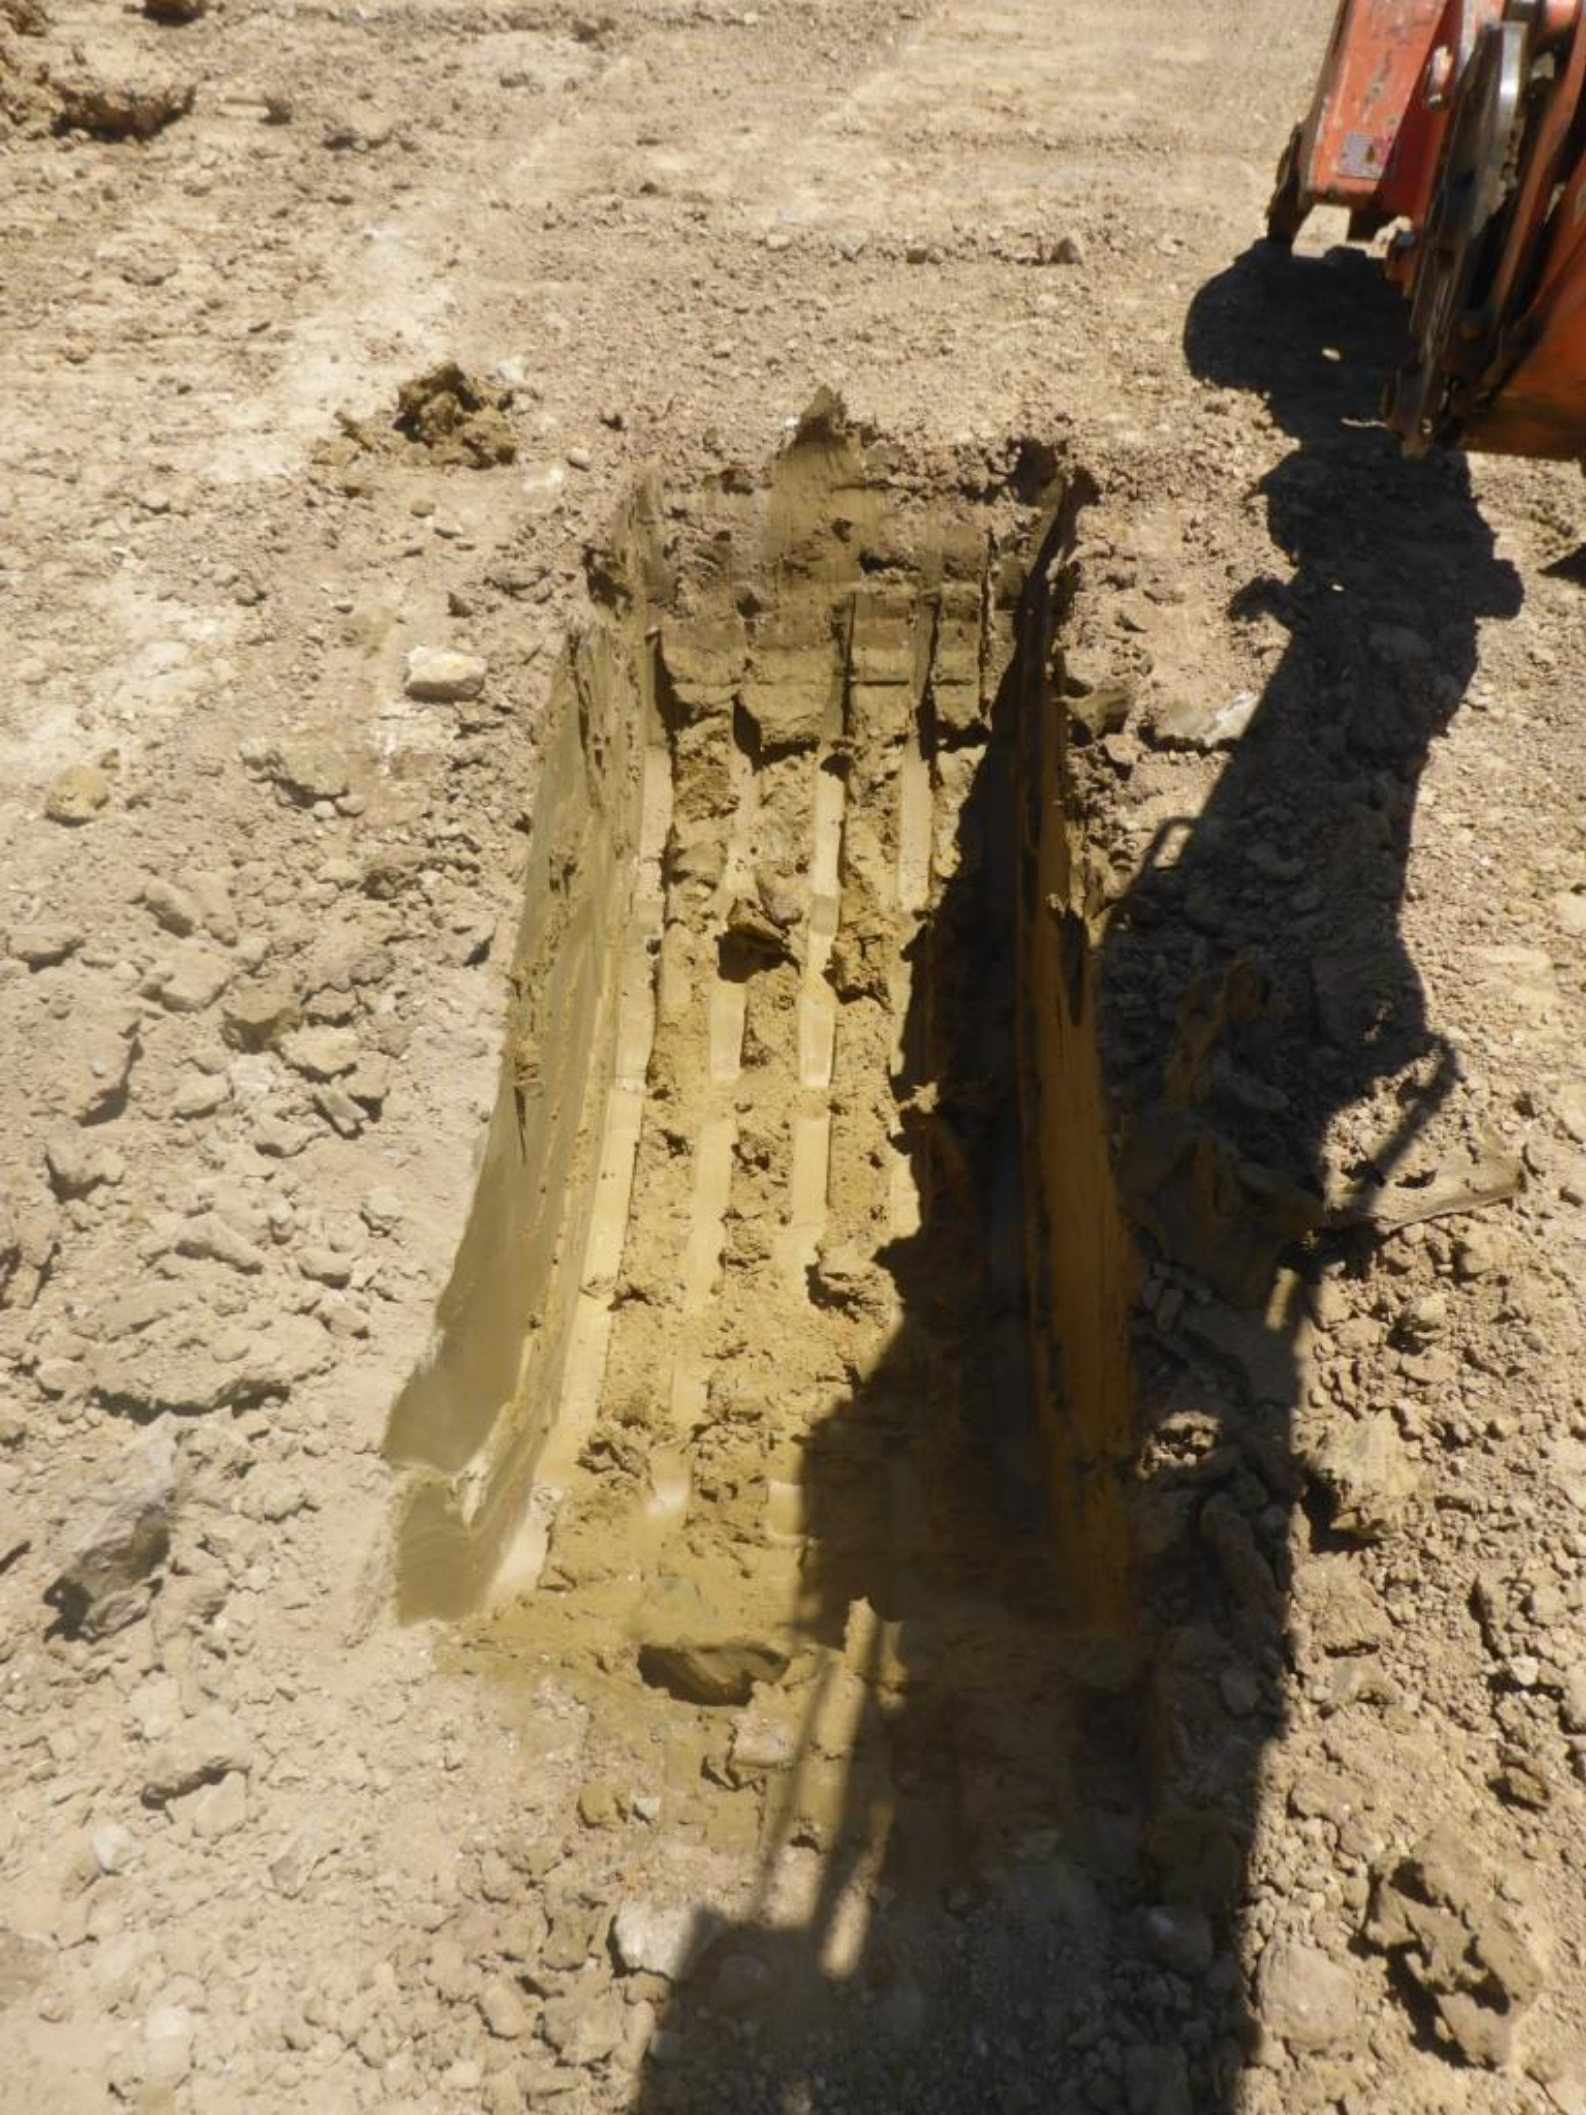
Field Log - Excavation

method	penet- 1 2 3	support	notes samples, tests, etc	depth (m)	USC	material soil name, plasticity or particle characteristics, colour secondary components & minor components	moisture	consist.	PP kPa 100 200 300 400	structure and additional observations
E				0	CH	CLAY: Hp, Pale Brown	>Wp	ST	200	FILL (CLAY LINER)
				0.5					200	
				1.0		0.6m			200	
				1.5		TP12 - TERMINATED @ 0.6m				
				2		Below ground level				
				2.5						
				3

☒ groundwater not observed ☐ groundwater inflow at: m ☐ standing water level m time: date:
