# Annual Environmental Management Report

*Woodlawn Mechanical Biological Treatment Facility*

*November 2016*

## Environment Protection Licence Monthly Summary

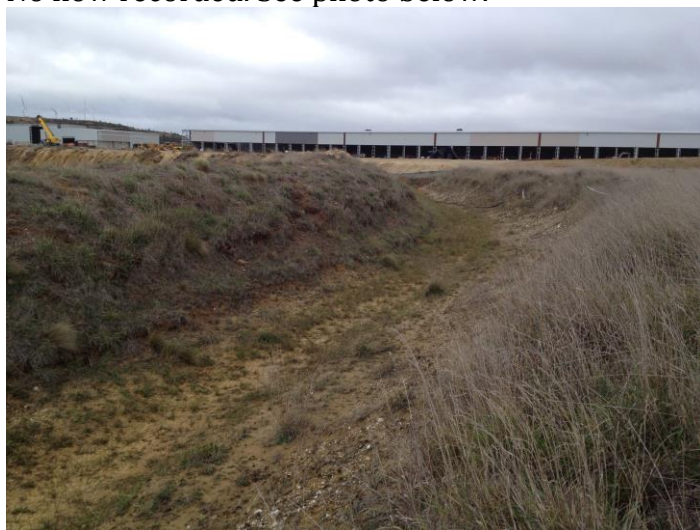
### Point 8

No flow recorded. See photo below.
