Woodlawn Bioreactor Expansion Project

Independent Odour Audit #7

July 2019

Final Report

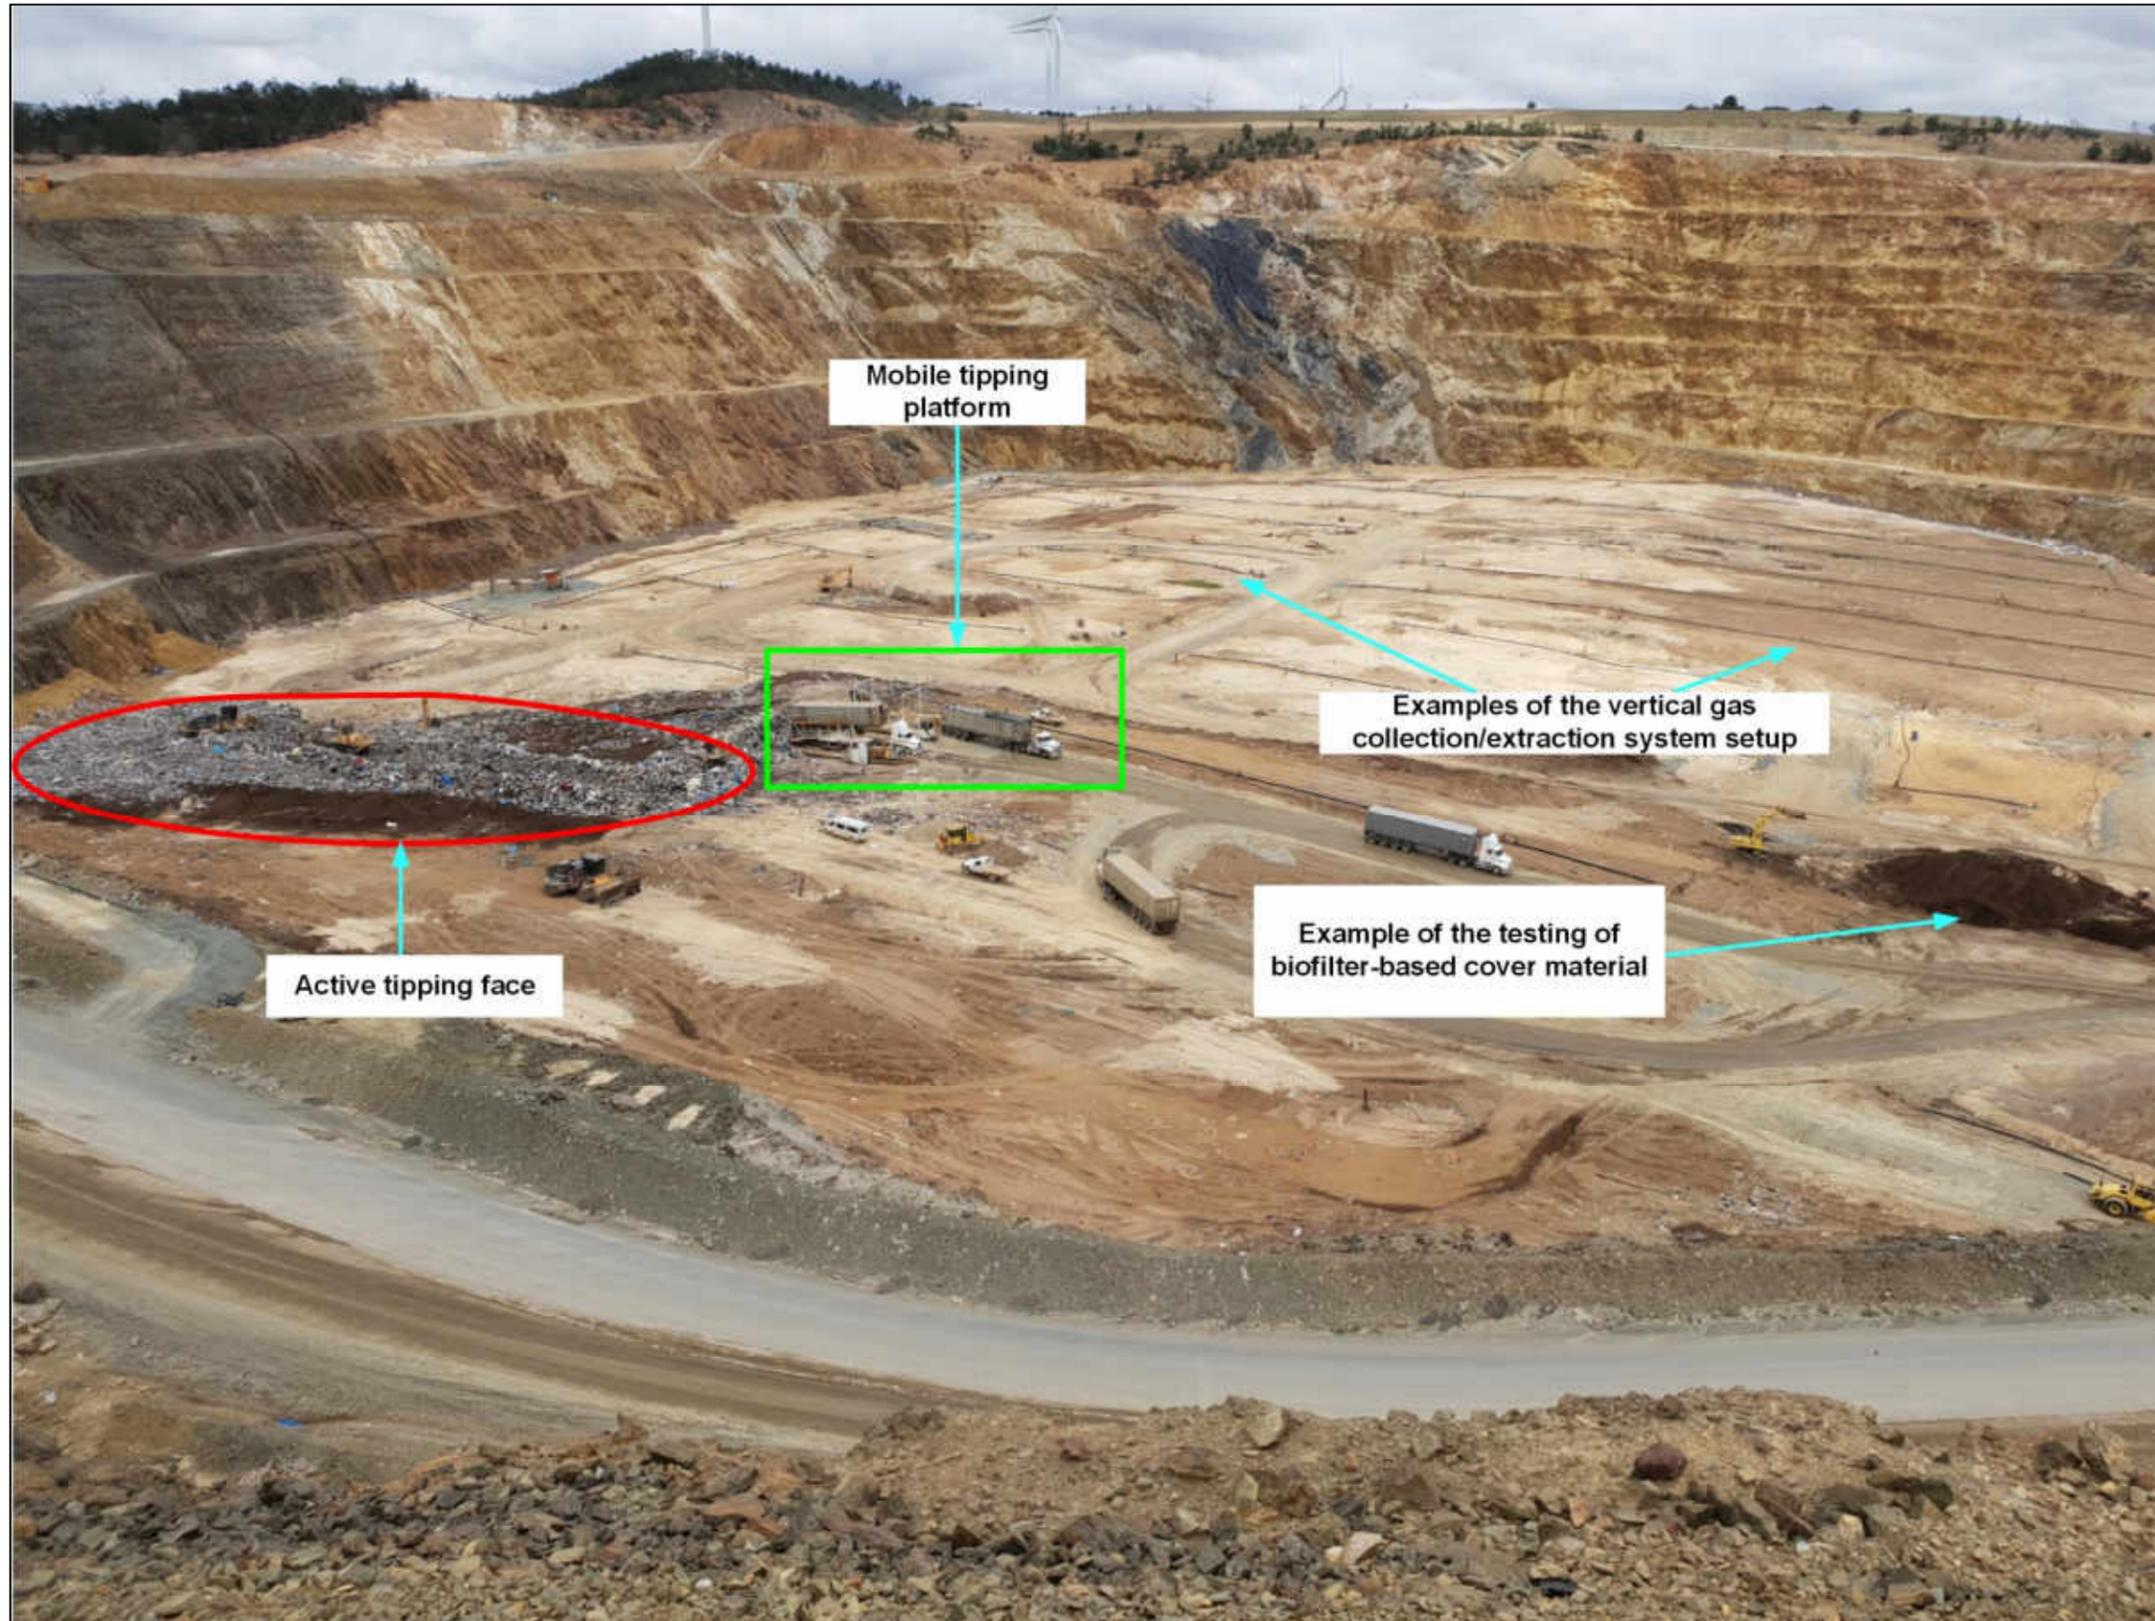
Figure 2.2 – Void layout and operations as found on 21 February 2019

The Void layout and operations prevalent at the time of the Audit are shown in **Figure 2.2**.

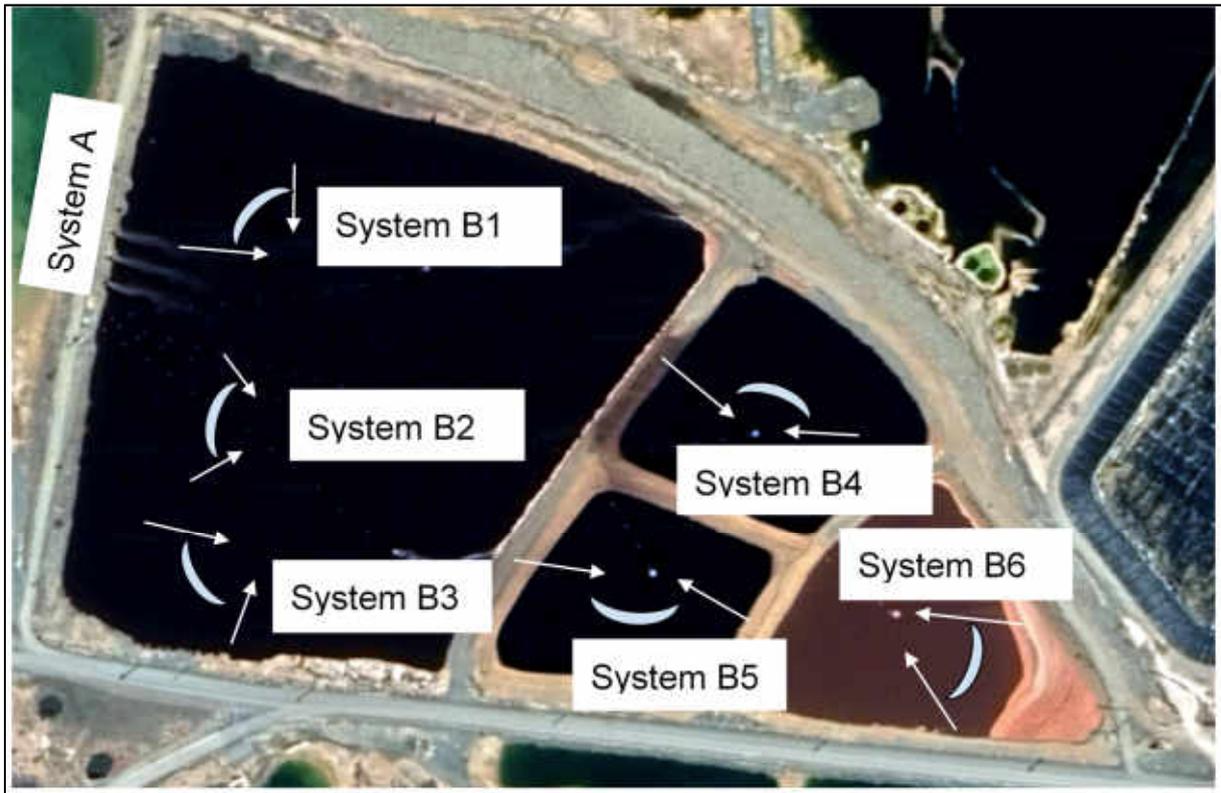
Figure 2.3 – The mechanical evaporation system layout for ED3N (Source: WIP 2019)

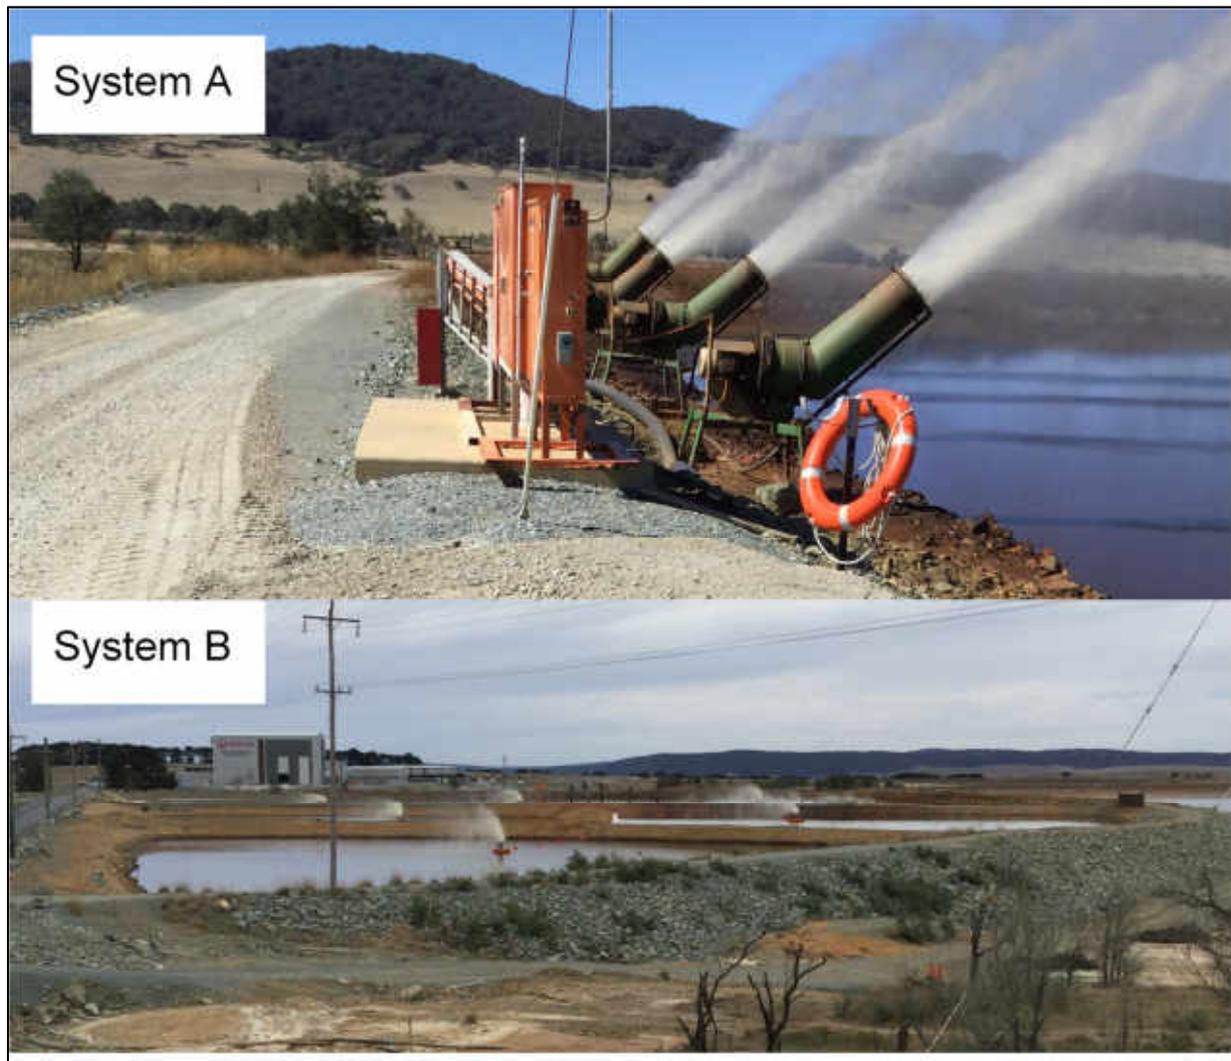
Figure 2.4 – Operation of System A and System B at the Site (Source: WIP 2019)

System B, which is a surface spray evaporator system, is composed of six (6) sprays (one in each of ED3N1 - 3 and three in ED3N4) floating in the middle of the dams and controlled by a weather station on the western bank of ED3N4. The operation of System B is in accordance with the feedback provided from the weather station, including temperature, humidity, wind direction and wind speed. Each of the sprayers is controlled independently, with setpoints based on weather conditions. As shown in **Figure 2.3**, the nominal location of each surface spray evaporator and the operating wind direction range are presented as arrows, with the span range visually illustrated. As documented in the WIP 2019, System B is still under a trial period and the setpoints are being tested to ensure the spray mist will not drift out of the dam area. As the humidity and temperature conditions vary across the seasonal cycles, the setpoint for wind speed is modified accordingly. The operation and effectiveness of System B is being regularly reviewed by the Site and setpoints optimised as required. A photo showing the operation of the surface spray evaporator system is shown in **Figure 2.4**.

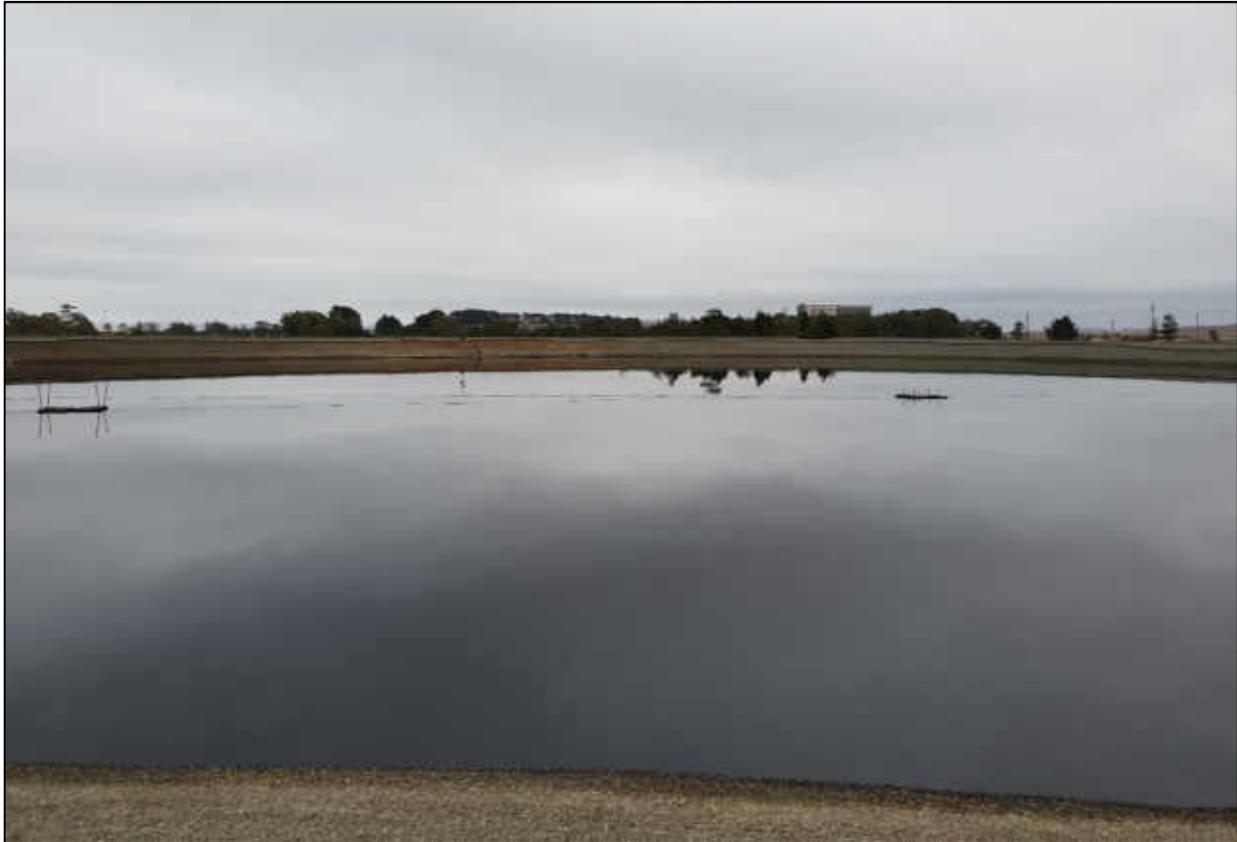
Photo 2.1 – ED3S-S as found on 20 February 2019

evaporation system, ED3S-S has three surface spray evaporators, similar to that described in **Section 2.4.2.1.2**. The operation of the surface spray evaporators occurs only during the daytime on weekdays and based on weather conditions.

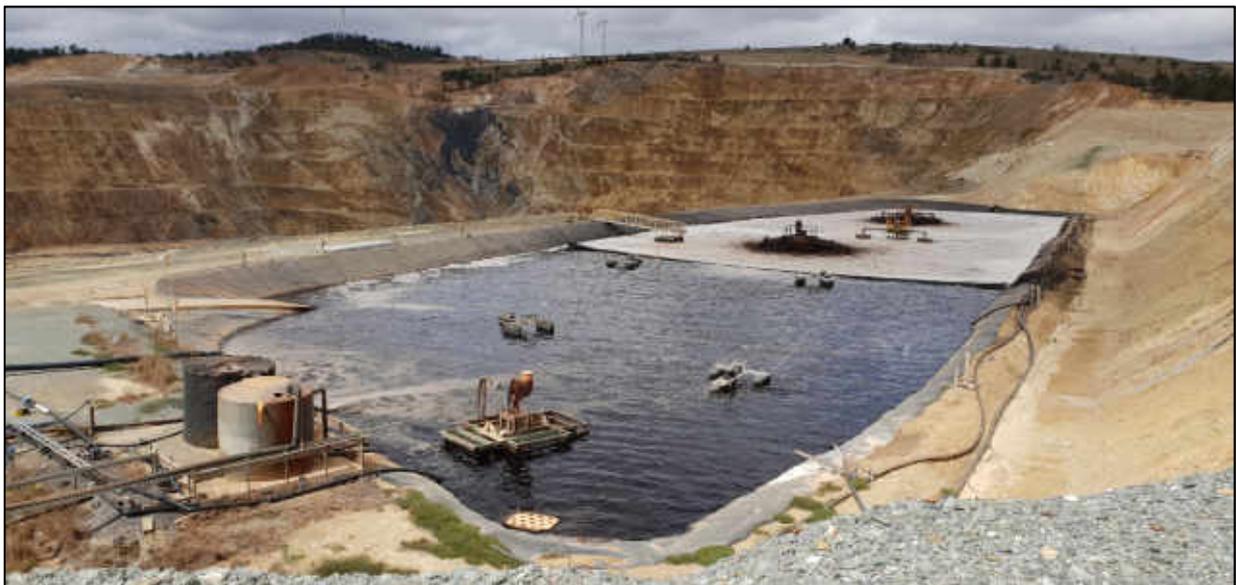
Photo 2.2 – The LTD as found on 21 February 2019

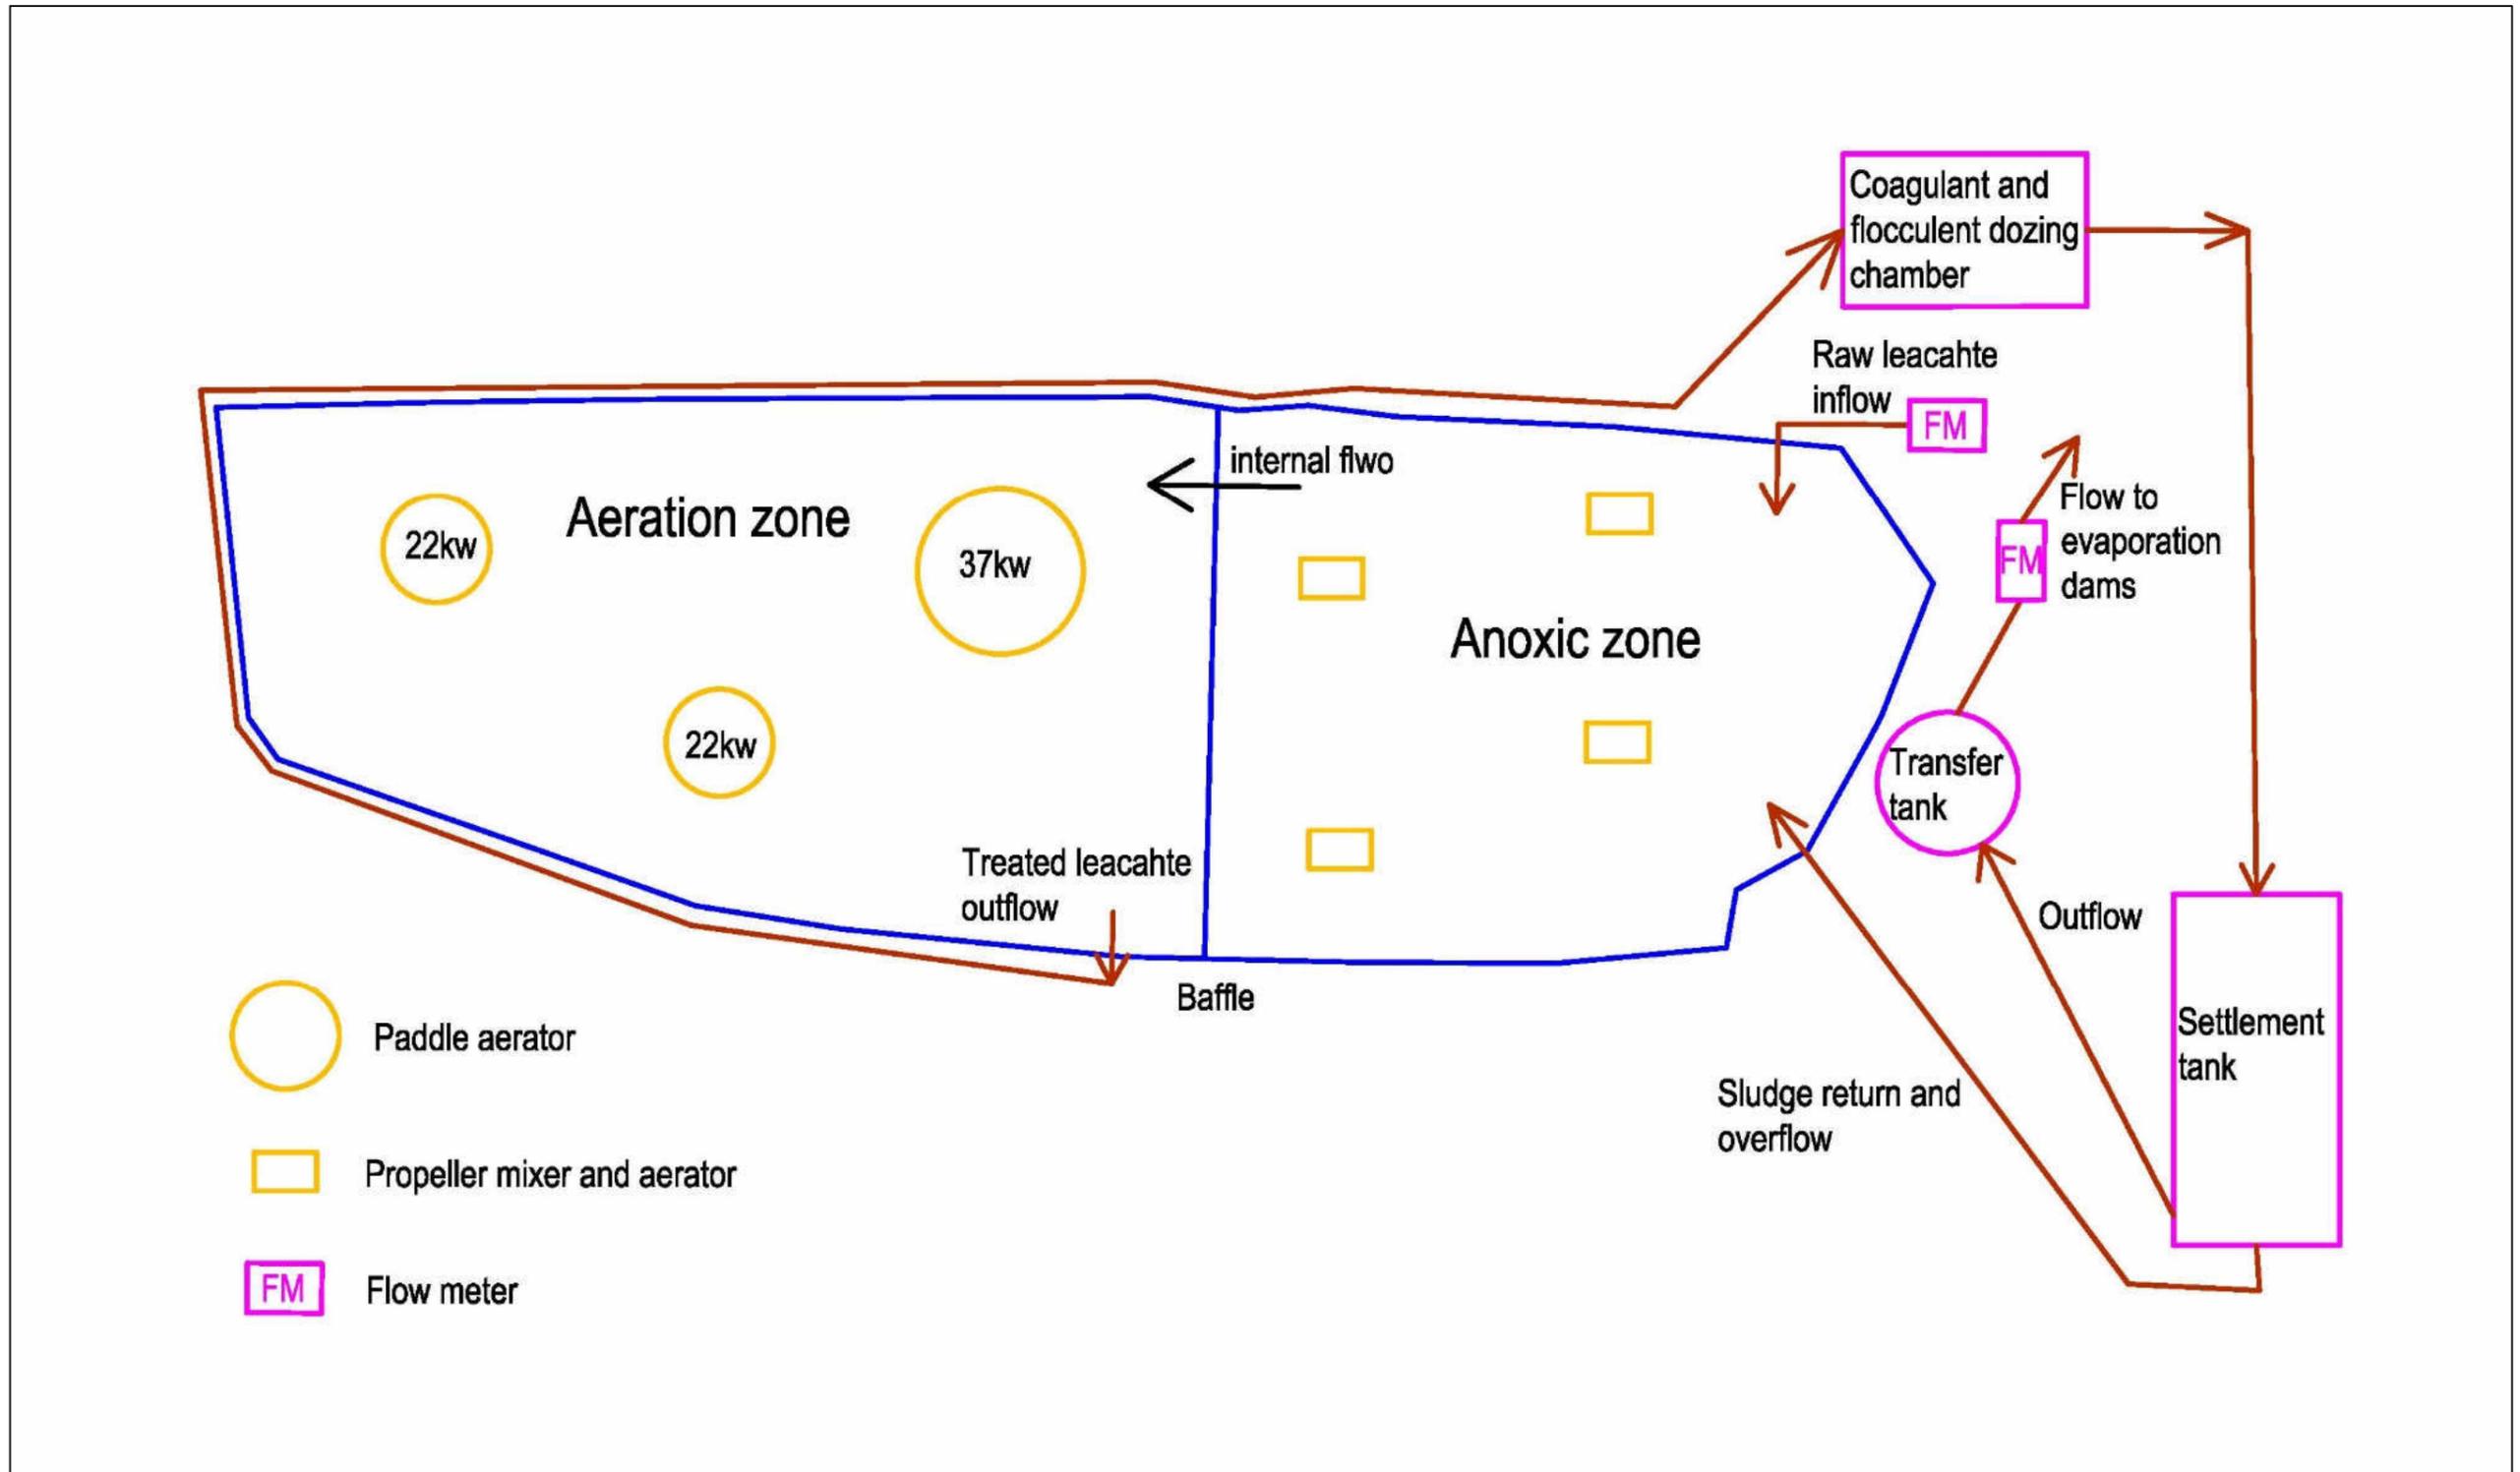
Figure 2.5 – A flow schematic of the current continuous treatment configuration for the LTD at the Site (Source: Veolia)

The LTD has a hydraulic retention time (**HRT**) of 33 days (dependent on treatment flow) and is capable of the continuous treatment of approximately 259,000 – 346,000 litres per day (**L/day**) of untreated leachate, equivalent to a current maximum treatment capacity of 3-4 L/s. The raw leachate is pumped from the Void and discharged into the anoxic zone of the LTD for denitrification. Following treatment in the anoxic zone, the leachate migrates to the aeration zone to promote mixing, oxygen transfer and nitrification. The effluent from the aeration zone of the LTD is dosed in-situ with ferric sulphate (**Fe₂(SO₄)₃**) and a polymer to facilitate with coagulation and flocculation processes before passing through a settling tank known as the Woodlawn Aerated Leachate Treated Effluent Refiner (**WALTER**). Under this treatment configuration, the LTD requires desludging at a frequency that is determined by Veolia experts. The sludge from the settling tank is returned to the LTD as required. Any sludge from the desludging process (and any excess sludge that may be generated) is transported and returned to the waste in the Void where it is buried and covered. A process of the LTD is provided as **Figure 2.5**.

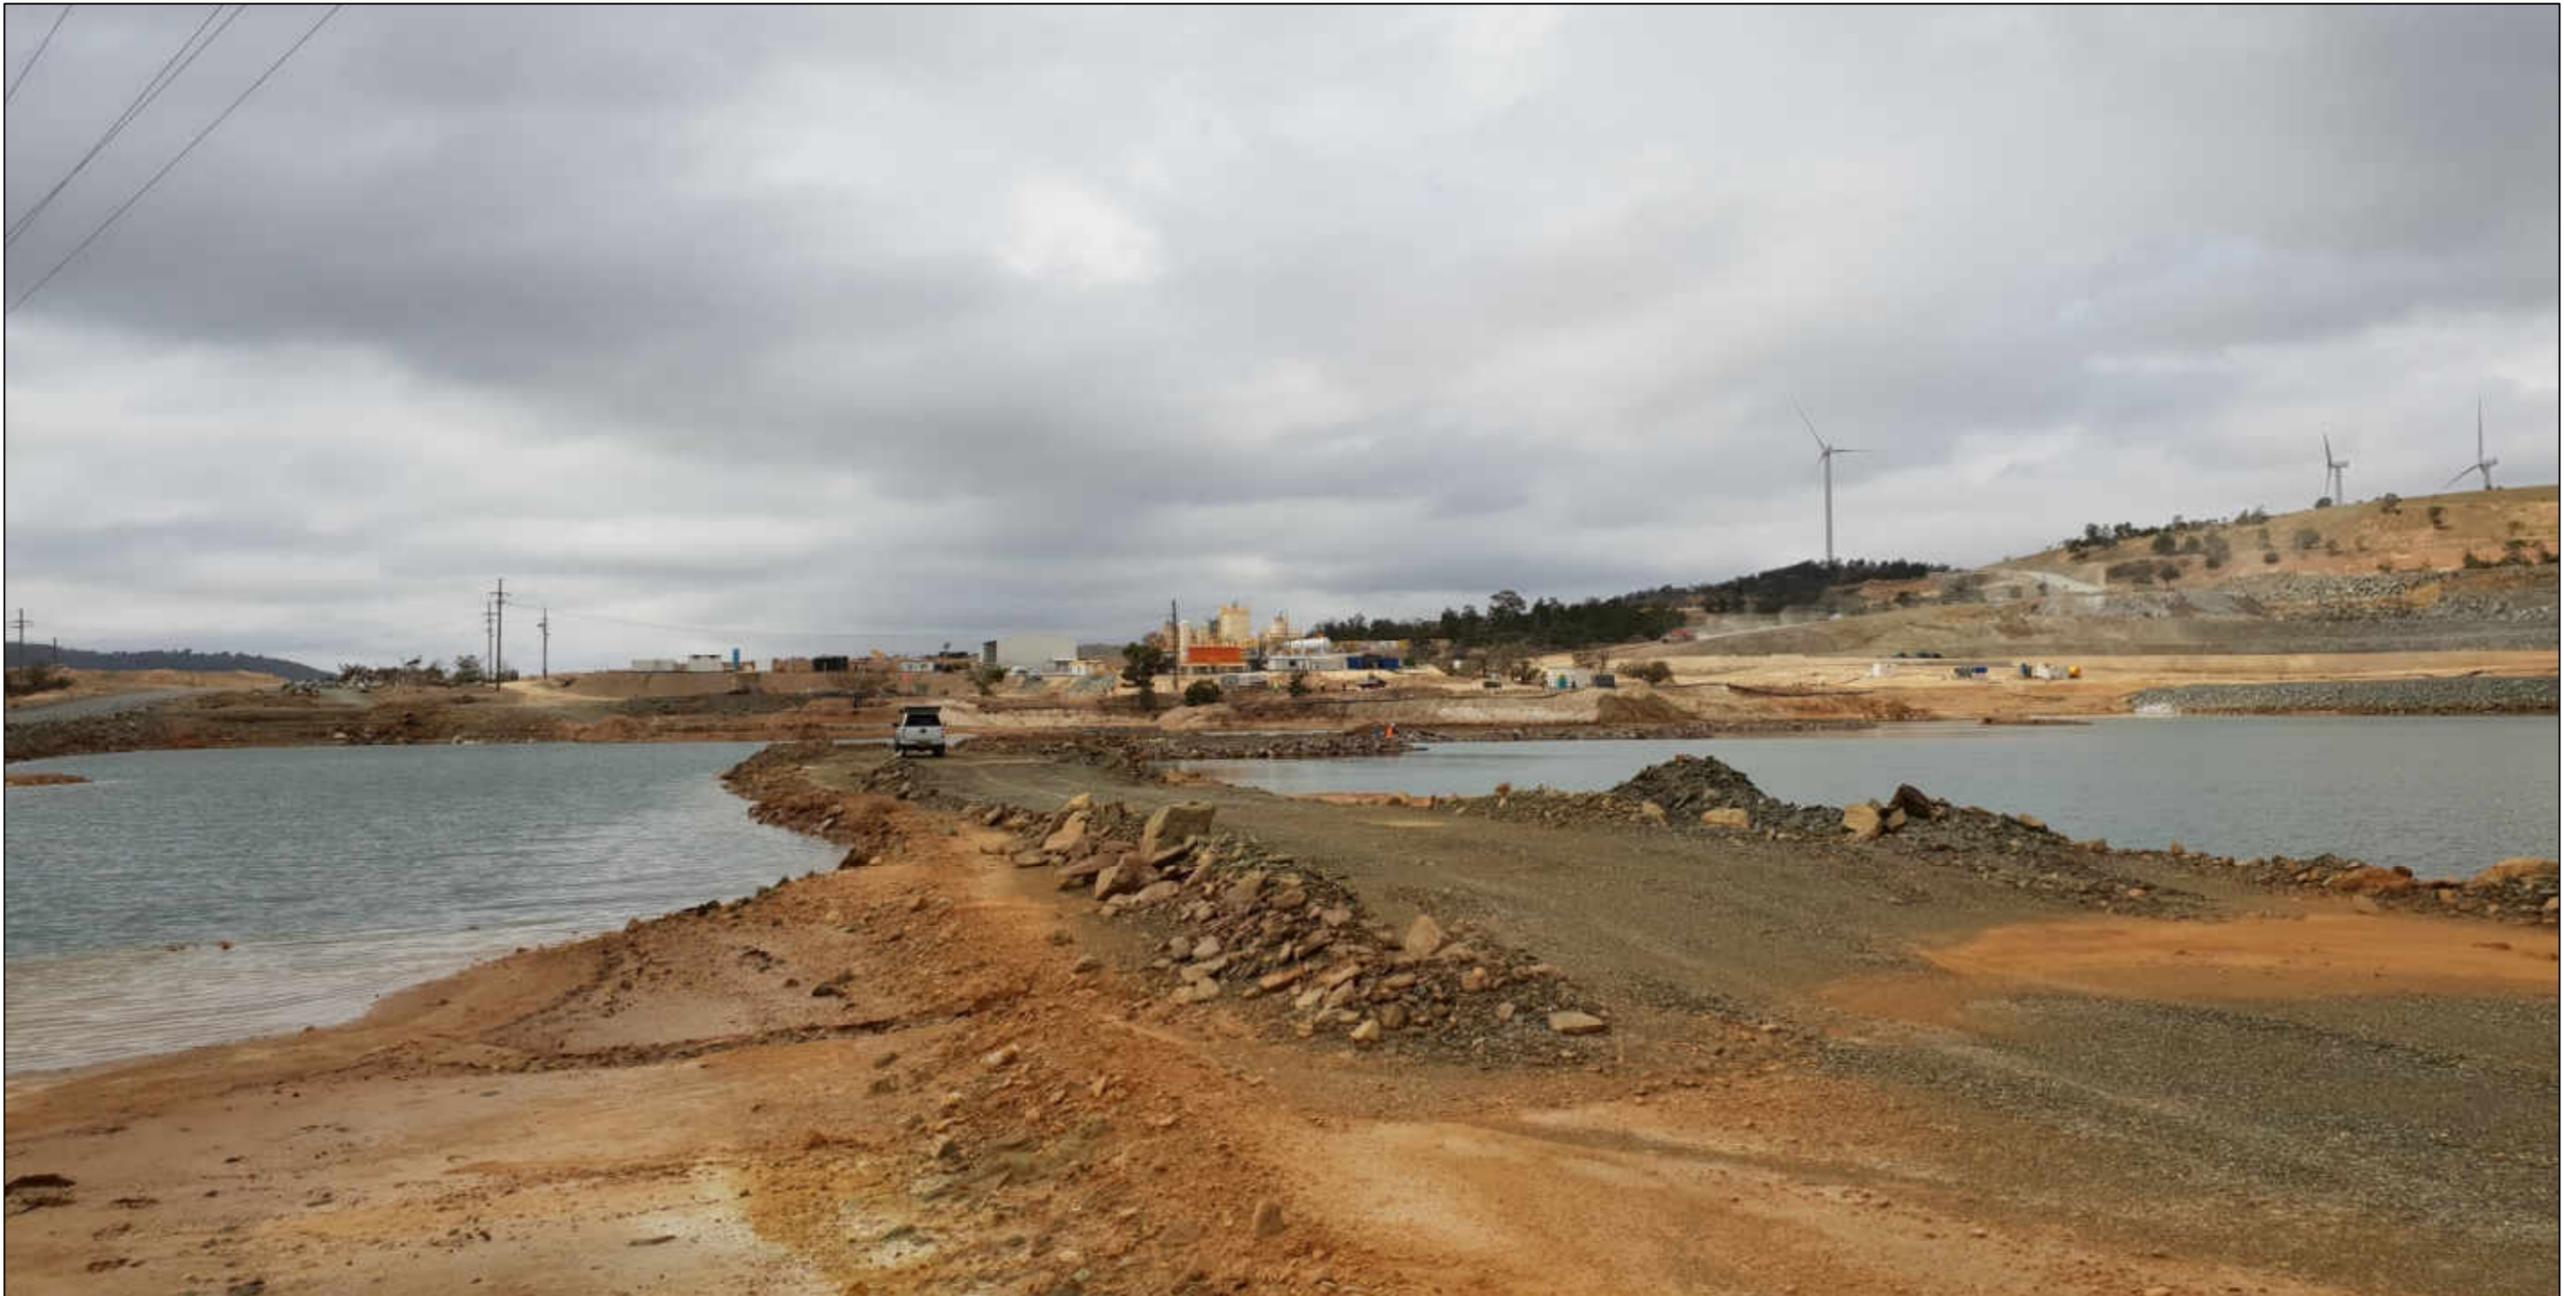
Photo 2.3 – ED3S as found on 20 February 2019

gas emissions from the Void. Given the importance of the management of high rainfall events in the Void, the WIP 2019 indicates that an upgrade to the stormwater management system will be undertaken at the Site to minimise excess leachate generation so that stormwater can be diverted to ED3S. This feature of the Void will be examined in the next IOA.

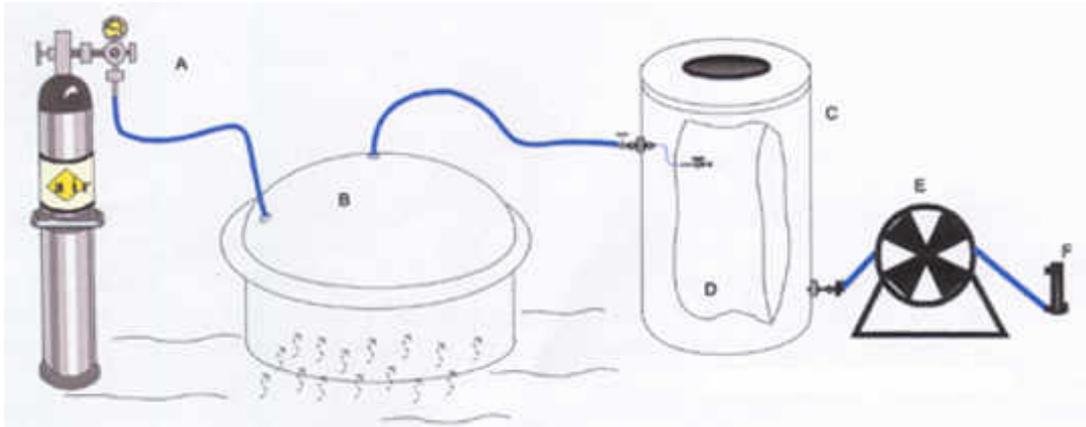
Figure 4.1 - Schematic of the isolation flux hood setup

The IFH is manufactured from acrylic resin to ensure it does not contribute to the odour sample. All other surfaces in contact with the sample are made from PTFE or stainless steel. An example of IFH sampling on a solid surface and a liquid surface is shown in **Photo 4.1 & Photo 4.2**, respectively.

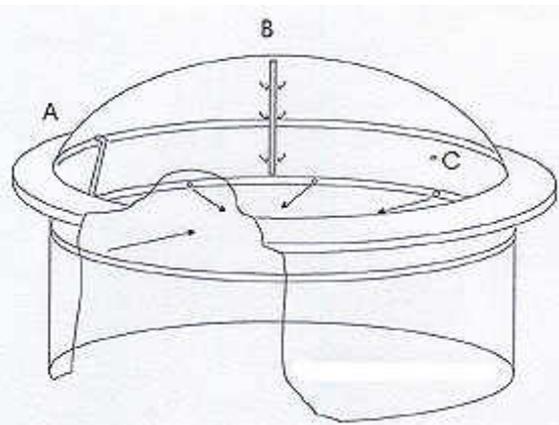
- A Inlet gas from the gas cylinder.
- B Outlet to sample bag.
- C Additional gas outlet points for other sampling, or temperature and moisture monitoring.

Figure 4.2 – Details of the isolation flux hood chamber

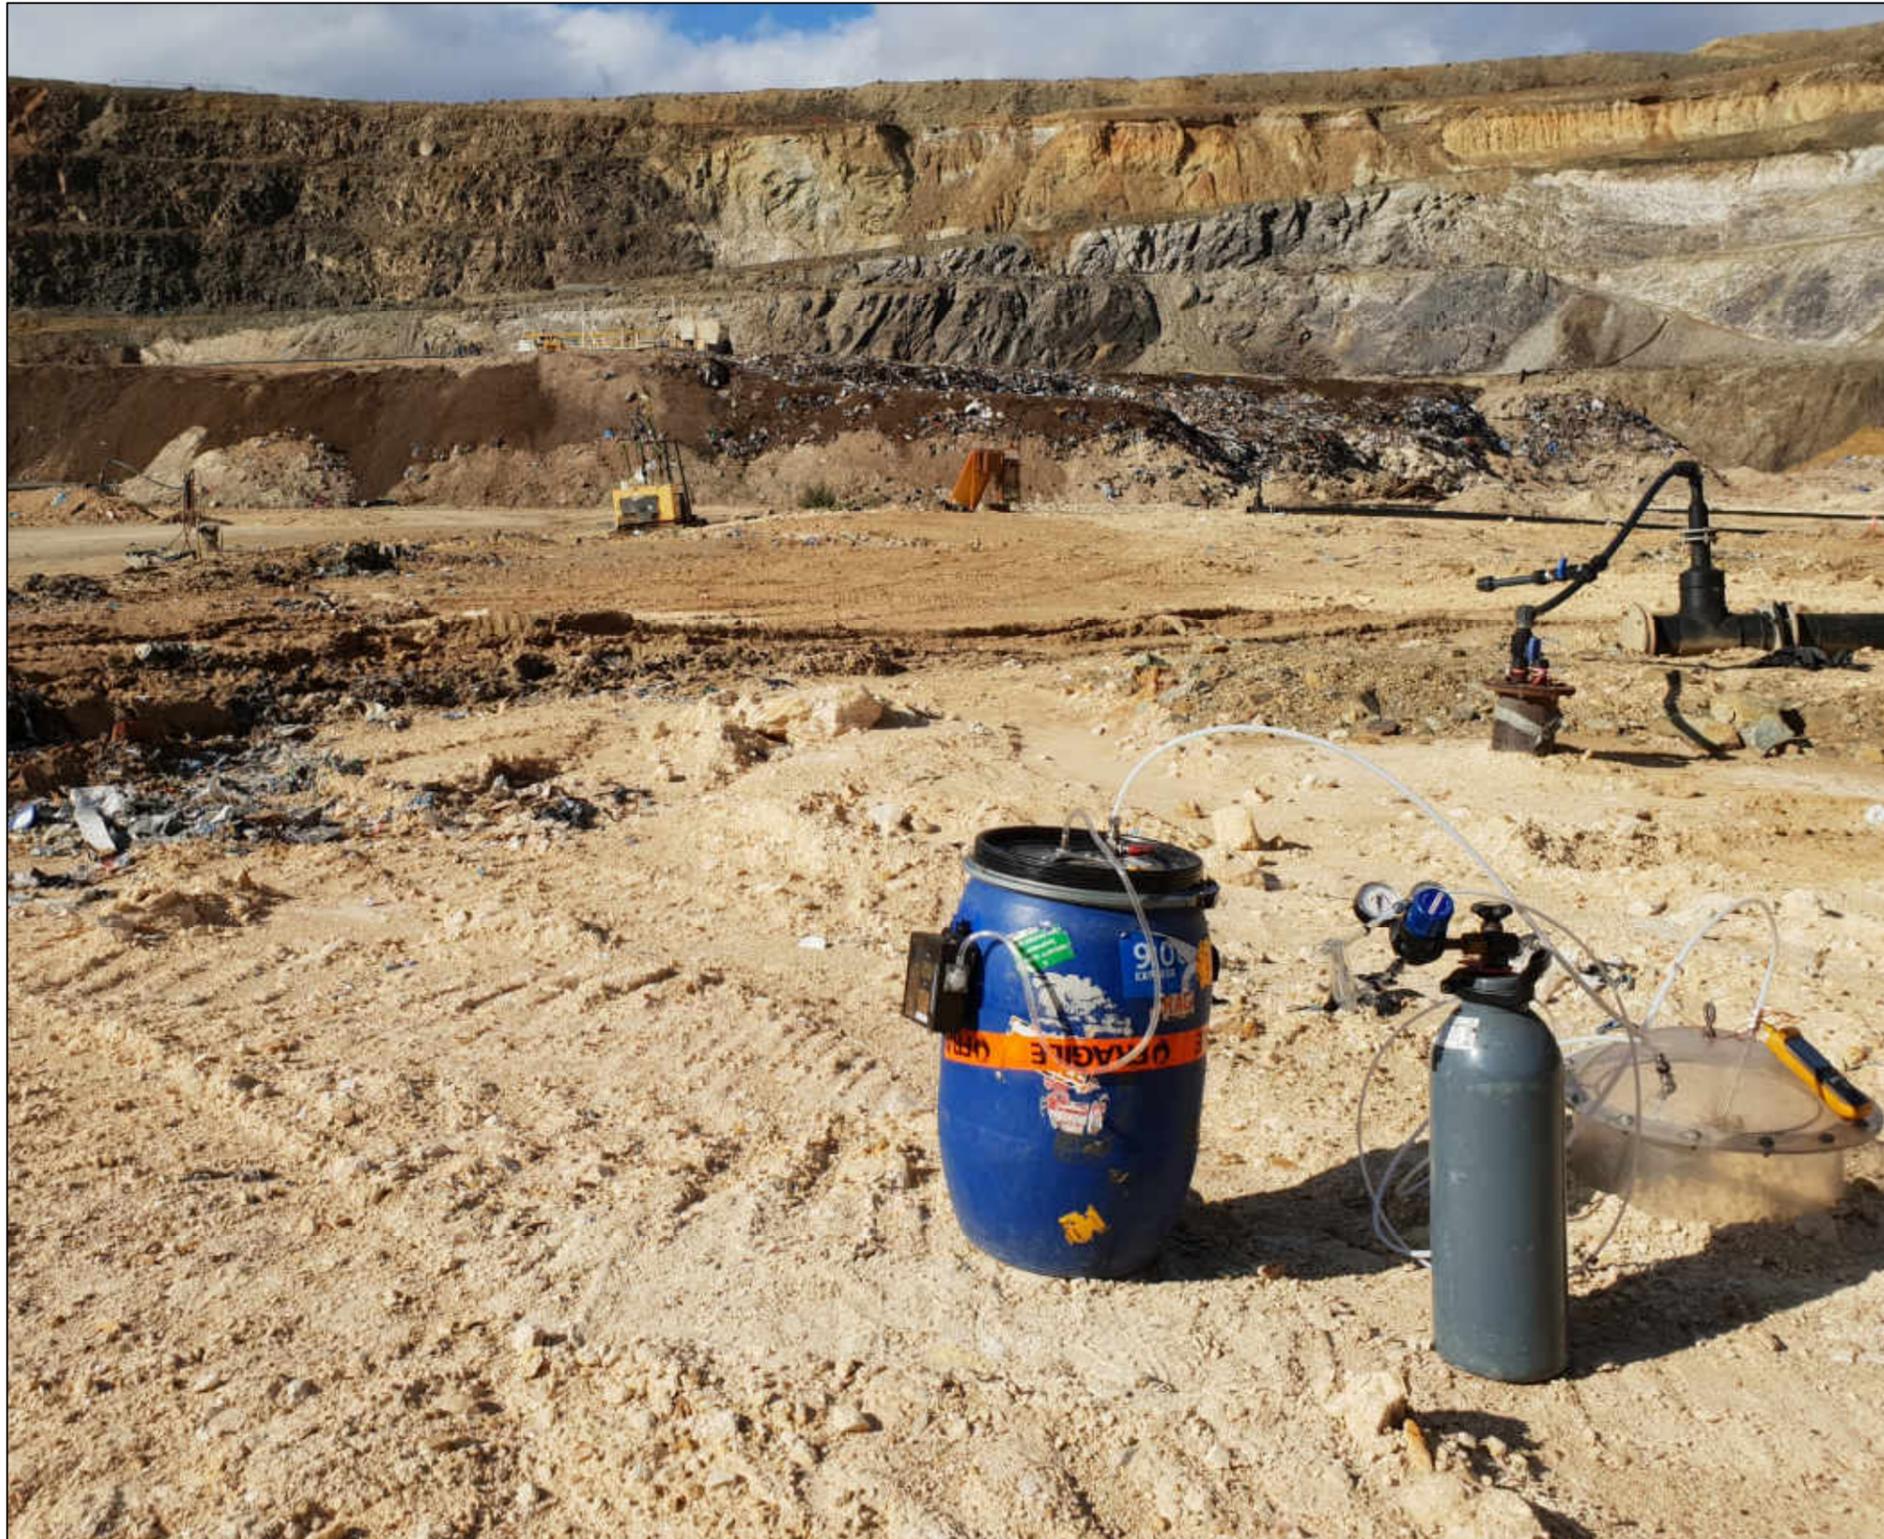
Photo 4.1 – An example of IFH sampling on a solid surface in the Void as occurred on 21 February 2019

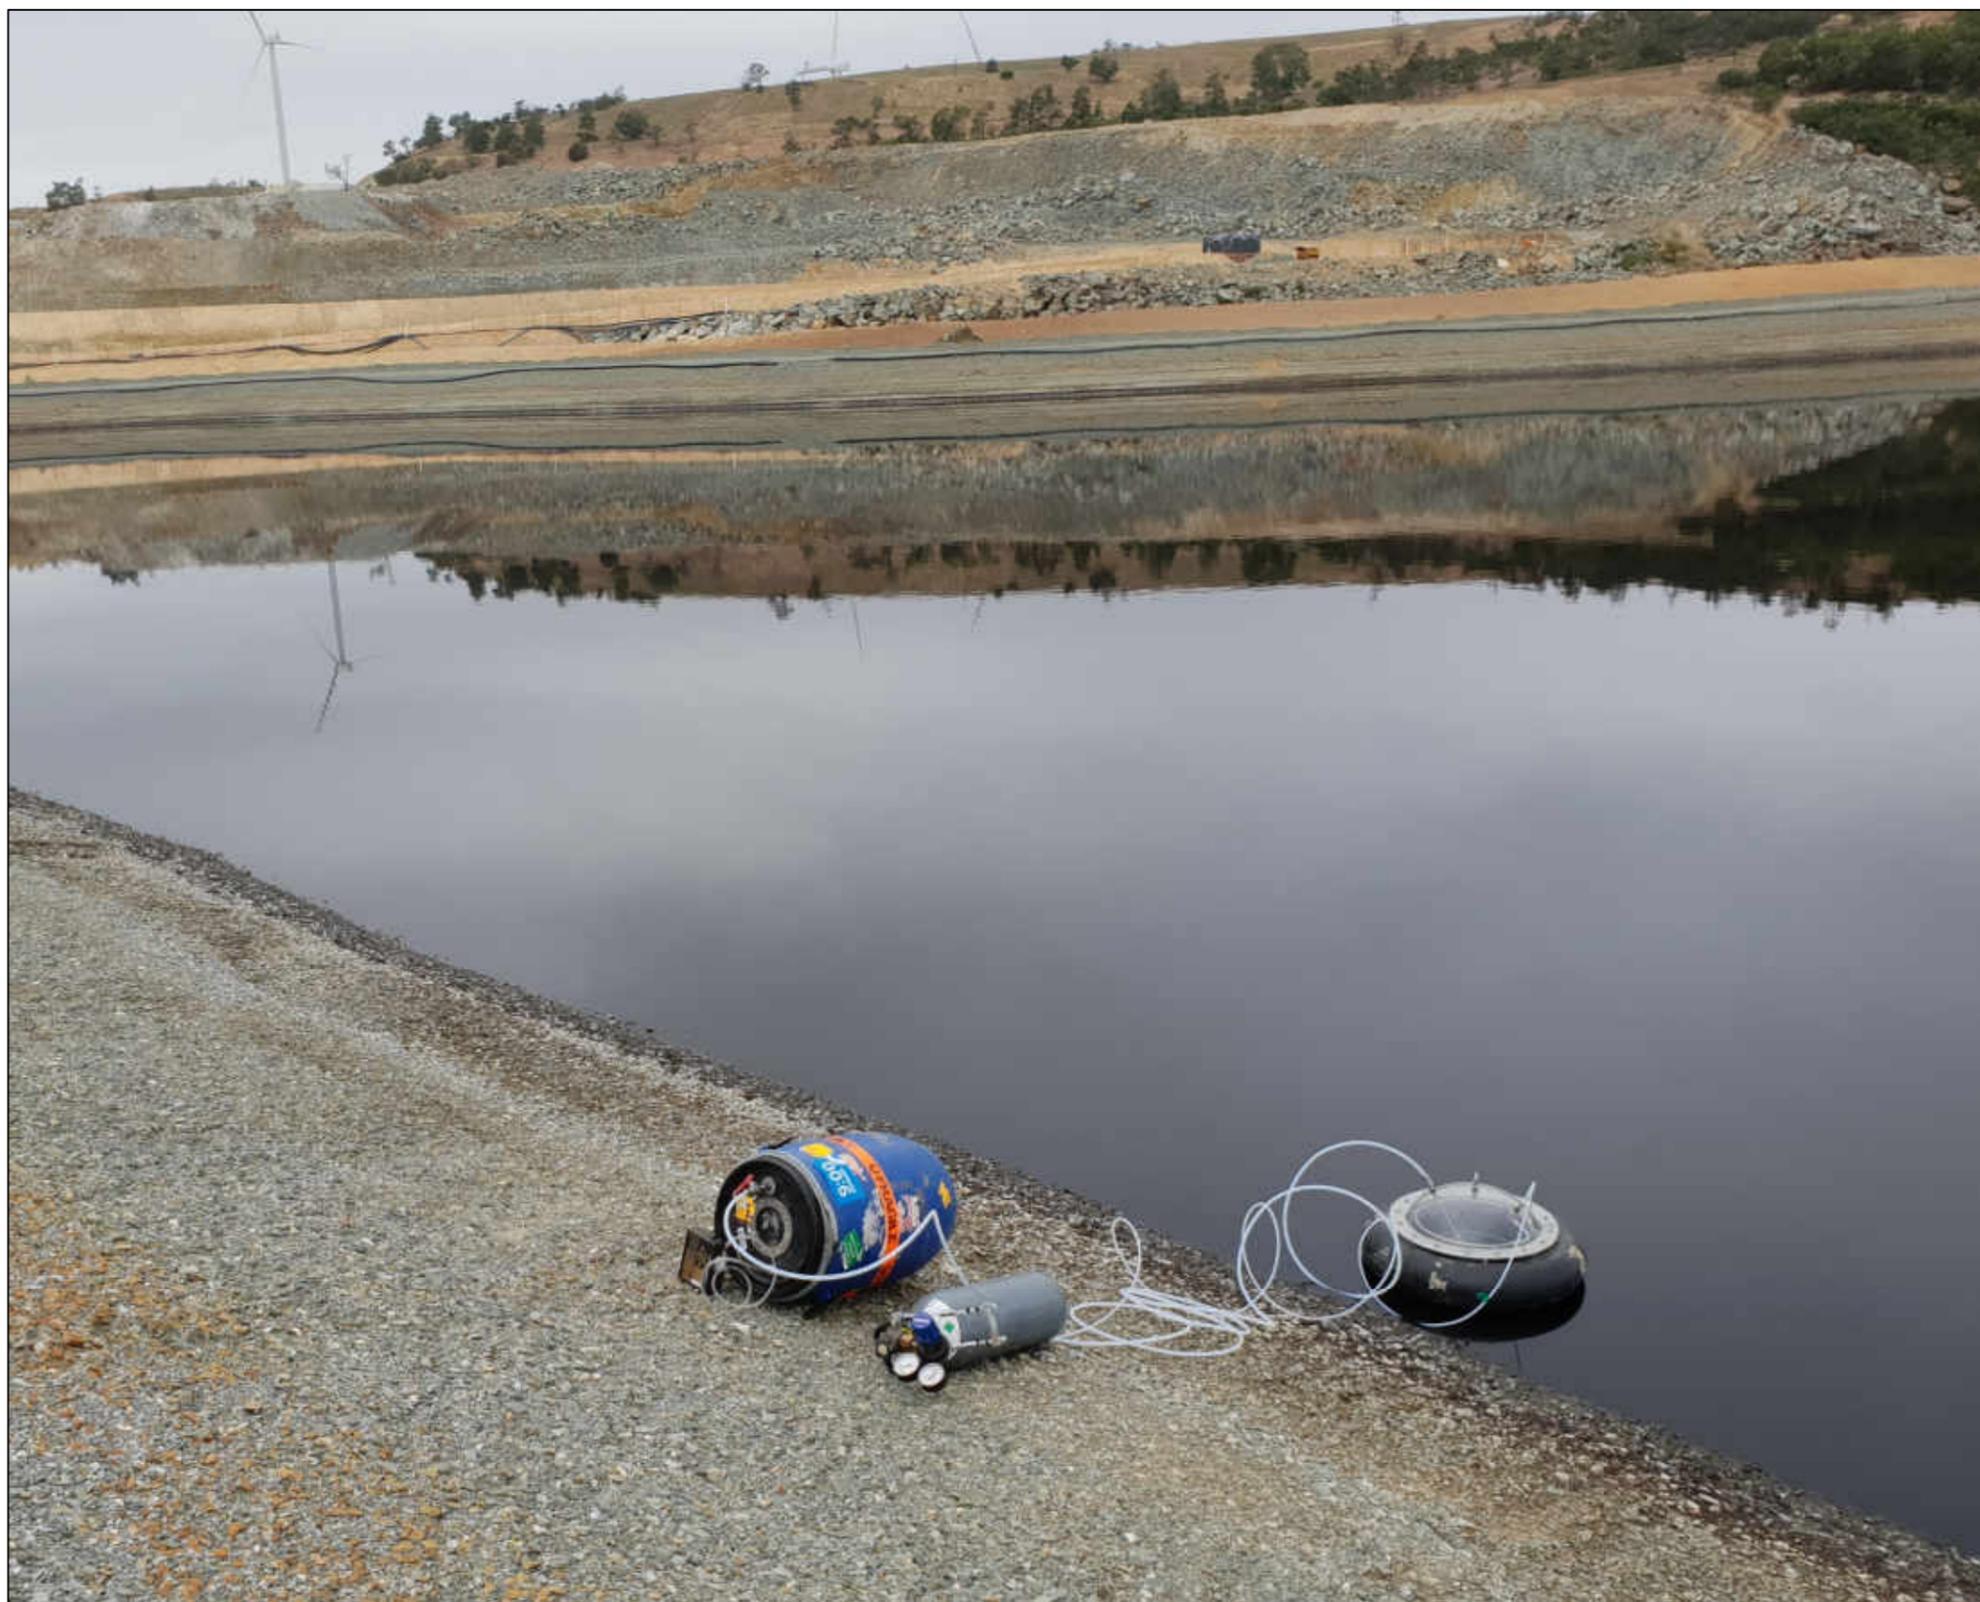
Photo 4.2 – An example of IFH sampling on a liquid surface (ED3-SS) as occurred on 20 February 2019
