Woodlawn Bioreactor Expansion Project

Independent Odour Audit #7

July 2019

Final Report

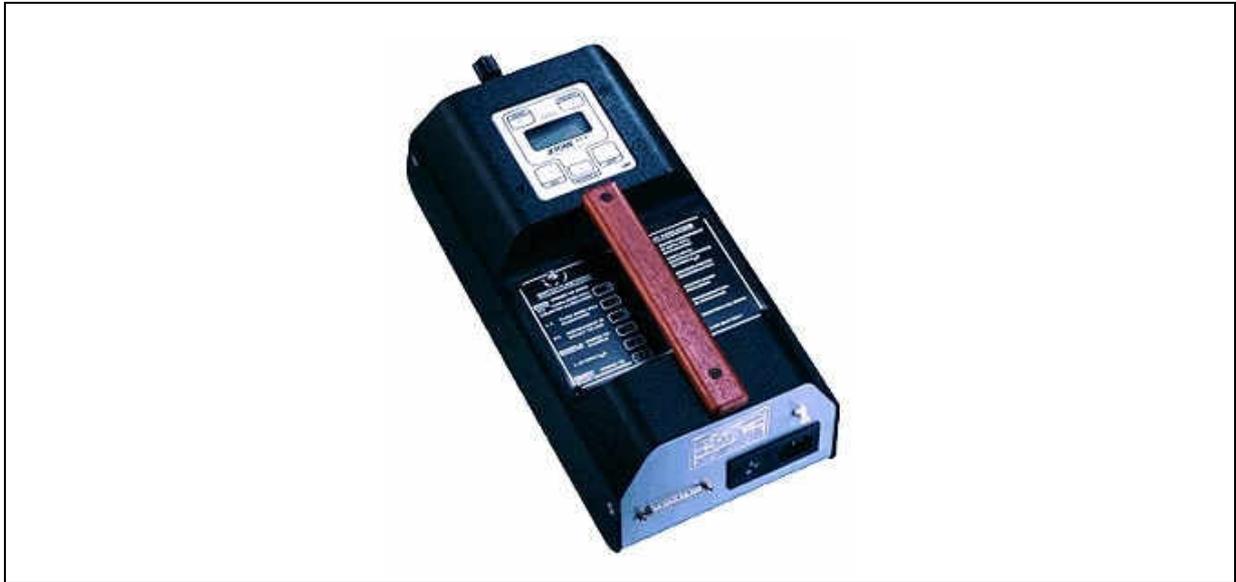
Photo 5.1– TOU's portable Jerome 631-X H₂S Analyser

Analyser (**Jerome Analyser**). The Jerome is a portable ambient air analyser with a range of 0.003 ppm to 50 ppm. All samples were measured on-site using the Jerome (see **Photo 5.1**), except where H₂S concentrations of greater than 50 ppm were encountered which necessitated the use of colorimetric tubes were used).

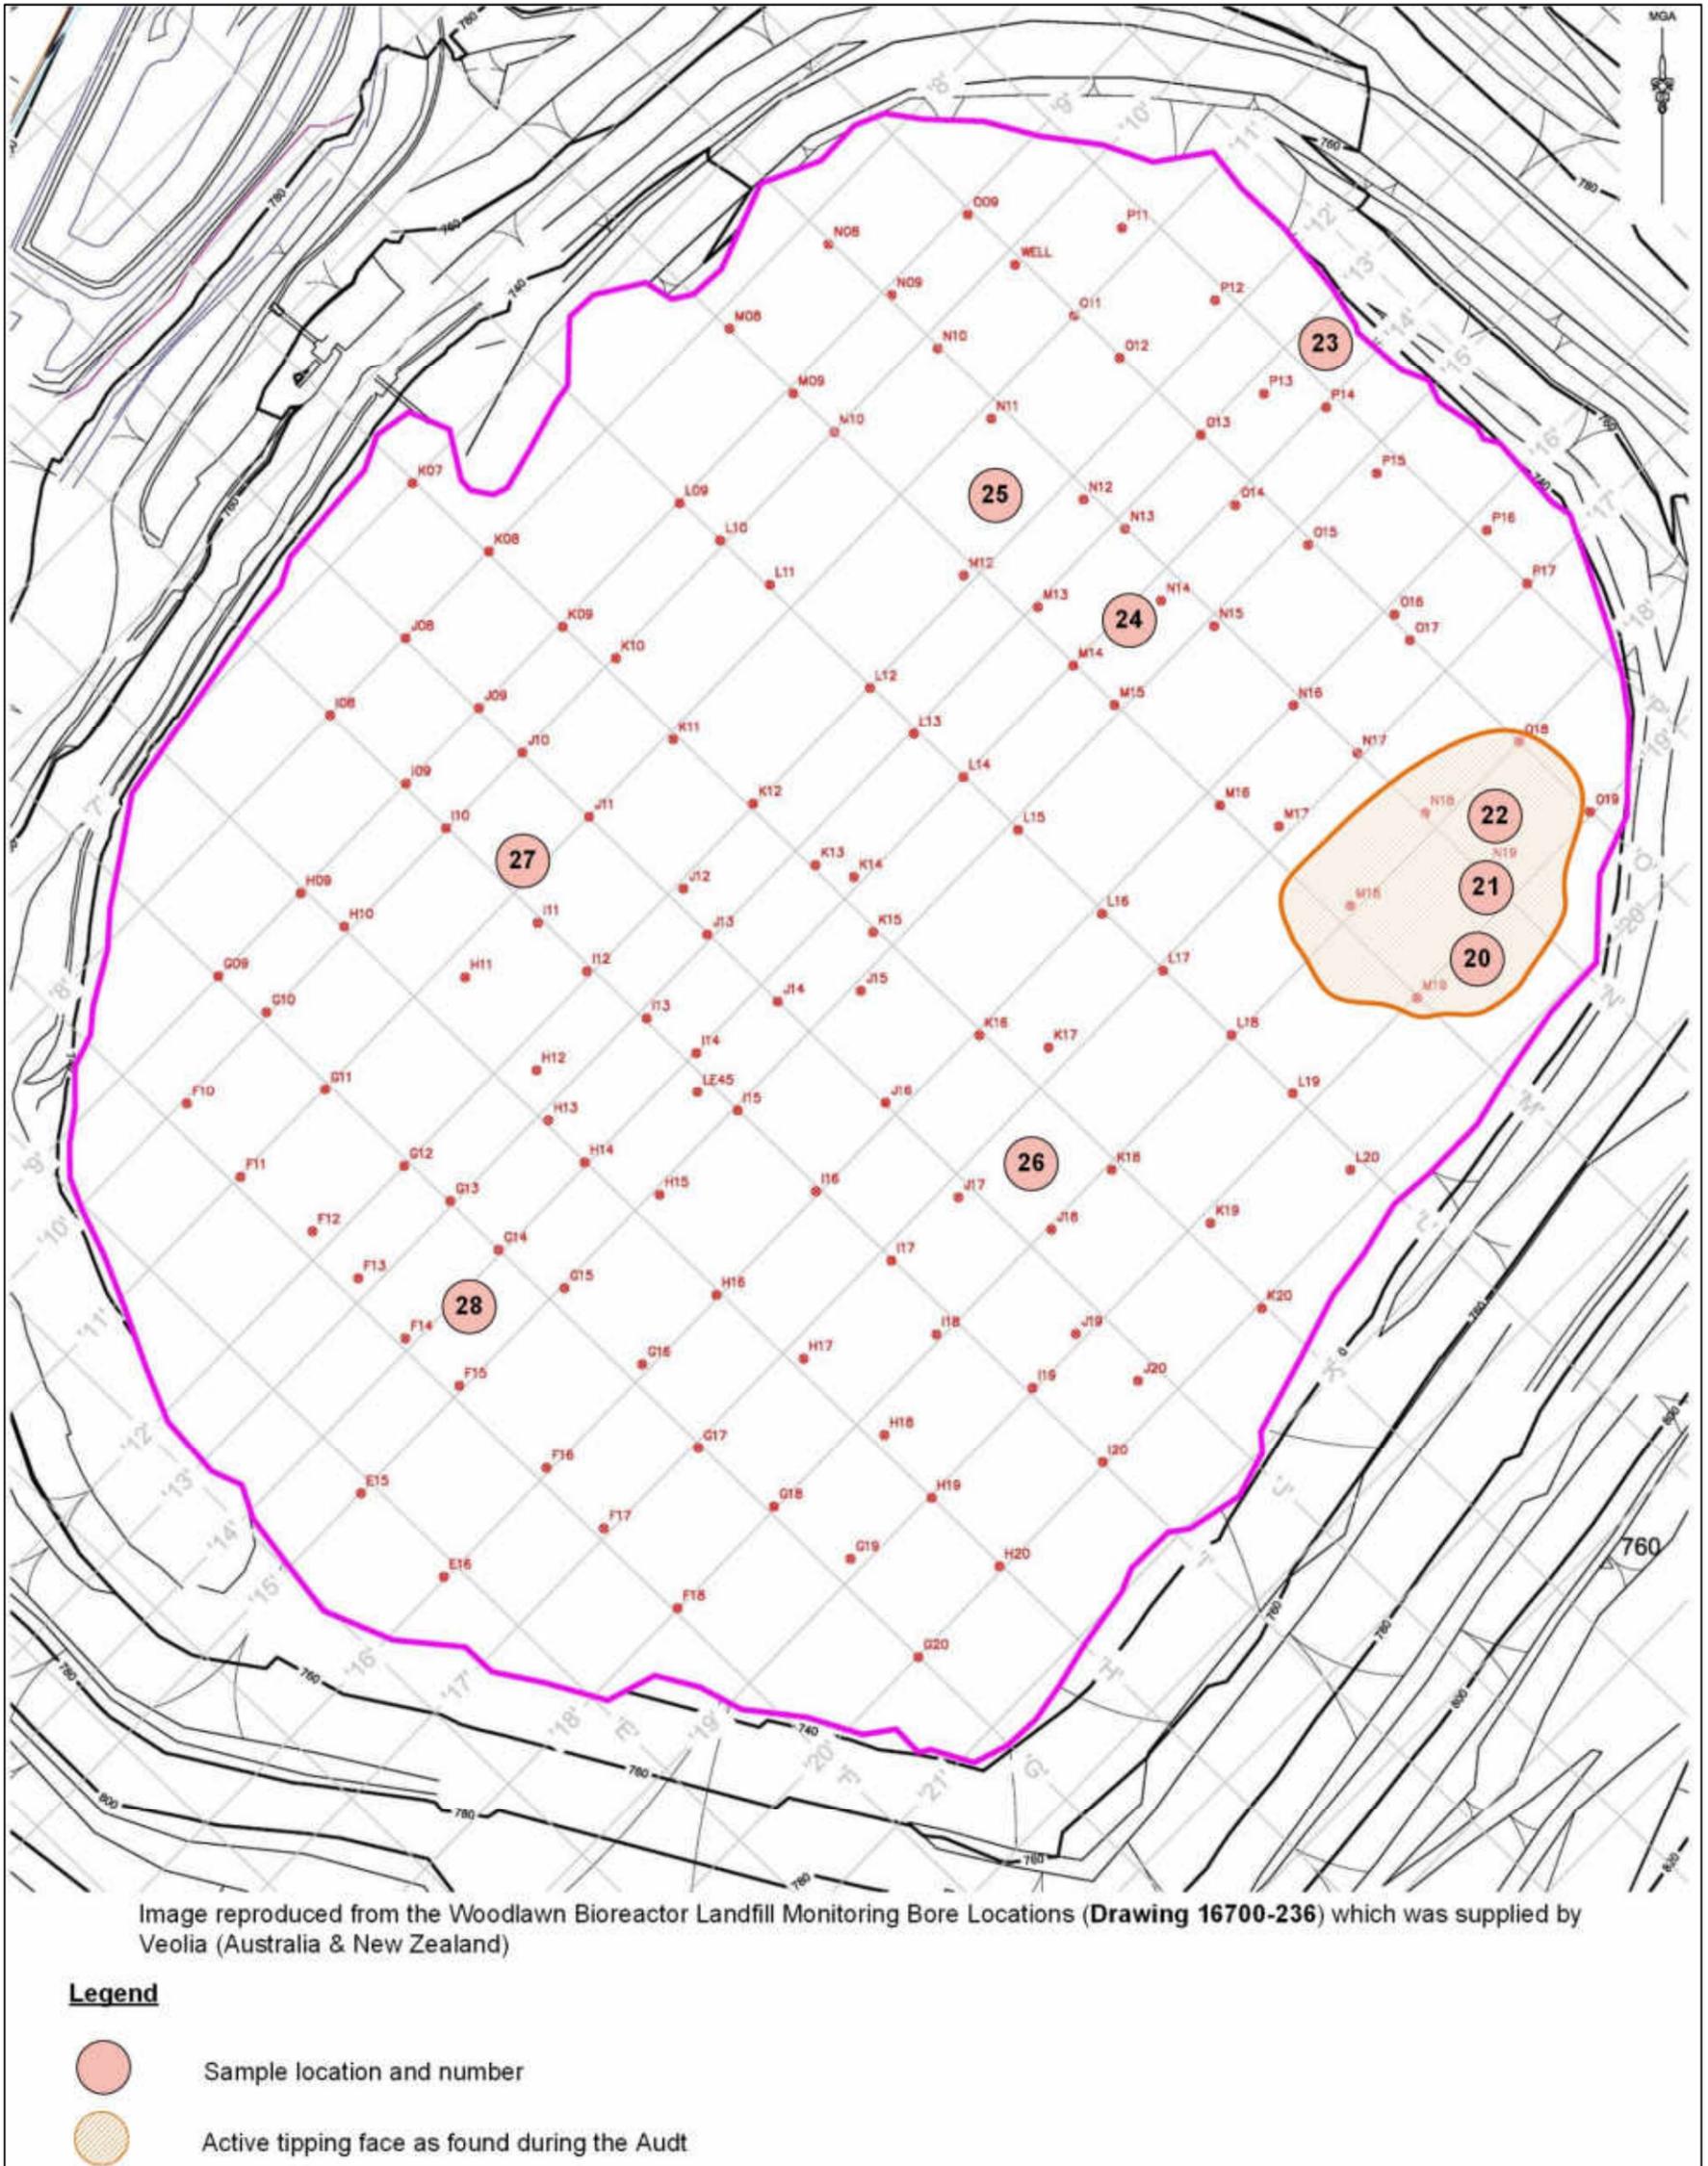
Figure 6.1 - Nominal sampling locations within the Void: 20 & 21 February 2019

- The sampling locations inside the Void have been nominally shown in **Figure 6.1**. The sample numbers presented in **Figure 6.1** correspond with those in the sampling location column in **Table 6.1**. The conditions prevailing in the Void at the time of the Audit is presented in **Photo 6.1**;

- The waste covered area sample (SC19118-SC19119), representing a 300 mm depth capped cover (see **Figure 6.1**), that is not categorised as a potential fugitive emission pathway based on the SOER result, is slightly above the EA target of 0.2 ou.m³/m².s (0.4 ou.m³/m².s) but not considered to be problematical as shown the odour modelling study (**Section 8**). These SOER results are considered to reflect an effective capping practice within the Void.

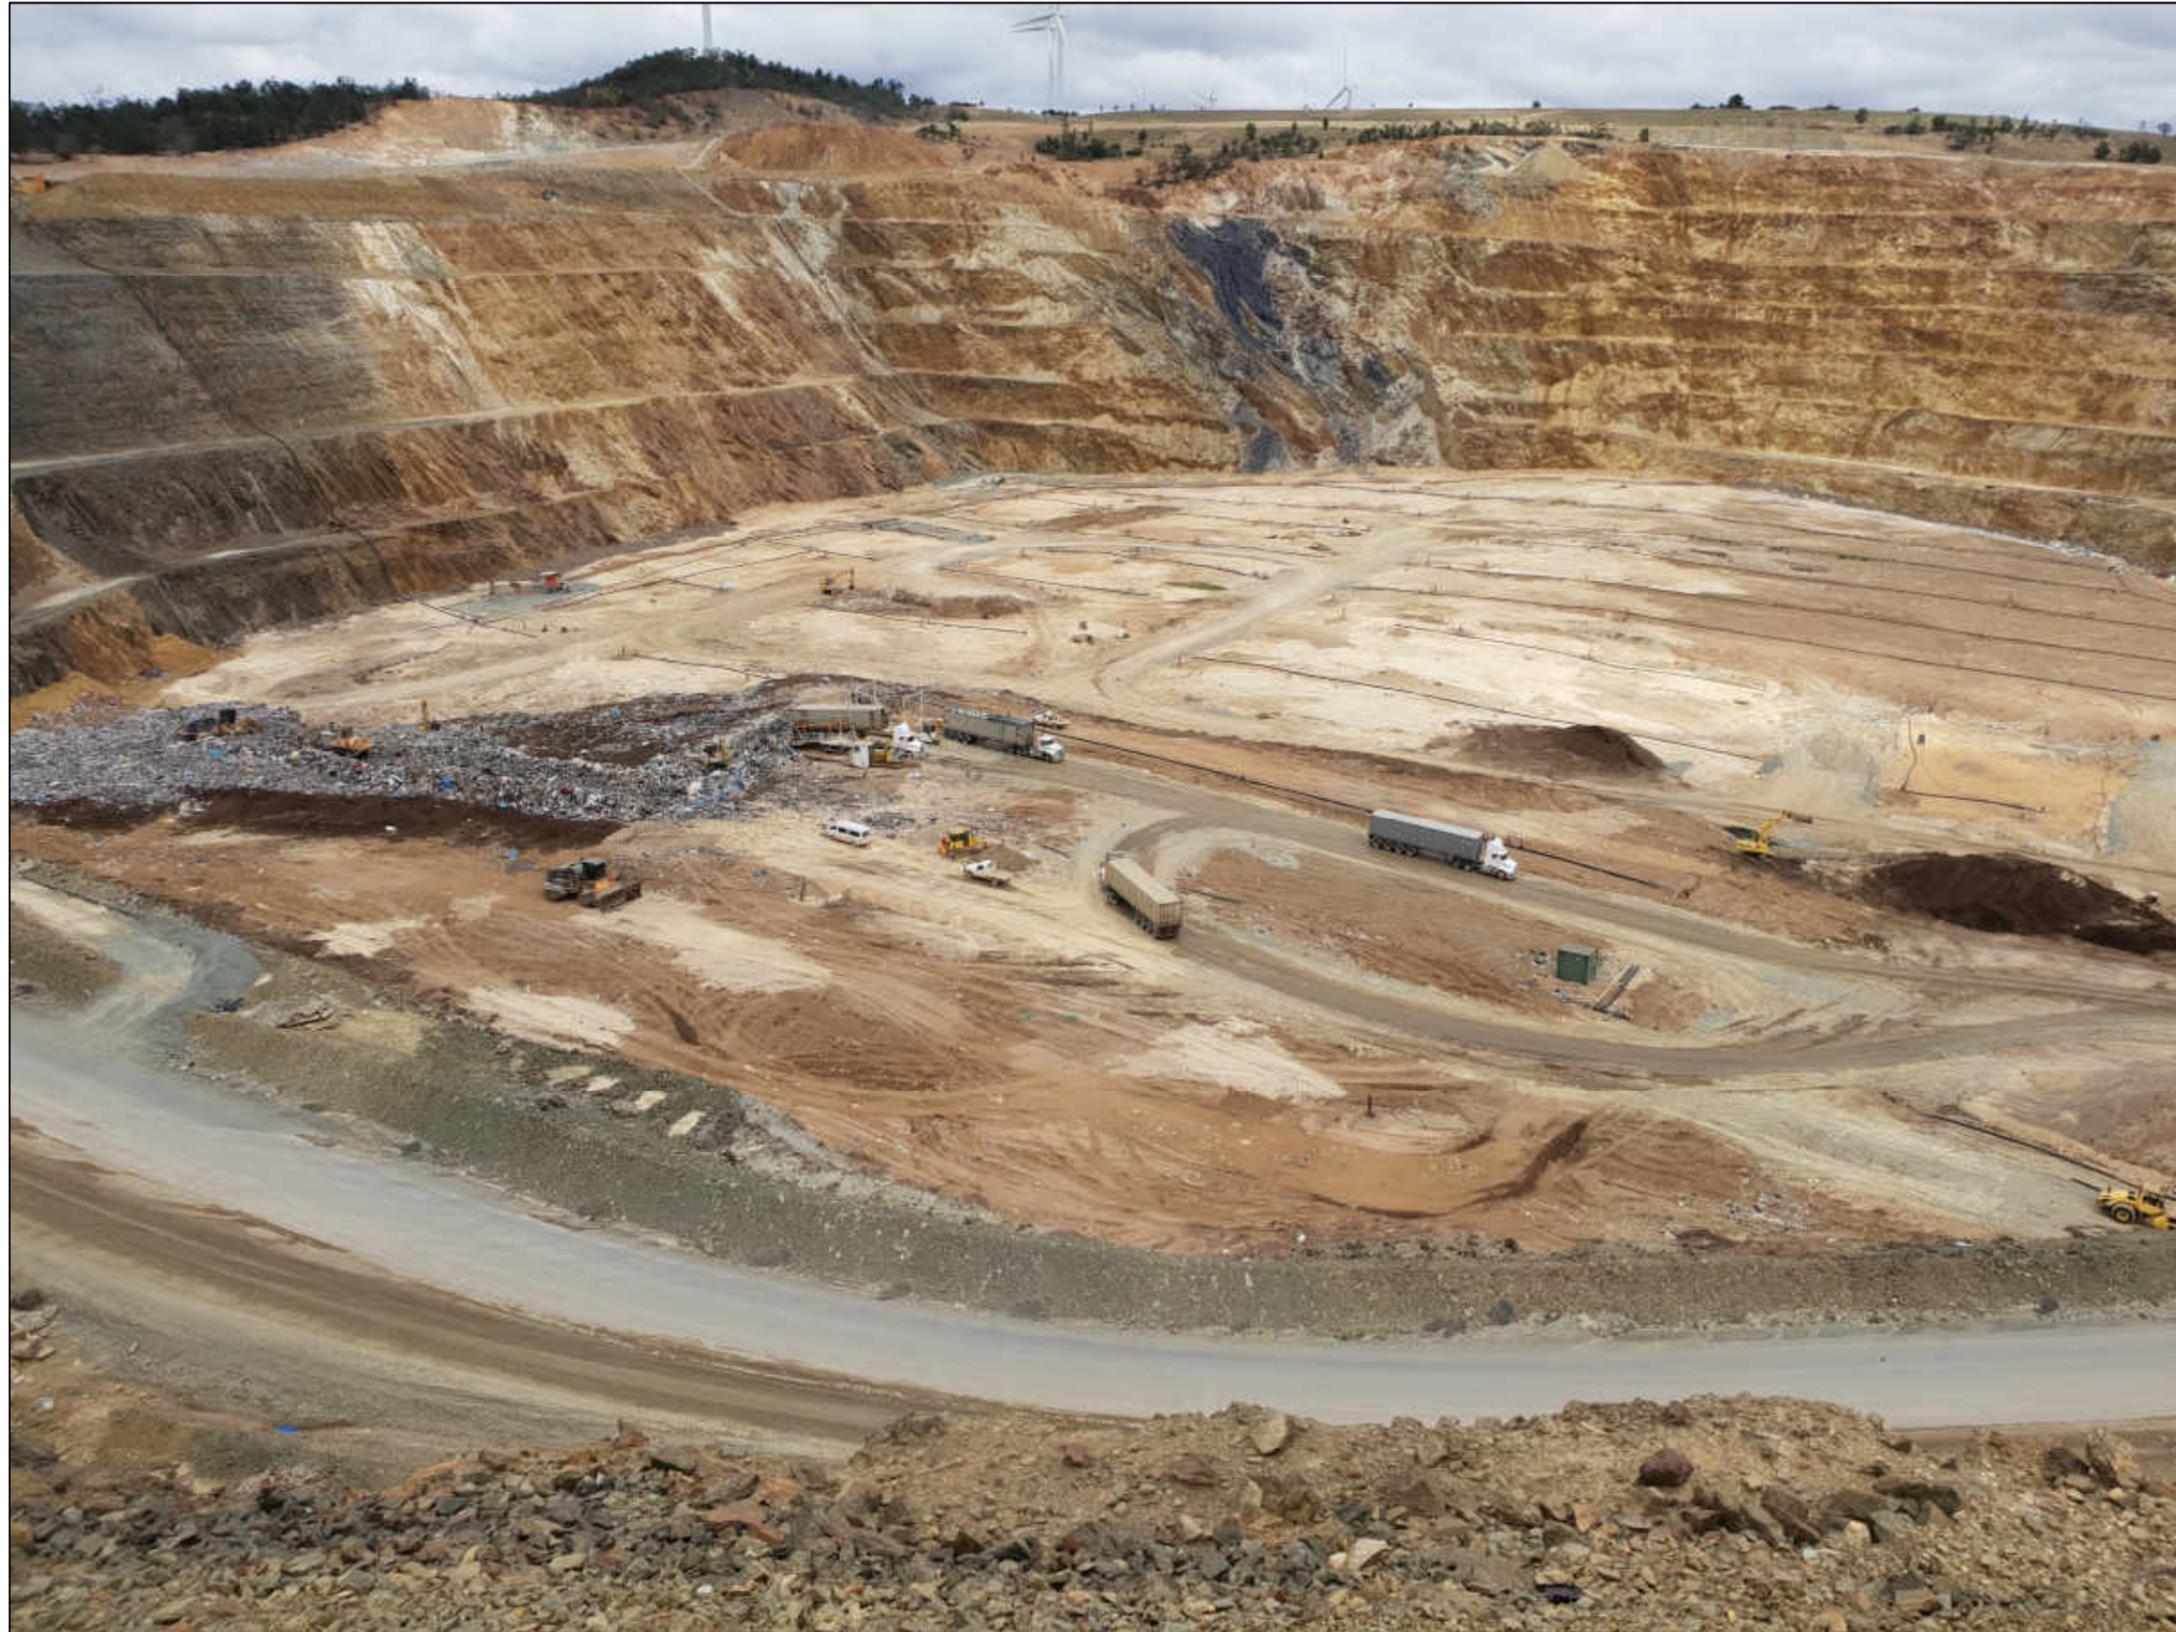
Photo 6.1 – Conditions prevailing in the Void during the Audit on 21 February 2019

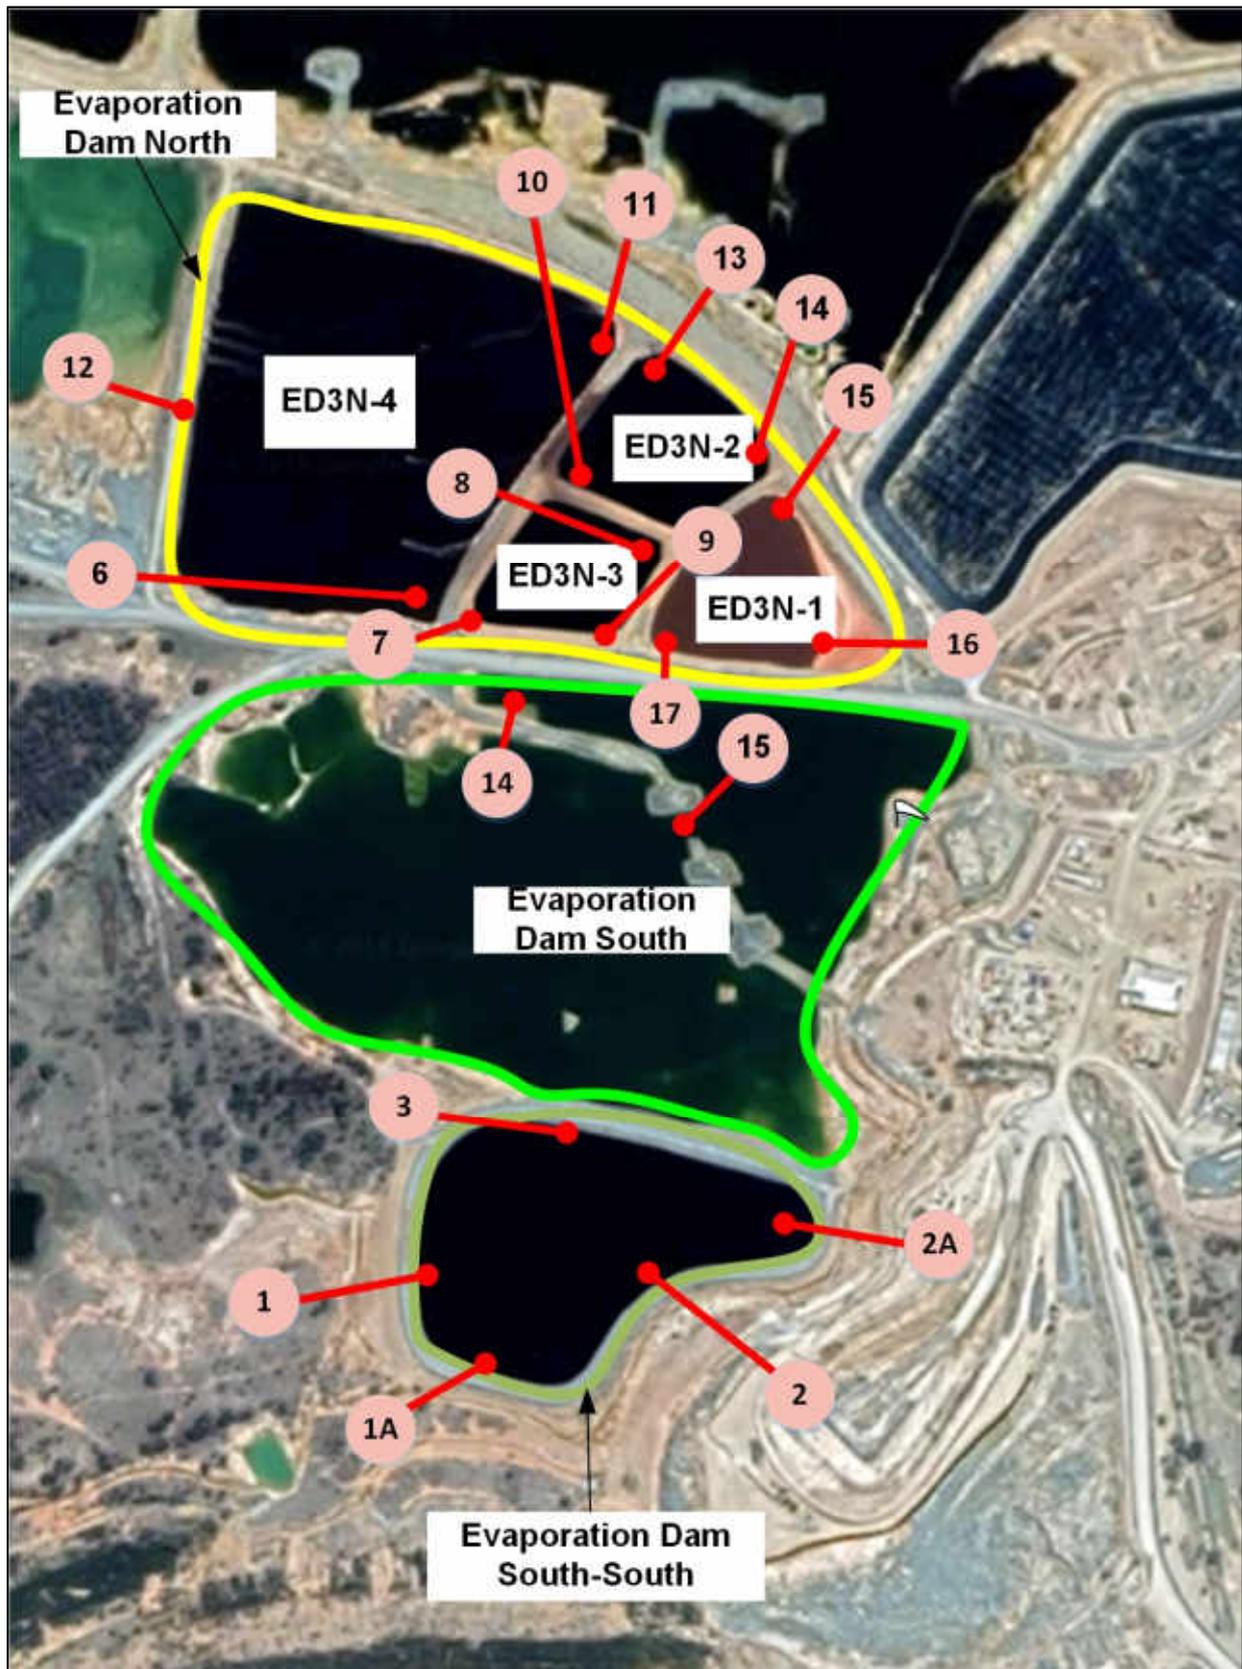
Figure 6.2 – Pond sources nominal liquid & gas sampling locations: 20 & 21 February 2019

- All samples from the ED3N system were collected from the bank of the dams. The nominal sampling locations are shown in **Figure 6.2**; and
- All samples collected and tested from the ED3N Pond system (i.e. SC19099 – SC19107) were found to be below the EA 2010 SOER model inputs for each dam. The very low SOER values for all ponds (0.03 – 0.46 ou.m³/m².s) are consistent with the previous IOA results. These consistent results indicate that the leachate treatment quality continues to be optimum and that the LMS at the Site is performing very well from an odour emissions viewpoint.

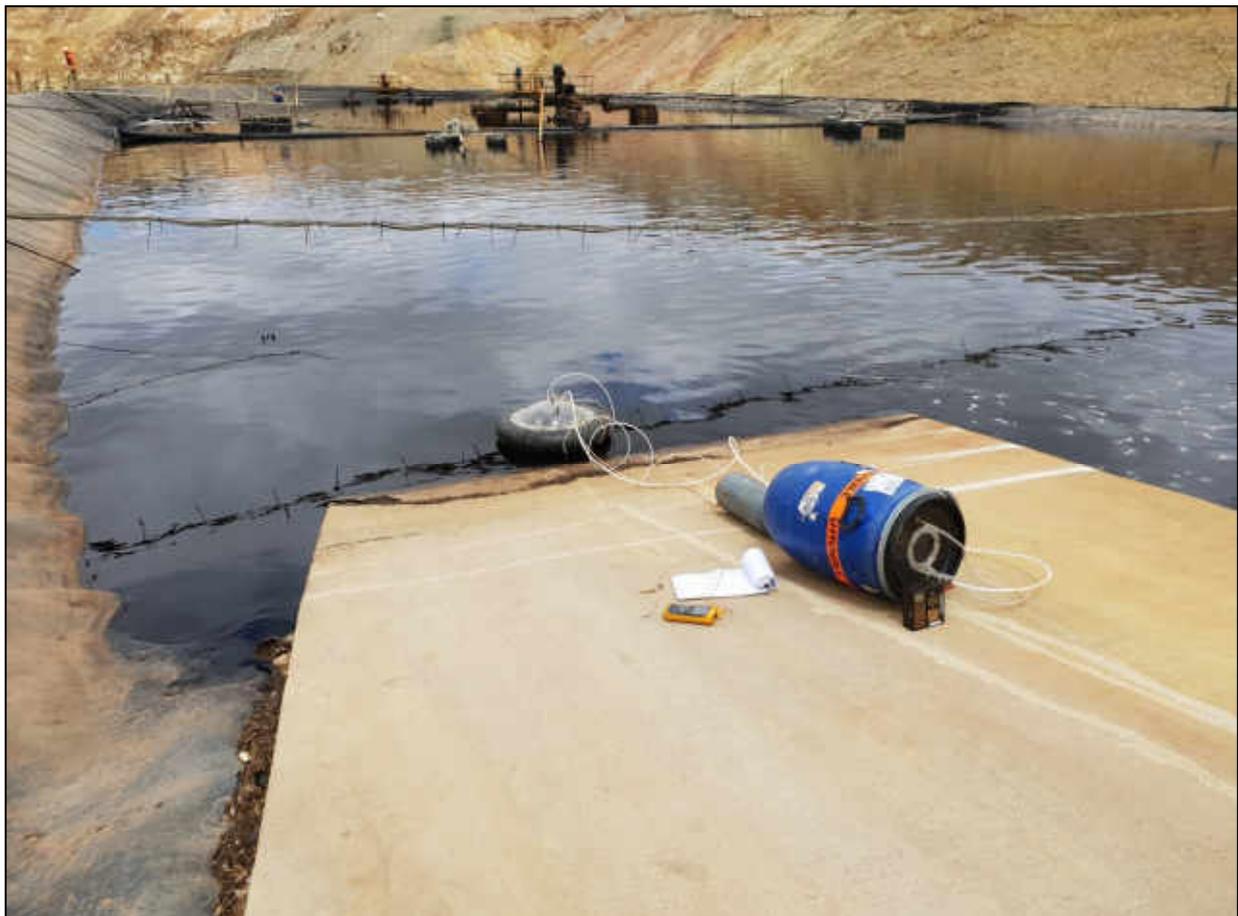
Photo 6.2 – The LTD as found on 21 February 2019

- The LTD was found to be operating under normal operating conditions at the time of the Audit. There are clearly now two treatment zones in the LTD including an anoxic zone and an aerobic zone. Both zones were sampled as part of the Audit;
- The SOER results suggest that the LTD is not a significant odour emission source. This implies that the LTD was operating in optimum conditions at the time of the Audit from an odour viewpoint;
- The mean SOER result derived in the Audit for the LTD is $0.186 \text{ ou.m}^3/\text{m}^2.\text{s}$. This value is well below the EA 2010 SOER value of $3.6 \text{ ou.m}^3/\text{m}^2.\text{s}$ for the LTD and compares well with the previous IOA result of $0.243 \text{ ou.m}^3/\text{m}^2.\text{s}$; and
- Three surface aerators were in active operation at the time of the Audit. **Photo 6.2** shows the LTD as found during the Audit.

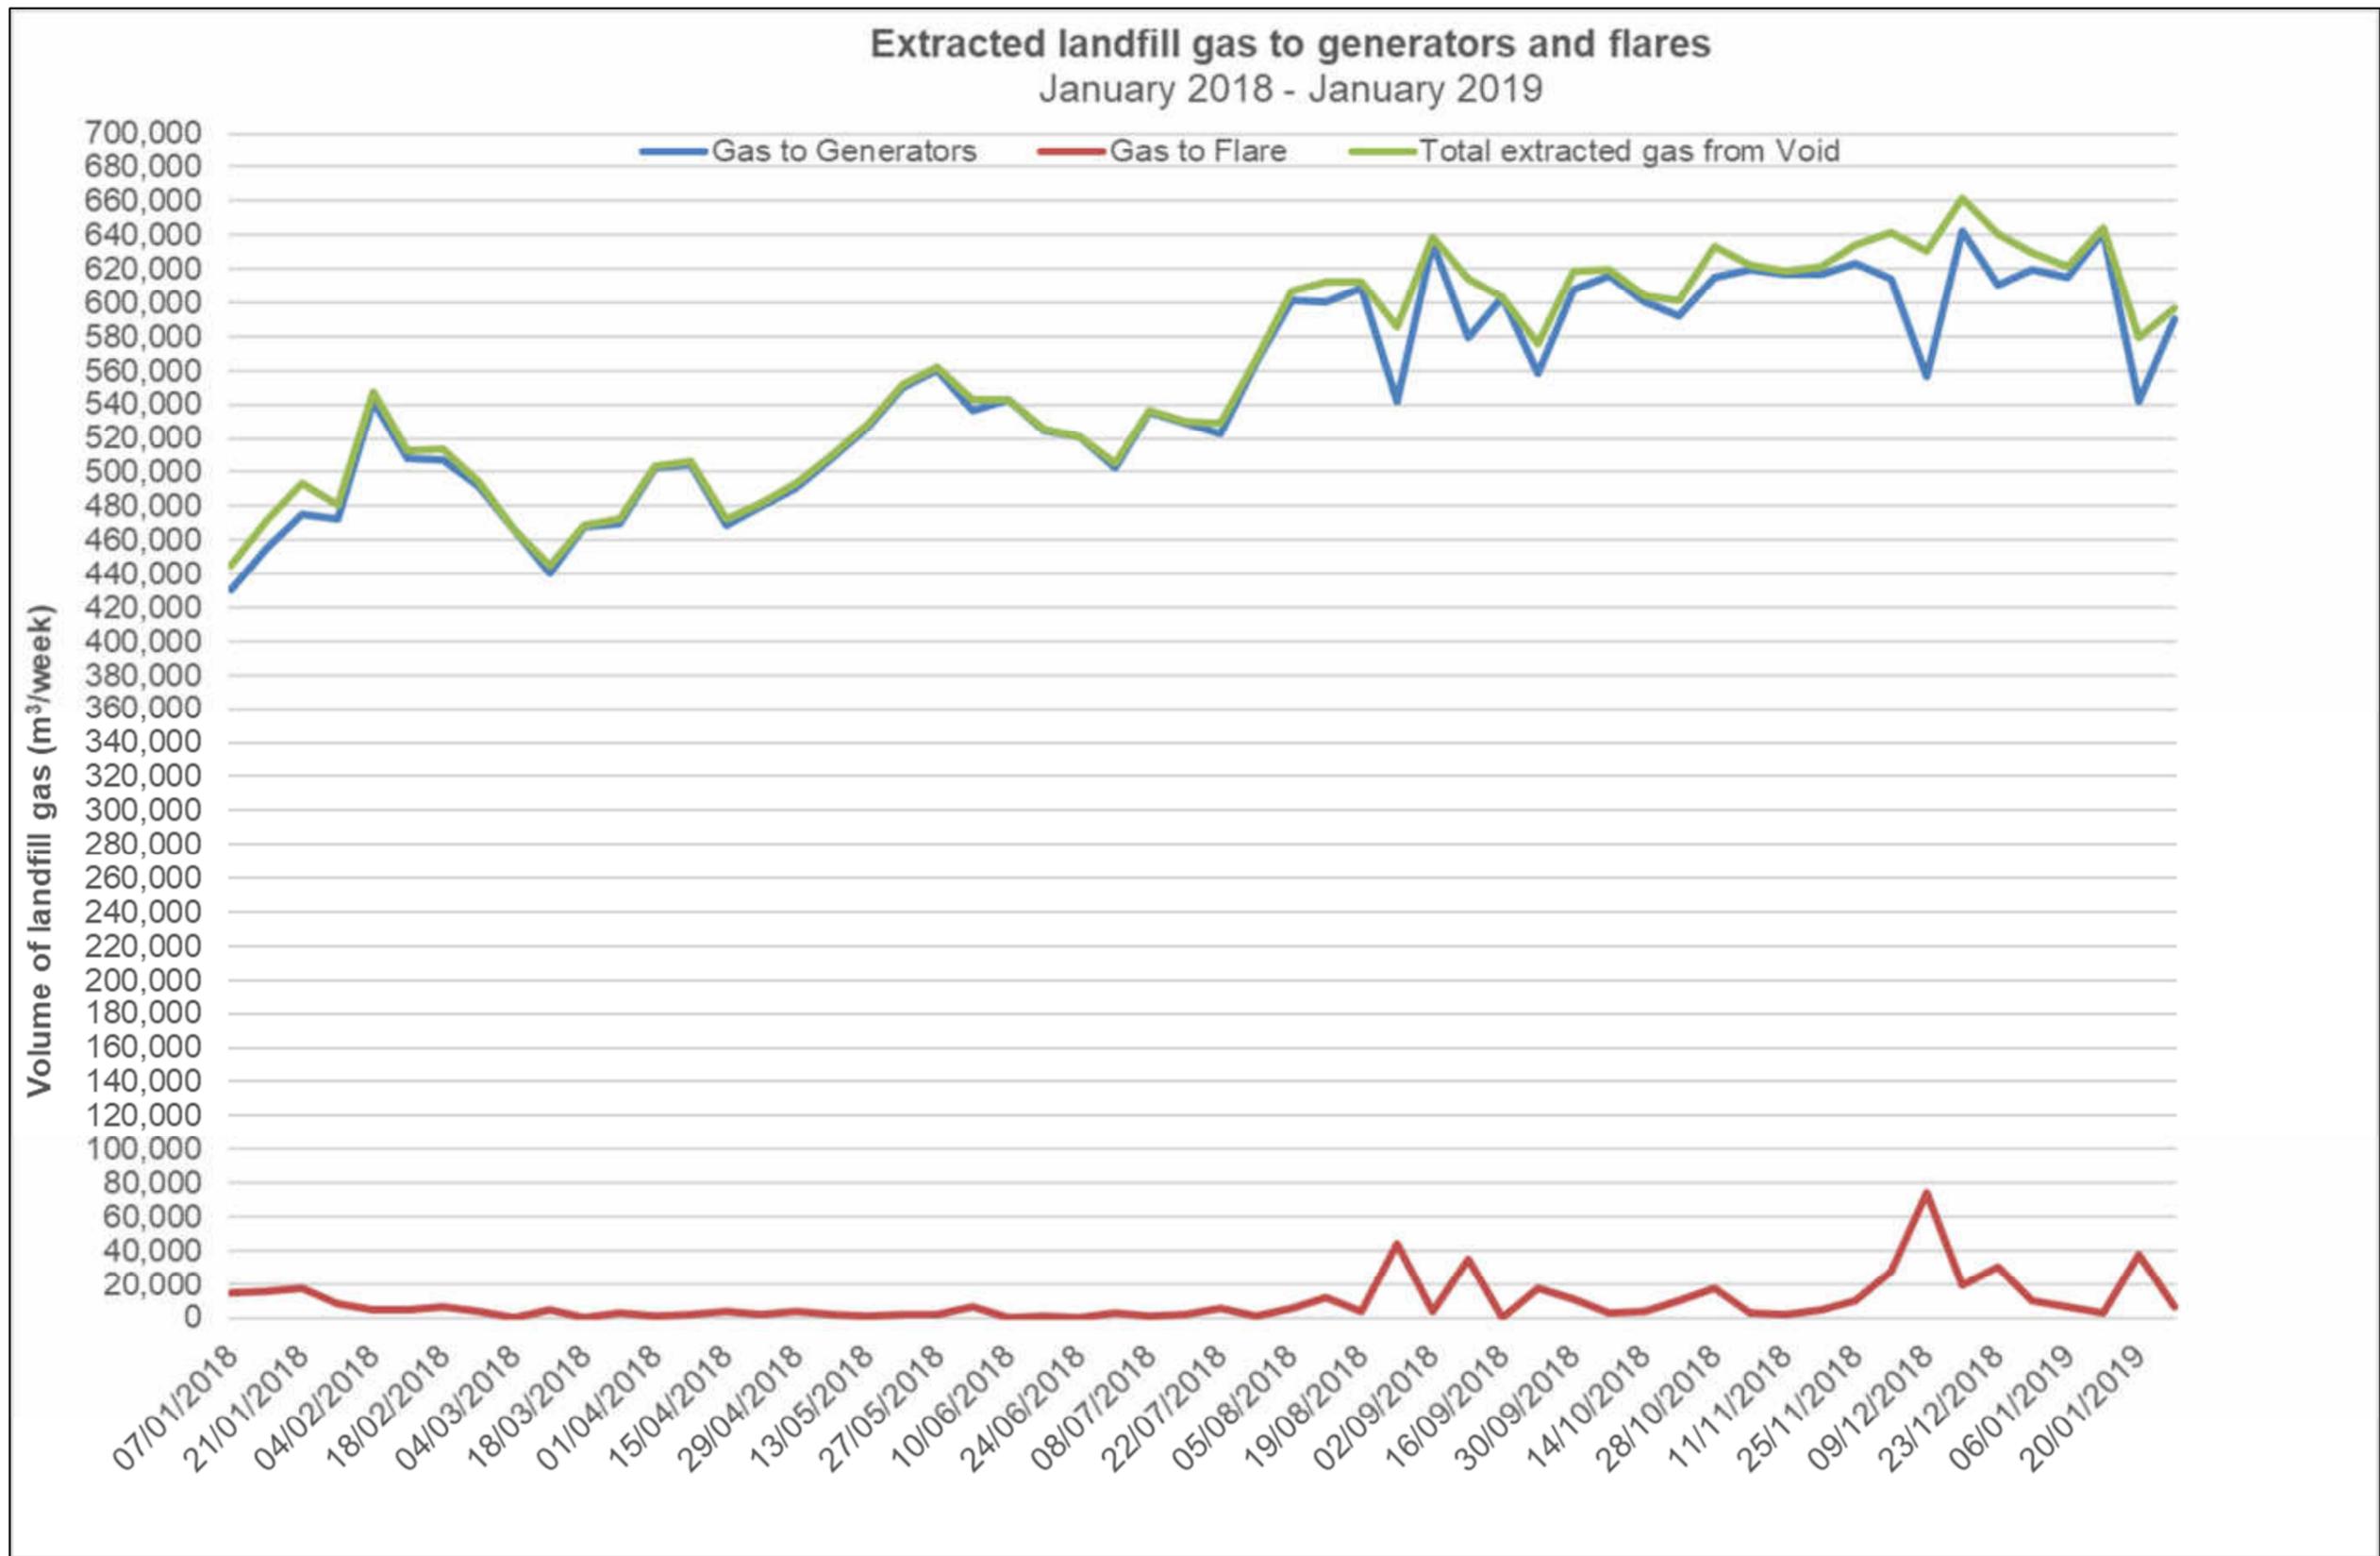
Figure 7.1 – Landfill gas trend between January 2018 and January 2019

- Optimise tipping strategy, as this ultimately affects the efficiency of landfill gas and leachate;
- The connection of more wells/trenches; and
- The implementation of the long-term leachate strategy via the commissioning of the LTP.

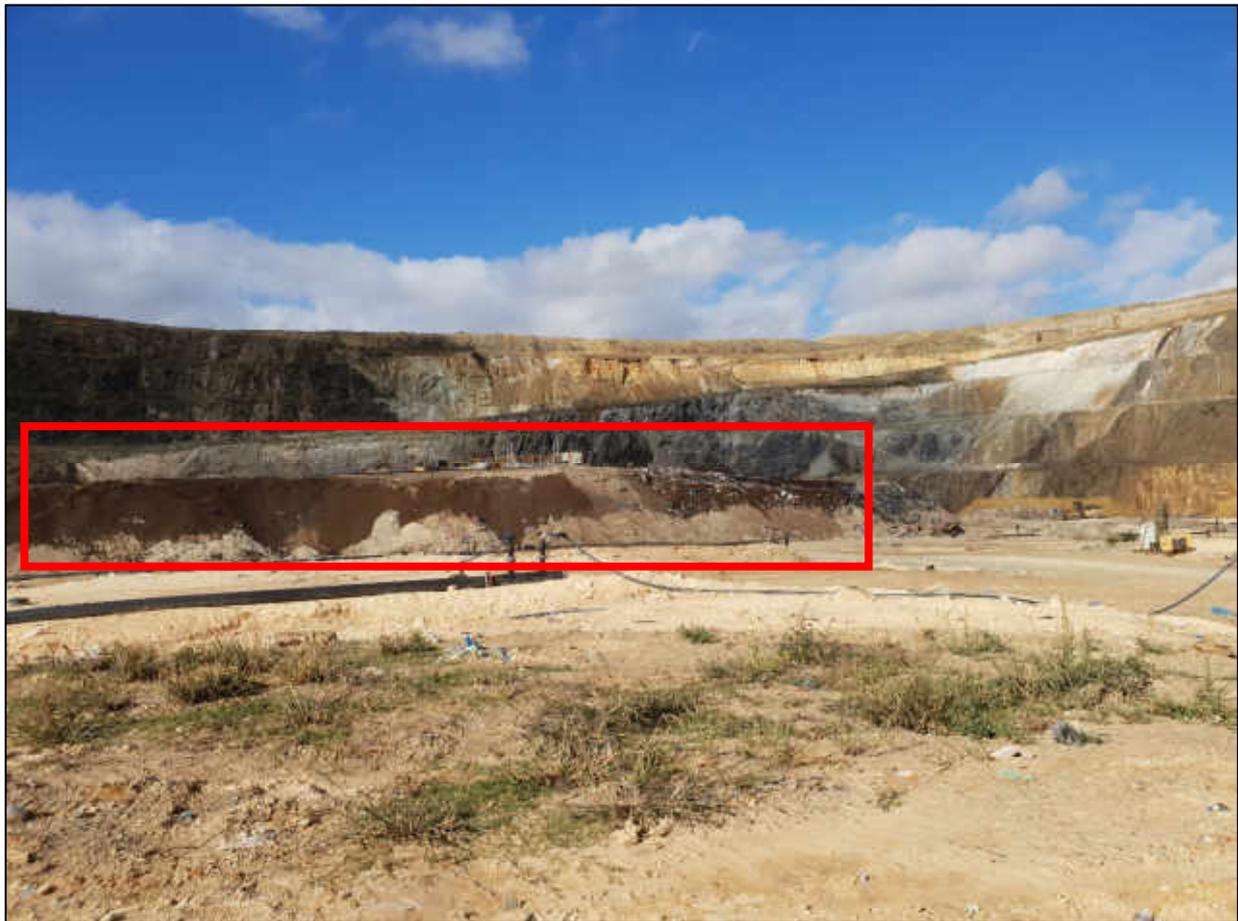
Photo 7.1 – Biofilter cover material applied on the active tipping face batter as occurred on 21 February 2019

An example of the adoption of biofilter cover strategy in the Void is shown in **Photo 7.1**. The Audit endorses its continued use around high-risk areas prone to fugitive gas emission leaks, where required. As can be seen in **Photo 7.1**, the application of biofiltration material on the batter of the active tipping face is intentional and designed to reduce fugitive gas emissions from new waste covered areas. It is understood that this strategy is adopted as the migration of landfill gas under this landform is primarily horizontal due to the compressive forces from compaction and machinery. No quantification of its effectiveness was possible due to safety and access concerns. Notwithstanding this, a field-based olfactory assessment conducted during the Audit visit indicated that this strategy is effective.

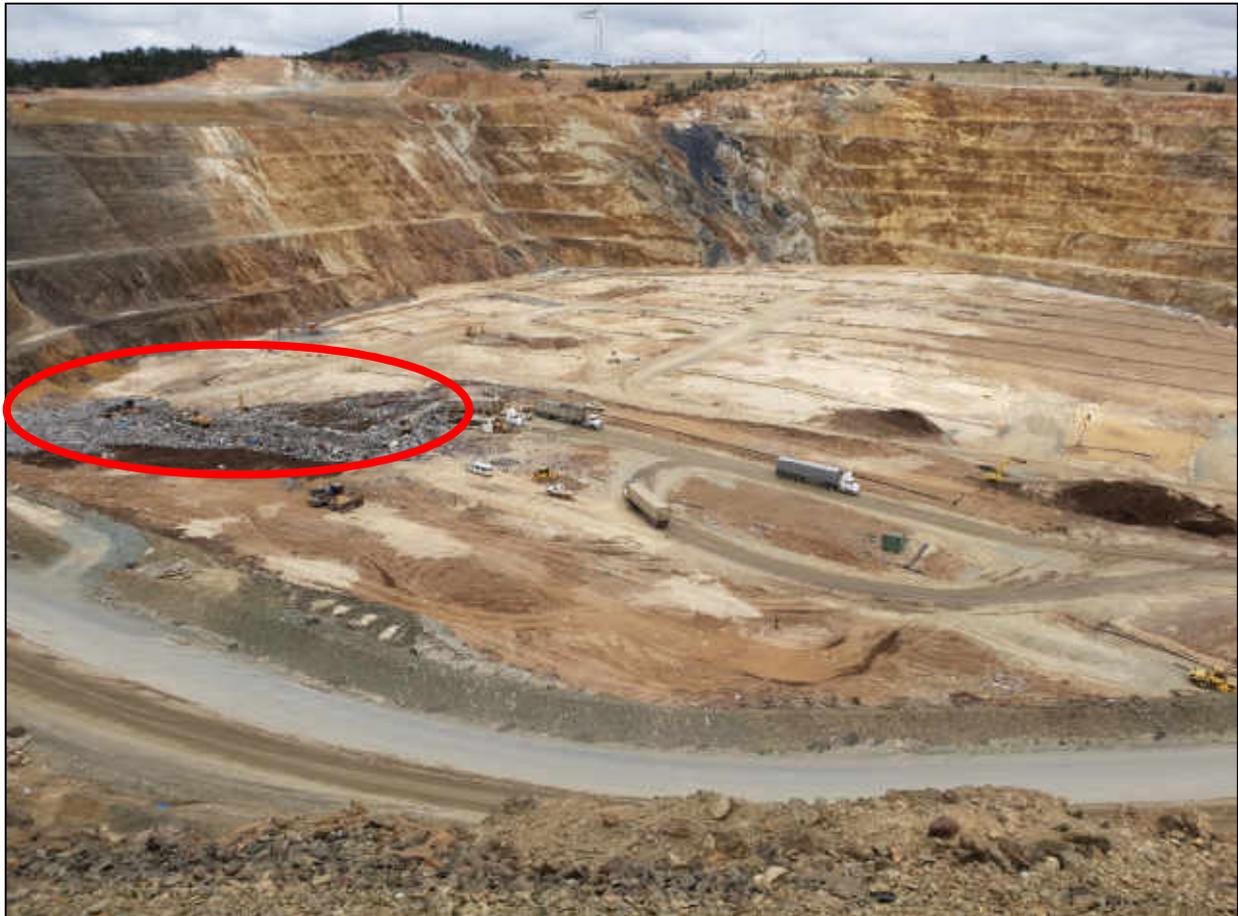
Photo 7.2 - A visual indication of the active tipping face area size as occurred on 21 February 2019

was 40,000 m². This value was later revised to between 4,000 m² and 6,000 m² in the 2013 IOA to reflect realistic and previous operating conditions occurring at the time. As of the Audit, the current active tipping area is now approximately between 1,000 m² and 2,000 m², reflecting Veolia's continued efforts at minimising the active tipping face in the Void.

The SOER value determined during this Audit was approximately 7.6 ou.m³/m².s. This is close to the SOER value used in the EA 2010 modelling of 7.3 ou.m³/m².s. Based on these results and the outcome of the modelling study (see **Section 8**), there is a very low risk that the active tipping face will result in downwind odour impact on the nearest sensitive receptor. Notwithstanding this, it should be noted that:

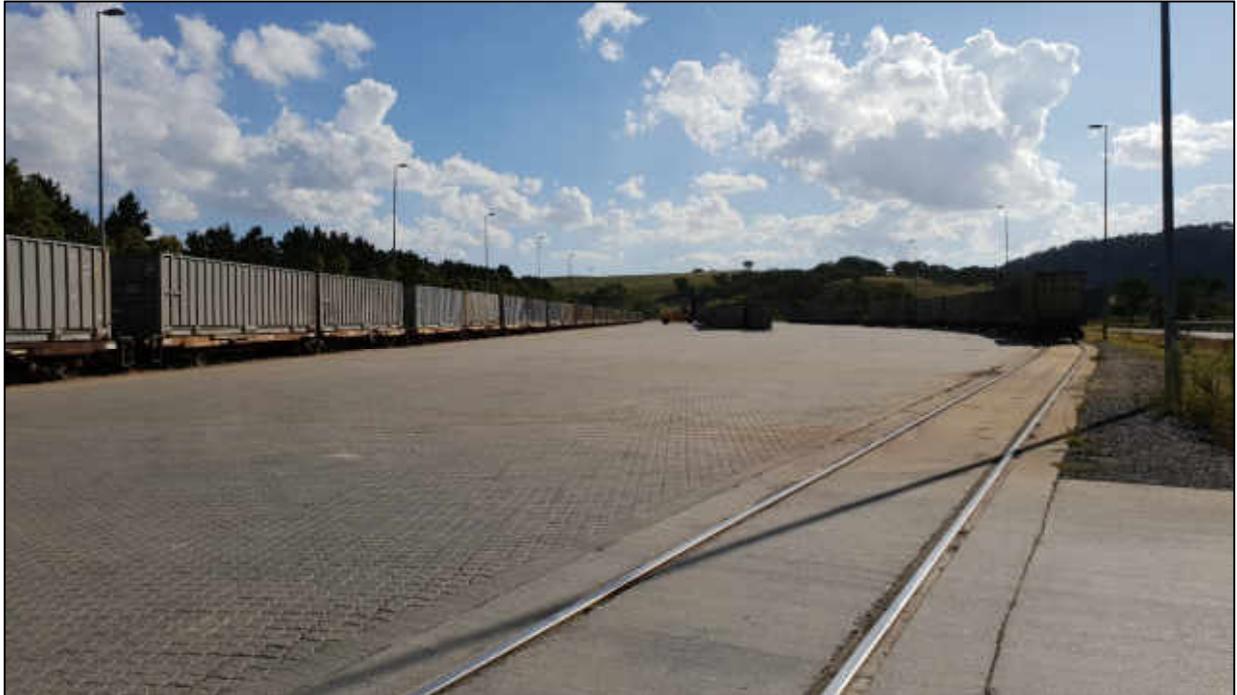
Photo 7.3 - The IMF facing south-west as observed during the Audit inspection visit on 20 February 2019

- The washing practice associated with the sealed containers; and
- The maintenance of the sealed containers.

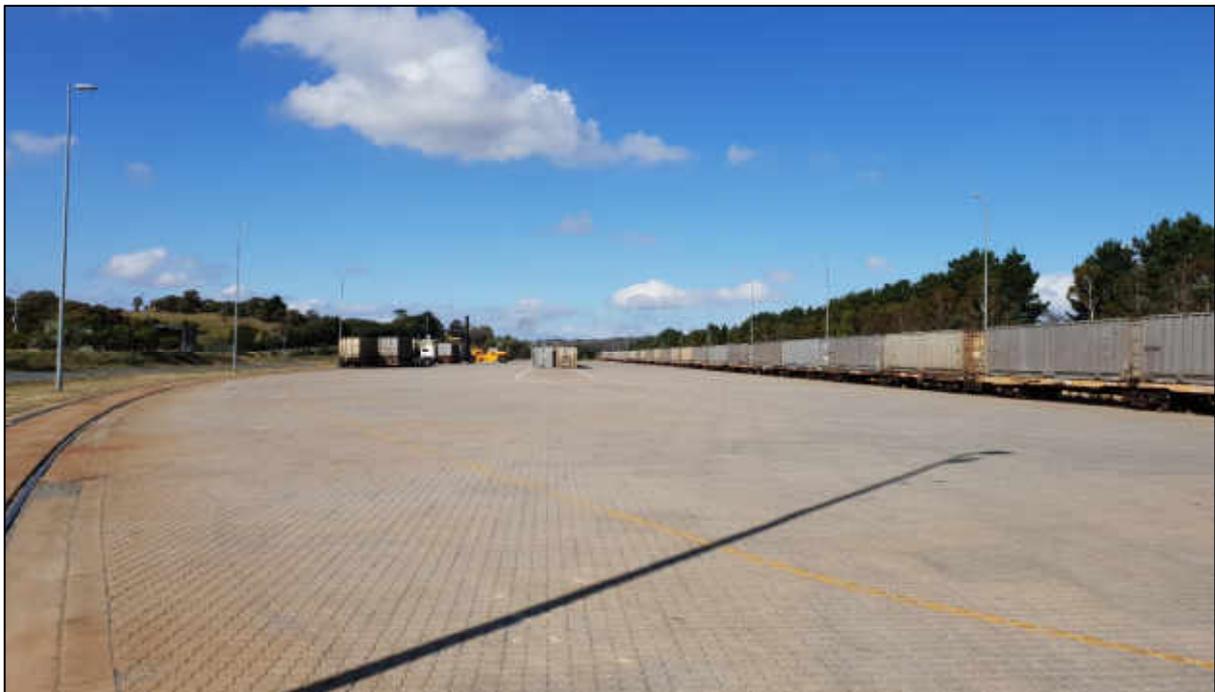
Photo 7.4 - The IMF facing south-east as observed during the Audit inspection visit on 20 February 2019
