Woodlawn Bioreactor Expansion Project

Independent Odour Audit #7

July 2019

Final Report

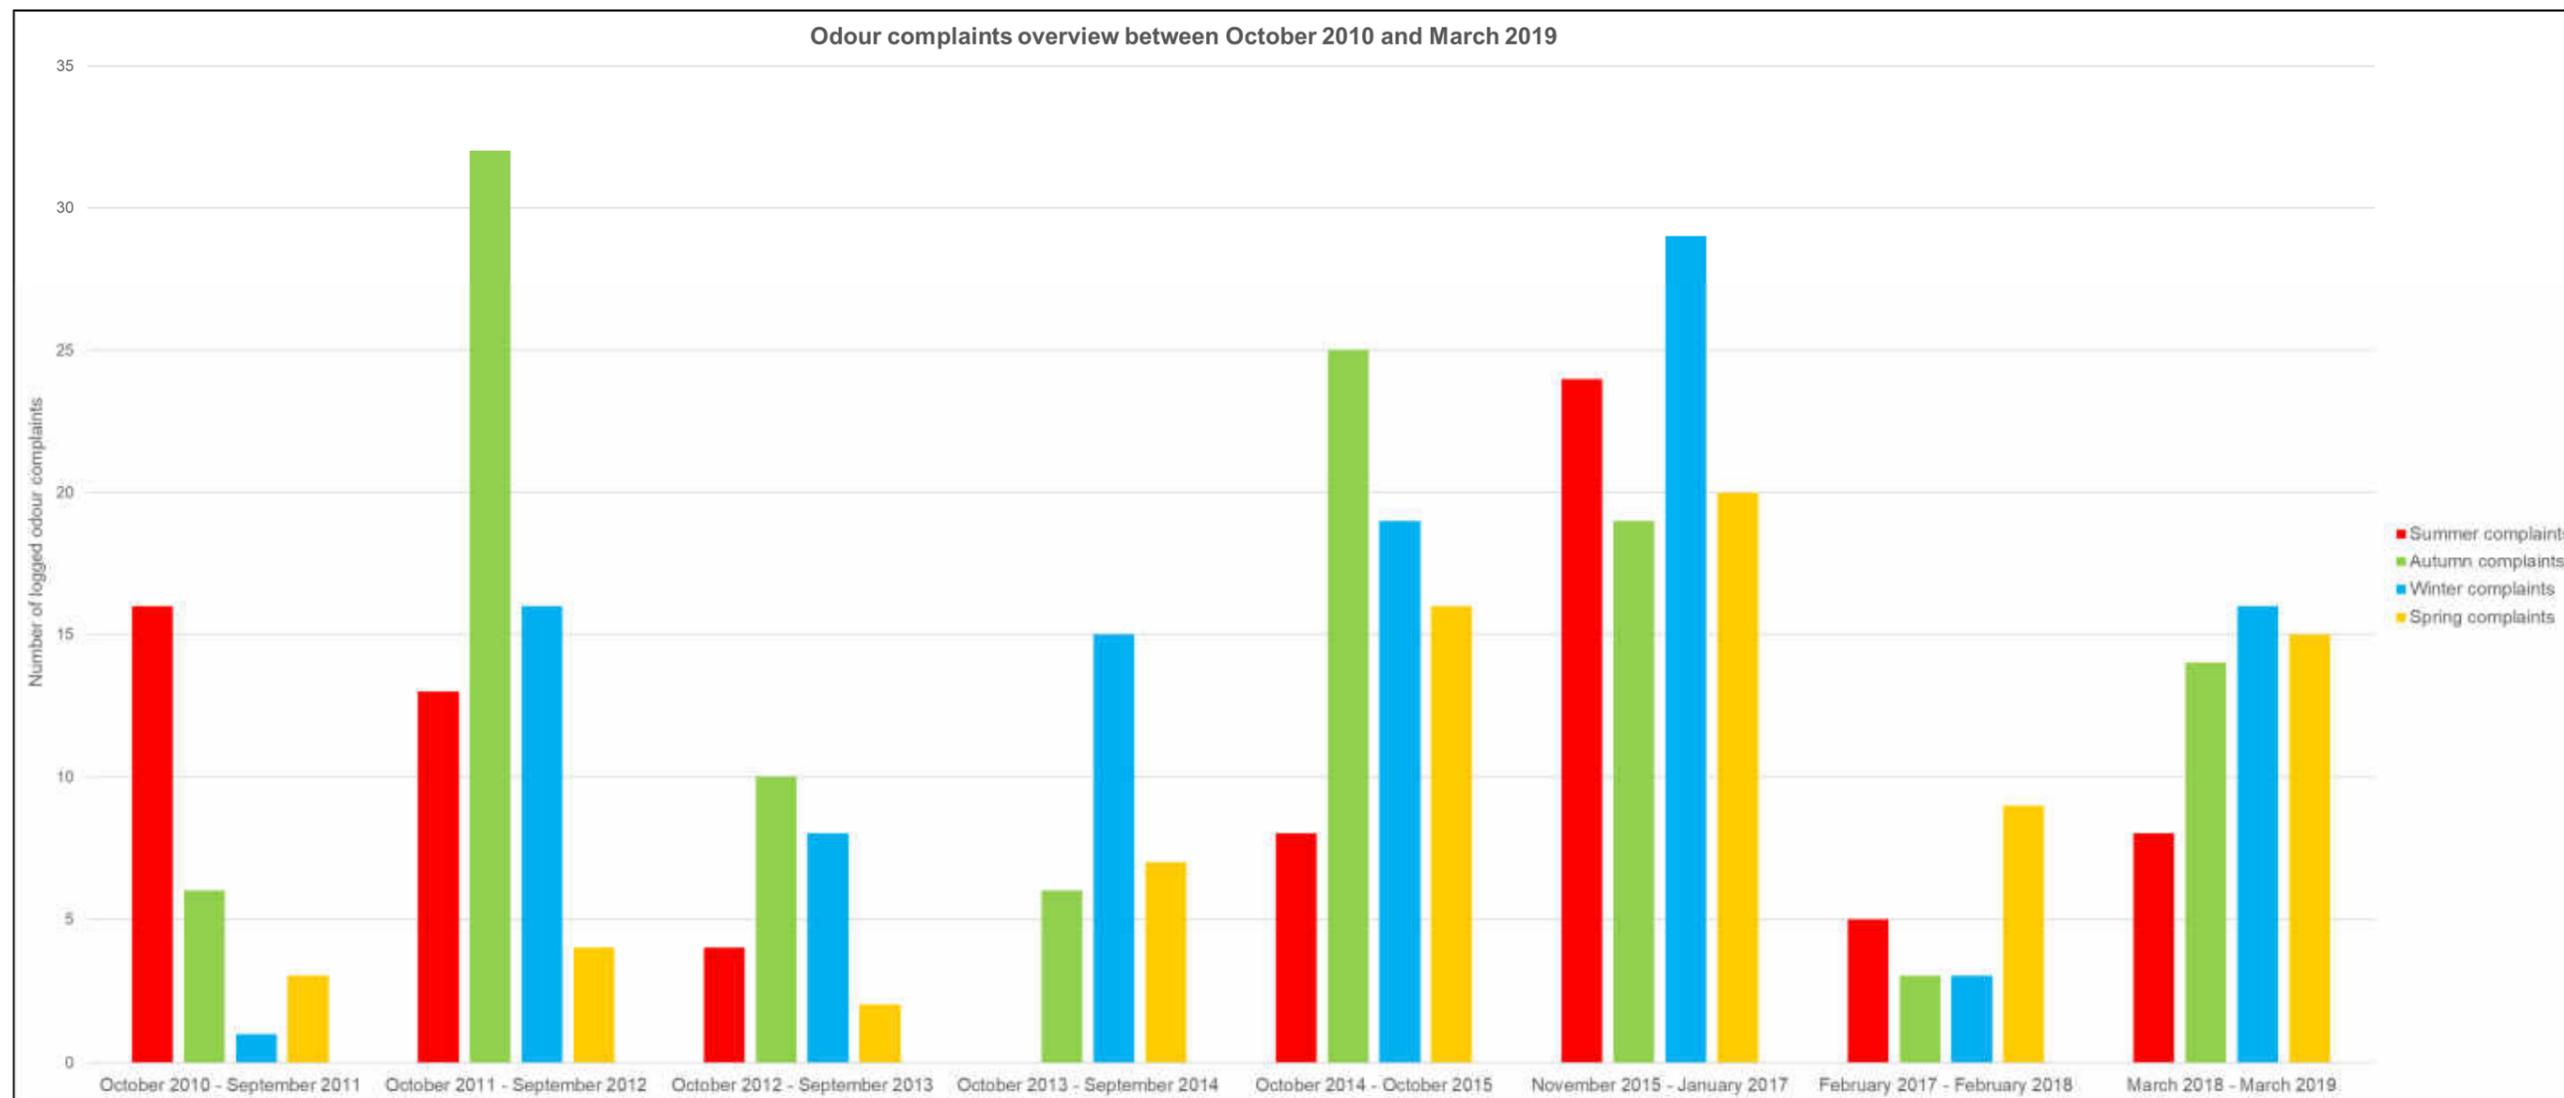
Figure 7.2 - Number of logged odour complaints between October 2010 and March 2019

Given this outcome, the Audit recommends that Veolia continue its active engagement with the community through its existing odour complaints and response management strategy. The handling and management of odour complaints will be reassessed in the next IOA to evaluate the need for additional forms of community engagement, given that the number of complaints remains historically low. As such, the refinement in community engagement remains as a non-mandatory recommendation in the Audit to ensure this matter is provided with the opportunity of continuous improvement (see **Section 9.3.2** for more details).

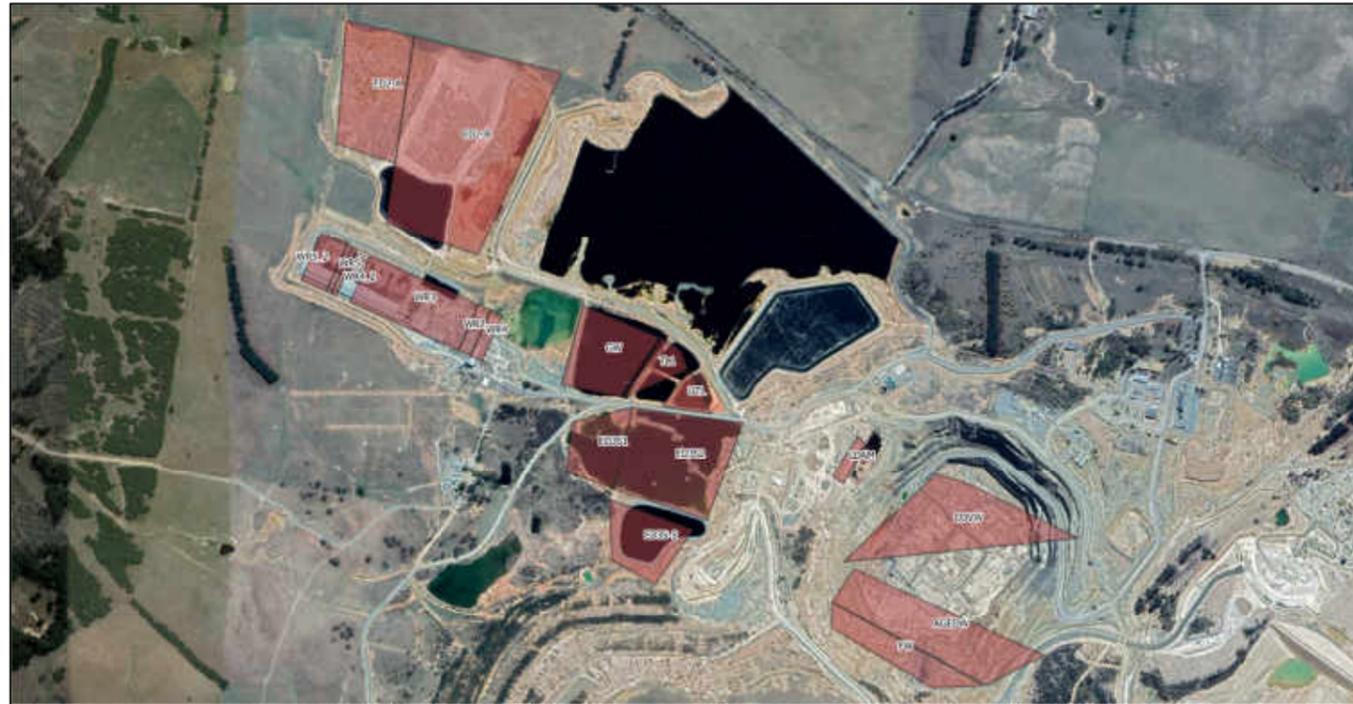
Figure 8.1 – Layout of area sources in the Previous Model

With the use of GIS vector processing tools and field calculator, areas were derived and multiplied by their previously modelled SOER to obtain the OER for each source used in the previous modelling. The results, along with OERs from two volume sources have been collated for the previous modelling and are shown in **Table 8.2**. Included in the table are descriptions of the changes made from the Previous Model to the updated model for the Audit. Current source areas and emission rates used for the Audit are presented in **Table 8.3**.

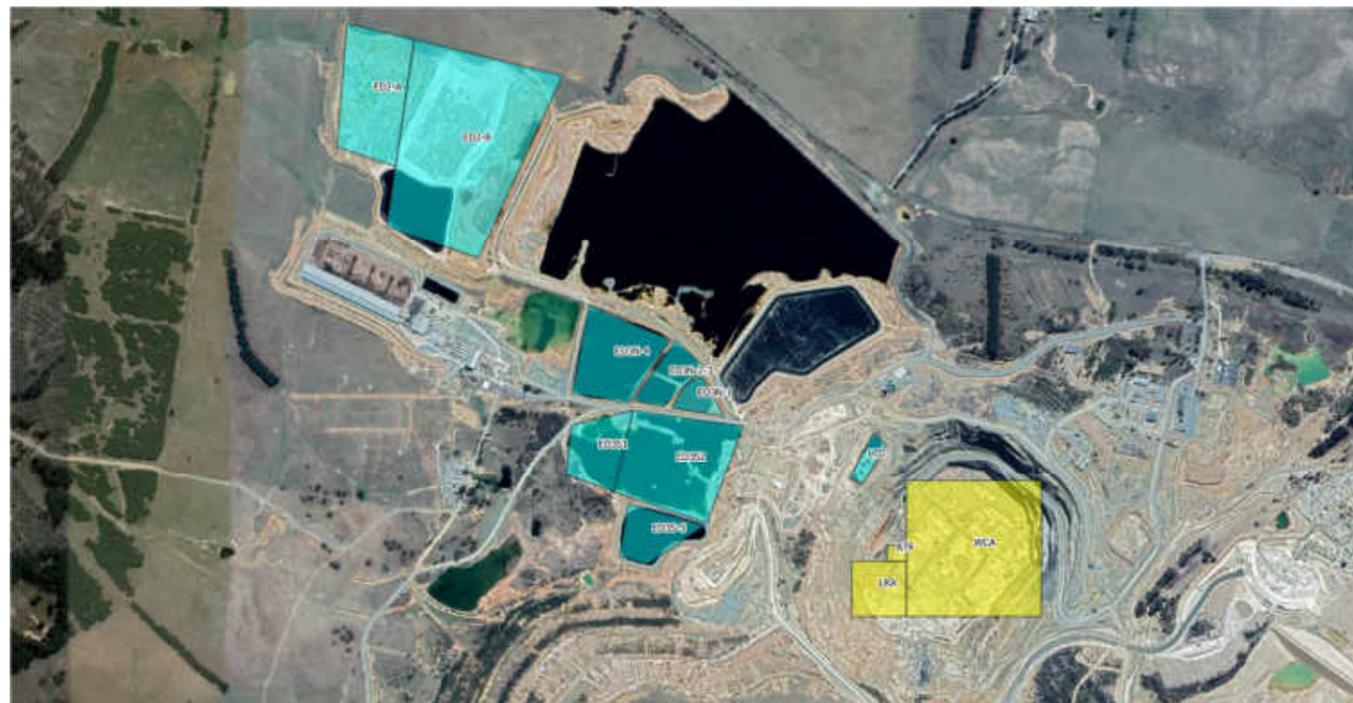
Figure 8.2 – Layout of area sources for the updated model used in the Audit

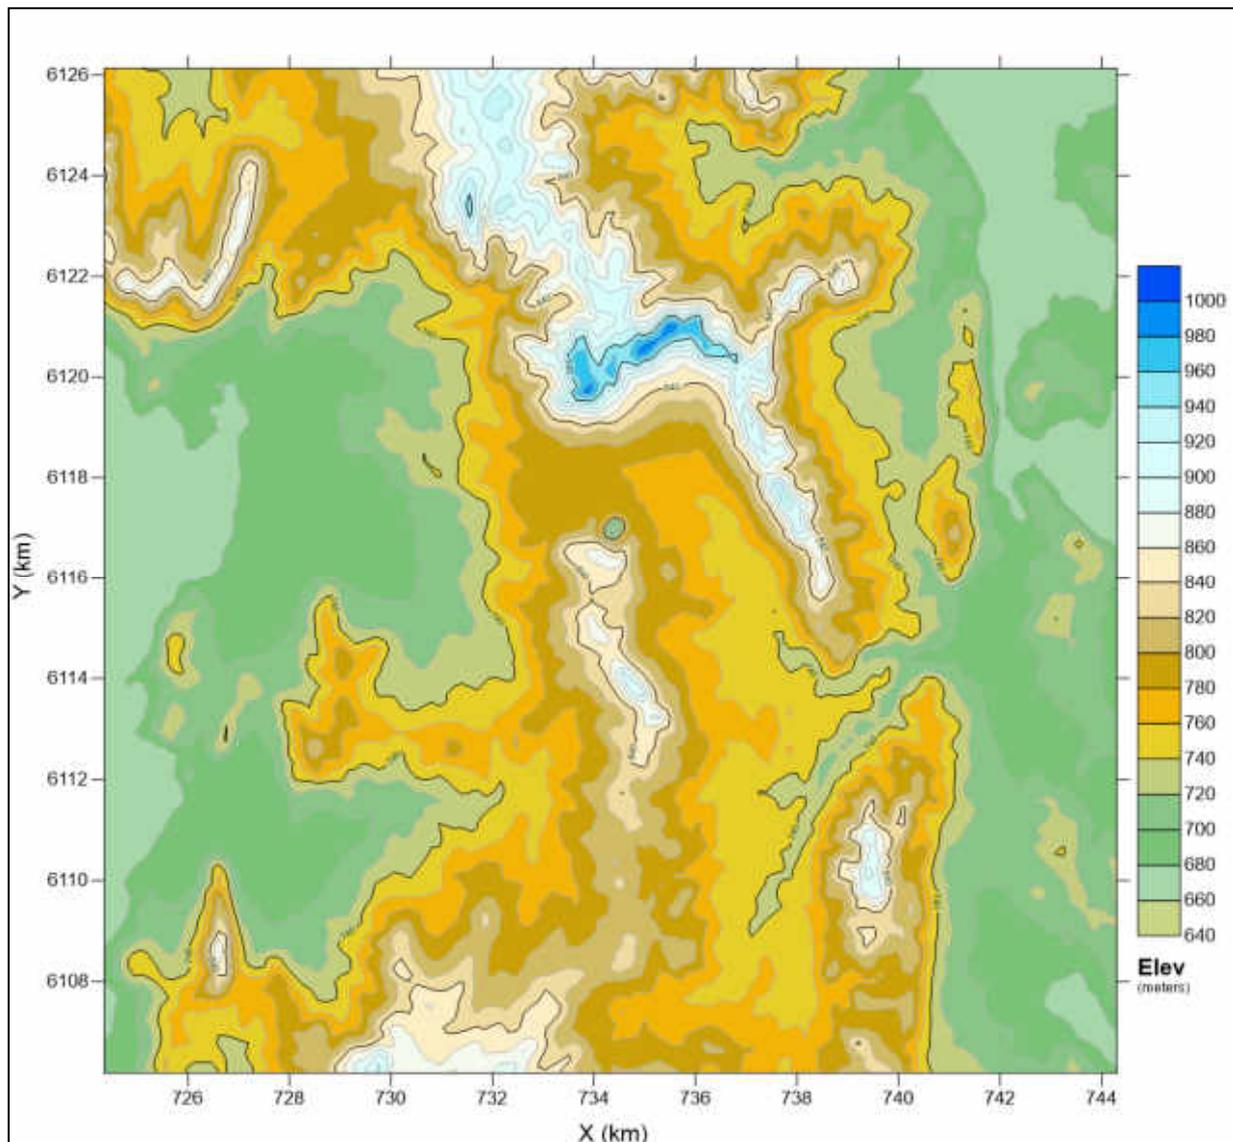
Figure 8.3 – Terrain map of Woodlawn and surrounds

Terrain elevations were sourced from 1 Second Shuttle Radar Topography Mission (**SRTM**) Derived Smoothed Digital Elevation Model (**DEM-S**). The SRTM data was treated with several processes including but not limited to removal of stripes, void filling, tree offset removal and adaptive smoothing. The DEM-S was used as input into TERREL processor to produce 20 kilometres (**km**) by 20 km grid at 0.15 km resolution. A map of the terrain is illustrated in **Figure 8.3**.

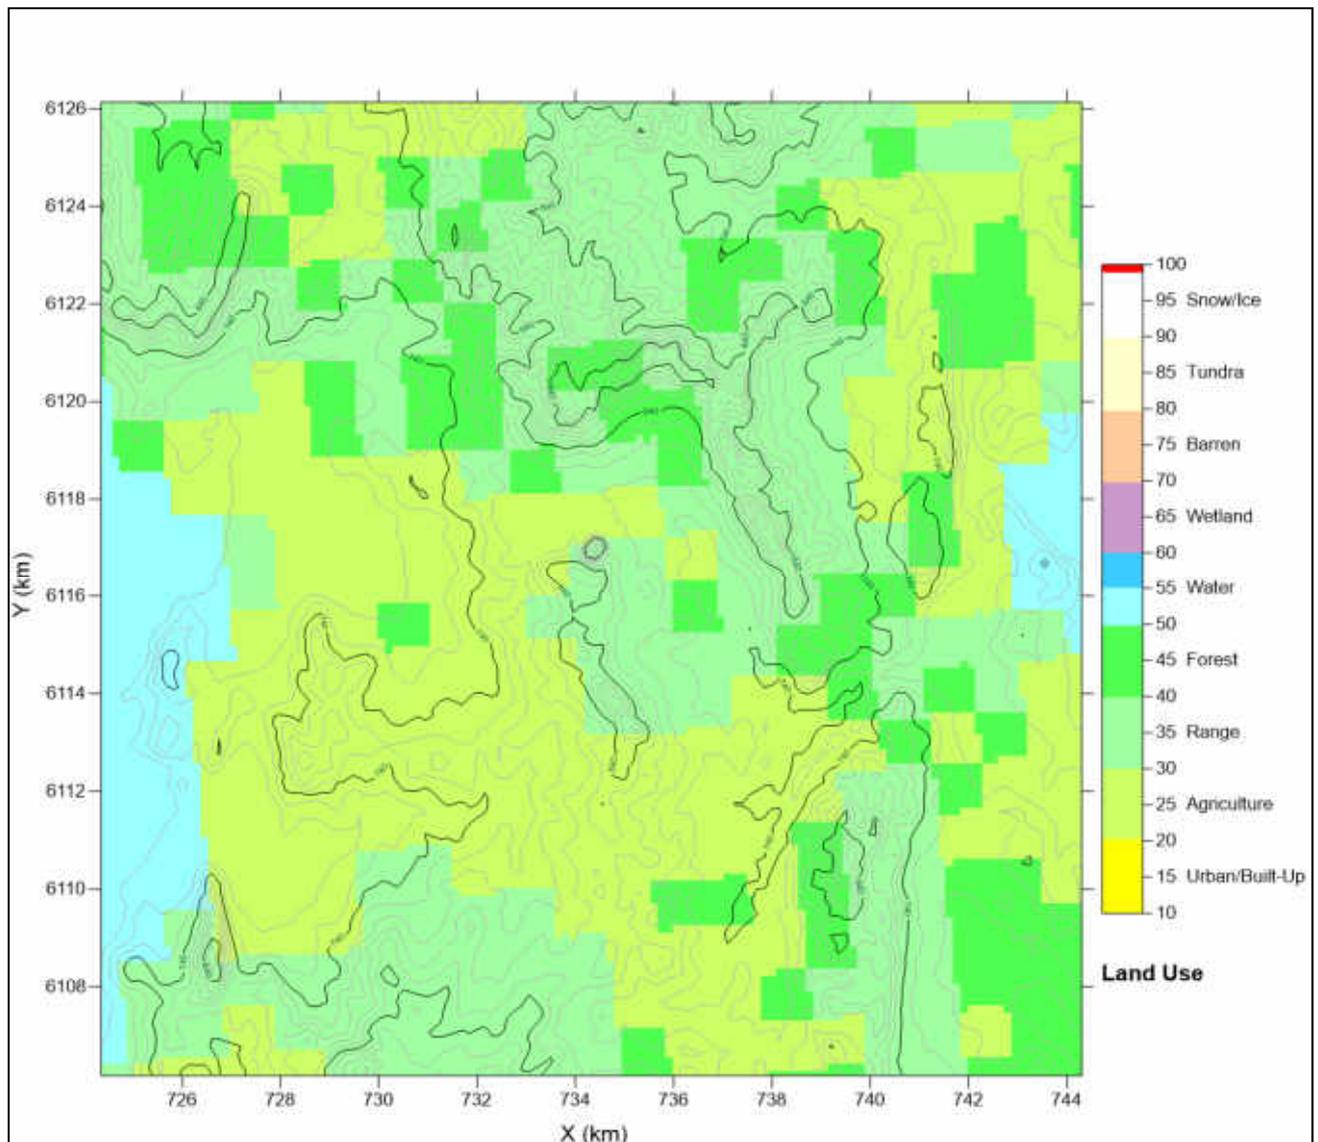
Figure 8.4 – Land use map of Woodlawn and surrounds

The geophysical data file was created using the MAKEGEO processor. Land use data from CTGPROC and terrain data from TERREL was used as input to produce a 20 km by 20 km geophysical grid at 0.15 km resolution.

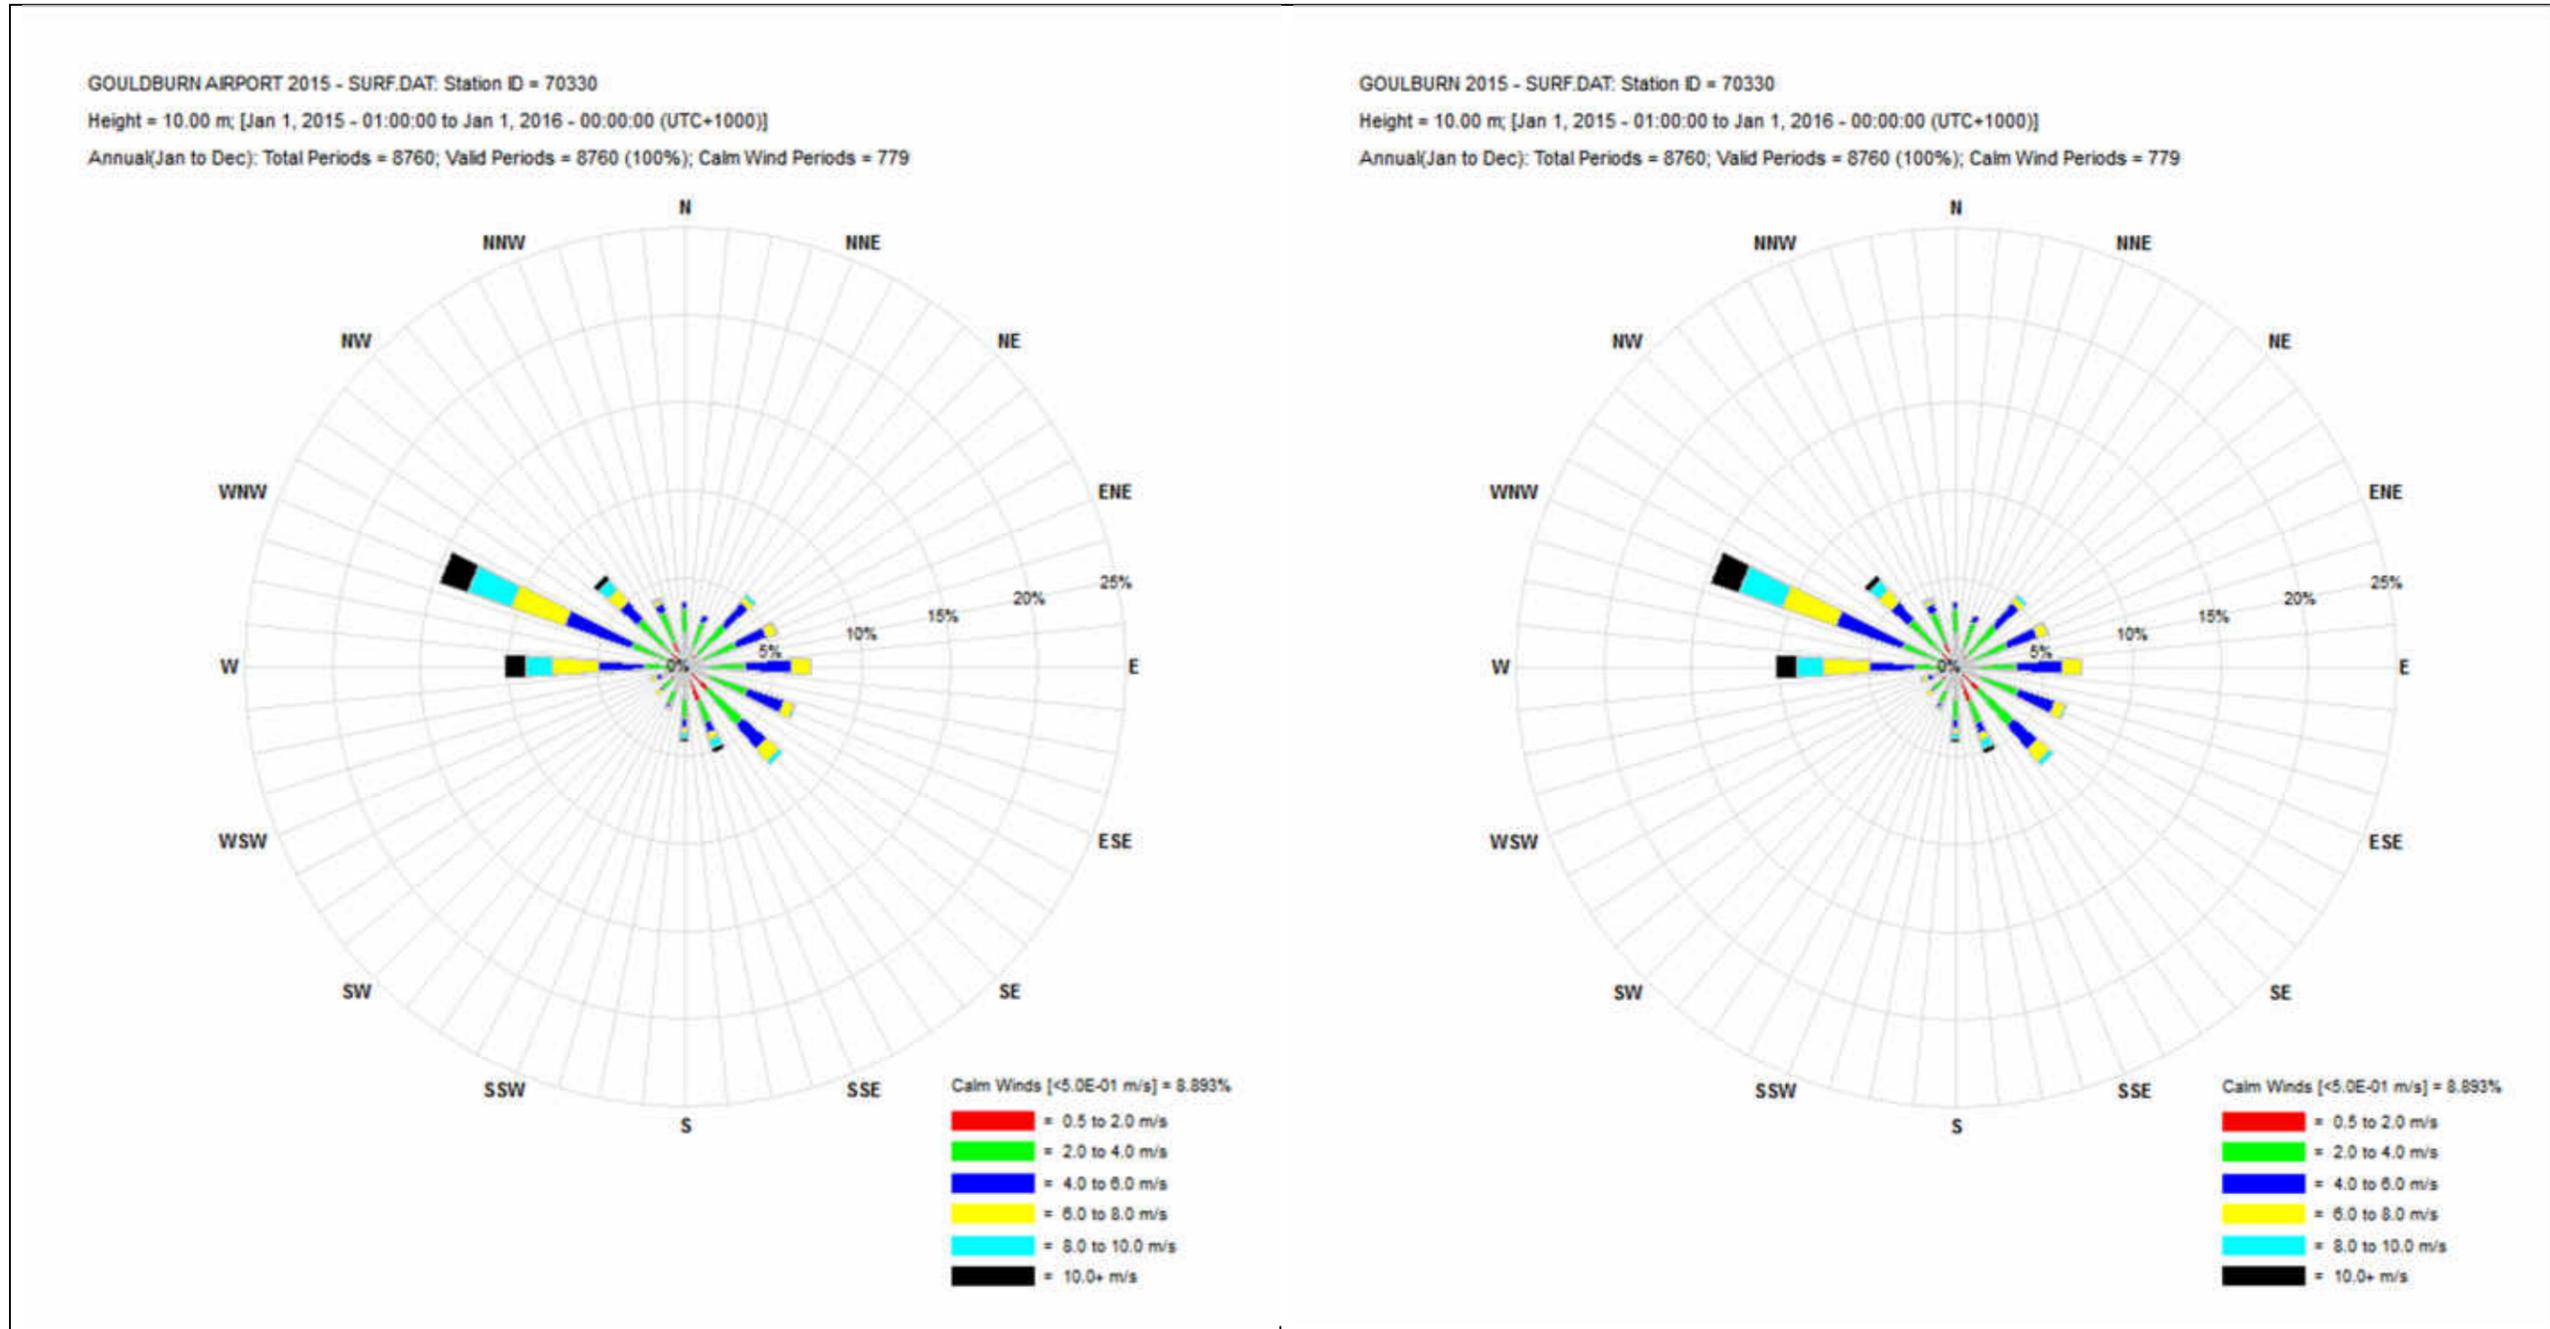
Figure 8.5 – Annual windroses for Goulburn Airport 5 years and 2015 only

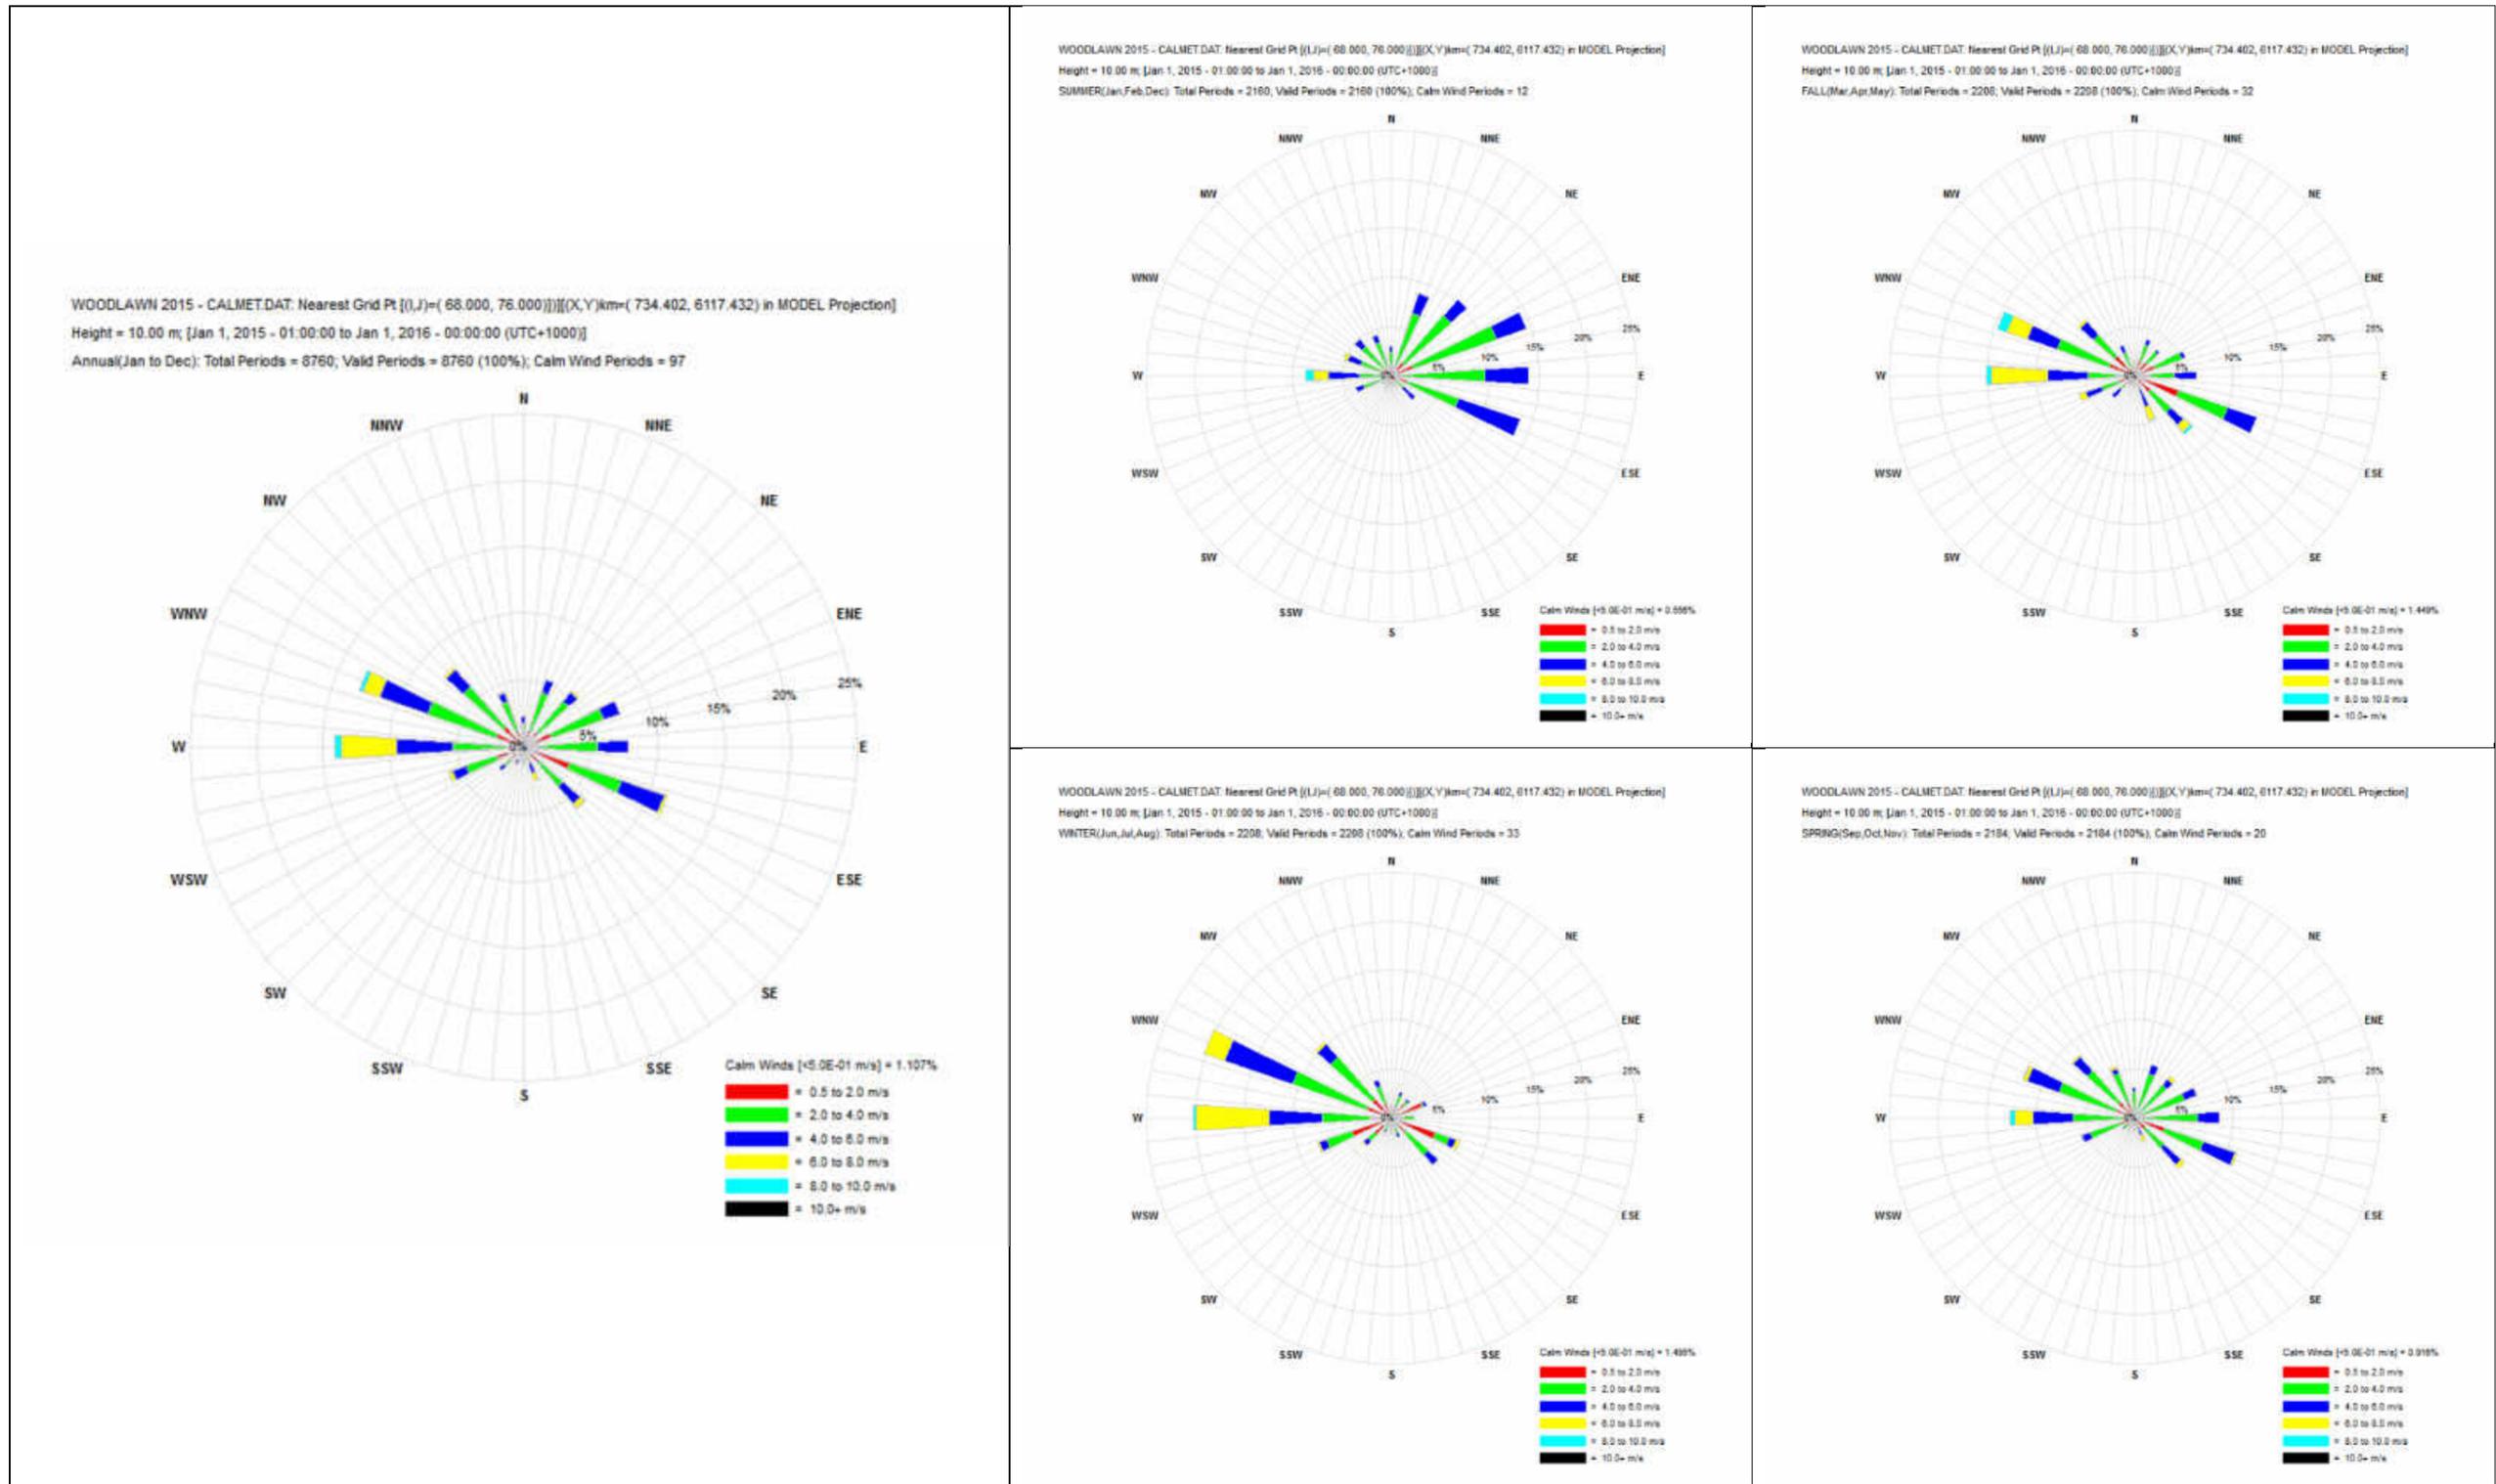
Figure 8.6 – Annual and seasonal windroses for Woodlawn 2015 (modelled)

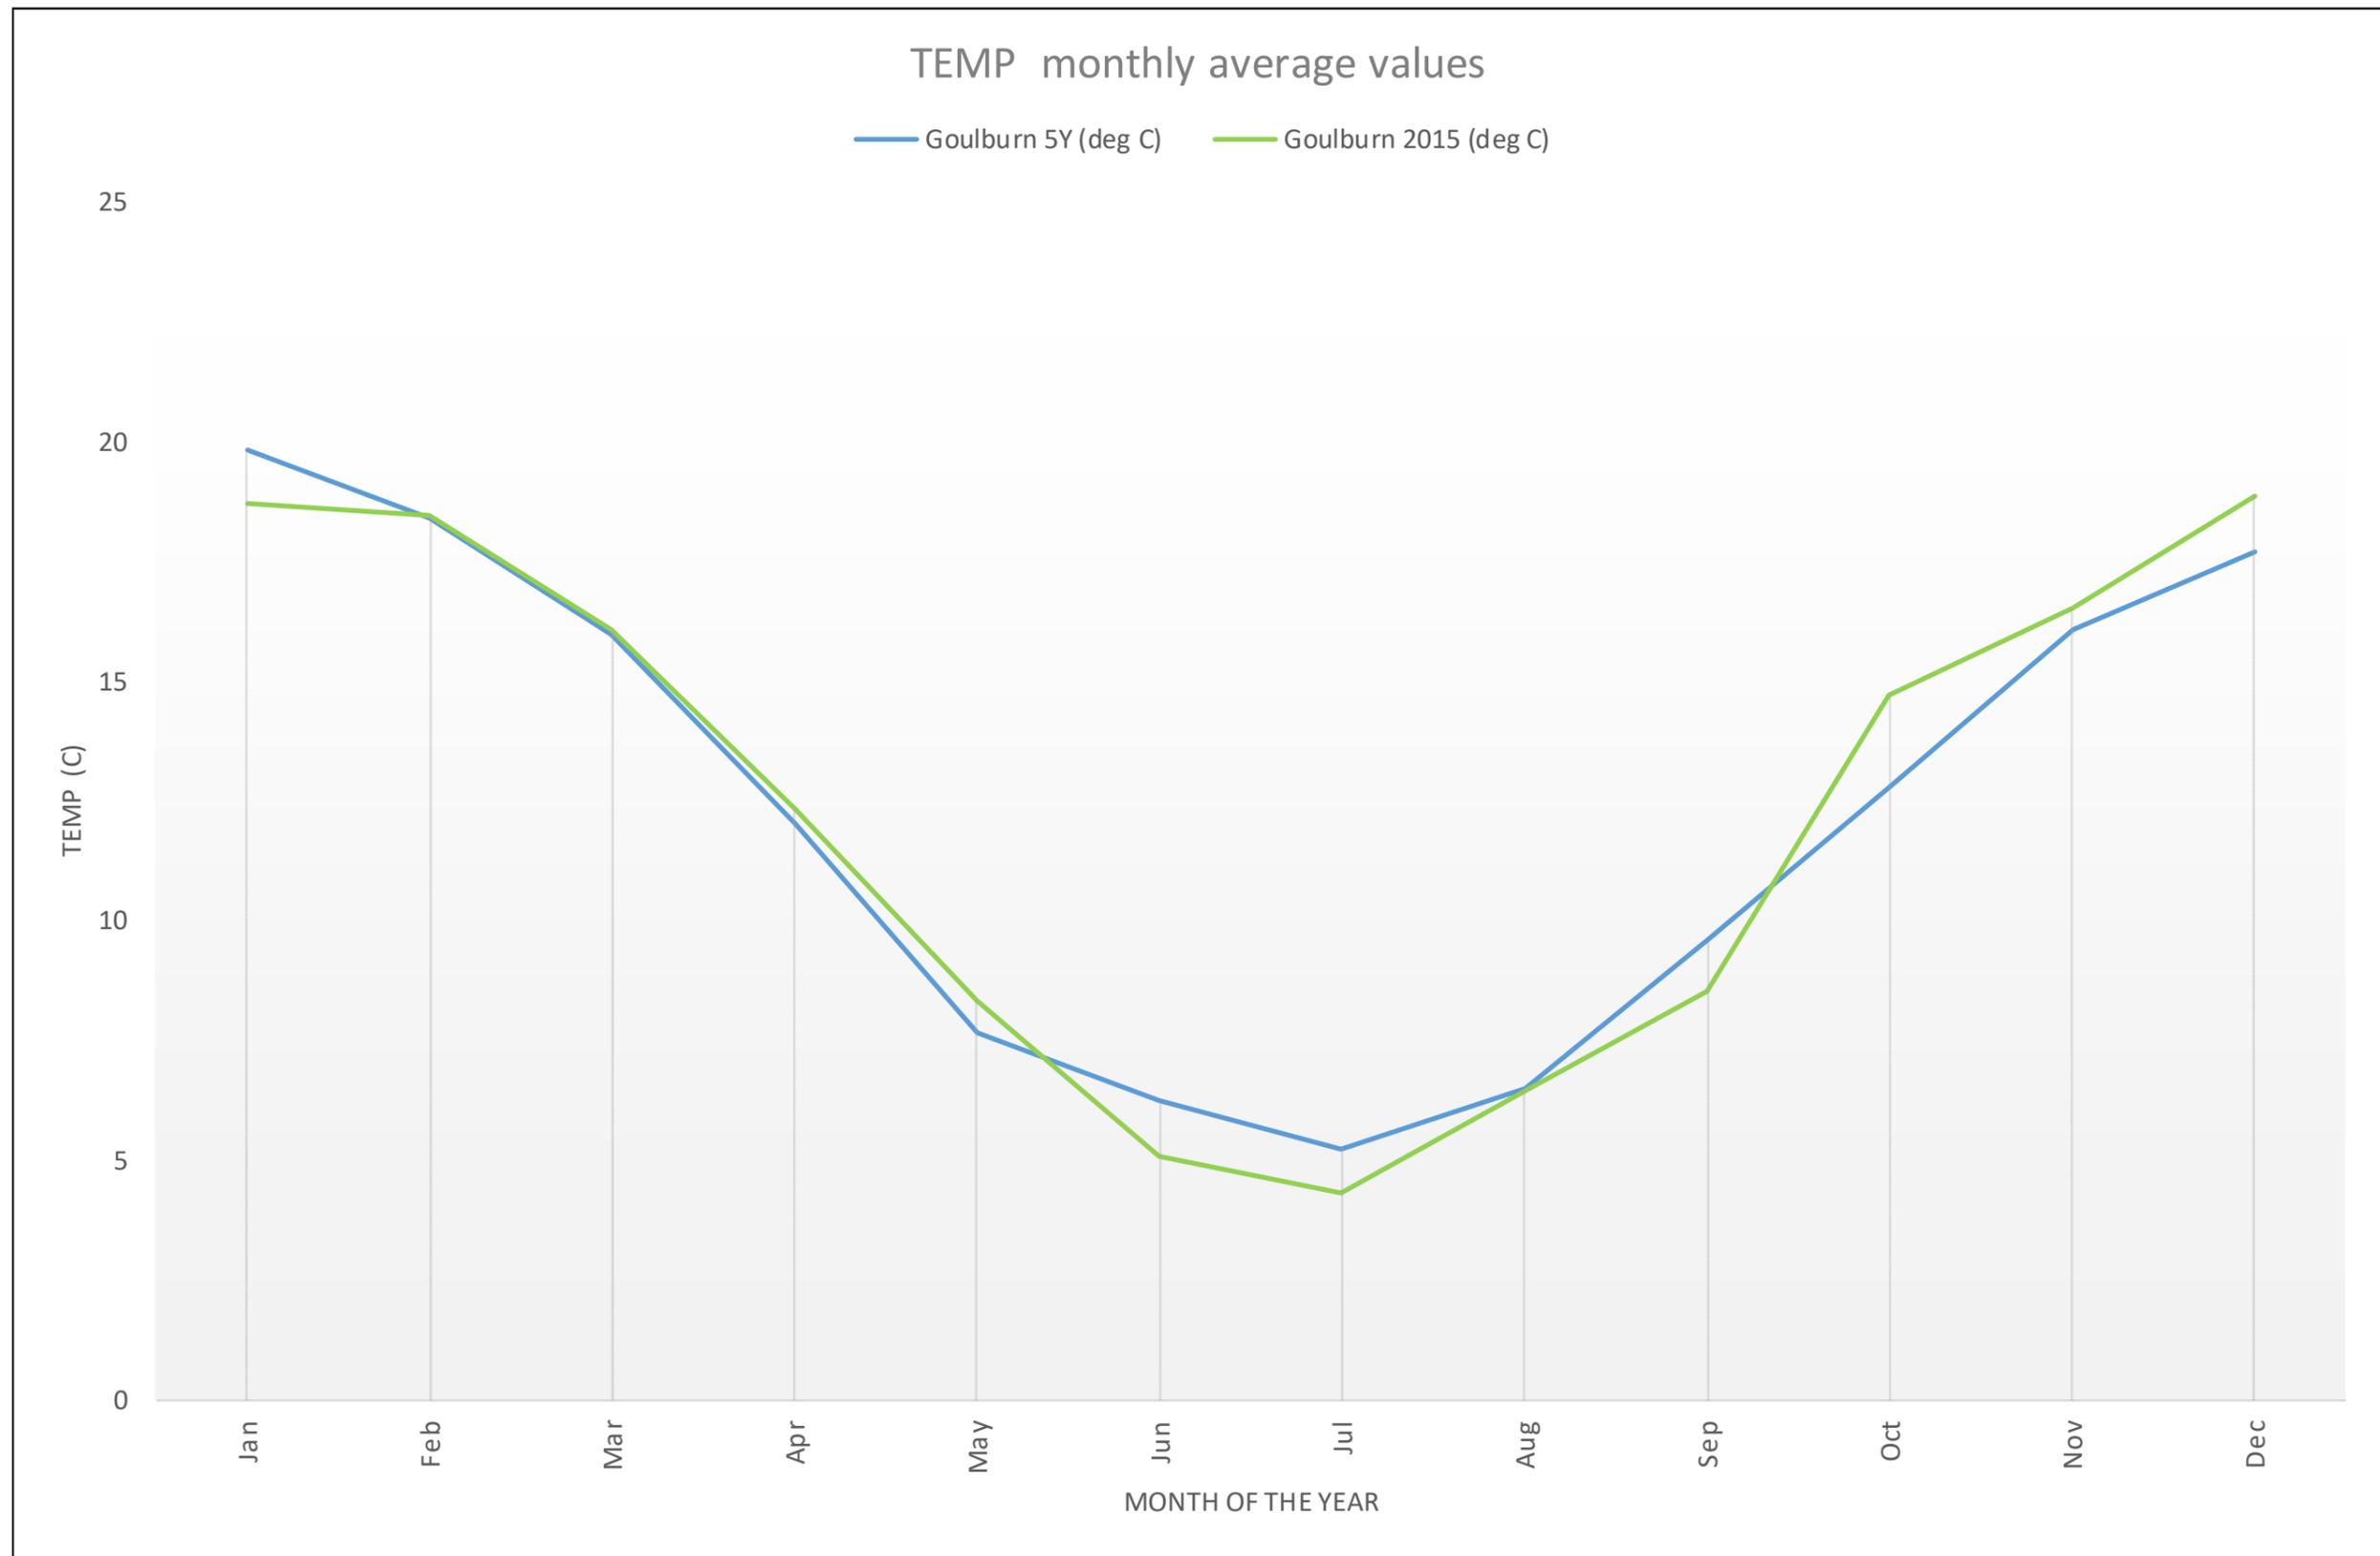
Figure 8.7 – Monthly average temperatures for Goulburn Airport 5 years and 2015 only

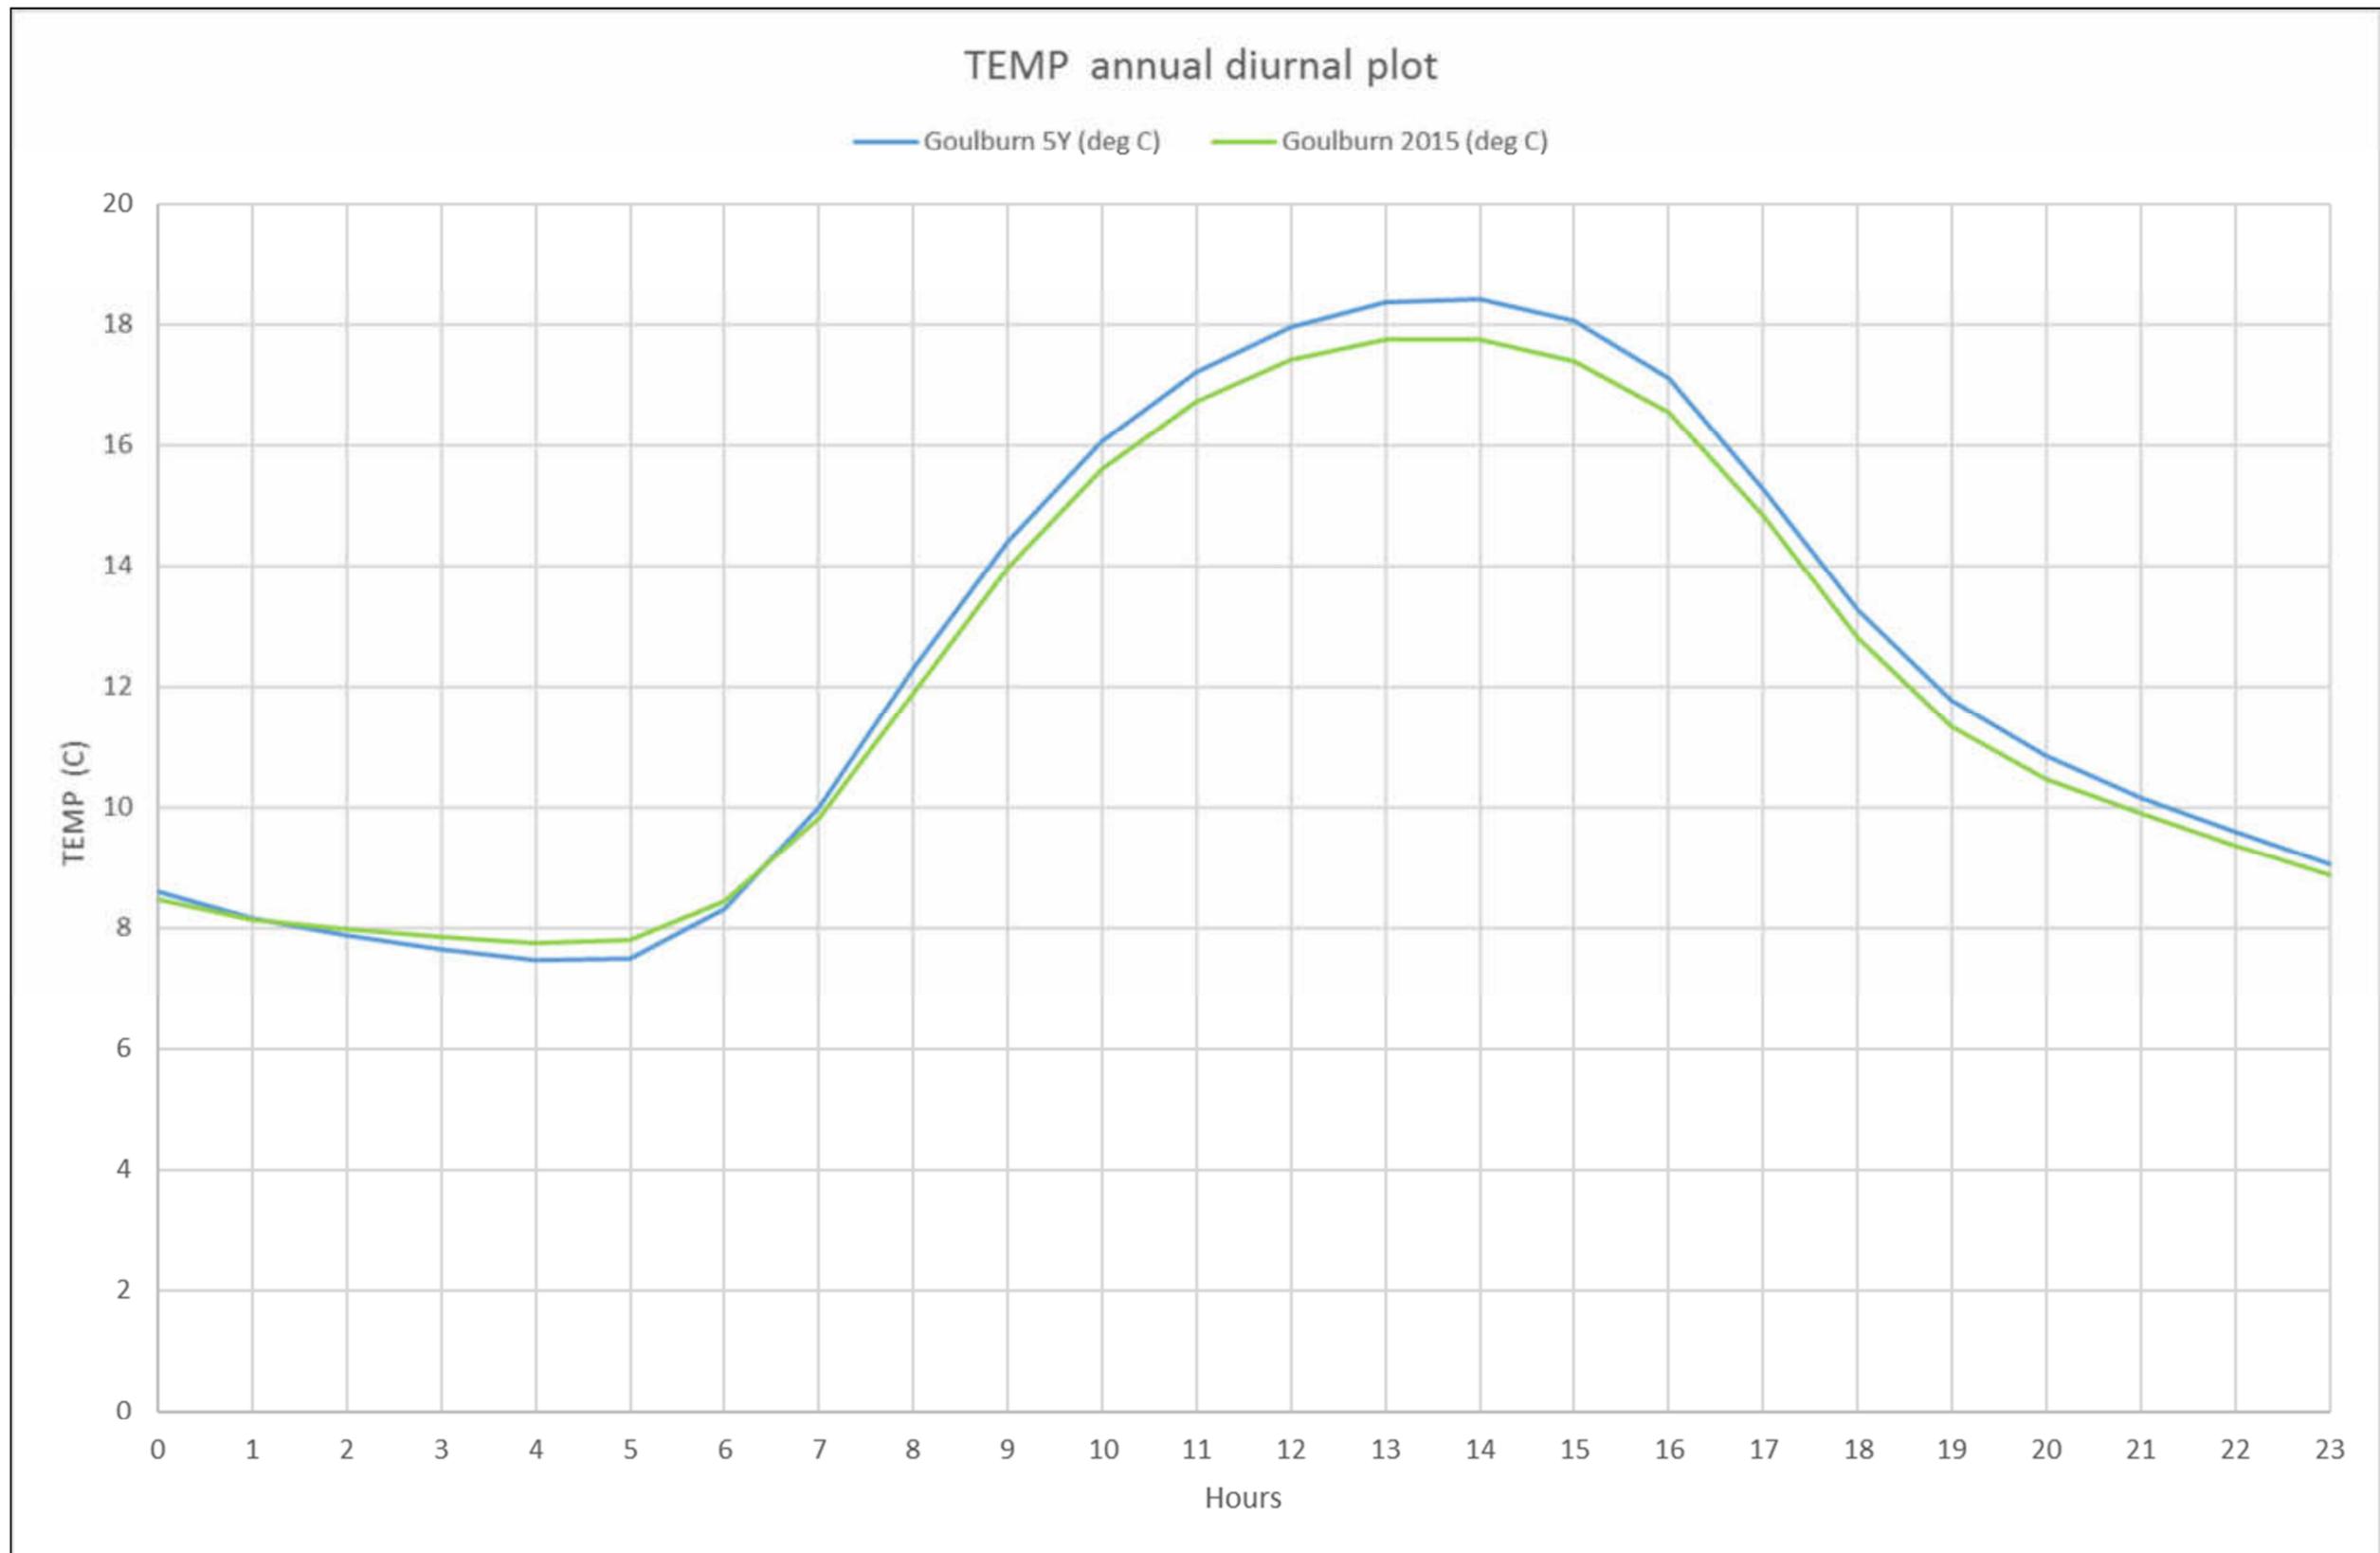
Figure 8.8 – Annual diurnal temperature for Goulburn Airport 5 years and 2015 only
