Woodlawn Bioreactor Expansion Project

Independent Odour Audit #7

July 2019

Final Report

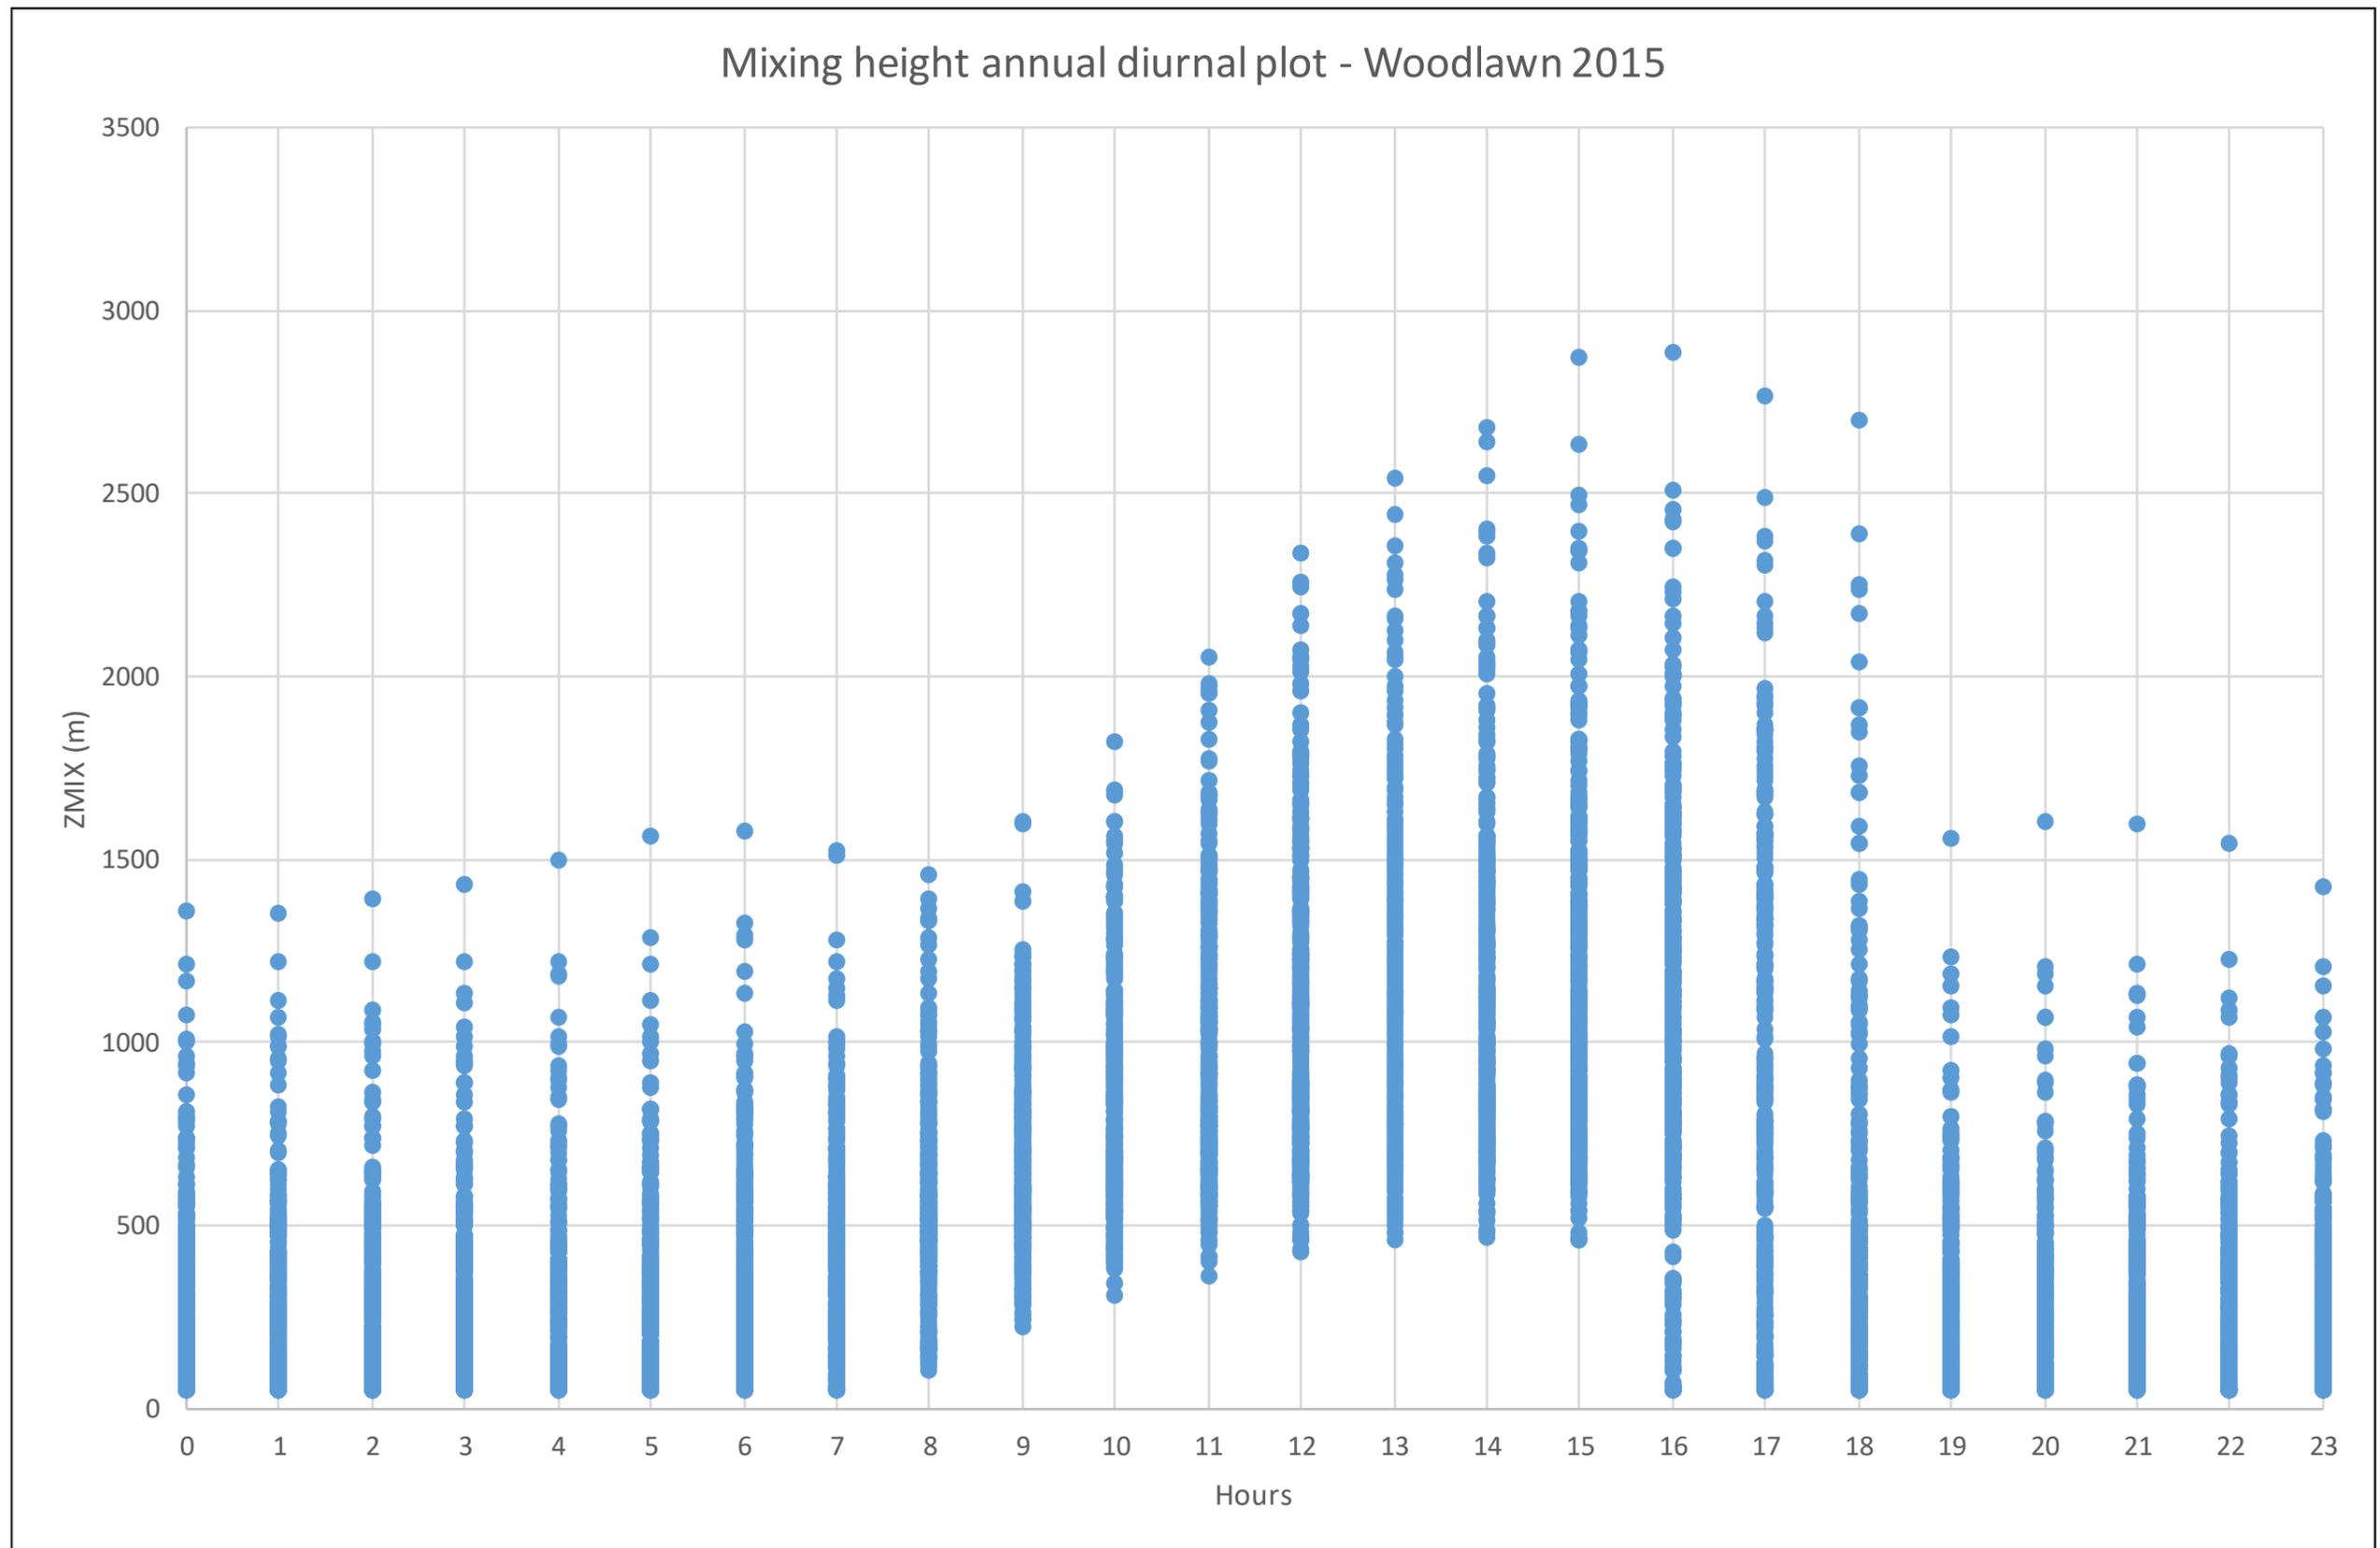
Figure 8.9 – Annual X-Y scatter plot diurnal mixing height for Woodlawn 2015 (modelled)

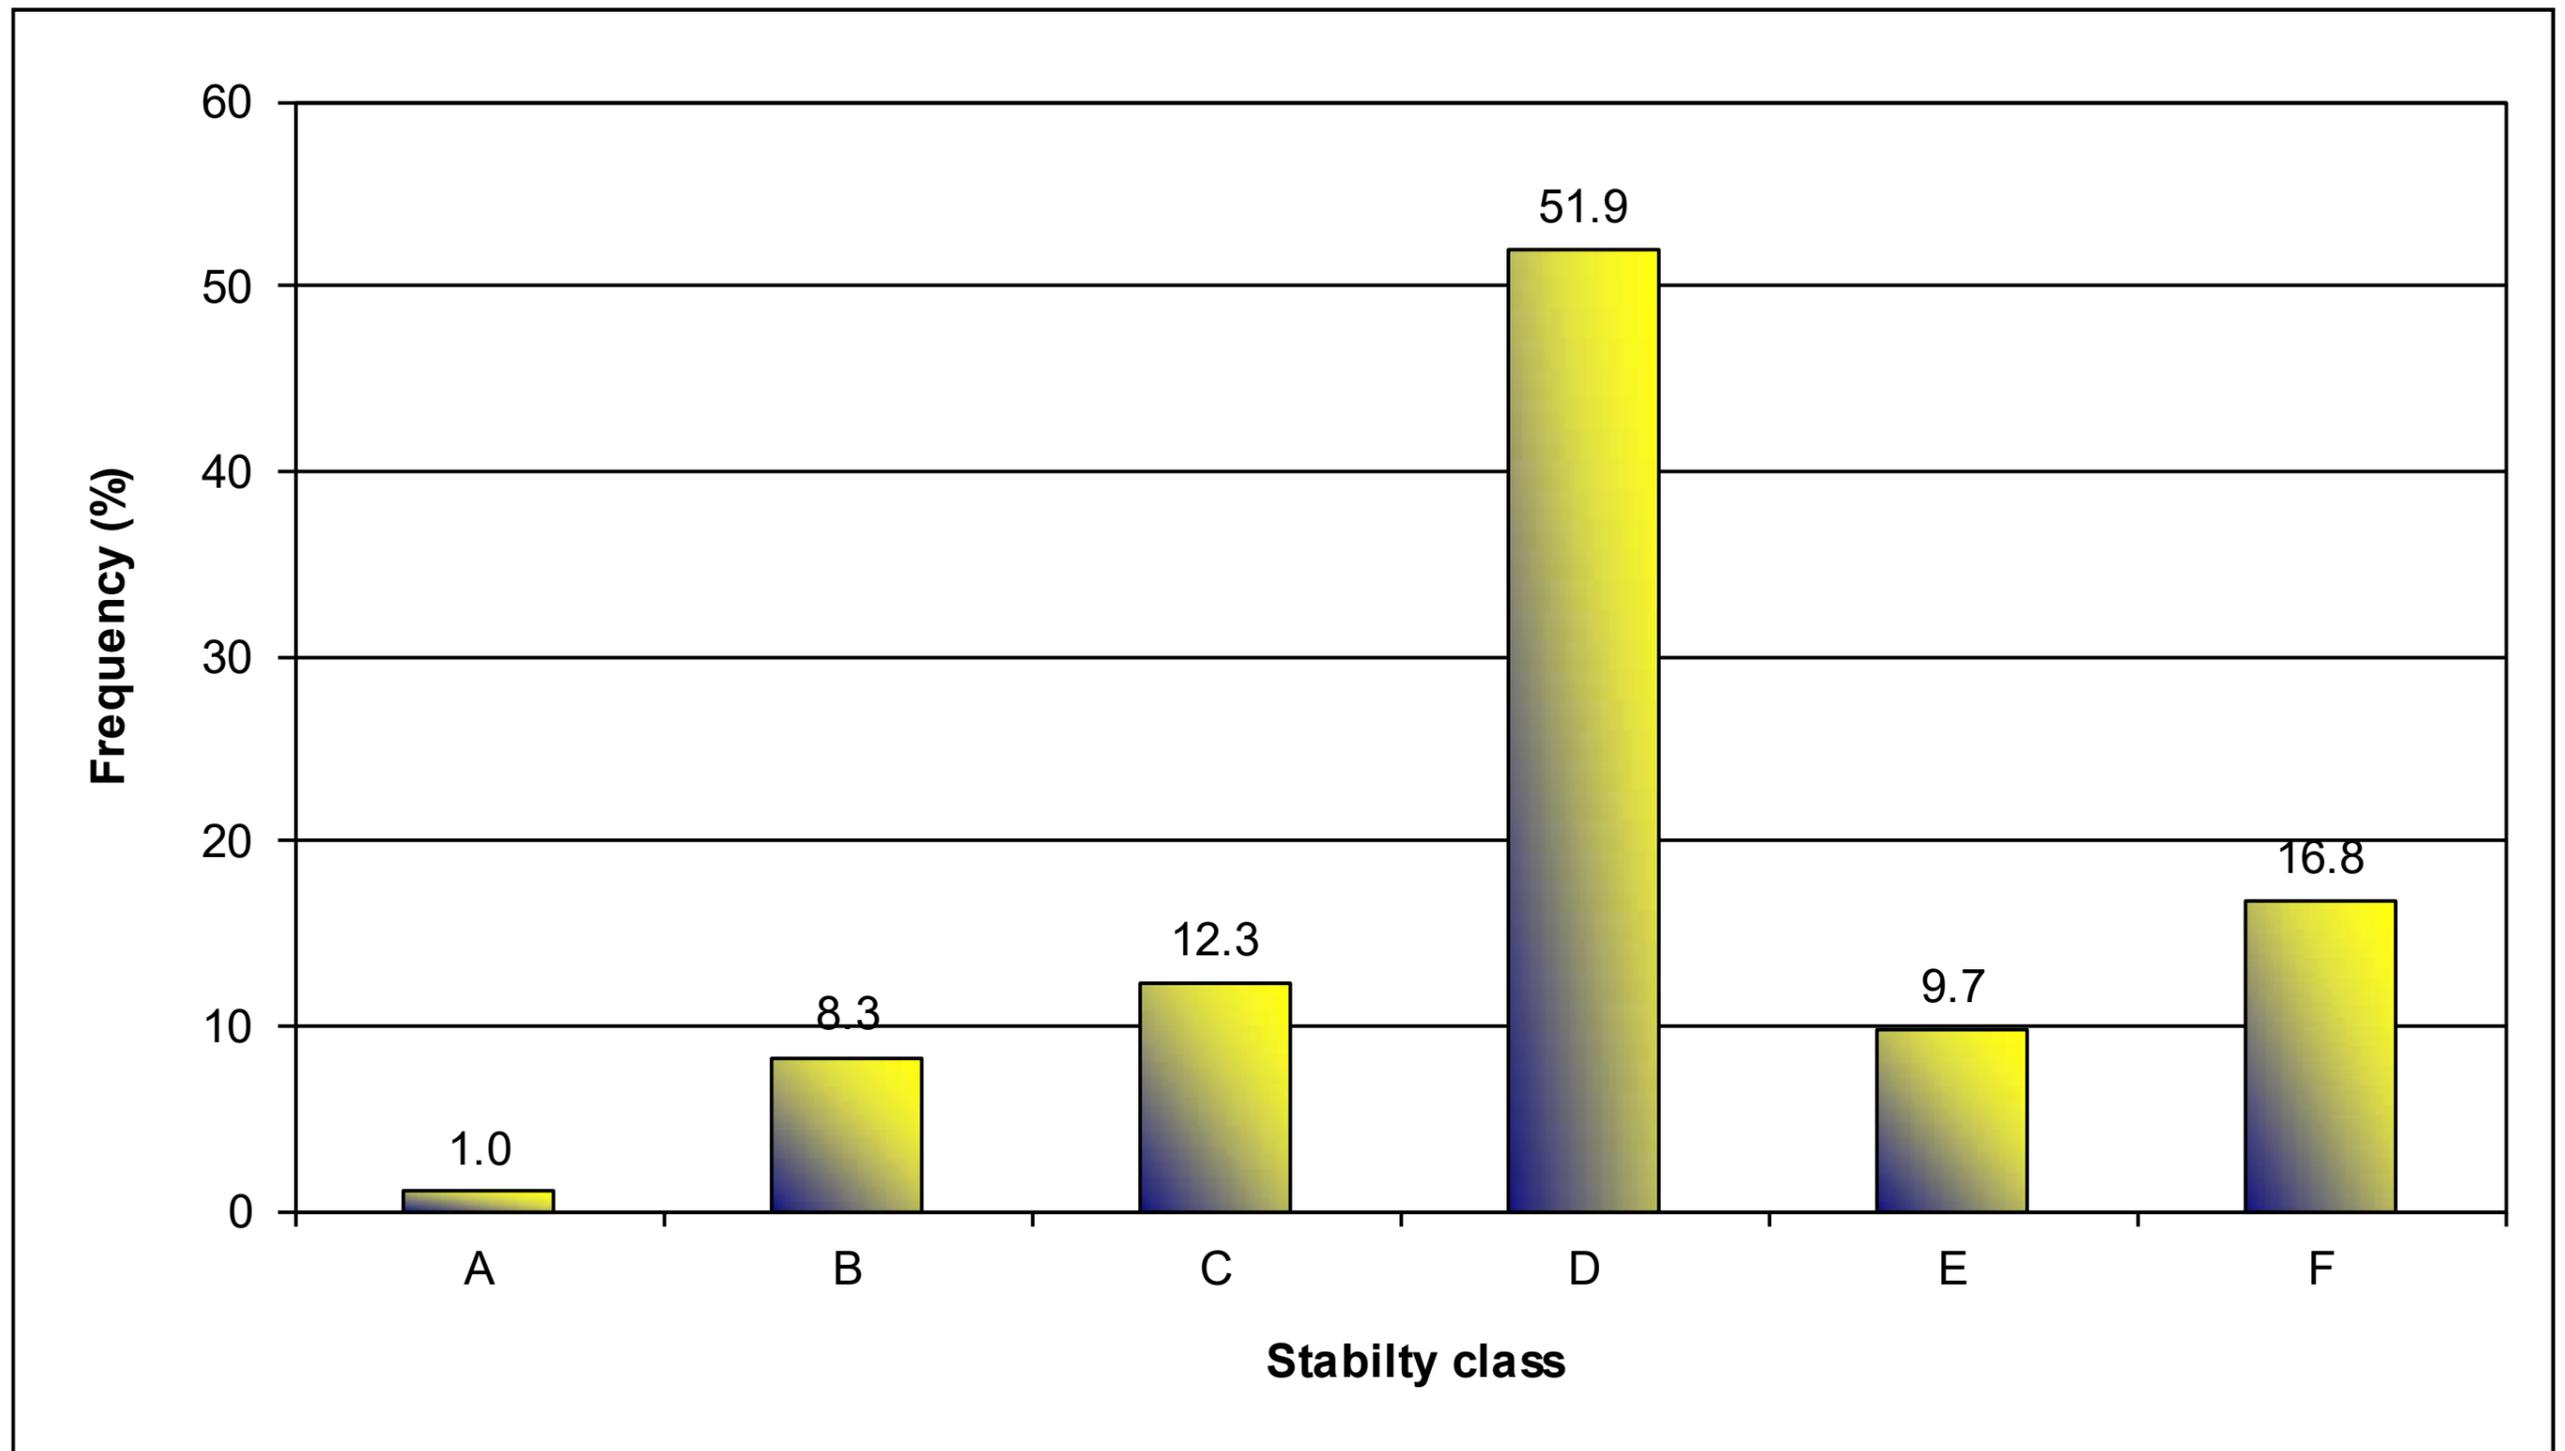
Figure 8.10 – Annual stability class frequency for Woodlawn 2015 (modelled)
