Veolia Australia & New Zealand

Woodlawn Bioreactor Expansion Project

Independent Odour Audit #9

August 2021

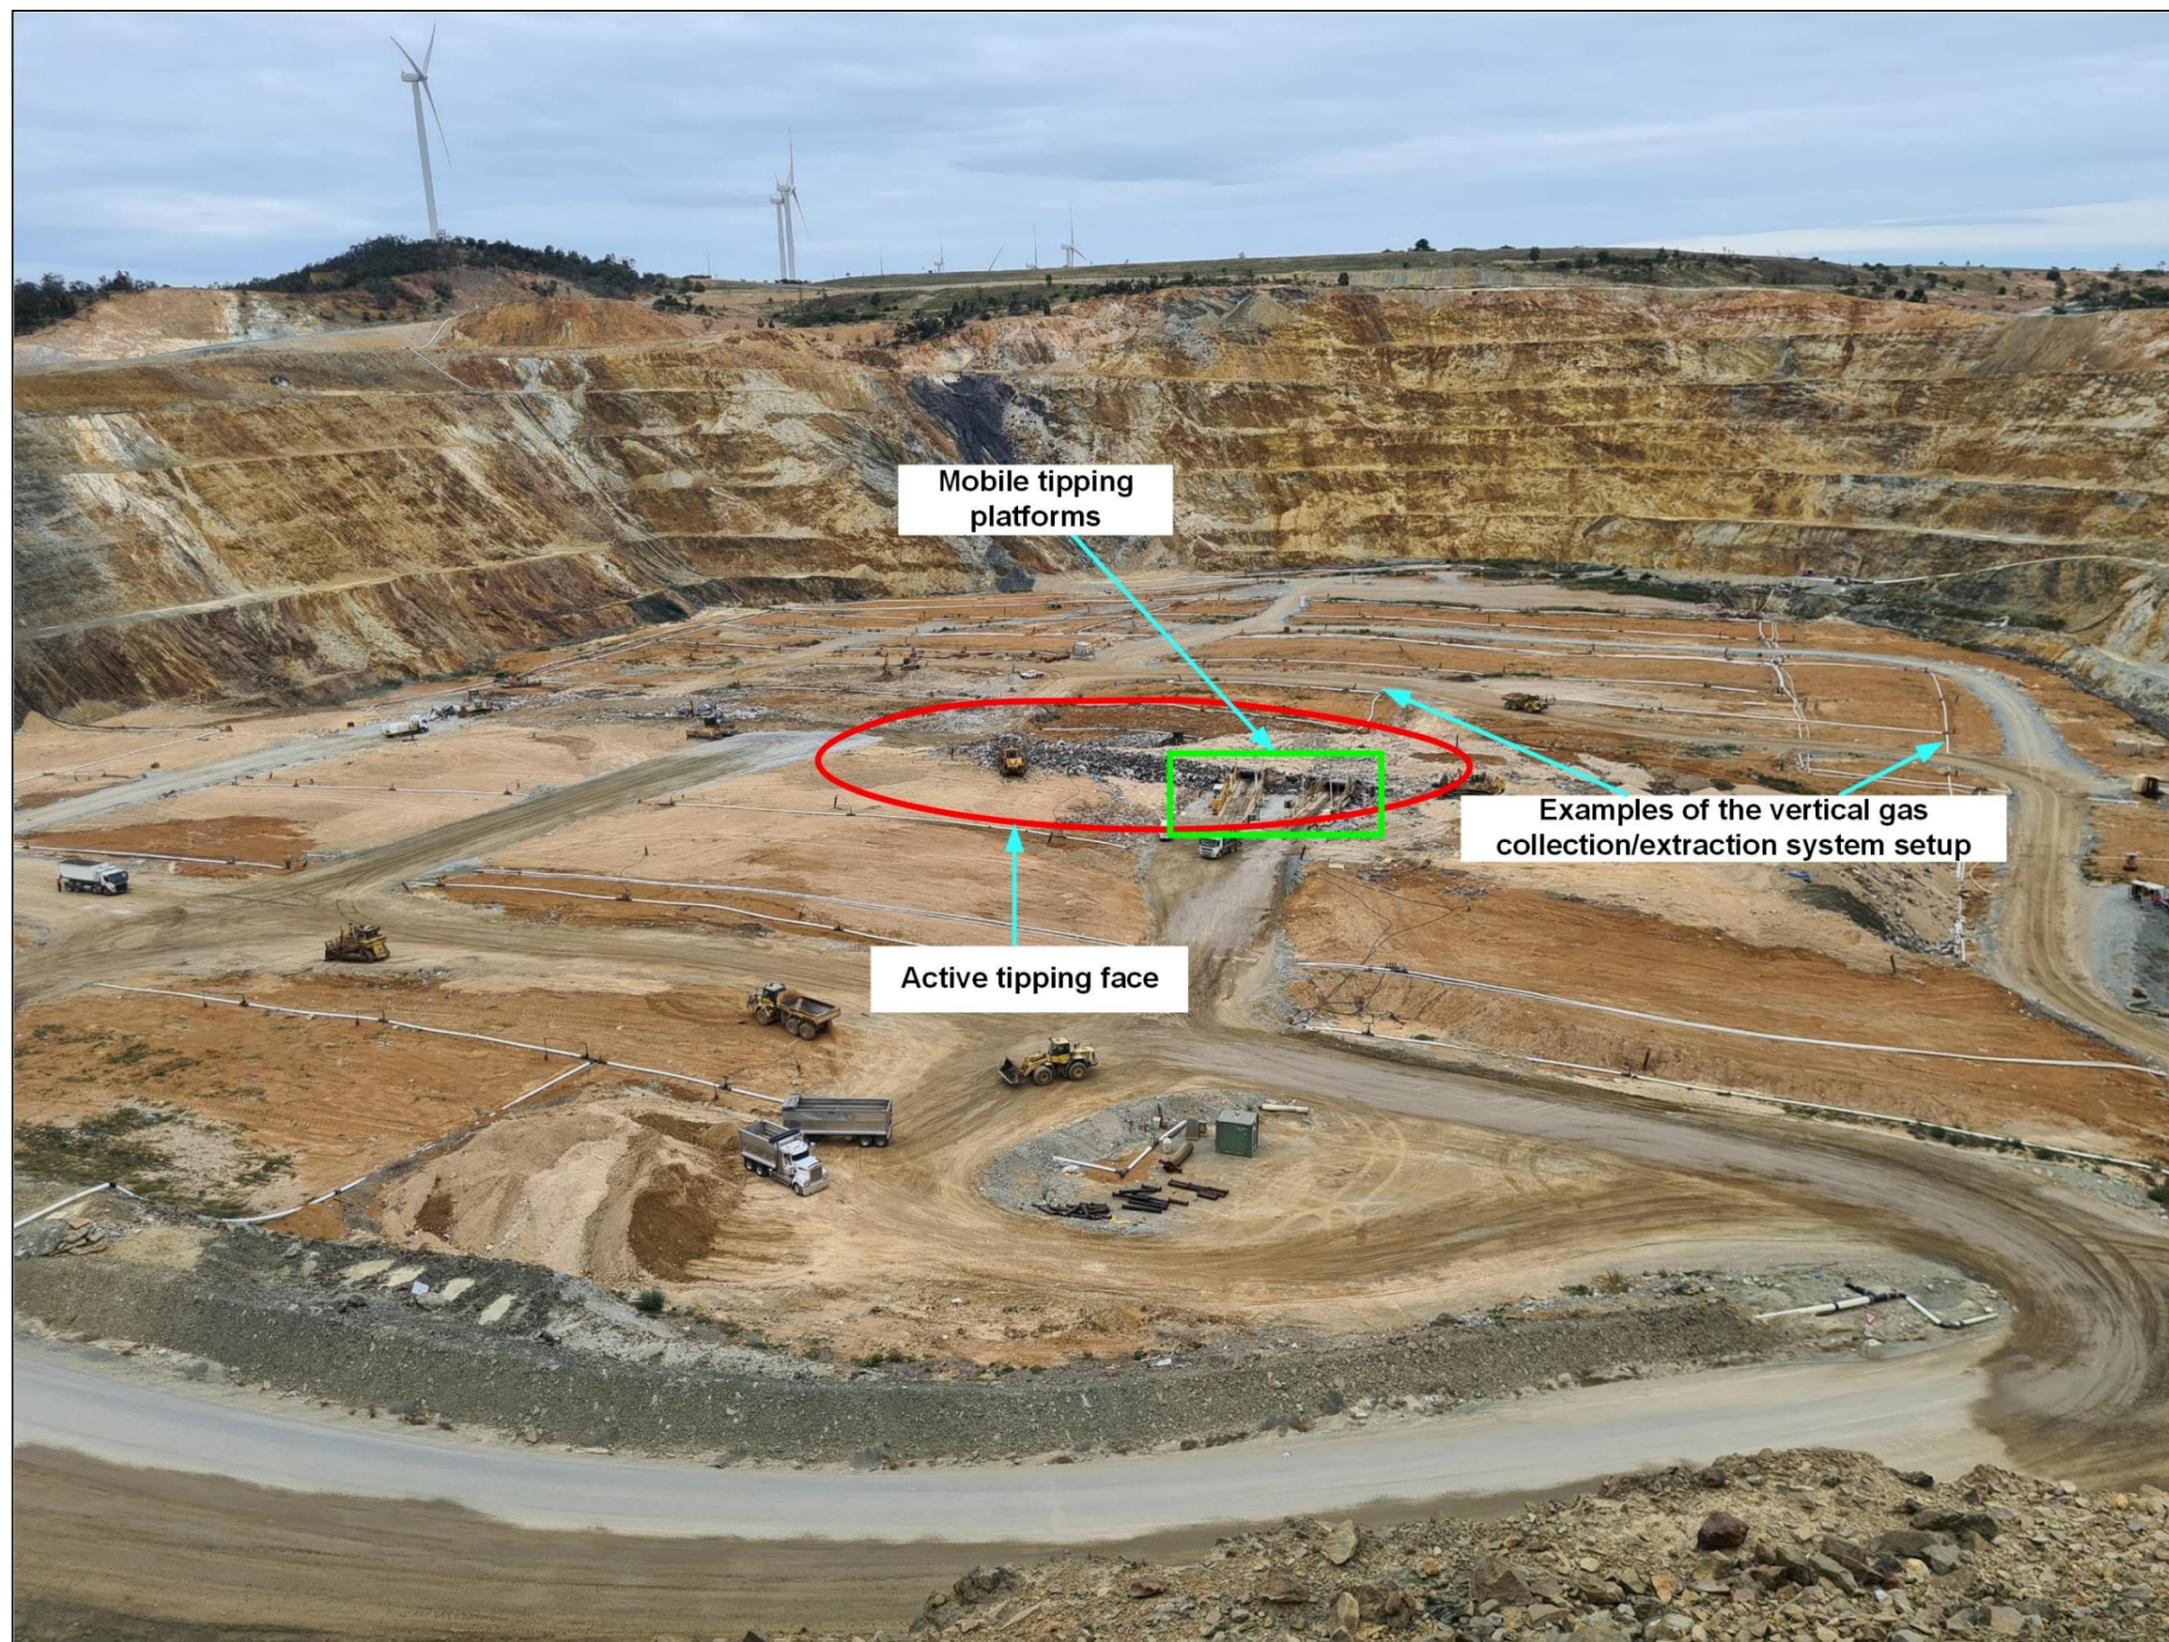
Figure 2.2 – Void layout and operations: 8 March 2021

The Void layout and operations prevalent at the time of the Audit are shown in **Figure 2.2**.

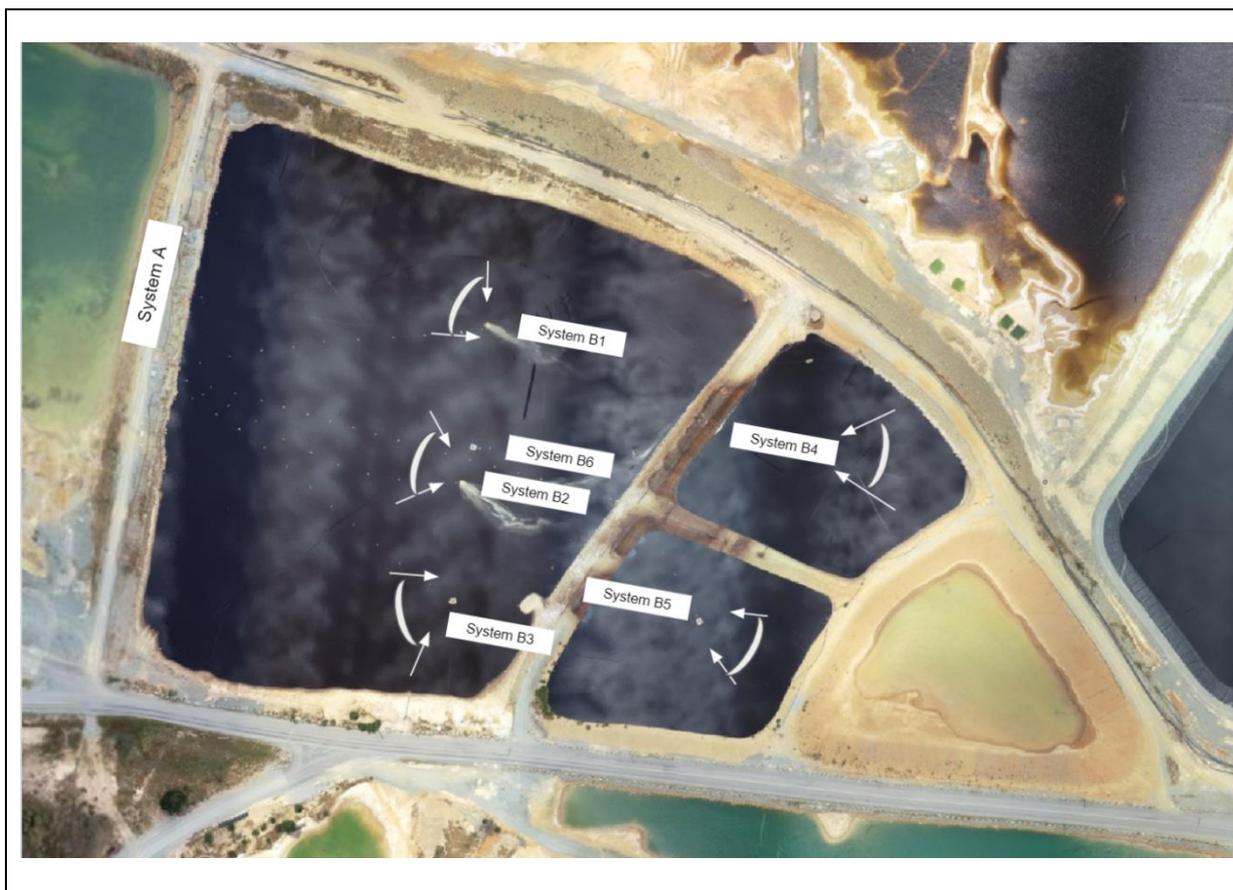
Figure 2.3 – The mechanical evaporation system layout for ED3N (**Source:** WIP 2020)

A mechanical evaporation system at the Site is currently active to manage the growing need for volume reduction in the ponds to retrieve storage capacity. The mechanical evaporation system is described and operated as per the WIP 2020. For ED3N-4, the mechanical evaporation system at the Site consists of four (4) Turbomist® evaporation units, driven by a common pump system. It is understood that the actual operating performance of the evaporation units is approximately 840-900 L/min. This evaporation mechanism is known as System A, as shown in **Figure 2.3**.

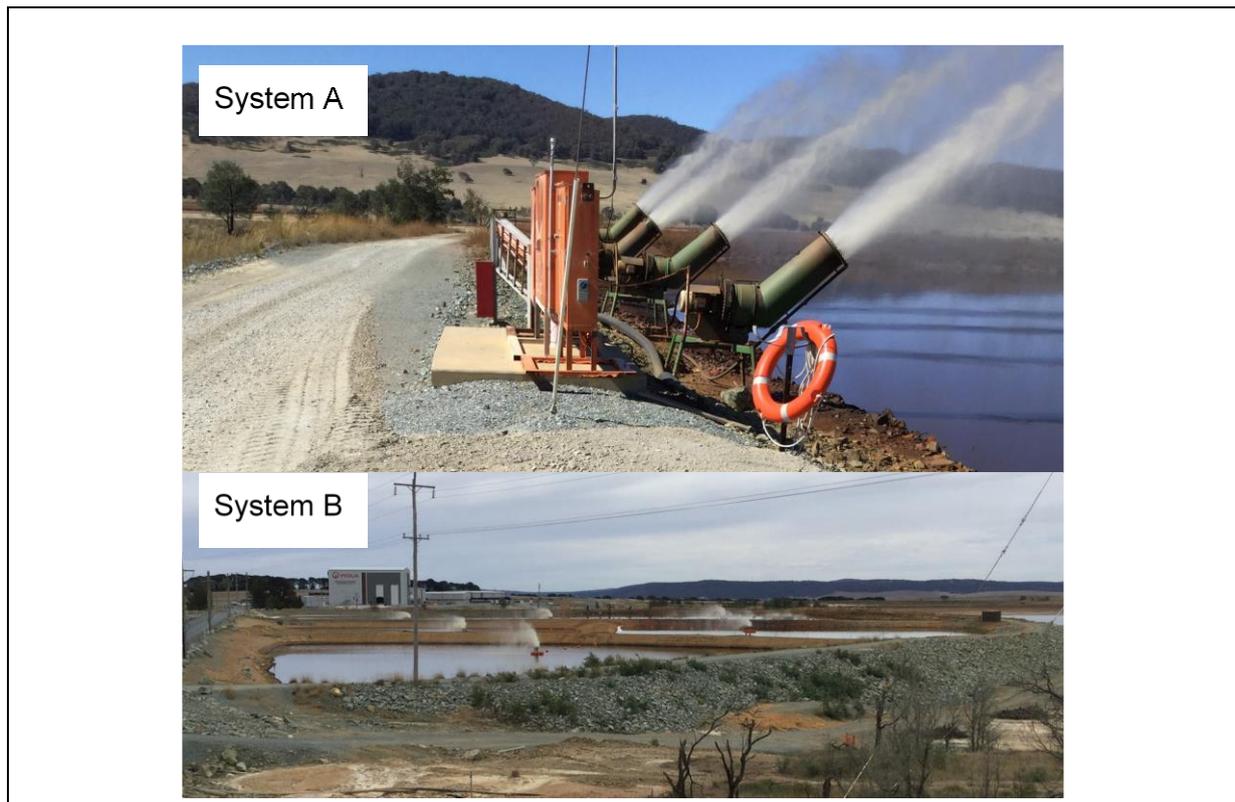
Figure 2.4 – Operation of System A and System B at the Site (**Source:** WIP 2020)

System B, which is a surface spray evaporator system, is composed of six (6) sprays (one in each of ED3N2 and ED3N3, and four in ED3N4) floating in the middle of the dams and controlled by a weather station on the western bank of ED3N4. At the time of the Audit, ED3N-1 was empty and therefore did not have an active surface spray evaporation system. The operation of System B is in accordance with the feedback provided from the weather station, including temperature, humidity, wind direction and wind speed. Each of the sprayers is controlled independently, with setpoints based on weather conditions. As shown in **Figure 2.3**, the nominal location of each surface spray evaporator and the operating wind direction range is presented as arrows, with the span range visually illustrated. As documented in the WIP 2020, System B is still under an active trial period, and the setpoints are being tested to ensure the spray mist will not drift out of the dam area. As the humidity and temperature conditions vary across the seasonal cycles, the setpoint for wind speed is modified accordingly. The operation and effectiveness of System B are regularly reviewed by the Site, and setpoints are optimised as required. A photo showing the operation of the surface spray evaporator system is shown in **Figure 2.4**.

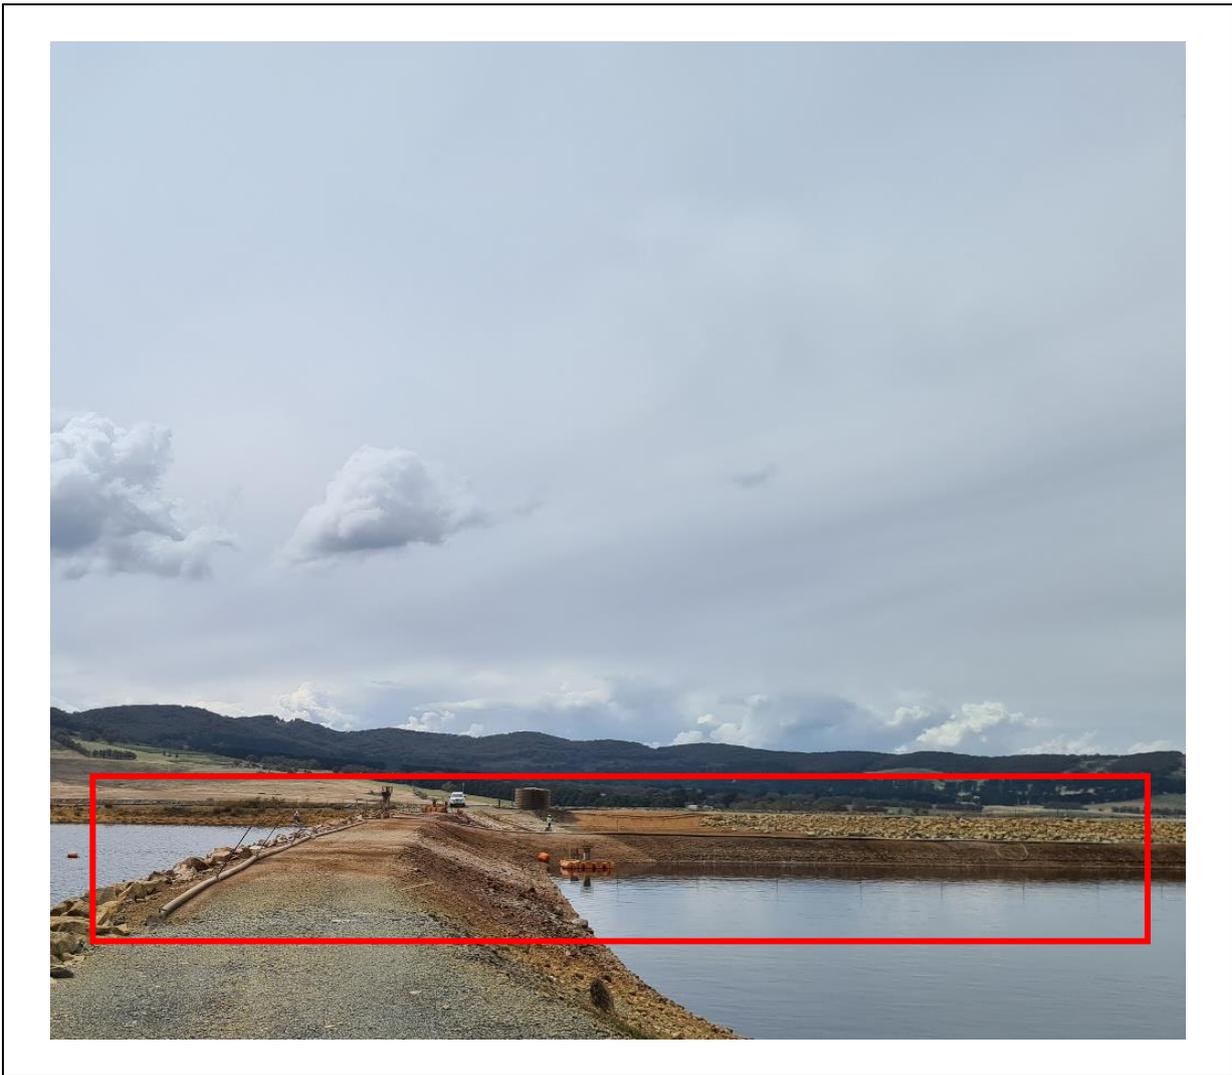
Photo 2.1 - A view of the ED3N middle bank spray evaporation system: 8 March 2021

Since the last IOA, another evaporation system has been installed in the ED3N area, located in the middle bank, as shown in **Photo 2.1** and **Figure 2.5**. An electric pump is set up and moved between ED3N2 and ED3N4, discharging into the spray system on the middle bank of the ponds. As the spray is at a modest distance from the external boundary of the ED3N area and the injection spray height is low, this system has the capacity to operate under most weather conditions. It is only turned on manually, weather dependent. During active operation, this spray system is controlled by a timer that operates based on seasonal conditions.

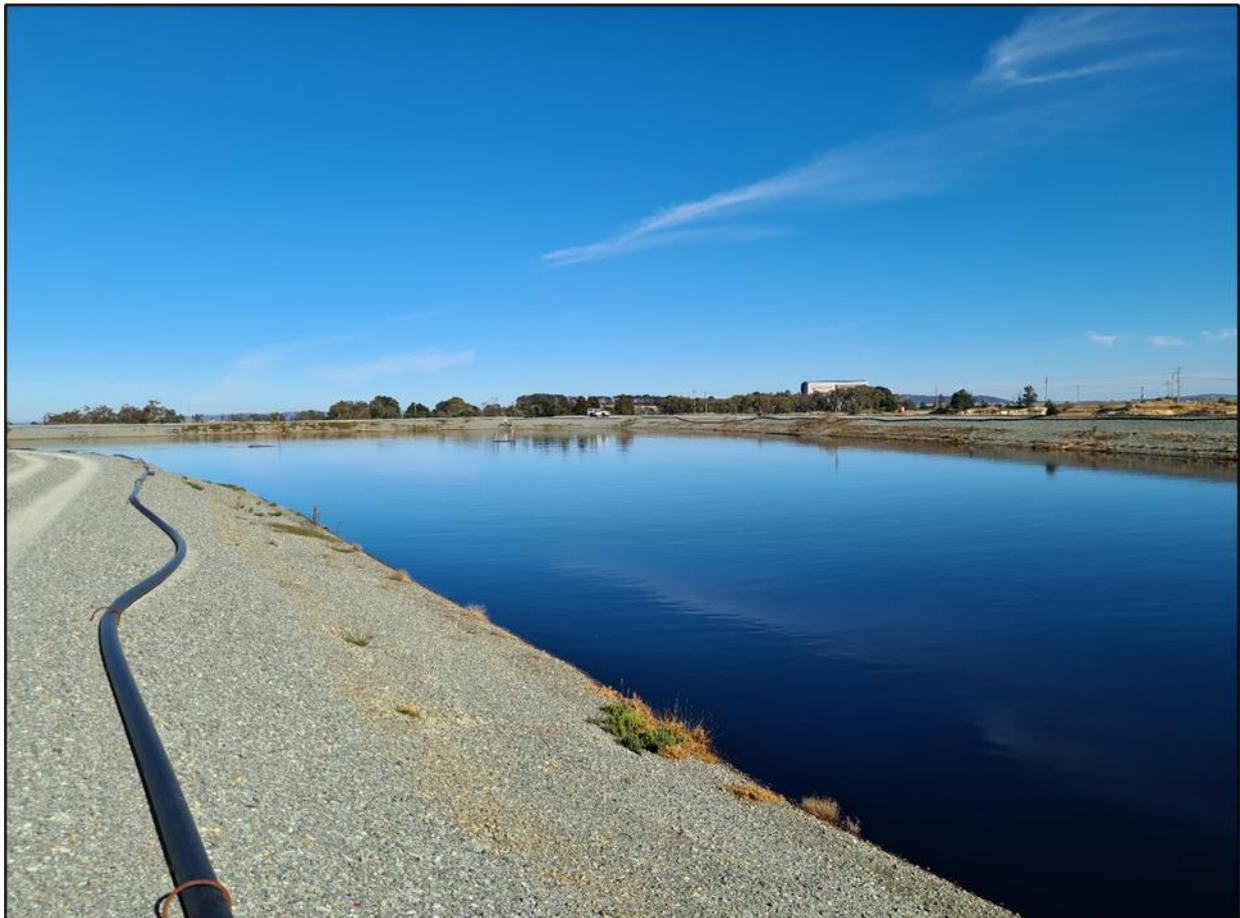
Photo 2.2 – ED3S-S: 9 March 2021

A ring main evaporation system is installed away from the bank of ED3S-S. A total of four spray bars, each bar with 5-6 nozzles, are installed at the north, west, south, and east of ED3S-S, respectively, approximately 2 m away from the bank. The spray nozzles are controlled by an in-situ weather station and operate only when the wind is blowing from a certain direction, i.e. behind the bank into the dam. In addition to the ring main evaporation system, ED3S-S has three floating surface spray evaporators, similar to that described in **Section 2.4.2.1.2**. The operation of the surface spray evaporators occurs only during the daytime on weekdays and based on weather conditions.

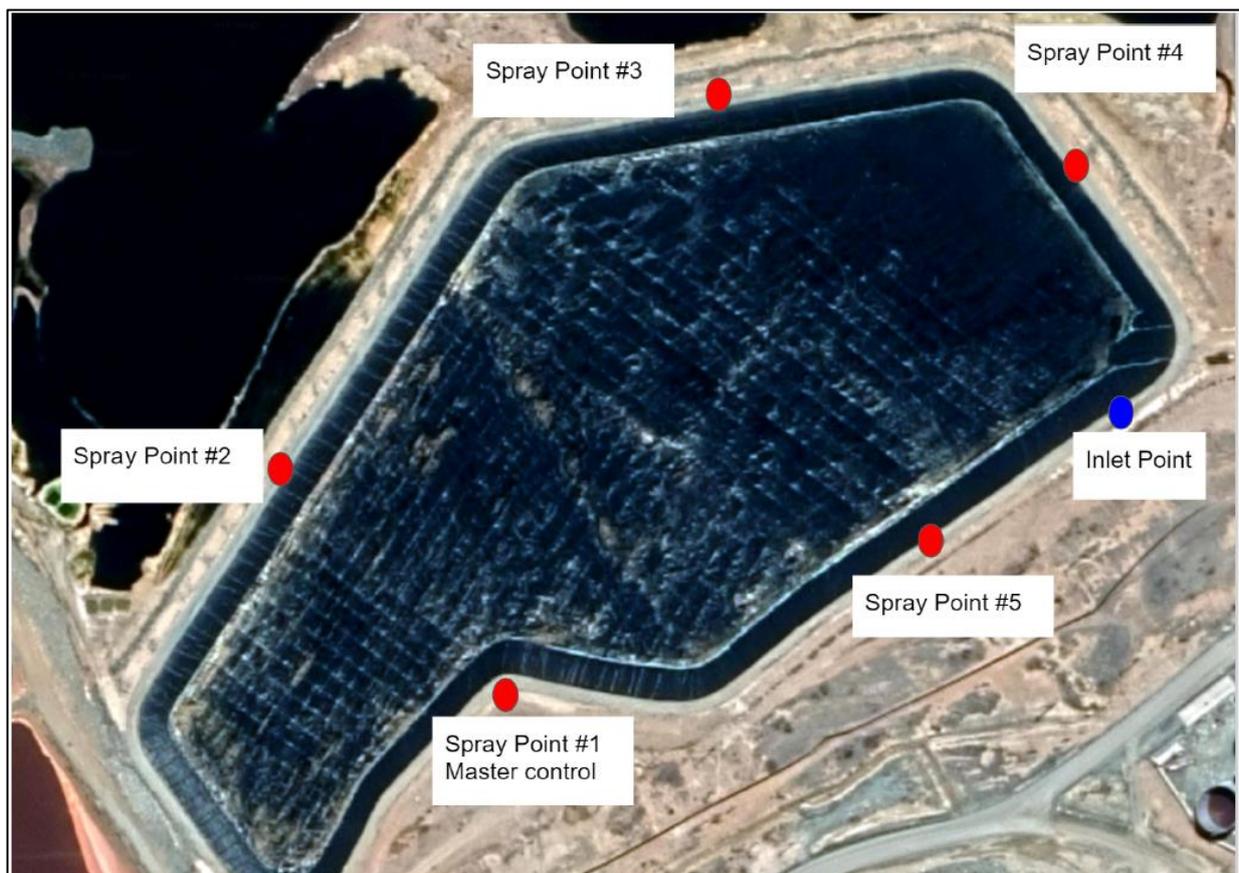
Figure 2.6 – ED1 Cofferd Dam: Proposed Evaporation Spray System (**Source:** WIP 2020)

As previously mentioned, effluent from the LTP is transferred to ED1 coffer dam for storage and evaporation. ED1 coffer dam needs to maintain a minimum freeboard of 0.5 m. As outlined in the WIP 2020, a new dam for LTP effluent is intended to be constructed once ED1 coffer dam reaches 80% of the volume storage capacity.

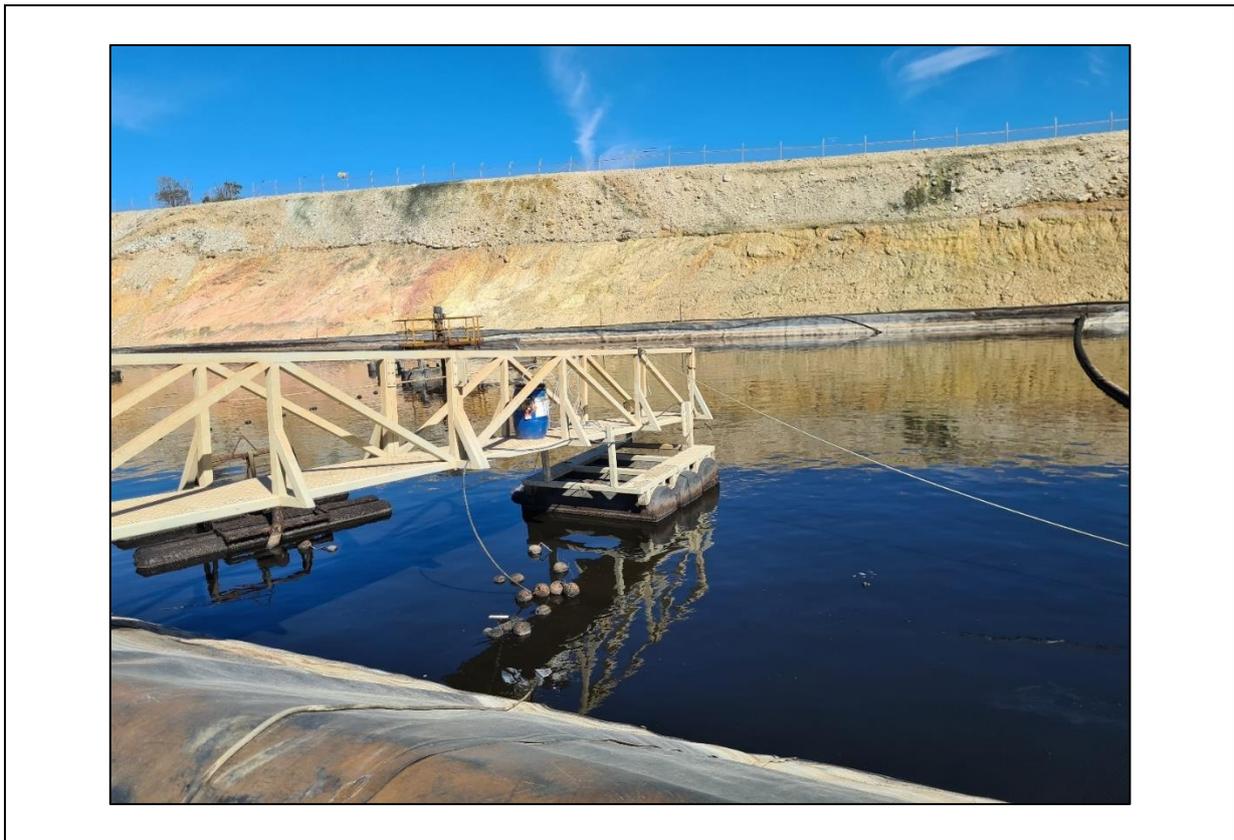
Photo 2.3 – A view of the LTD: 9 March 2021

The LTD is in the upper north-western edge of the Void and is an integral part of the LMS at the Site. Leachate from the Void is pumped directly to the LTD as required. Since the 2012 IOA, the LTD was upgraded from a batch-based wastewater treatment system to a continuous configuration. The upgraded system was commissioned in April 2013. Following this upgrade, the LTD process was modified since the previous audit to consist of anoxic and aeration zones to increase the efficiency of the leachate treatment process. **Photo 2.3** shows the LTD as occurred during the Audit, and **Figure 2.7** illustrates the current continuous treatment configuration for the LTD.

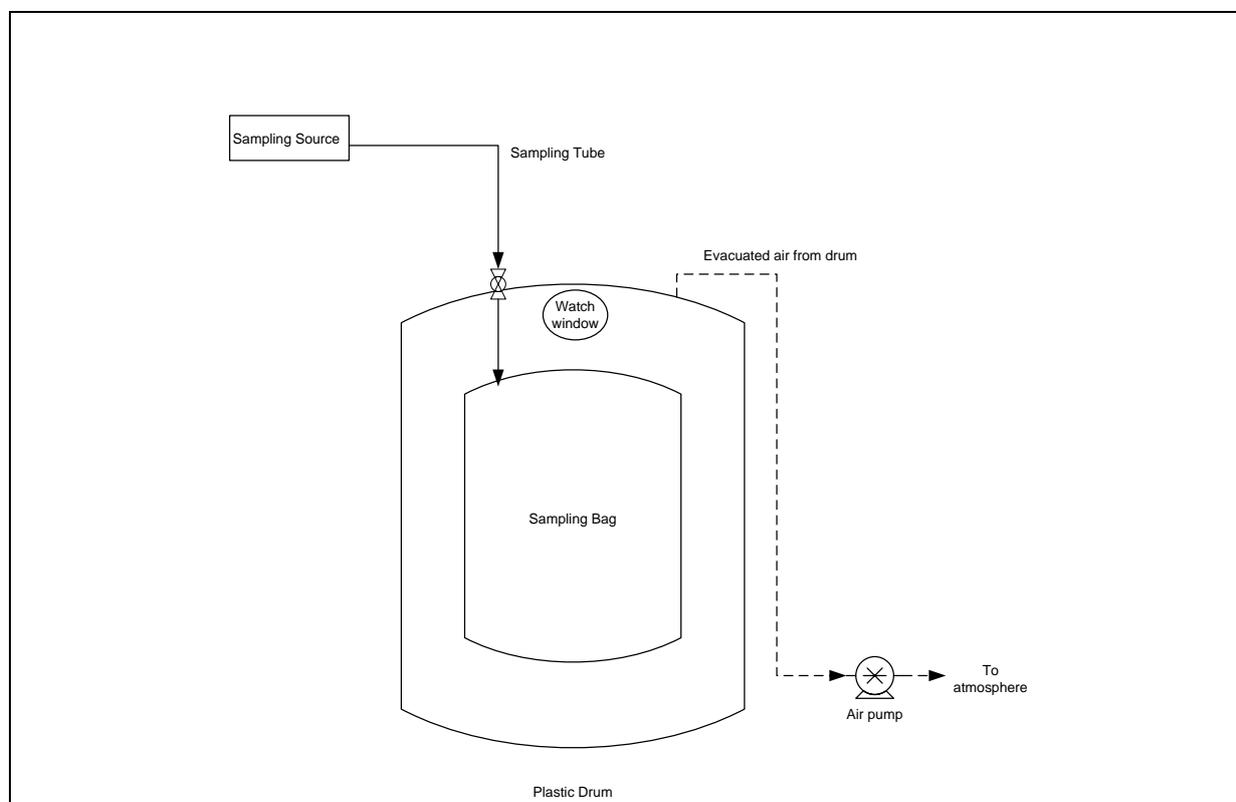
Figure 4.1 - Schematic of point source sampling

The method used for the collection of gas samples from the inlet and outlet locations of the biofilter systems at the MBT Facility involved the use of a point source sampling, consisting of the drum and pump method. This method involves the drawing of the sample air through a polytetrafluoroethylene (PTFE) sampling tube into a single-use, Nalophan sample bag. The bag was housed within a container (sampling drum) that was evacuated with a vacuum pump, and the sample collected by induced flow. The "lung method", by which this sampling procedure is known, allowed the sample air to be collected without encountering any potentially odorous material. **Figure 4.1** illustrates a schematic of the point source sampling method.

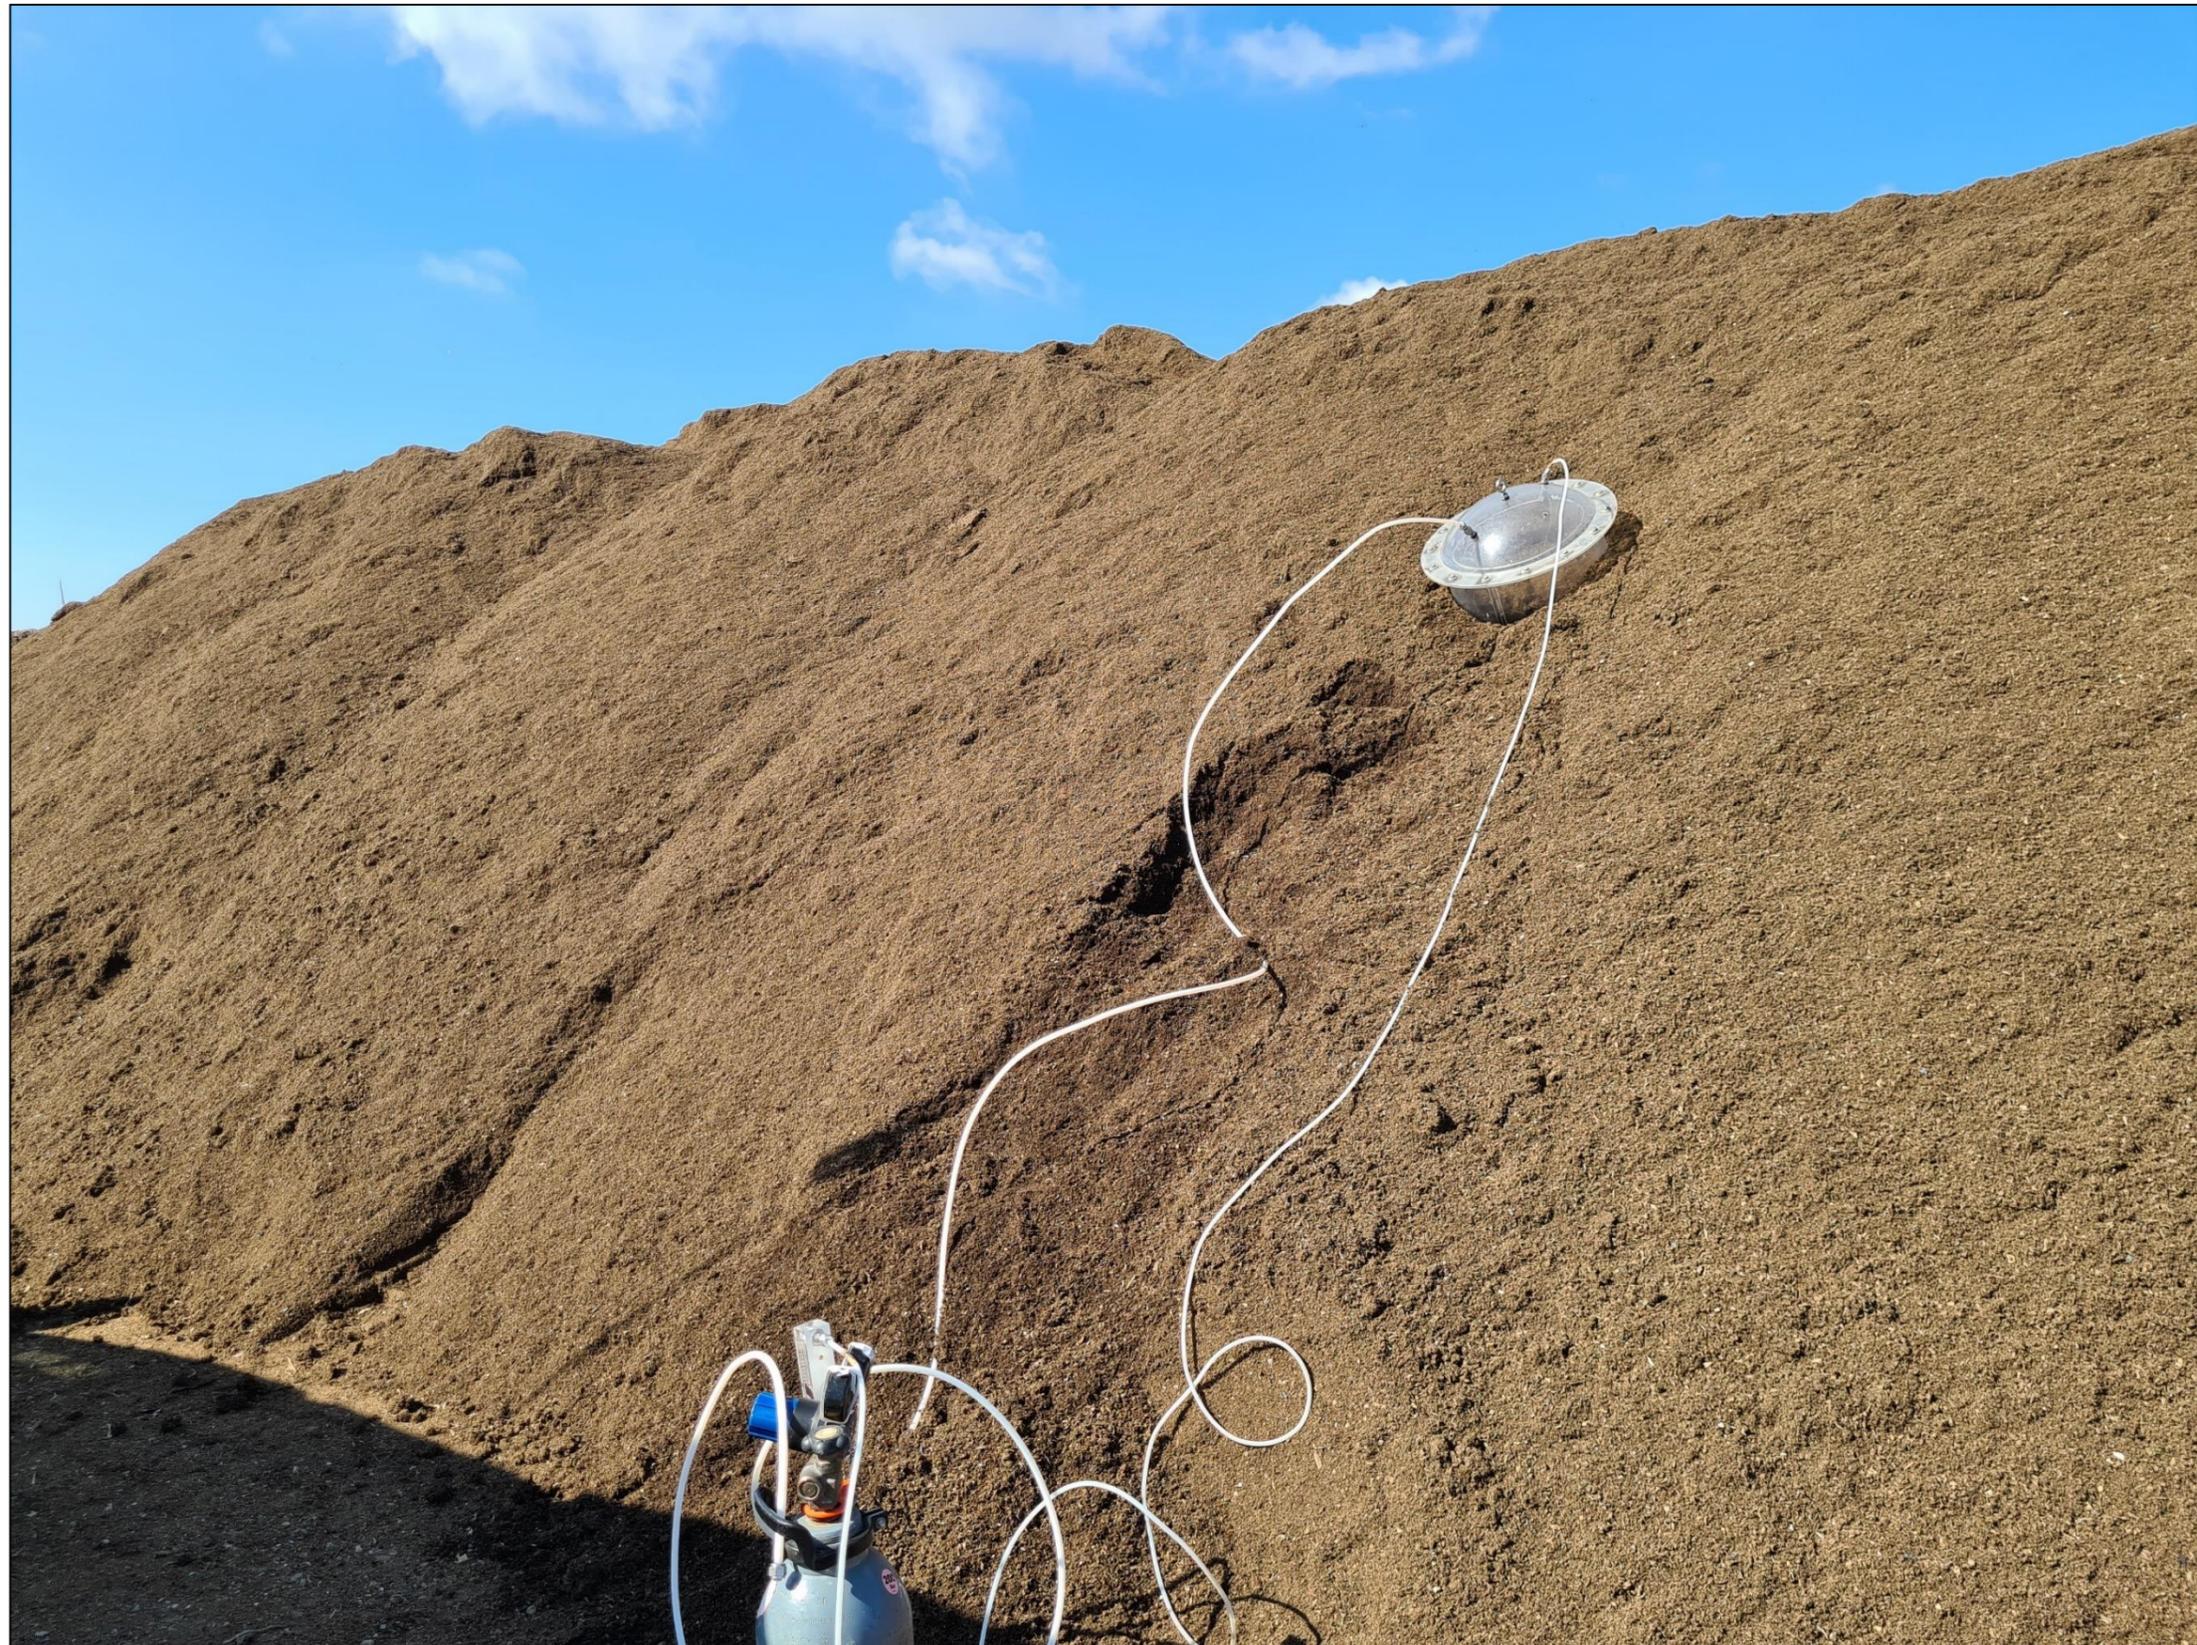
Photo 4.1 – An example of IFH sampling on a solid surface at the MBT Facility as occurred on 11 March 2021

The IFH is manufactured from acrylic resin to ensure it does not contribute to the odour sample. All other surfaces in contact with the sample are made from PTFE or stainless

steel. An example of IFH sampling on a solid surface and a liquid surface is shown in **Photo 4.1 & Photo 4.2**, respectively.

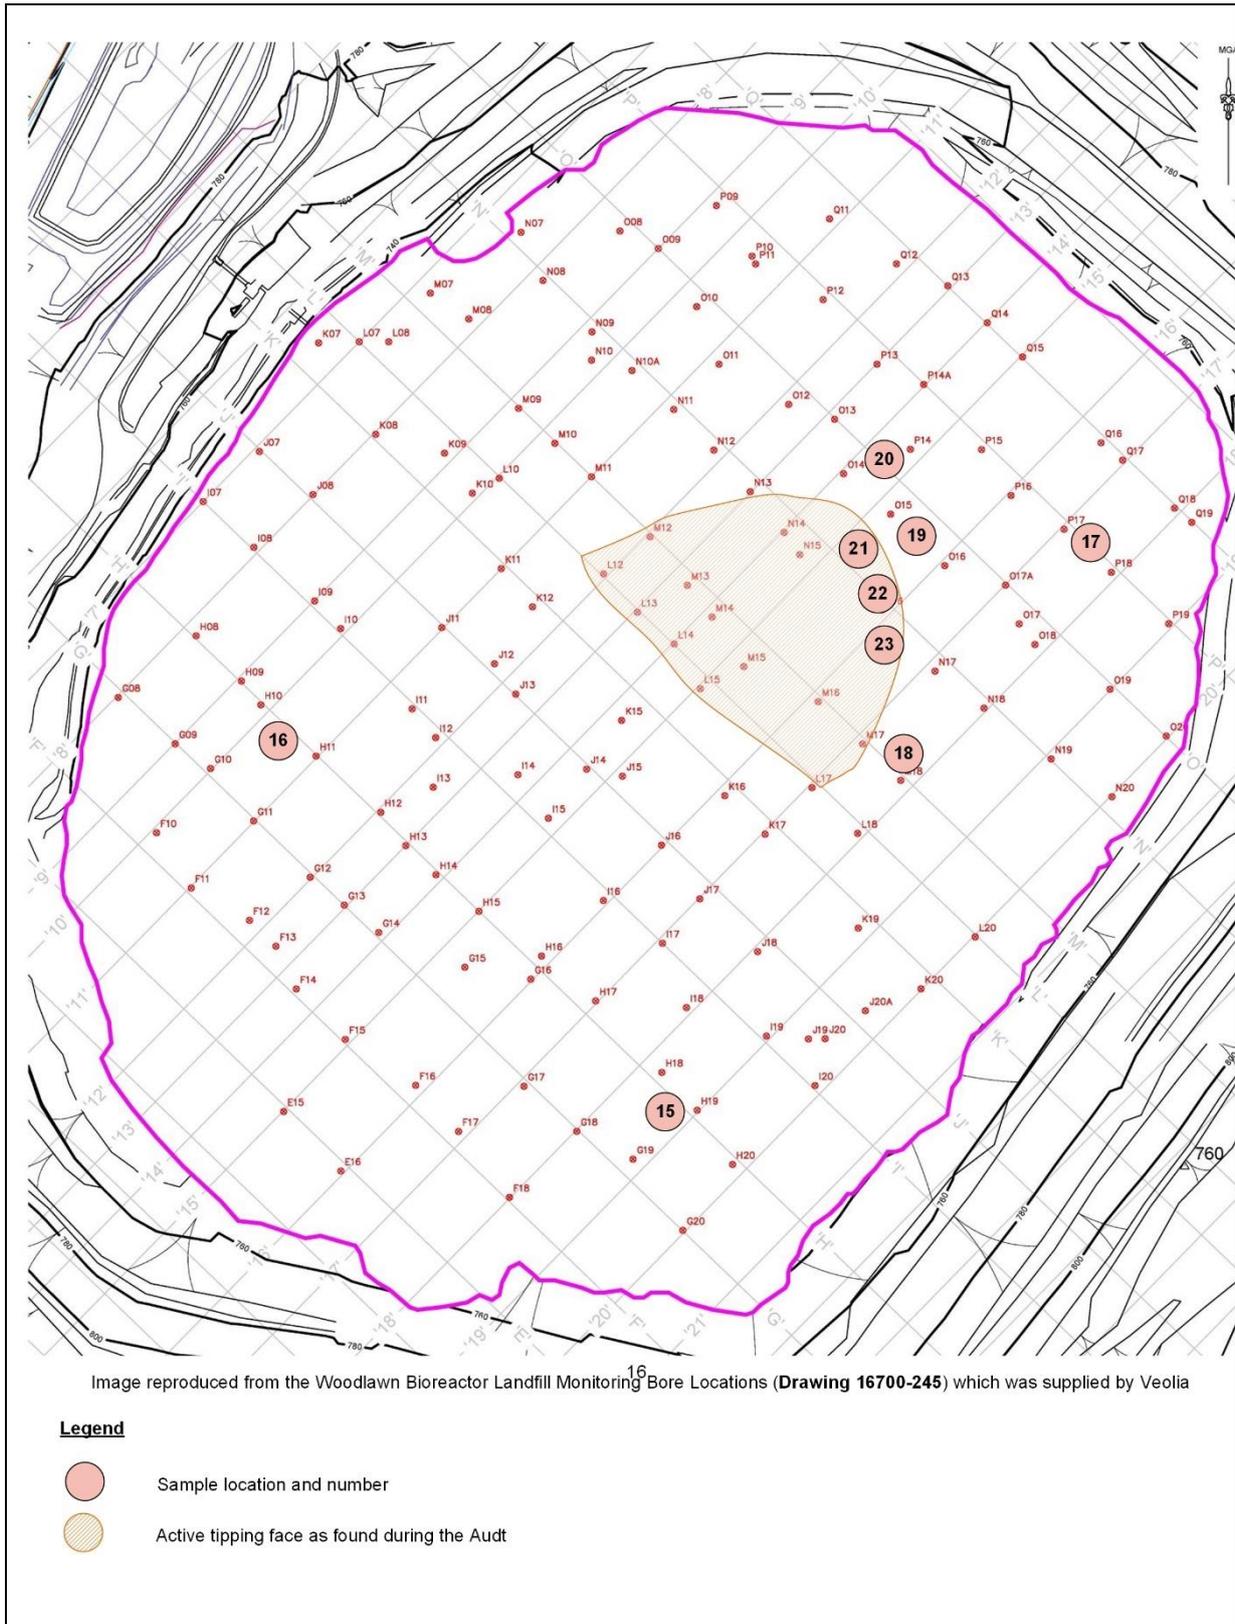
Figure 6.1 - Nominal sampling locations within the Void: 10 March 2021

- The sampling locations inside the Void have been nominally shown in **Figure 6.1**. The sample numbers presented in **Figure 6.1** correspond with those in the sampling location column in **Table 6.1**. The conditions prevailing in the Void at the time of the Audit is presented in **Photo 6.1**;

- The Waste Covered Area samples (SC21142 – SC21147) were collected from covered areas within the Void, including 150 mm and 300 mm VENM cover, at strategic locations designed to quantify the general emissions emanating from the Void. The SOER results are low and suggest fugitive emission release and cover condition at the sampled locations was effective at the time.

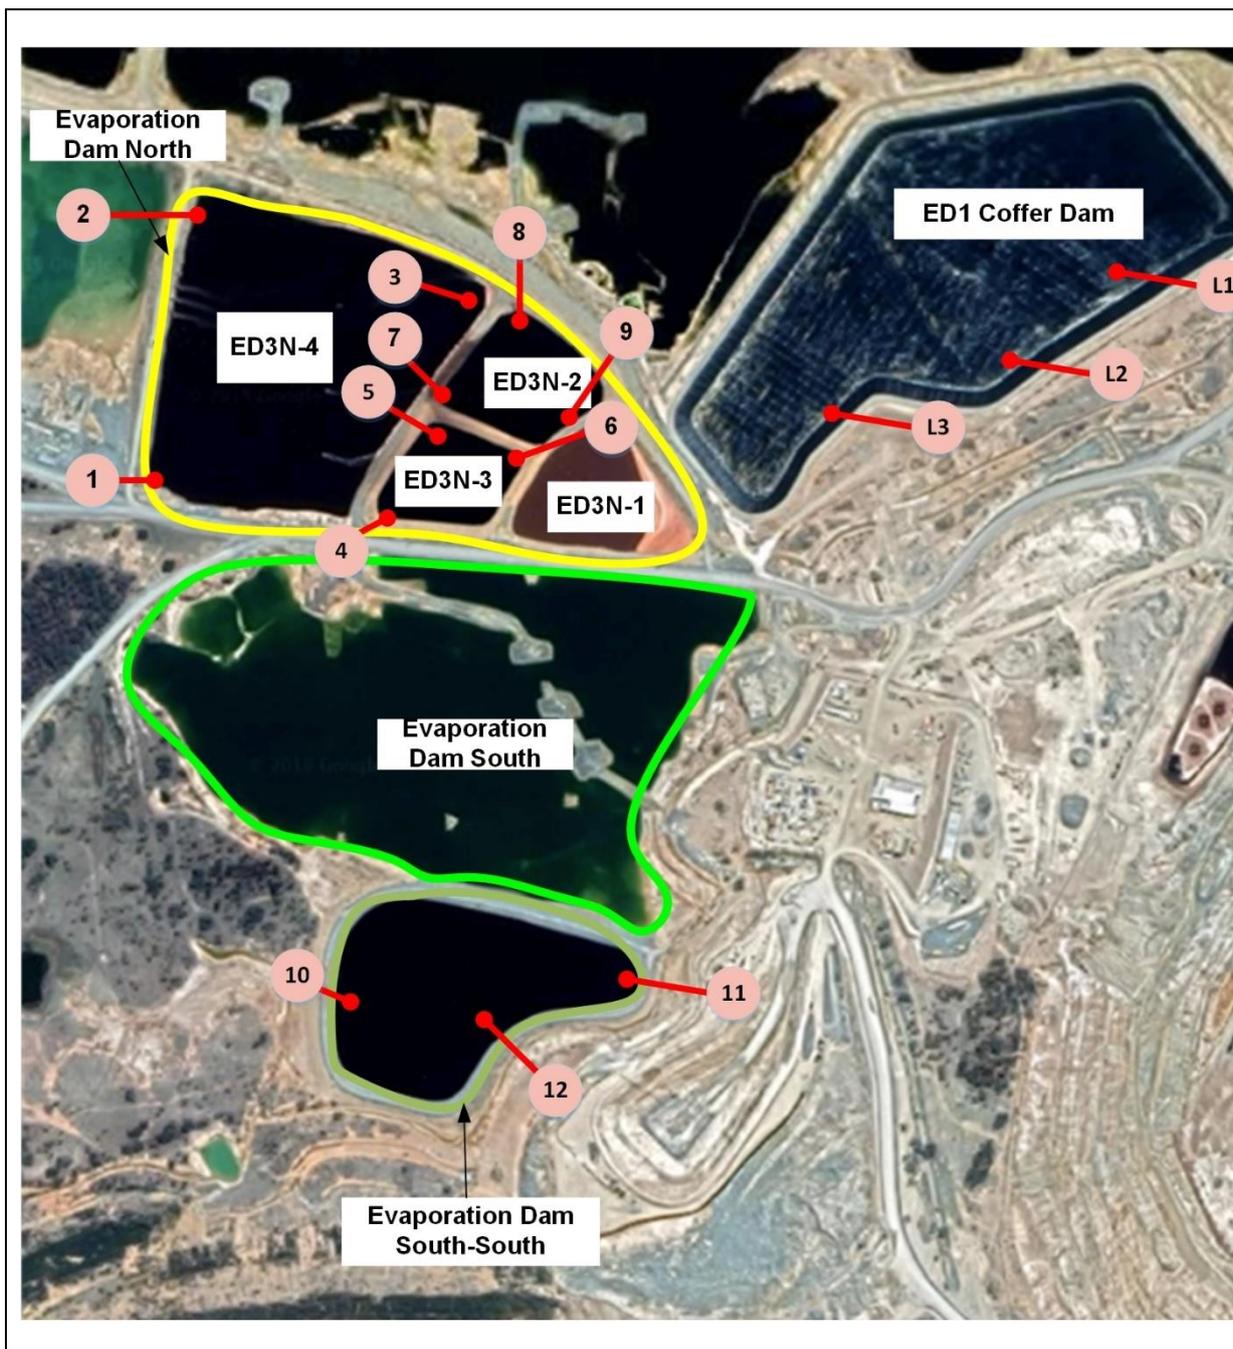
Figure 6.2 – Pond sources nominal liquid & gas sampling locations: 8 March 2021 to 11 March 2021

- ED3N-1 was empty, and therefore no samples were collected;
- All samples from the ED3N system were collected from the bank of the dams. The nominal sampling locations are shown in **Figure 6.2**; and
- All samples collected and tested from the ED3N Pond system (i.e. SC21124 – SC21132) were found to be below the EA 2010 SOER model inputs for each dam, with the exception of an individual result for ED3N-4 at 1.1 ou.m³/m²/s (SC21126). Notwithstanding this, with the exception of SC21127, the majority of SOER values for all ponds are low (0.029 – 0.268 ou.m³/m².s) and consistent with previous IOA results. These results indicate that the leachate treatment quality continues to be optimum and that the LMS at the Site is performing well from an odour emissions viewpoint.

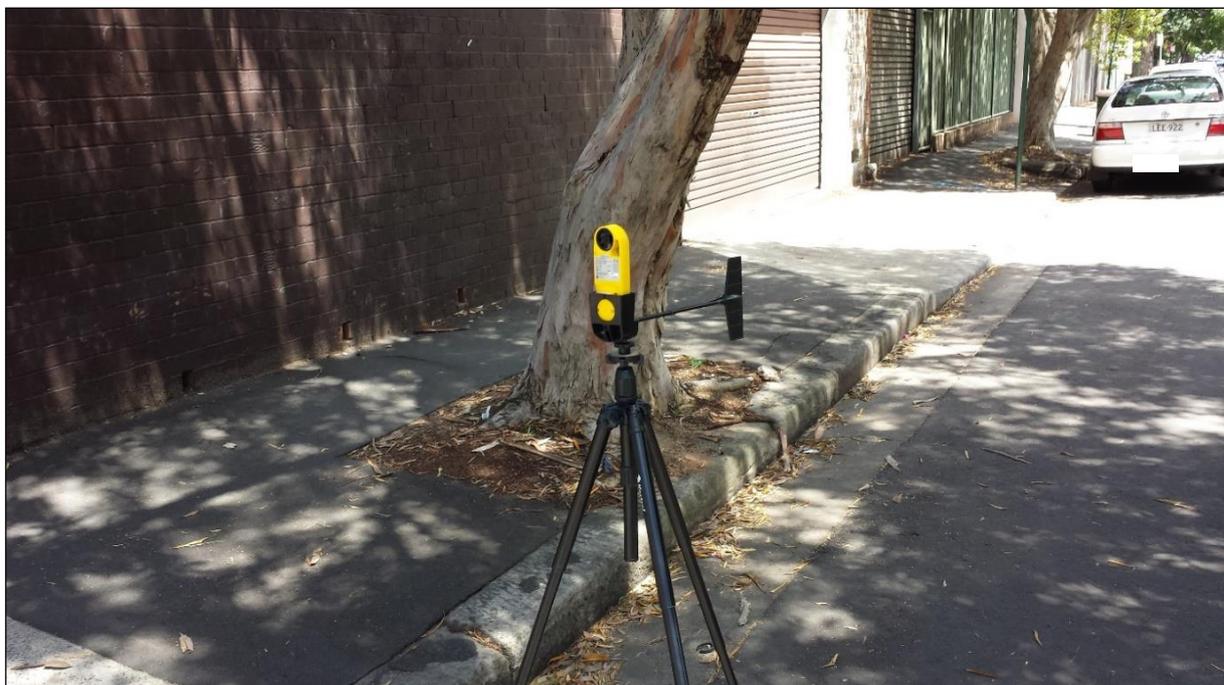
Photo 7.1 - Illustrated setup of the Kestrel Anemometer apparatus in operation (Source: The Odour Unit Pty Ltd)

Local meteorological conditions prevailing over the duration of the FAOA surveys were recorded using a Kestrel 4500 Pocket Weather Tracker Anemometer (see **Photo 7.1** for an illustrated setup). At each MLP assessed, the assessors would set up the anemometer apparatus enabling for a grab measurement of wind speed and direction at an MLP. This was undertaken during every survey at each MLP.

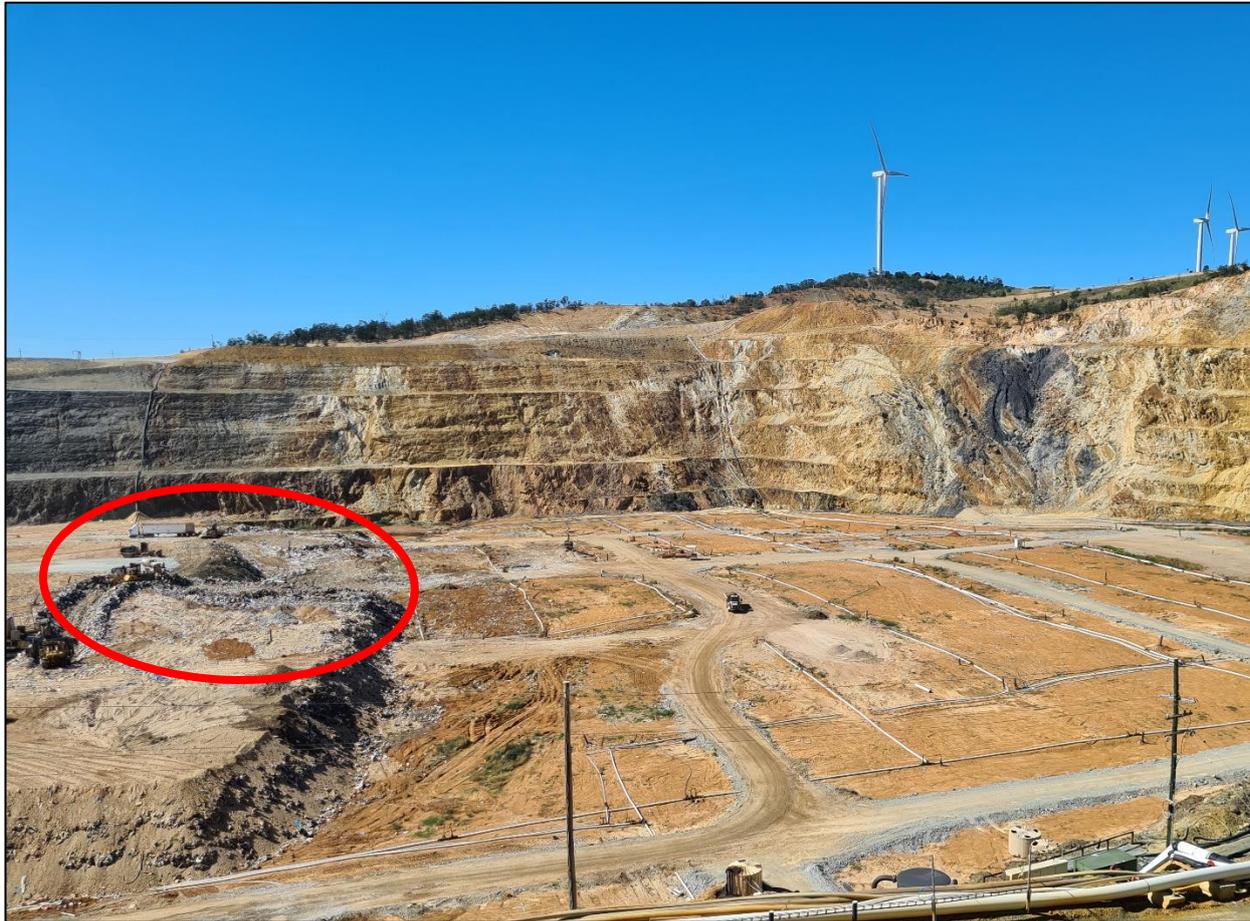
Photo 8.1 - A distant view of the active tipping face area size as found on 9 March 2021

2013 IOA to reflect realistic and previous operating conditions occurring at the time. As of the Audit, the current active tipping area is now approximately between 1,000 m² and 2,000 m², reflecting Veolia's continued efforts at minimising the active tipping face in the Void.
