Veolia Australia & New Zealand

Woodlawn Bioreactor Expansion Project

Independent Odour Audit #9

August 2021

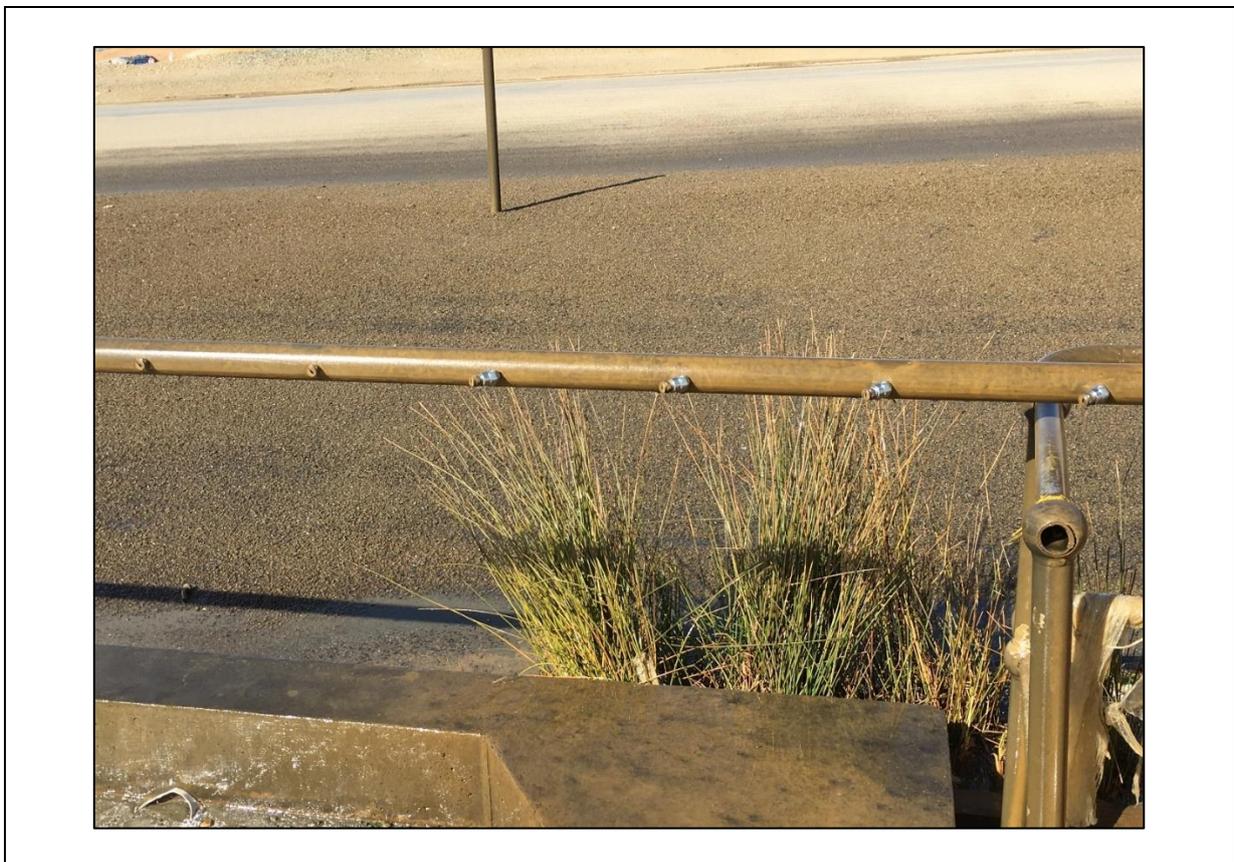
Photo 8.2 – Truck wash bay nozzle optimisation (**Source:** Previous IOA)

- Wheel wash is continuously used for the clean the trucks coming out of the void and the performance of the wheel wash was monitored during operation; and
- Several of the spray nozzles have been modified and changed the spray angle to achieve better coverage (especially the tail of the truck) and washing performance, as shown in **Photo 8.2**. This optimisation will minimise transient levels of odour that may be detectable and associated with truck movement in the community.

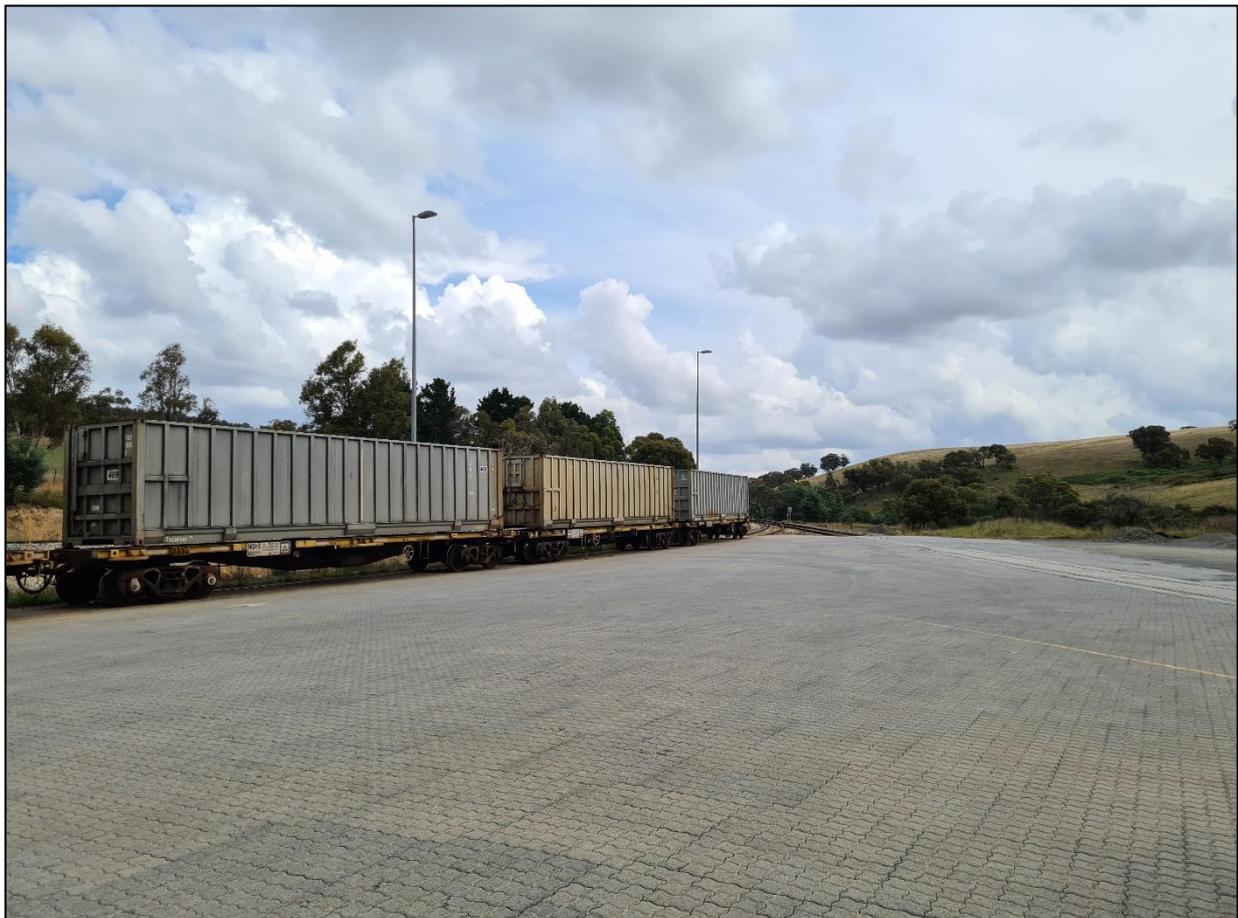
Photo 8.3 - The IMF facing south-west as observed during the Audit inspection visit on 11 March 2021

- The washing practice associated with the sealed containers; and
- The maintenance of the sealed containers.

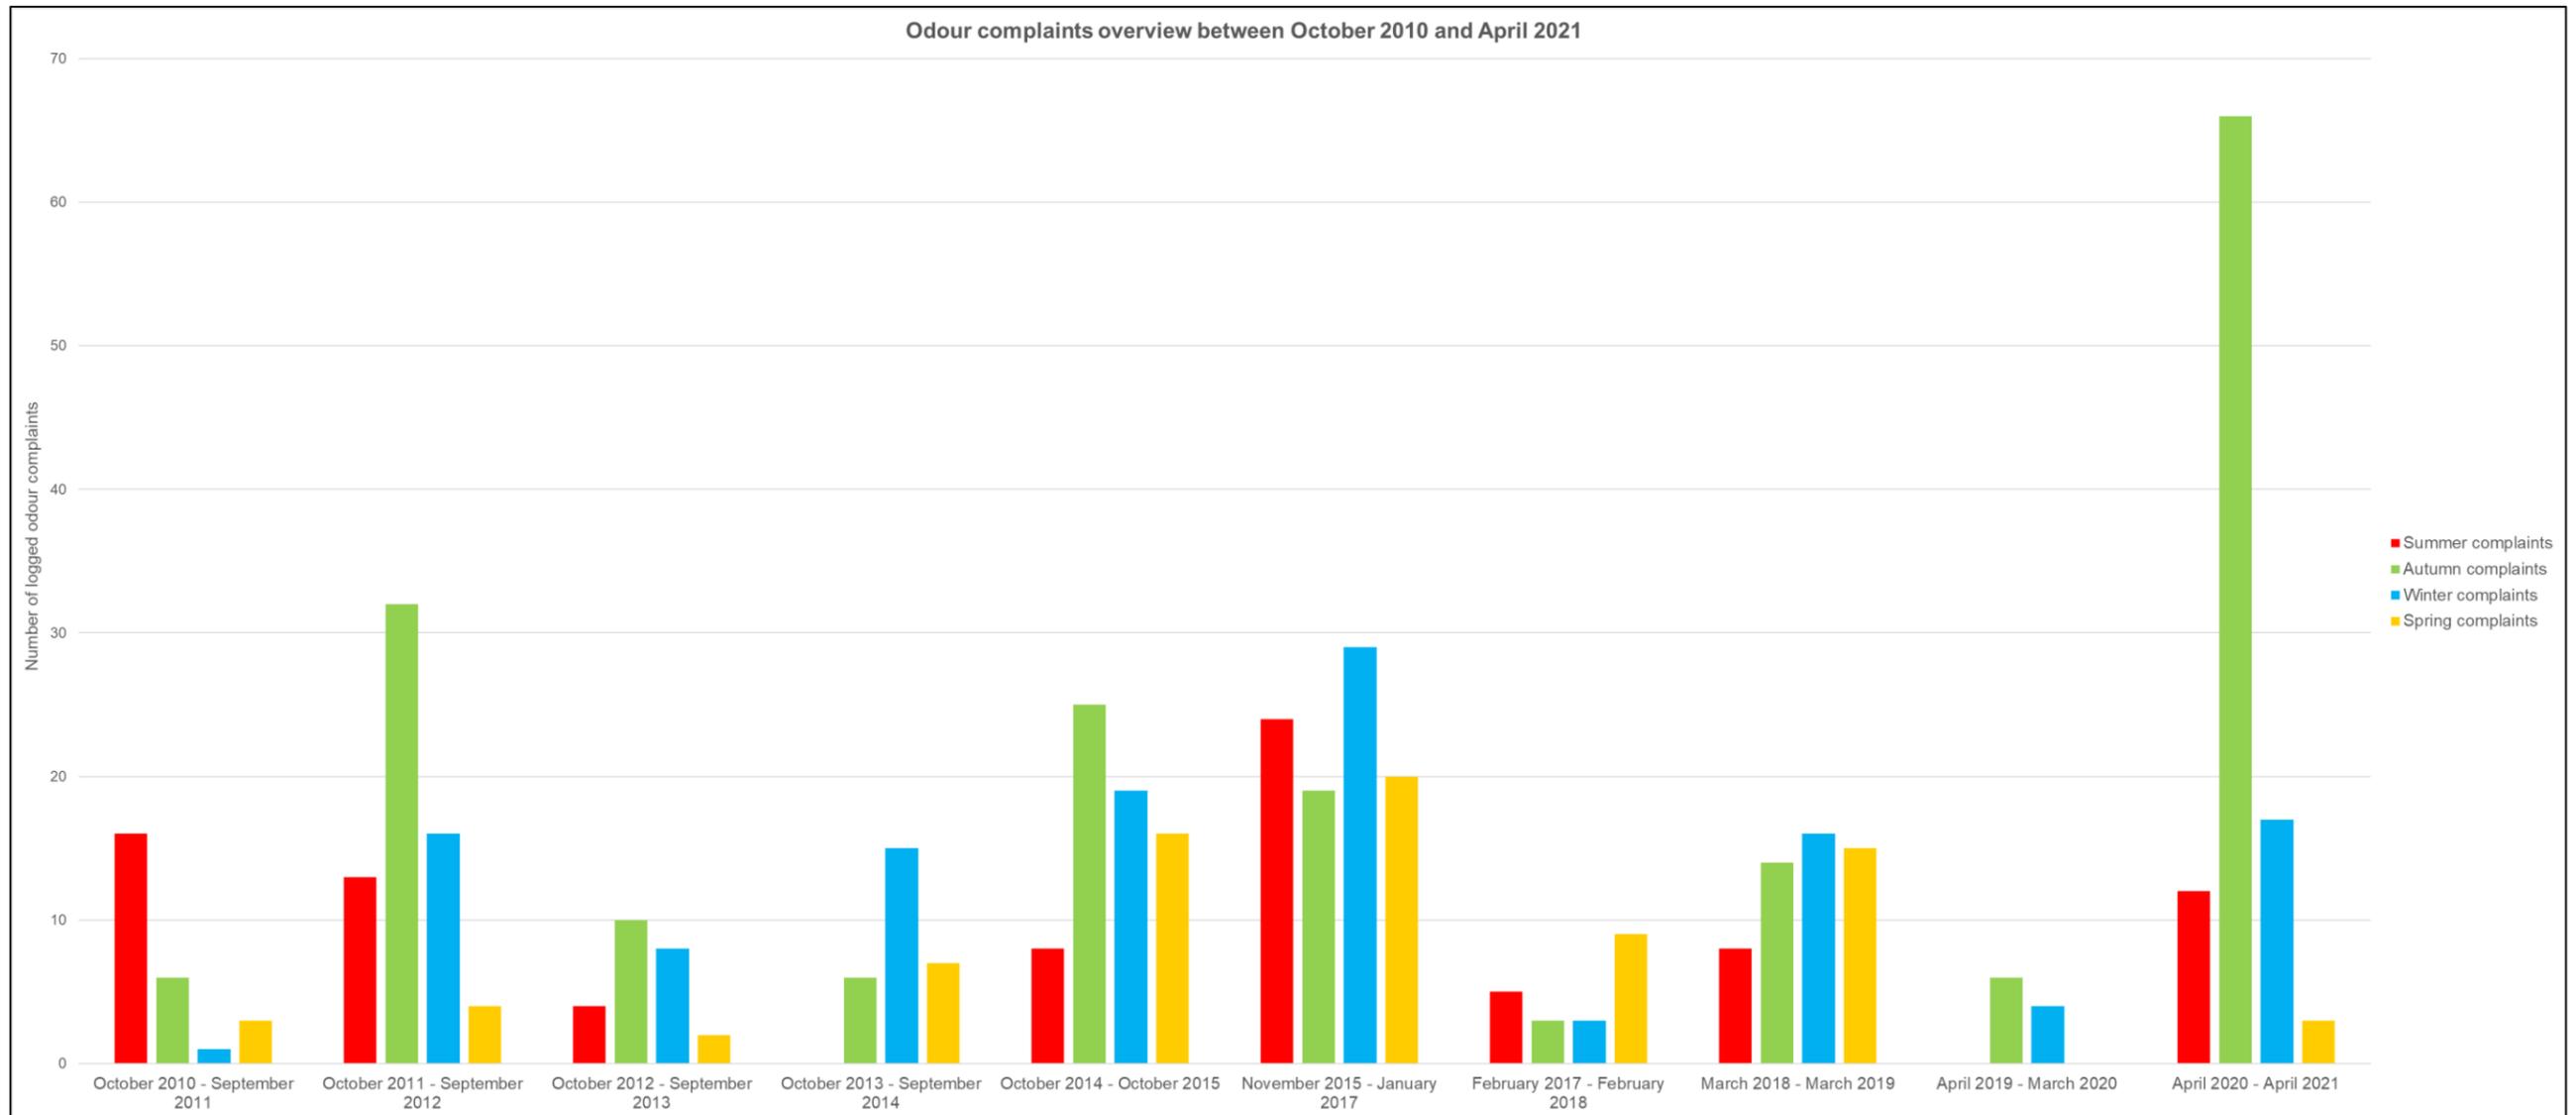
Figure 8.2 - Number of logged odour complaints between October 2010 and April 2021

Despite the significant improvement in landfill gas extraction in the Void and expansion and improvement in the leachate management system through optimisation of surface water catchments, landfill gas infrastructure design, active tipping practices and increased leachate treatment capacity via the commissioning of the LTP, the odour complaints trend appear to reflect the operational challenges associated with the high rainfall conditions over the Audit period (refer to **Section 8.2.1.10.1**). As a result, the Audit recommends that Veolia has intensified engagement with the community through its existing odour complaints and response management strategy. The handling and management of odour complaints will be reassessed in the next IOA to evaluate the need for additional forms of community engagement. As such, the refinement in community engagement remains as a non-mandatory recommendation in the Audit to ensure this matter is provided with the opportunity of continuous improvement (refer to **Section 10.2.4** for more details).

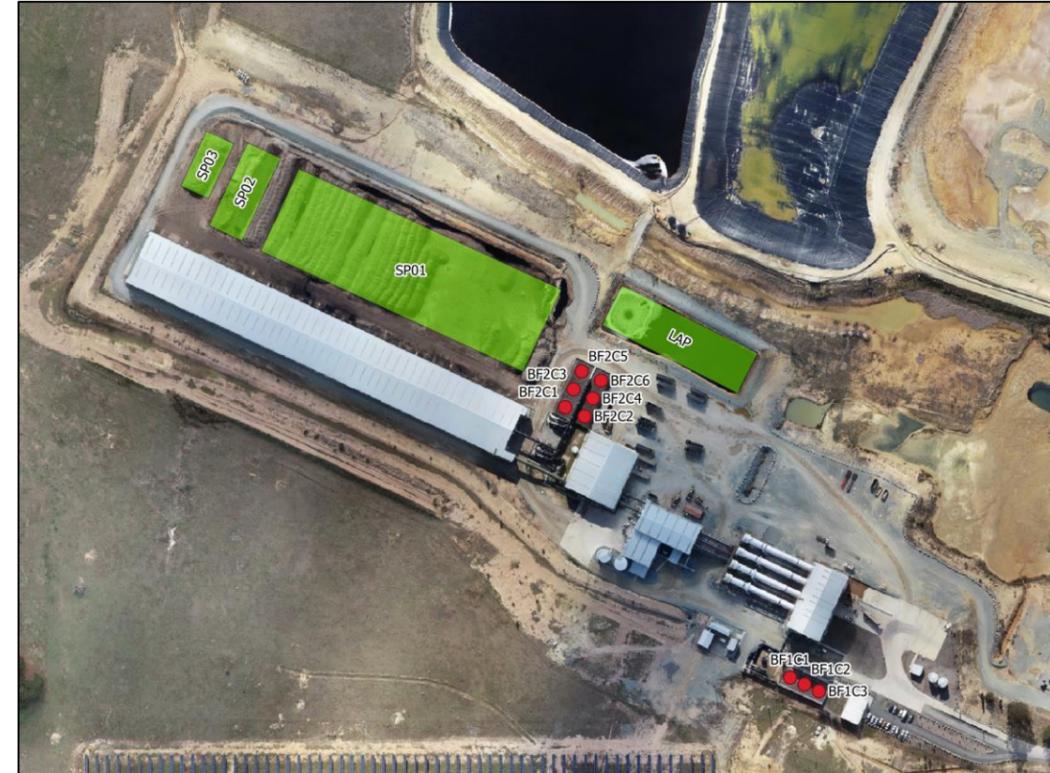
Figure 9.2 – Layout of MBT sources in the Audit

Sources from the previous IOA model had their location and areas corrected (most by minor SOER adjustments), defunct sources were removed, and new sources were added to best represent the present operations reflected in the latest iteration of odour emissions testing for the Audit. The result is illustrated in **Figure 9.1**. It should be noted that odour sources from the MBT Facility and the LTP have been added to the Audit model, shown in **Figure 9.2** and **Figure 9.3**, respectively.

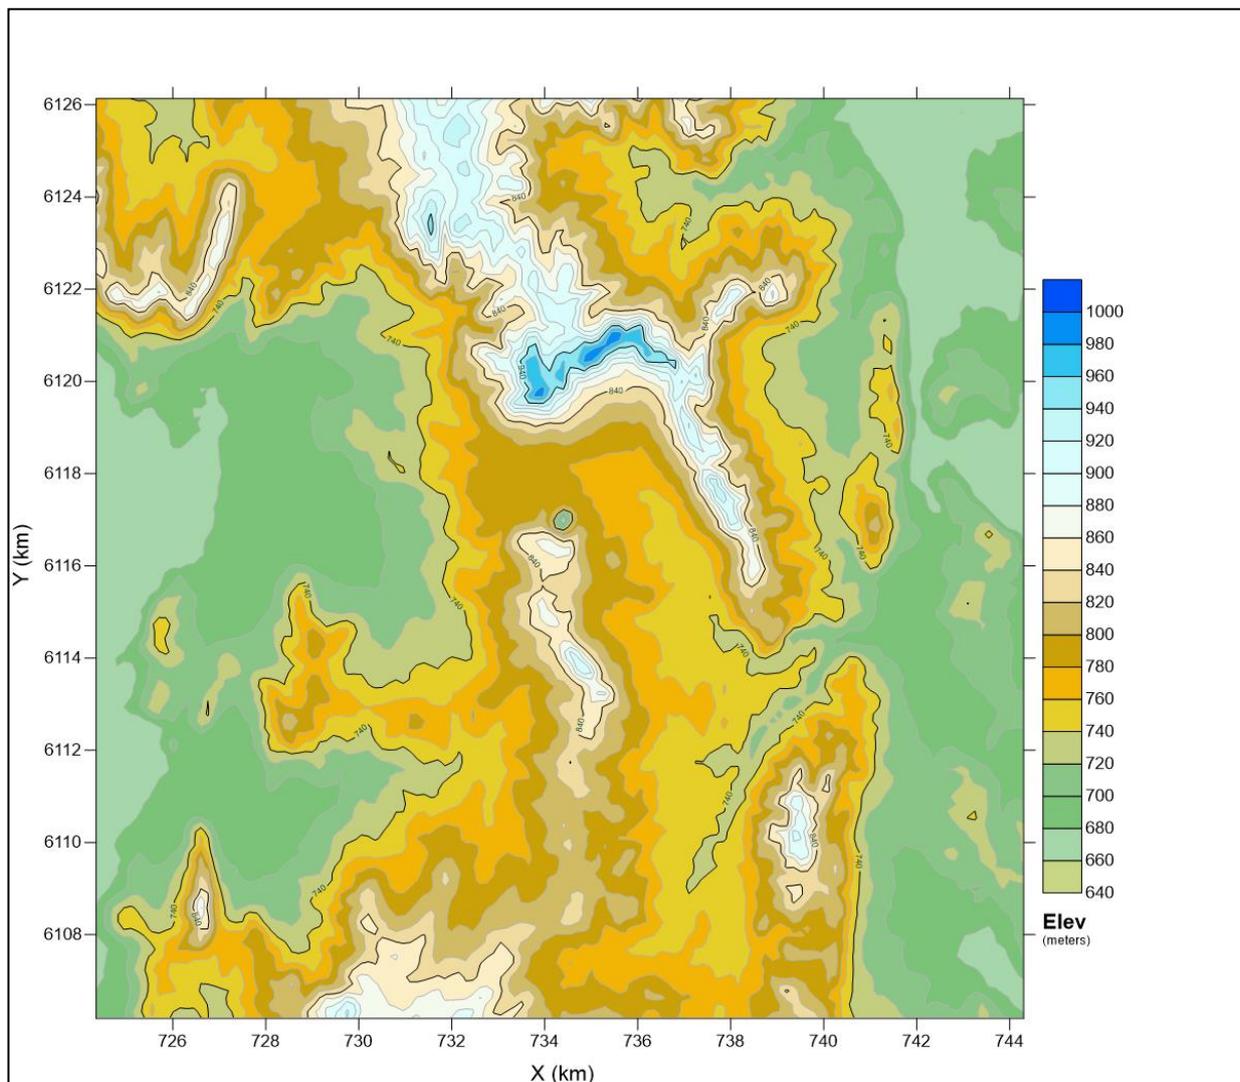
Figure 9.4 - Terrain map of Woodlawn and surrounds

treated with several processes including but not limited to removal of stripes, void filling, tree offset removal and adaptive smoothing. The DEM-S was used as input into TERREL processor to produce 20 kilometres (**km**) by 20 km grid at 0.15 km resolution. A map of the terrain is illustrated in **Figure 9.4**.

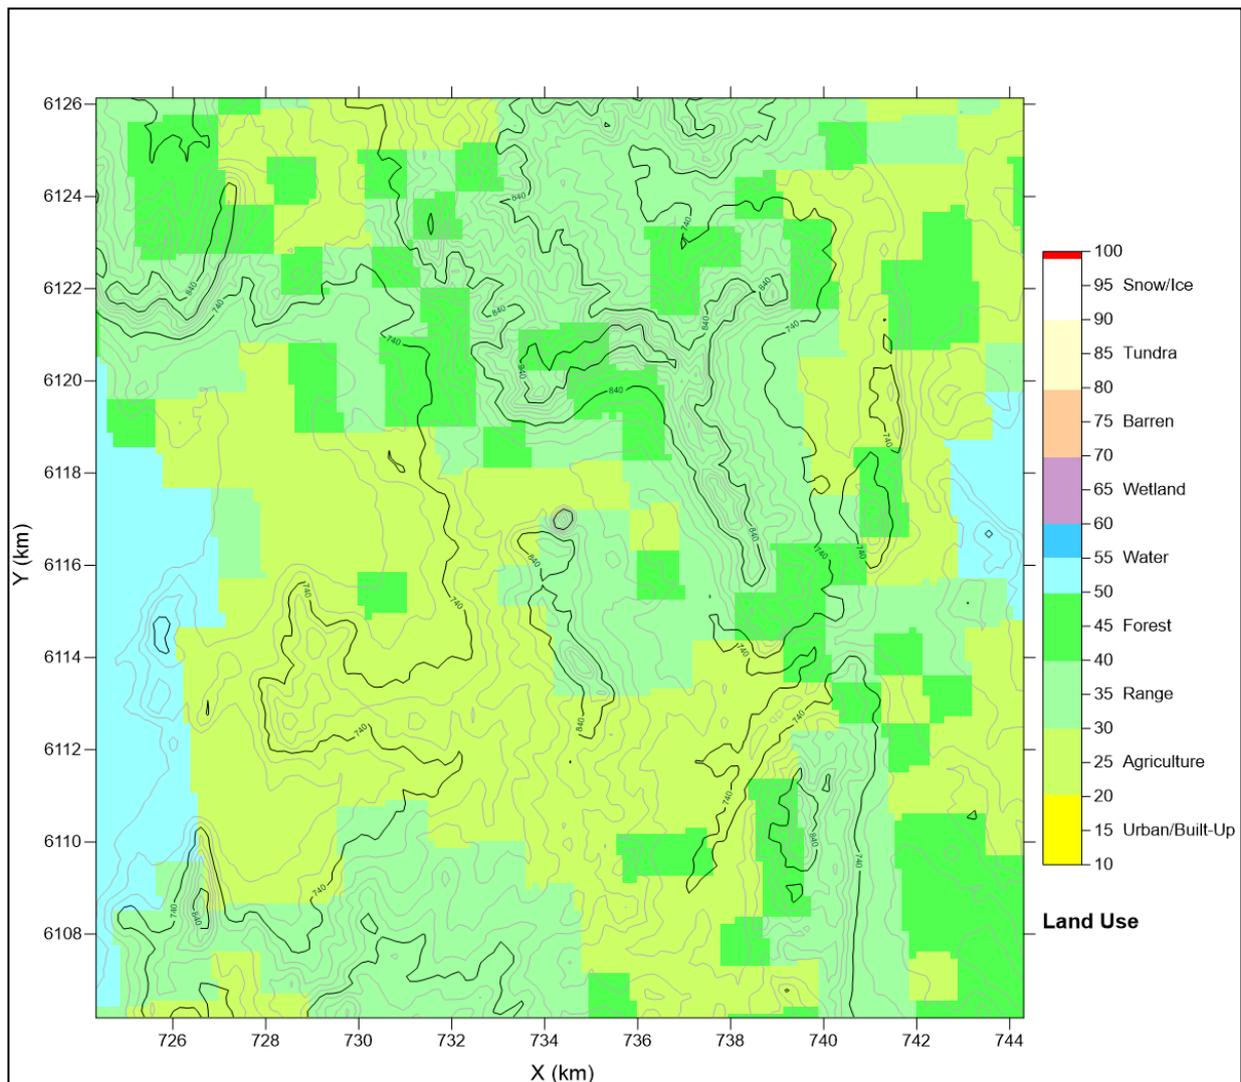
Figure 9.5 – Land use map of Woodlawn and surrounds

The geophysical data file was created using the MAKEGEO processor. Land use data from CTGPROC and terrain data from TERREL was used as input to produce a 20 km by 20 km geophysical grid at 0.15 km resolution.

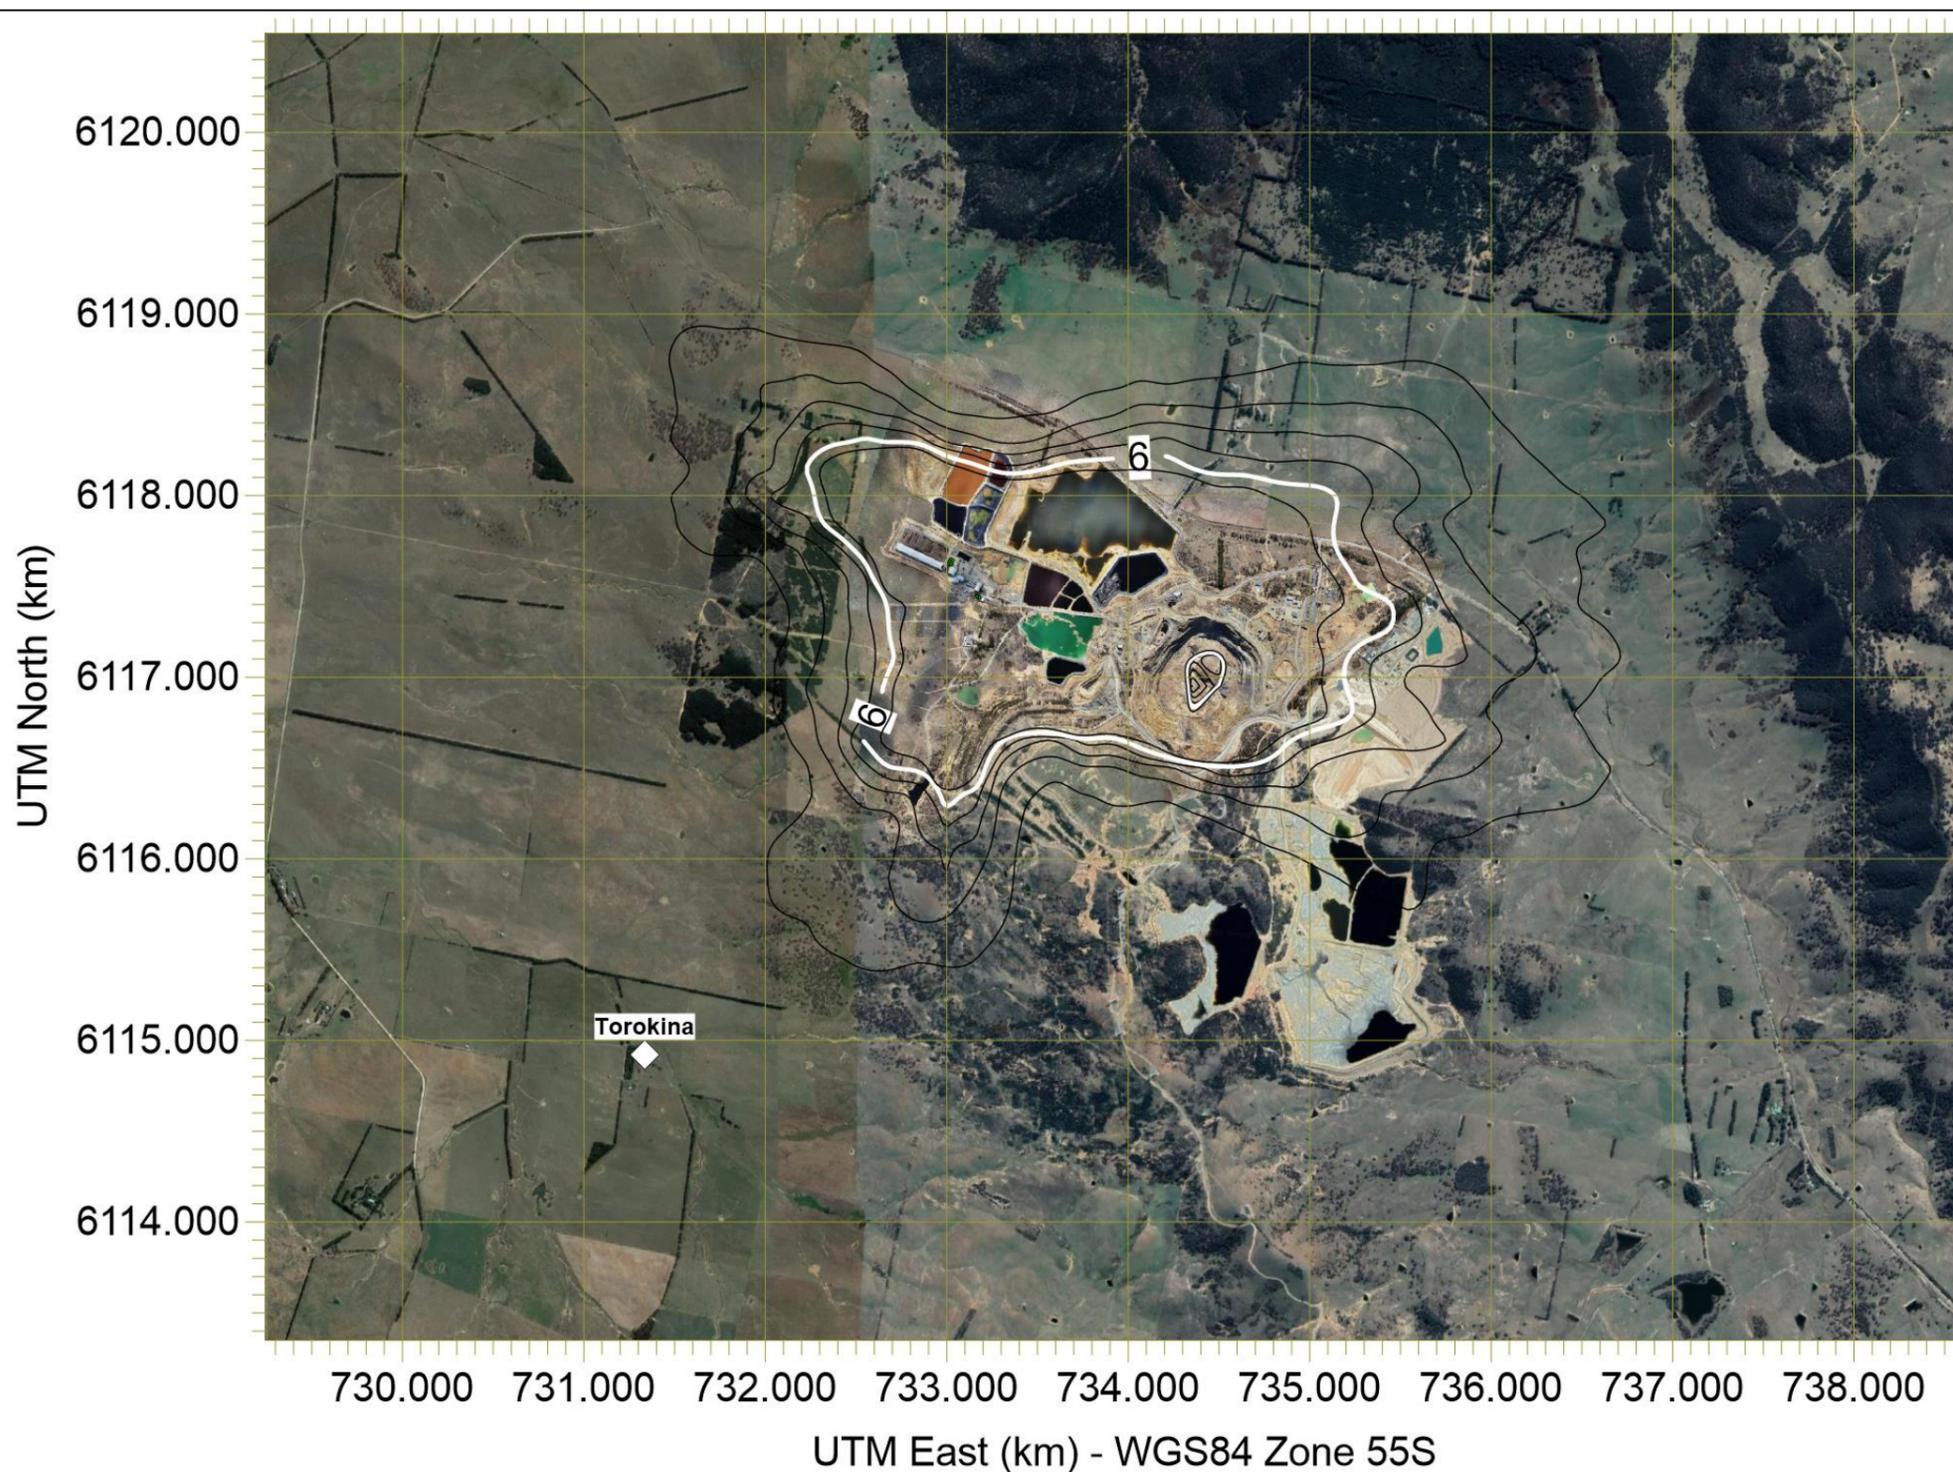
Figure 9.12 - Predicted odour impact from all odour sources of Woodlawn operations

<p>CALPUFF modelling for Veolia Woodlawn Odour Audit #9 Modelled by: S. Hayes 29/07/21 Checked by: M. Assal</p>	<h3>Predicted odour impact from Woodlawn operations</h3>	<p>Ground level odour concentration (ou, 99%, P/M60) 1 ou contour intervals as black, 6 ou contour as white CALMET (Hybrid) 2015 meteorology Odour Audit #9 (2020) meas/est emissions included</p>
--	---	--	--

- **Figure 9.12** - Predicted odour impact from all odour sources of Woodlawn operations;
- **Figure 9.13** - Predicted odour impact from Bioreactor/Leachate and MBT source groups;
