RE: Odour Audit – Veolia Resource Recovery Facility at Wetherill Park

Dear Dora,
Todoroski Air Sciences has conducted an odour audit and odour survey for the Veolia Resource Recovery Facility at Wetherill Park (hereafter referred to as the Project).

The Project is a resource recovery facility that receives and processes up to 500 tonnes per day of both putrescible and non-putrescible general dry and wet waste from commercial premises. The waste material is delivered onsite and deposited within the warehouse where it is sorted and consolidated before being transferred offsite for alternative processing and disposal.

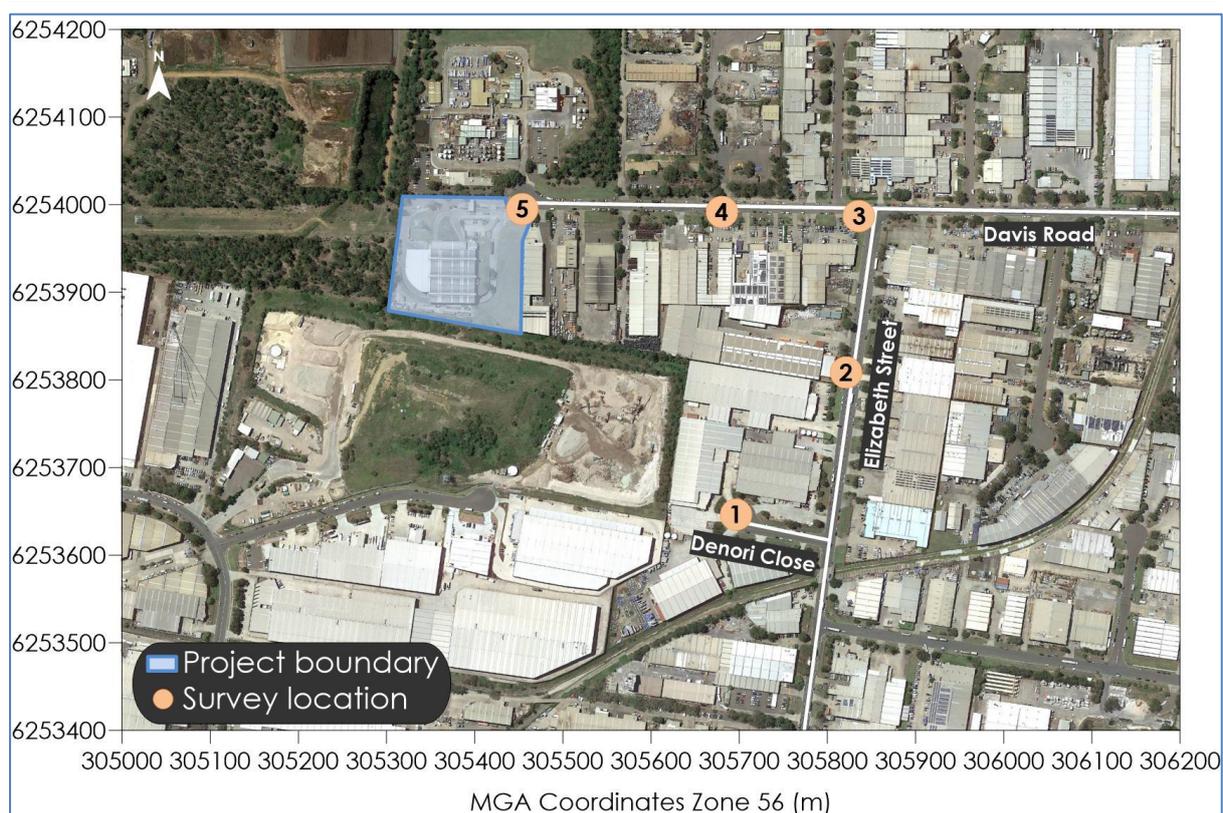
Figure 2: Odour survey monitoring locations

The odour survey locations are shown in **Figure 2**. The odour survey locations on each day are presented in **Table 1**. A portable weather monitor (Kestrel type 5500) was positioned at each survey location to record the prevailing wind conditions for the duration of the monitoring period and to ensure that each location was representative of locations downwind of the Project.

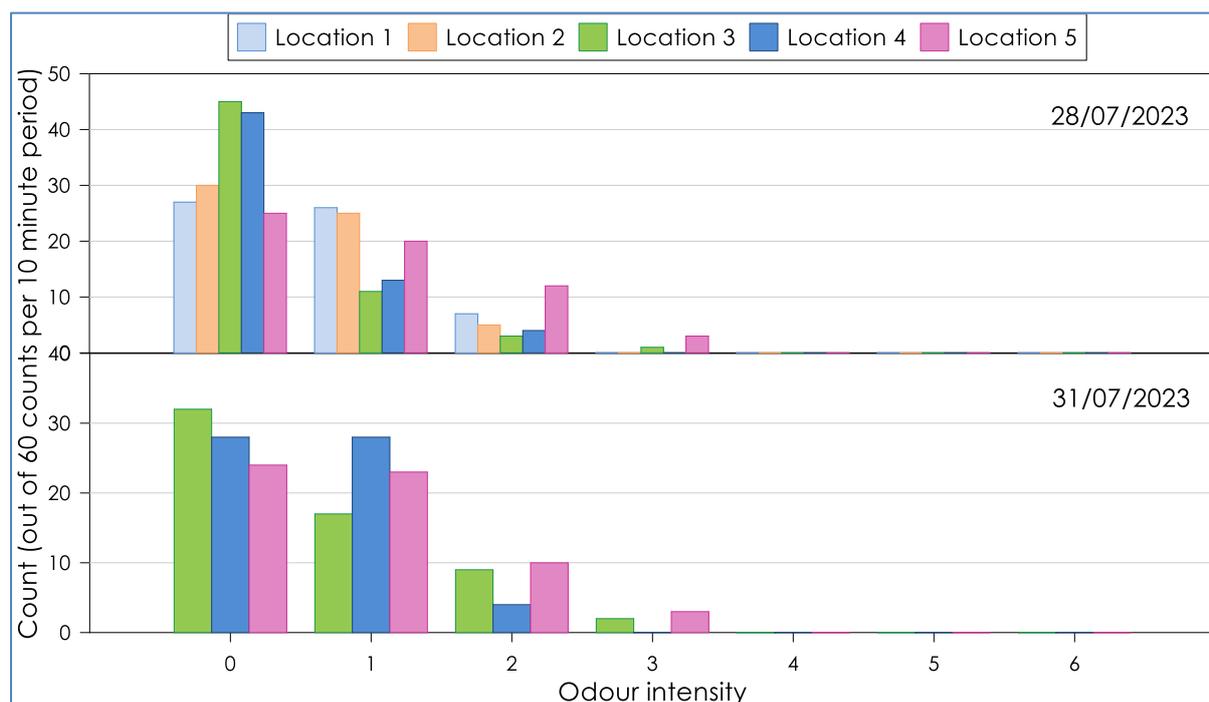
Figure 3: Field odour survey results - Count of odour intensity for garbage odour

Figure 3 presents the count of odour intensity for at each location for each survey period.

While the garbage odour characters are considered to have an unpleasant hedonic tone, as the intensity was predominately very slight to slight (i.e. only just detectable), and the odours frequency and duration were low, it is considered that this odour could not reasonably be perceived as offensive.

Only 3% and 5% of the monitoring period at Location 3 and 5, respectively, was detected at a distinct intensity for garbage odour which is below the 10% VDI threshold for any odour to be considered offensive. The distinct odours at Location 3 were attributed to passing trucks delivering waste material to the site. Location 5 is the site boundary and is anticipated that odour would be detectable at this location.

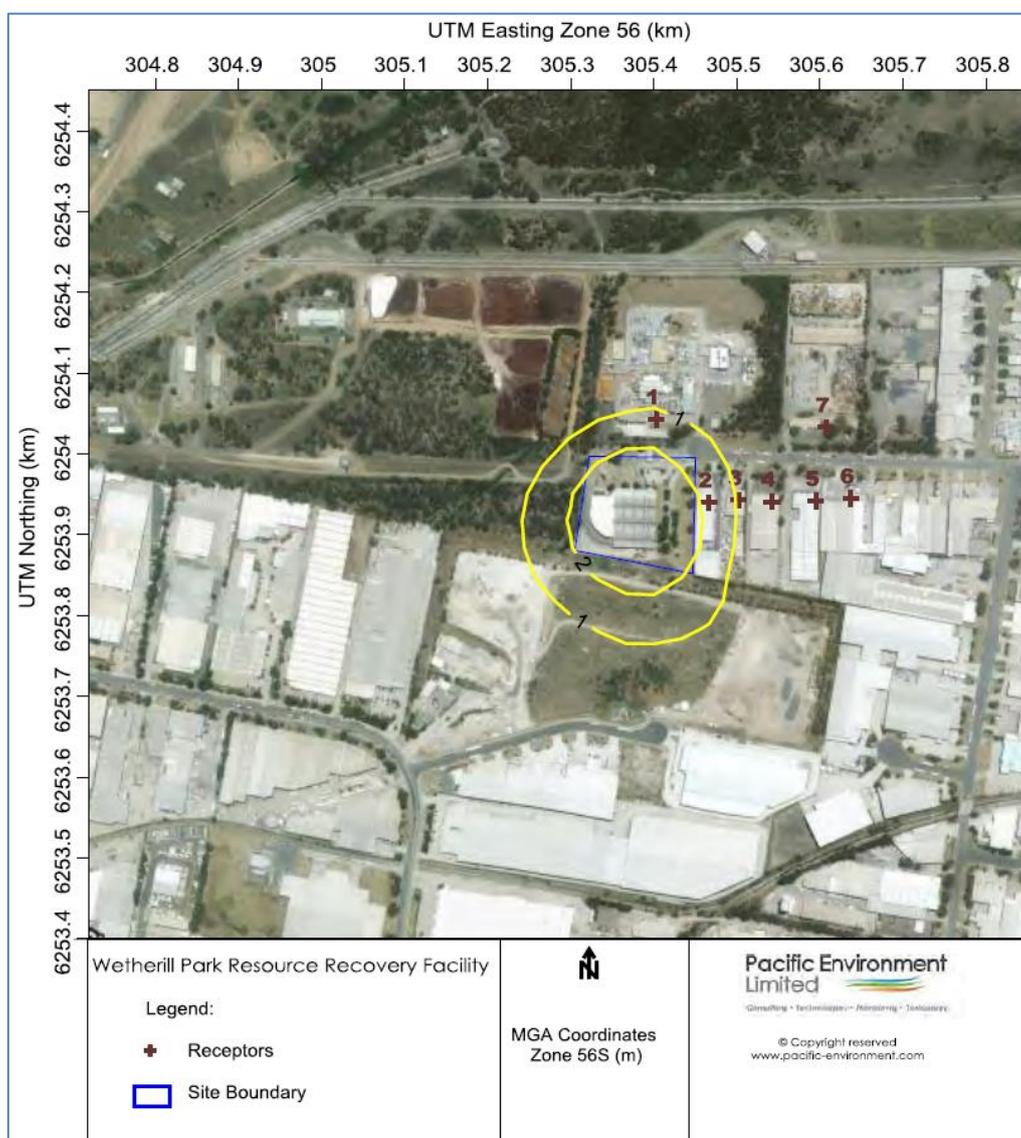
Figure 4: Predicted 99th percentile odour concentrations (Pacific Environment, 2016)

Figure 4 presents the predicted odour concentration as prepared in the odour assessment report. The modelling results show that the odour concentrations will not exceed the 2OU criterion at the nearest industrial receptors immediately adjacent to the Project site.

The odour survey results are considered consistent with the modelling predictions, as odours detected from the Project site were most noticeable at the Project boundary with infrequent and less intensity odours detected at offsite locations, however, as discussed, these odours were due to passing trucks delivering waste material to the site.

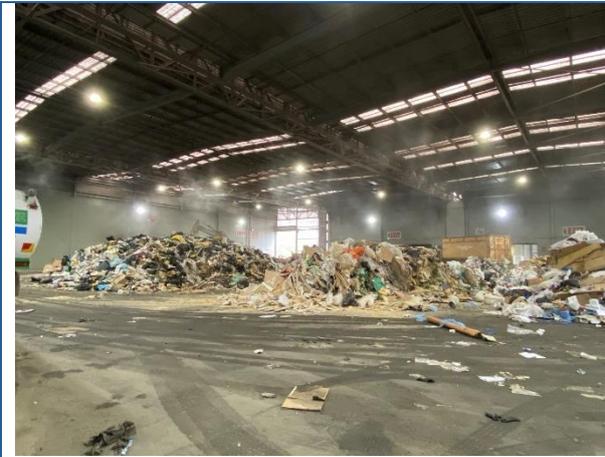
Todoroski Air Sciences identified the key odour emission sources at the site as the waste receive pit and storage area, leachate containment and stormwater pits and vehicles entering and exiting the site. Images of the potential odour sources that were taken during the site audit are presented in **Table 5**.

Waste storage area	Waste pit

The current odour controls, mitigation and management measures are considered to be effective in reducing odour impacts in the surrounding environment. No additional measures are recommended for the site.

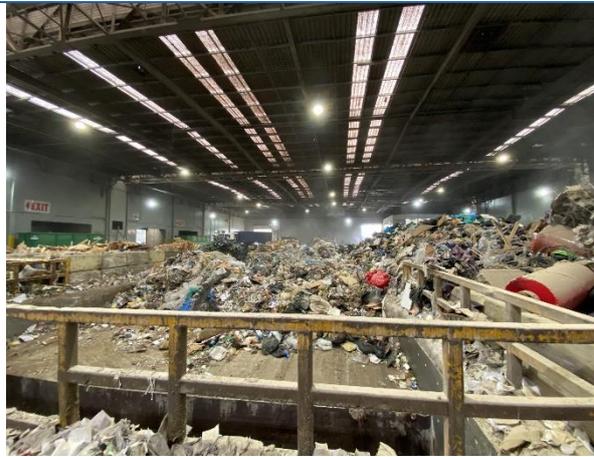
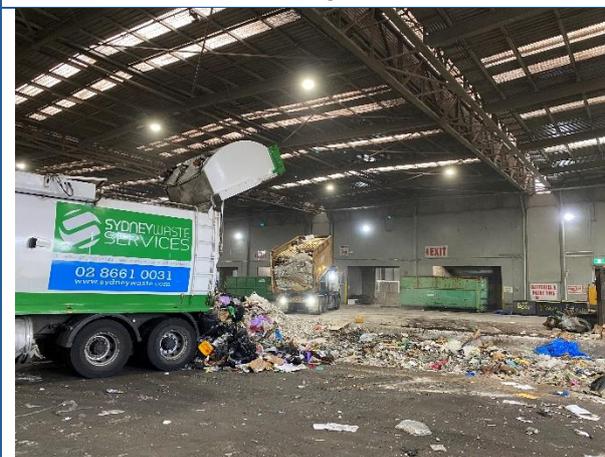
Waste pit	Vehicles entering and exiting the site

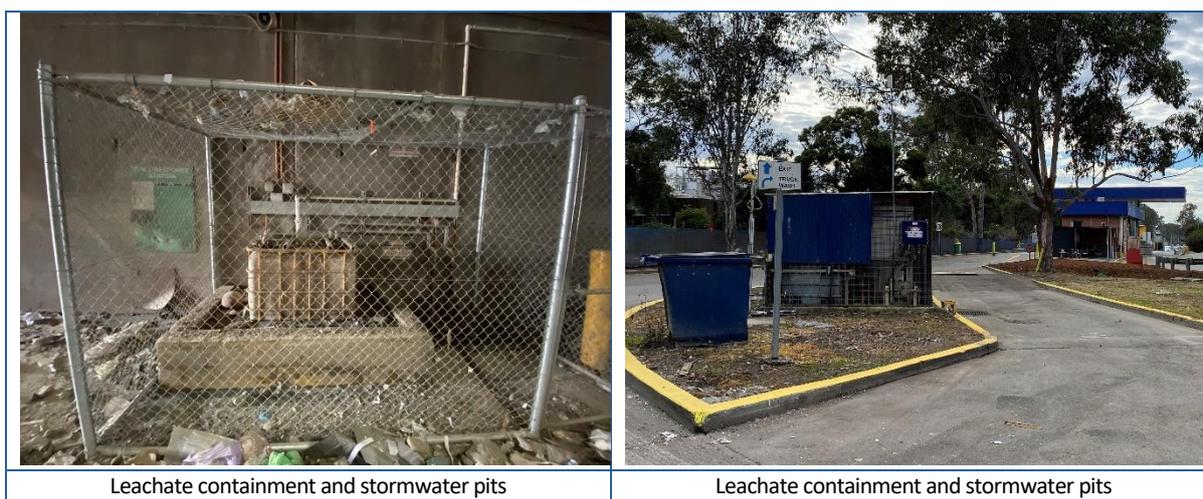
- ✦ Misting sprays and deodorisers are located on the ceiling and roller doors which are operated for 10 to 15 seconds every 45 seconds;
- ✦ Leachate containment and stormwater pits are inspected and tested every 90 days by onsite personnel and routinely maintained every 60 days by an independent contractor;
- ✦ Truck loads covered before entering and exiting the site;
- ✦ Trucks are routinely washed twice a month at the designated truck wash area;
- ✦ Misting sprays are located at the roller door entrances; and,
- ✦ Hardstand areas are swept twice a week and inspected daily.
