# Annual Environmental Management Report - Camellia Materials Recycling Facility 2022-2023

<b>Name of operation</b>	Camellia Materials Recycling Facility
<b>Name of operator</b>	Veolia Environmental Services (Australia) Pty Ltd
<b>Development consent / project approval #</b>	SSD 4964
<b>Name of holder of development consent / project approval</b>	Veolia Environmental Services (Australia) Pty Ltd
<b>Mining lease #</b>	N/A
<b>Name of holder of mining lease</b>	N/A
<b>Water licence #</b>	N/A
<b>Name of holder of the water licence</b>	N/A
<b>MOP/RMP start date</b>	N/A
<b>MOP/RMP end date</b>	N/A
<b>Annual Review start date</b>	6 July 2022
<b>Annual Review end date</b>	5 July 2023
<p><b>I, Anae Ressos, certify that this audit report is a true and accurate record of the compliance status of Camellia Materials Recycling Facility for the period 2022-2023 and that I am authorised to make this statement on behalf of Veolia.</b></p> <p><i>Note:</i></p> <p>a) <i>The Annual Review is an 'environmental audit' for the purposes of section 122B(2) of the Environmental Planning and Assessment Act 1979. Section 122E provides that a person must not include false or misleading information (or provide

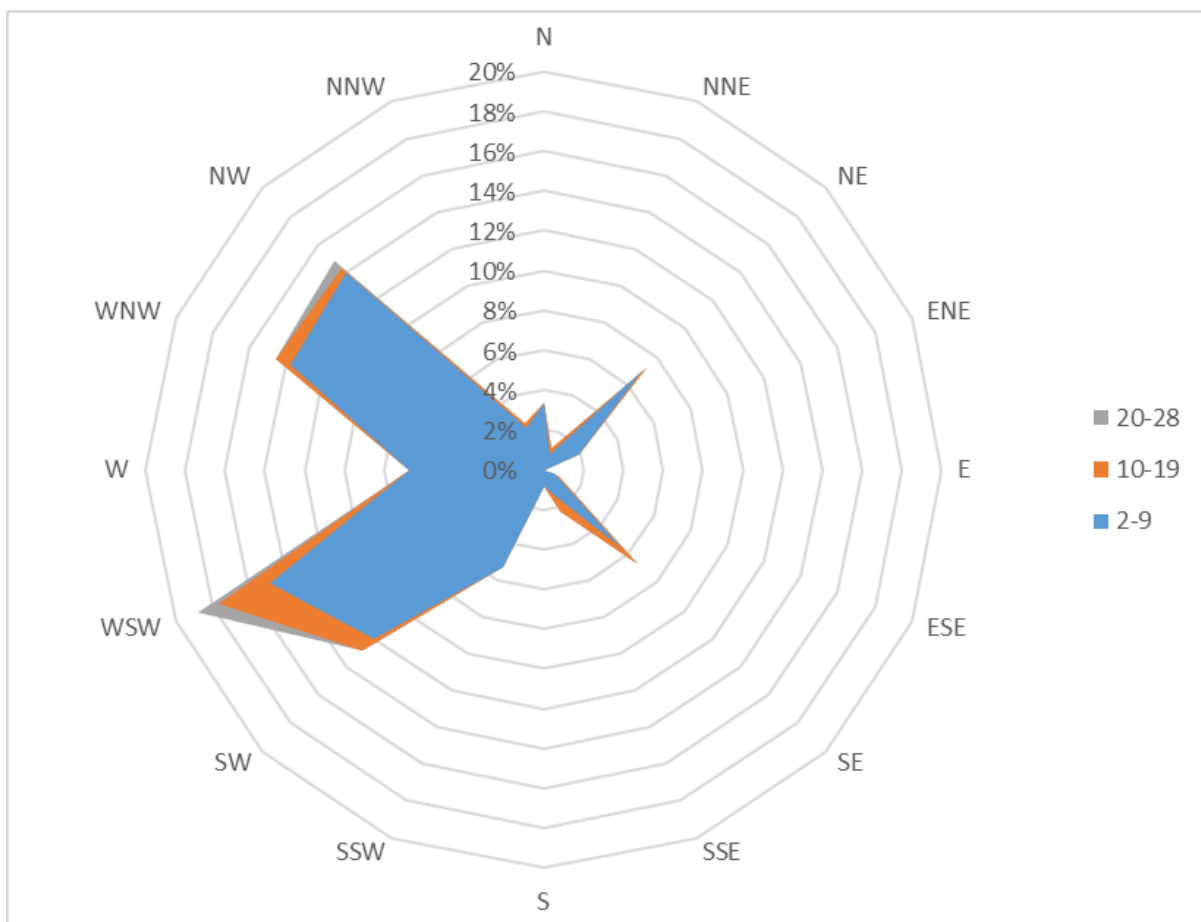
**Figure 2.1** Distribution of 9AM wind speed and direction data during the reporting period

A summary of daily wind speeds and wind directions at 9am at the nearby BoM weather station is presented in Figure 2.1 and Figure 2.2. During the reporting period, the 9am prevailing wind directions were predominantly north westerly and south westerly and the wind speeds were most frequently between 2 - 9 m/s.

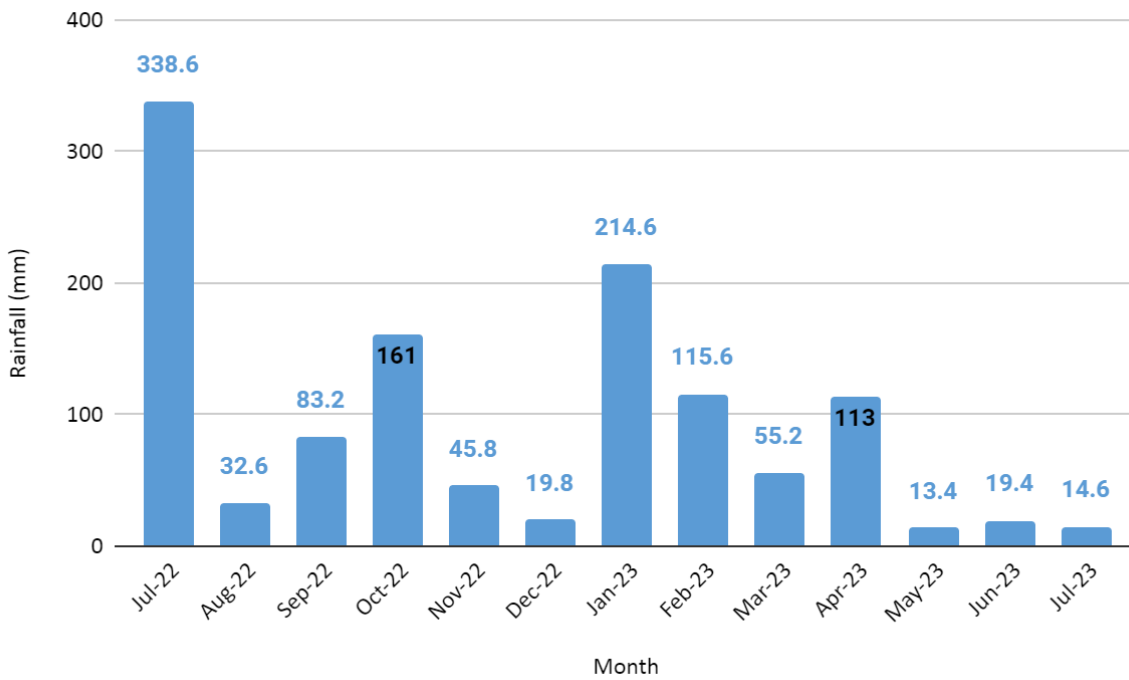
Figure 2.2 Monthly rainfall data during the reporting period

A summary of rainfall data at the Site during the reporting period is presented in Figure 2.2. Overall, the average rainfall for the Site during the reporting period was approximately 94.3mm per month. Significant rainfall (338.6mm in total) was observed during July 2022.
