A site audit was conducted on 2 September 2025 to identify the potential odour and noise sources and current odour and noise control measures.

This report has investigated the potential for odour and noise impacts associated with the Veolia Spring Farm Resource Recovery Park at Spring Farm.

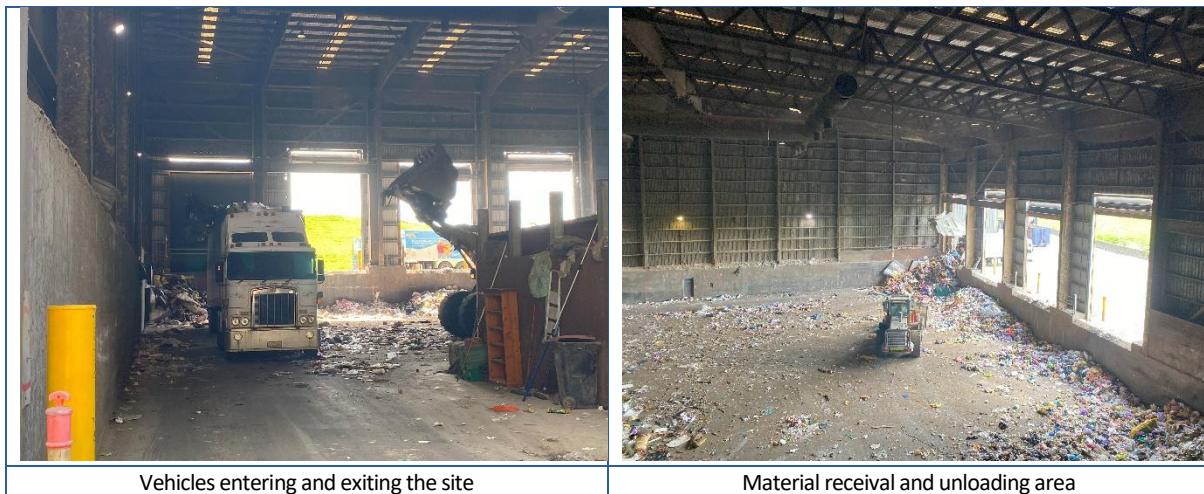
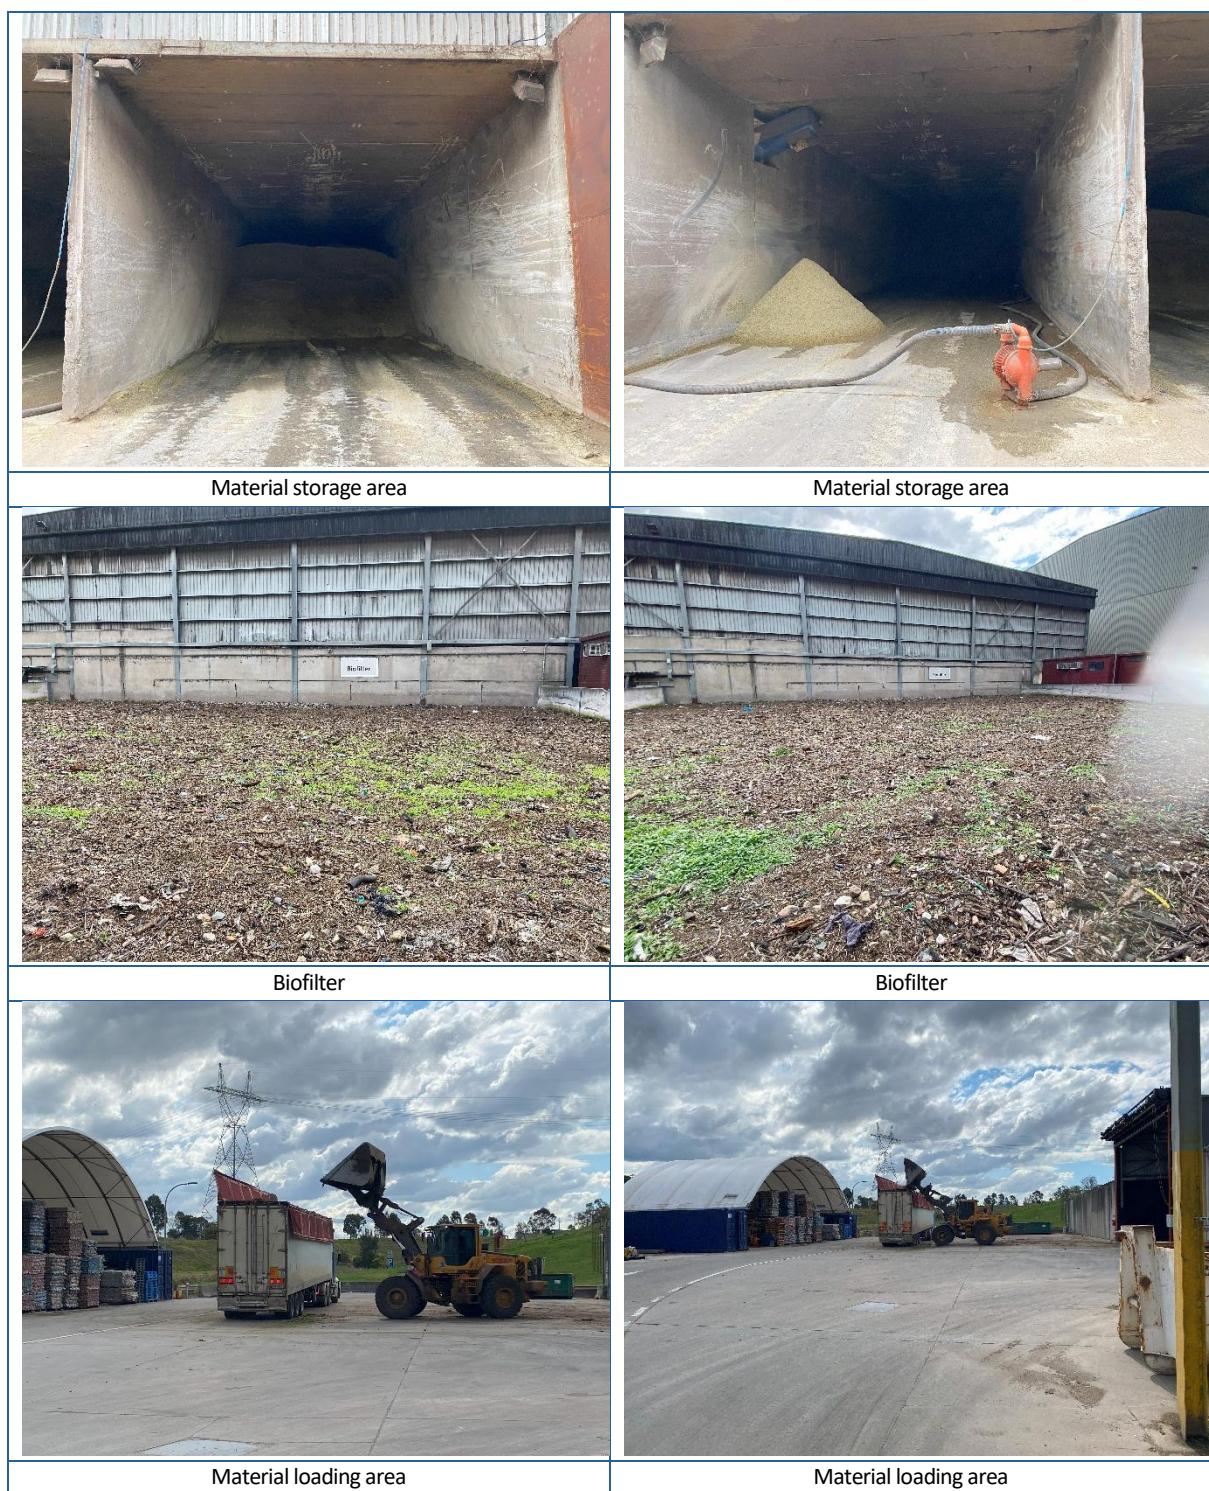
Figure 9: Potential odour and noise sources

Todoroski Air Sciences identified the key odour and noise emission sources at the site as the material receival and unloading/loading area, vehicles entering and exiting the site, biofilter, storage bunkers, the MRF screening processing plant, ARRF processing area, and the glass processing plant.

Images of the potential odour and noise sources that were taken during the site audit are presented in **Figure 9**.

The odour survey results identified sour garbage odours as the most prevalent at the Project boundary, with no such odours detected at offsite locations, apart from passing waste trucks associated with waste material delivery to the site. A site inspection determined that the primary source of odour was likely attributable to materials being received and unloaded at the site. Attended noise monitoring confirmed that noise from the Project was not audible at any of the offsite monitoring locations and were below the applicable criterion.

The current odour and noise controls, mitigation and management measures are considered to be effective in reducing odour and noise impacts in the surrounding environment. No additional measures are recommended for the site.
