# Annual Environmental Management Report

Clyde Transfer Terminal

March 2017

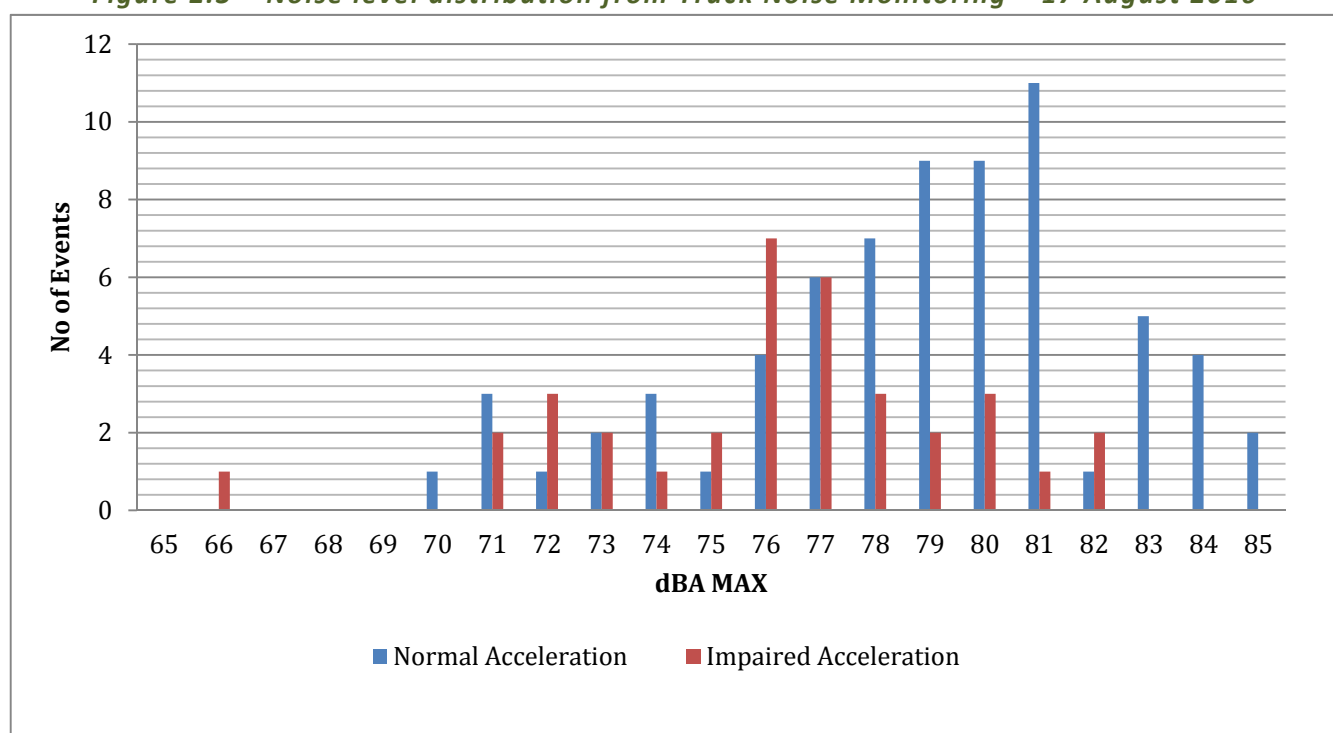
**Figure 2.3 – Noise level distribution from Truck Noise Monitoring – 17 August 2016**

One round of truck noise monitoring was undertaken in accordance with Consent Condition 112 for this reporting period. Noise levels of 108 truck movements out of a daily total of 317 truck movements were measured, equivalent to 34% of truck movements. A summary of the results is illustrated in **Figure 2.3**. Further details regarding truck movements at the site is discussed in Section 2.4.1.

A detailed truck noise monitoring report can be found in **Appendix C3** for the 2016-2017 reporting period. There were no registered noise complaints from either industrial or residential neighbours throughout this reporting period

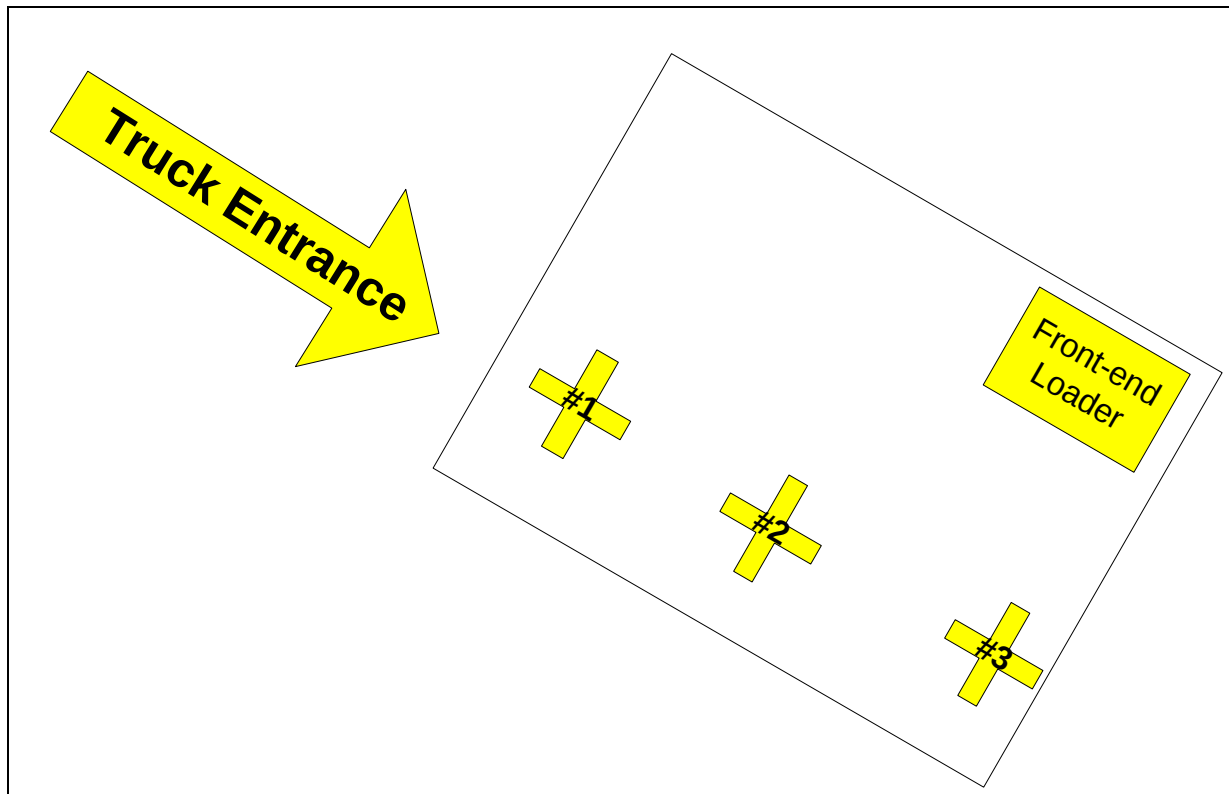
**Figure 2.1** - Smoke testing release points within the TTB on 18 May 2016

As per previous audits, smoke testing was carried out within the TTB to assist in determining the effectiveness of the forced air extraction system, as well as the extent to which the TTB has been sealed from leaks. Smoke was released from within the building from three (3) different points within the TTB. **Figure 2.1** shows the three points where the smoke was released. These are identical locations to that of previous Odour Audits. **Photo 2.3** shows smoke testing at one of the test locations on 18 May 2016.

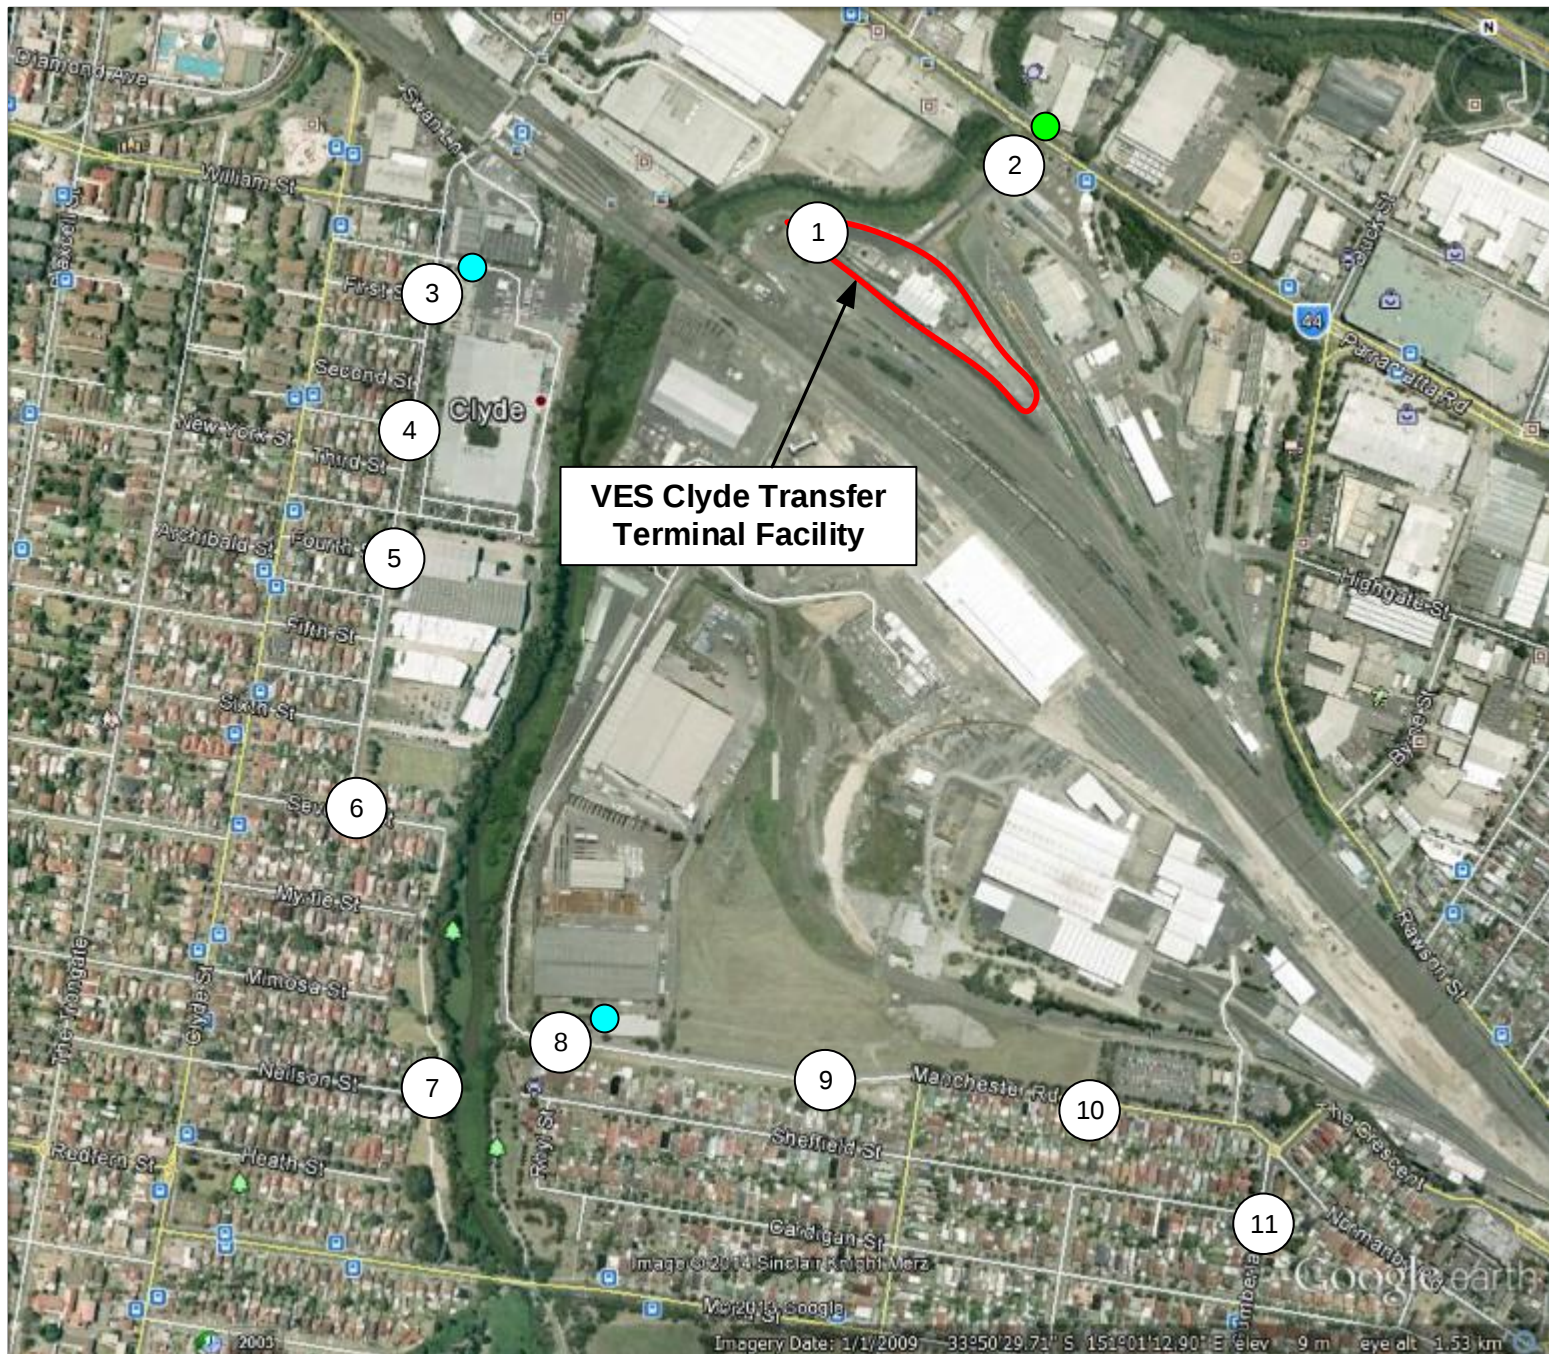
**(18 May 2016)**

The results of the odour audits indicate that the Terminal generally complies with Consent Condition 48E which states that odour at the Terminal shall not exceedance 2OU at the nearest receiver, with exception to Points 4 and 8 during the May odour audit (18/05/2016).

Despite this exceedance, the TOU noted that a fire at a nearby factory (11 Highgate Street, Auburn) was occurring during the time of the odour audit and may have affected general ambient air quality in the region.

It should also be noted that the prevailing wind direction at the time of the audit was in a West to South-Western direction which flows from Highgate Street towards Points 4 and 8, as illustrated within the audit's Field Ambient Odour Assessment Survey.

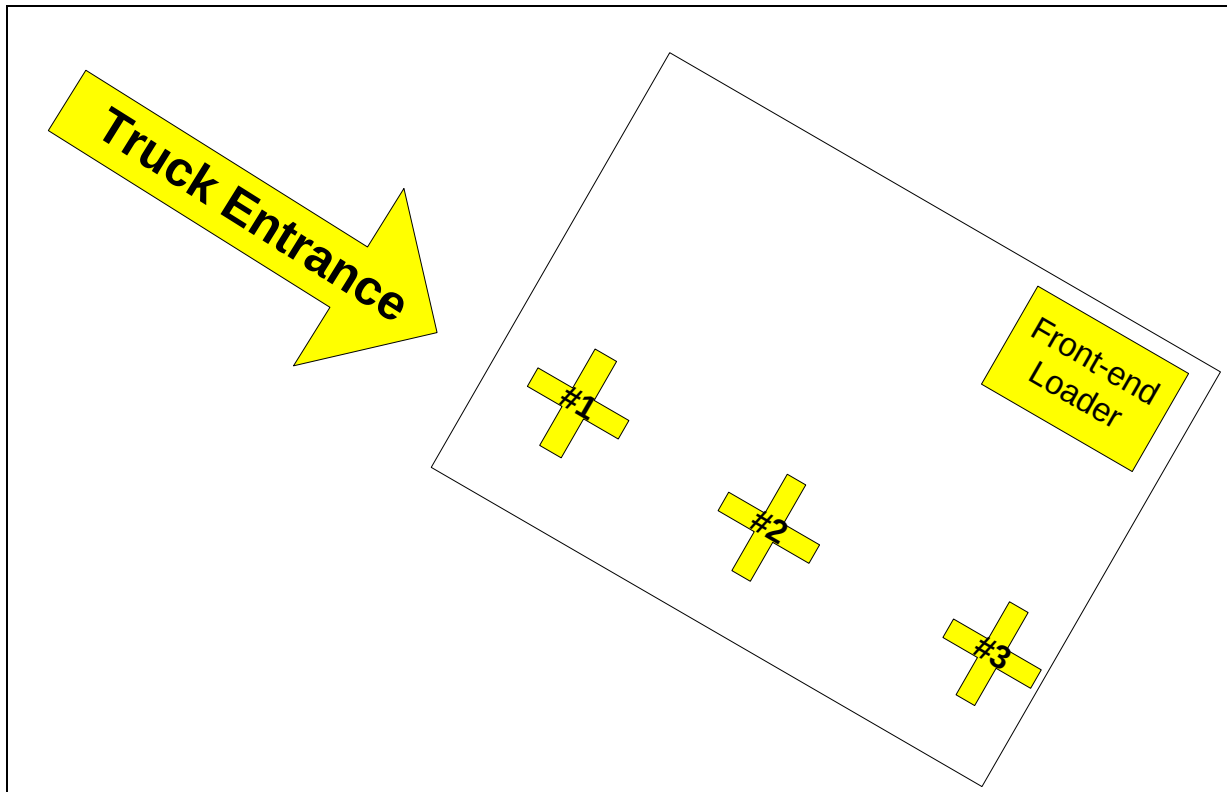
**Figure 2.1** - Smoke testing release points within the TTB on 9 November 2016

As per previous audits, smoke testing was carried out within the TTB to assist in determining the effectiveness of the forced air extraction system, as well as the extent to which the TTB has been sealed from leaks. Smoke was released from within the building from three (3) different points within the TTB. **Figure 2.1** shows the three points where the smoke was released. These are identical locations to that of previous Odour Audits. **Photo 2.4** shows smoke testing at one of the test locations on 9 November 2016.

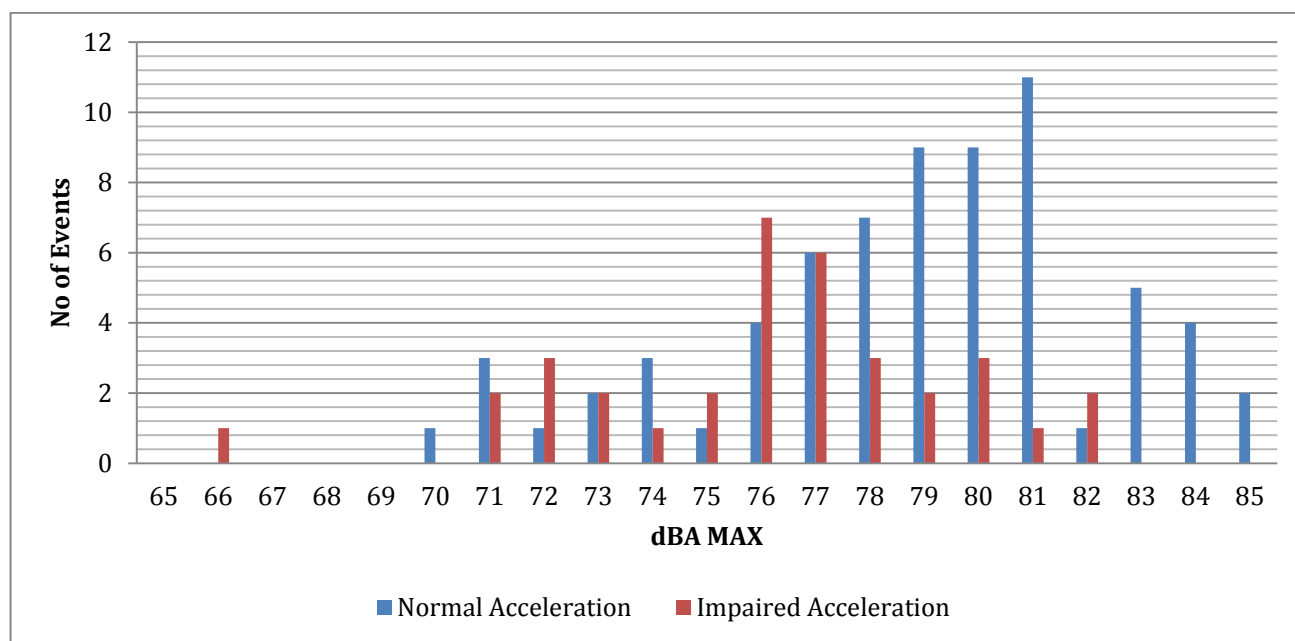
**Figure 1:** Noise level distribution from Truck Noise Monitoring – 17 August 2016

A total measurement of 34.07% of all truck movements (317) was achieved during this monitoring round, which satisfies the minimum requirements of Condition 112 (25% of daily truck movements).

Figure 1 presents the distribution of recorded sound level frequencies which were measured in A-weighted decibels (dBA). Measurements of 'normal' truck acceleration ranged from 70.1dBA to 85.9dBA with the highest frequency occurring between 76dBA to 80dBA. Impaired acceleration readings due to the impeded traffic conditions ranged from 65.2dBA to 81.2dBA. Impaired acceleration readings were plotted separately from the normal accelerating vehicles on Figure 1.
