# Annual Environmental Management Report - Clyde Transfer Terminal 2018-2019

Veolia has prepared this AEMR in accordance with Consent Condition 58 and 59 of the Development Consent DA 205-08-01 (the Consent) and subsequent modifications, as well as relevant legislative requirements and industry best practices.

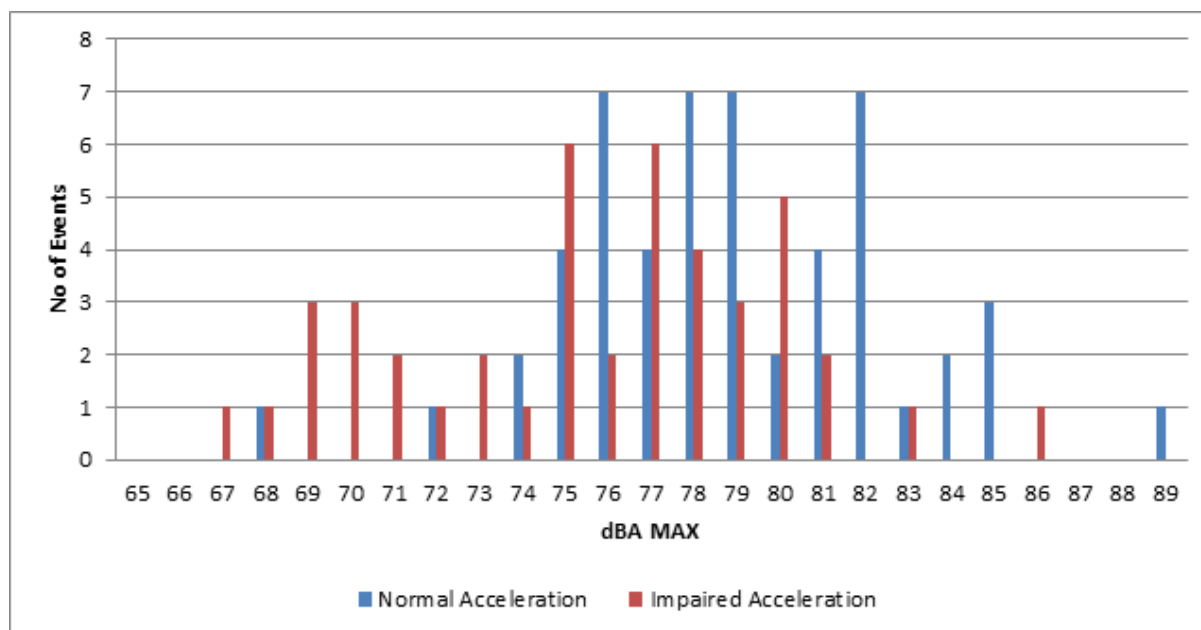
*Figure 2.3 - Noise level distribution from Truck Noise Monitoring - 16 August 2018*

All trucks monitoring were between 66 dBA to 85.4 dBA, where most fell within or below the thresholds of 81 to 87 dBA for Heavy Goods Vehicles with a GVM > 12 tonne in accordance with the Australian Design Rules (ADR) 28/01, with the exception of one truck that exceeded the noise level criteria. Refer below to **Table 2.7** for the truck noise exceedance recorded.

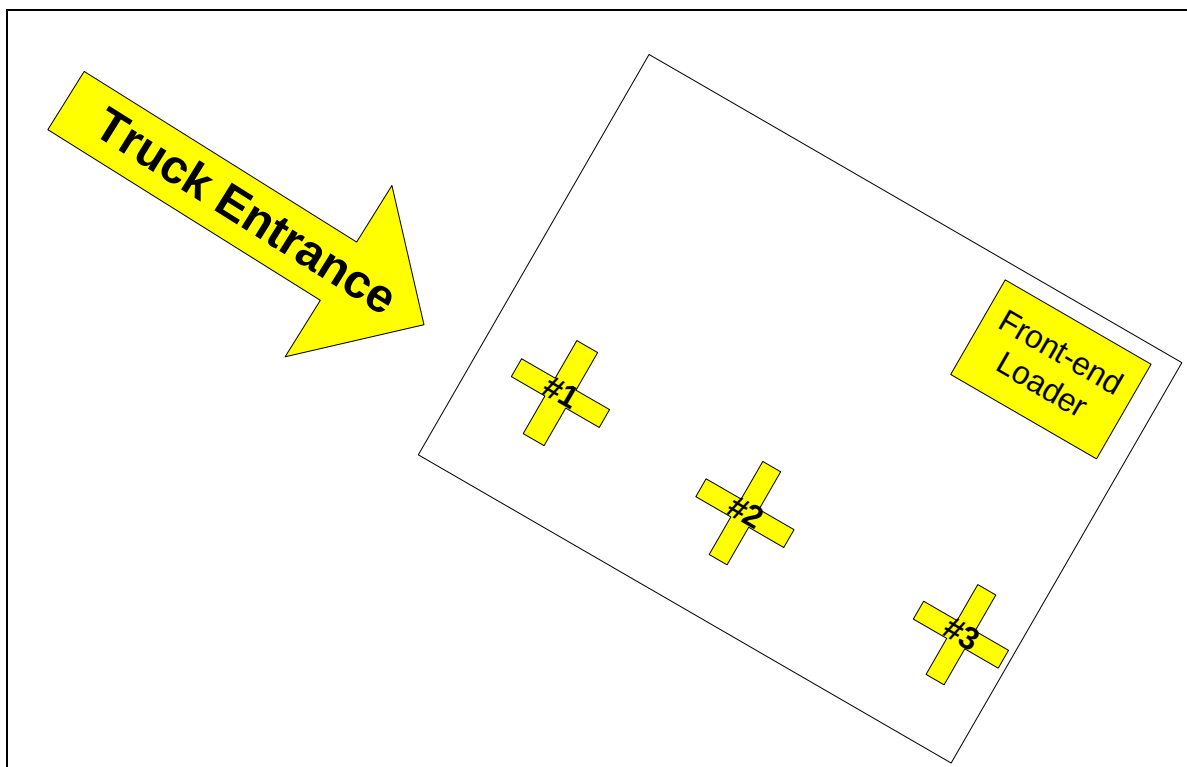
**Figure 2.1 - Smoke testing release points within the TTB on 24 May 2018**

As per previous audits, smoke testing was carried out within the TTB to assist in determining the effectiveness of the forced air extraction system, as well as the extent to which the TTB has been sealed from leaks. As per previous audits, smoke was released from within the TTB at three points within the TTB. For the Odour Audit visit, an additional smoke testing point outside of the truck entrance was completed to assist with the observations made from smoke testing within the TTB (discussed in **Section 2.1.8.1**). **Figure 2.1** shows the three points where the smoke was released within the TTB. **Photo 2.5** and **Photo 2.6** shows smoke testing at one of the test locations (Smoke Testing Point #2) and outside of the truck entrance as occurred on 24 May 2018.

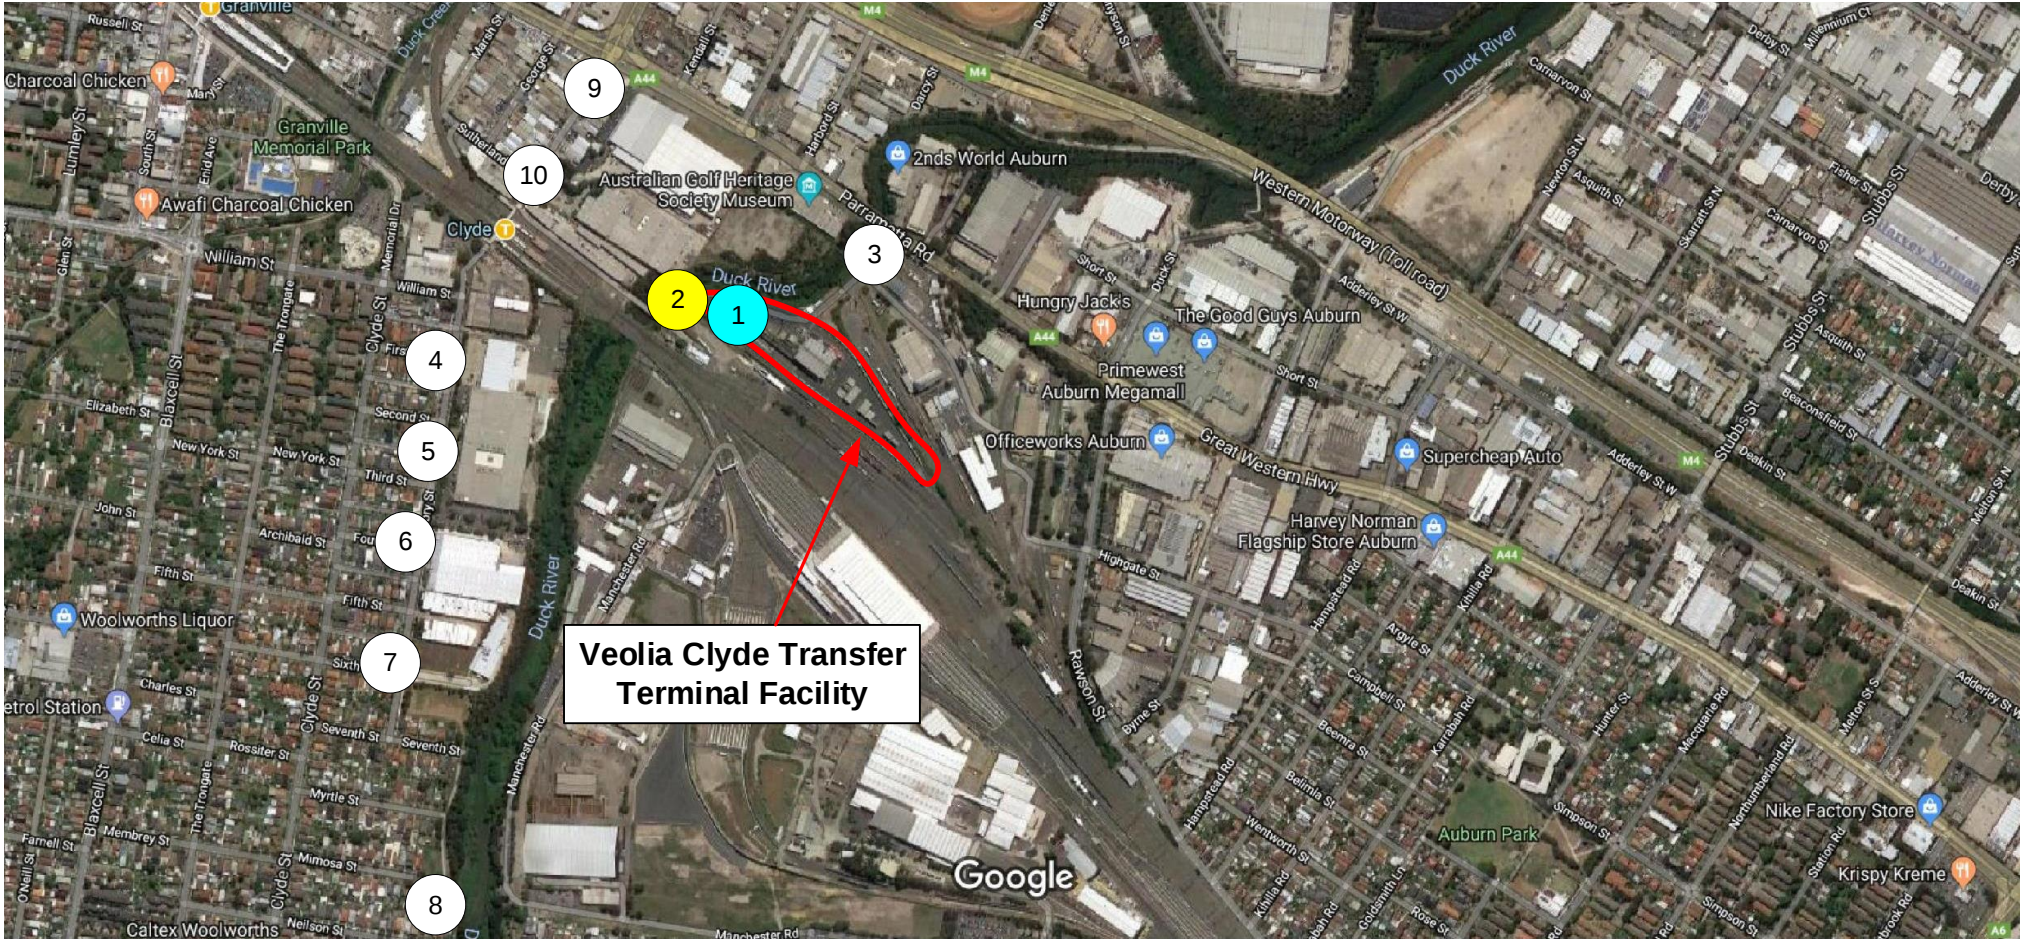
The container packing area and site roadways were found to be clean and well managed with no evidence of waste or exposed leachate. Like previous Odour Audits, the container compacting/train packing area had a weak to distinct odour that was intermittently detectable but was confined to this area only (see **Appendix C** for Field Ambient Odour Assessment Survey results). It appeared during the Odour Audit visit that just a single compactor was operating, with the other undergoing maintenance. The general house-keeping around this area was observed to be of high quality, with no evidence to suggest otherwise. The condition of the compactor area as found on 24 May 2018 is shown in **Photo 2.2** and **Photo 2.3**.

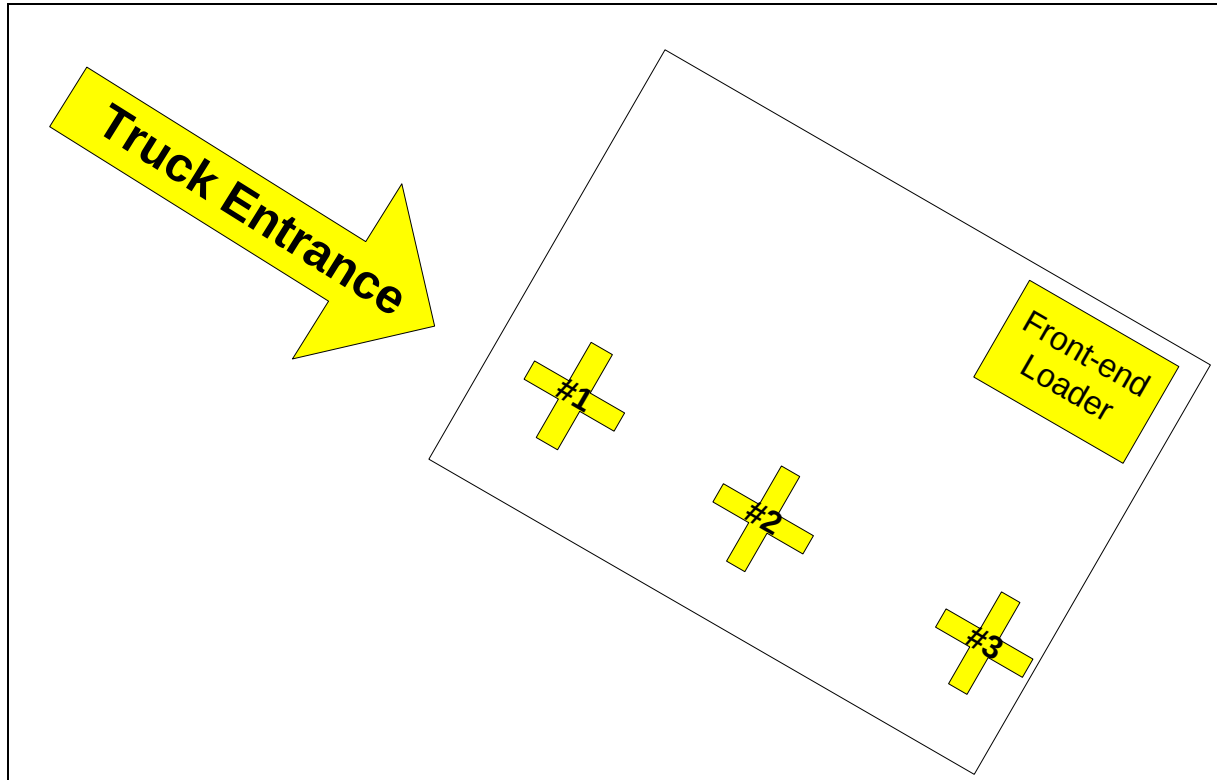
**Figure 2.1** - Smoke testing release points within the TTB on 15 November 2018

As per previous audits, smoke testing was carried out within the TTB to assist in determining the effectiveness of the forced air extraction system, as well as the extent to which the TTB has been sealed from leaks. As per previous audits, smoke was released from within the TTB at three points within the TTB. **Figure 2.1** shows the three points where the smoke was released within the TTB. **Photo 2.5** shows smoke testing at one of the test locations (Smoke Testing Point #2) as occurred on 15 November 2018.

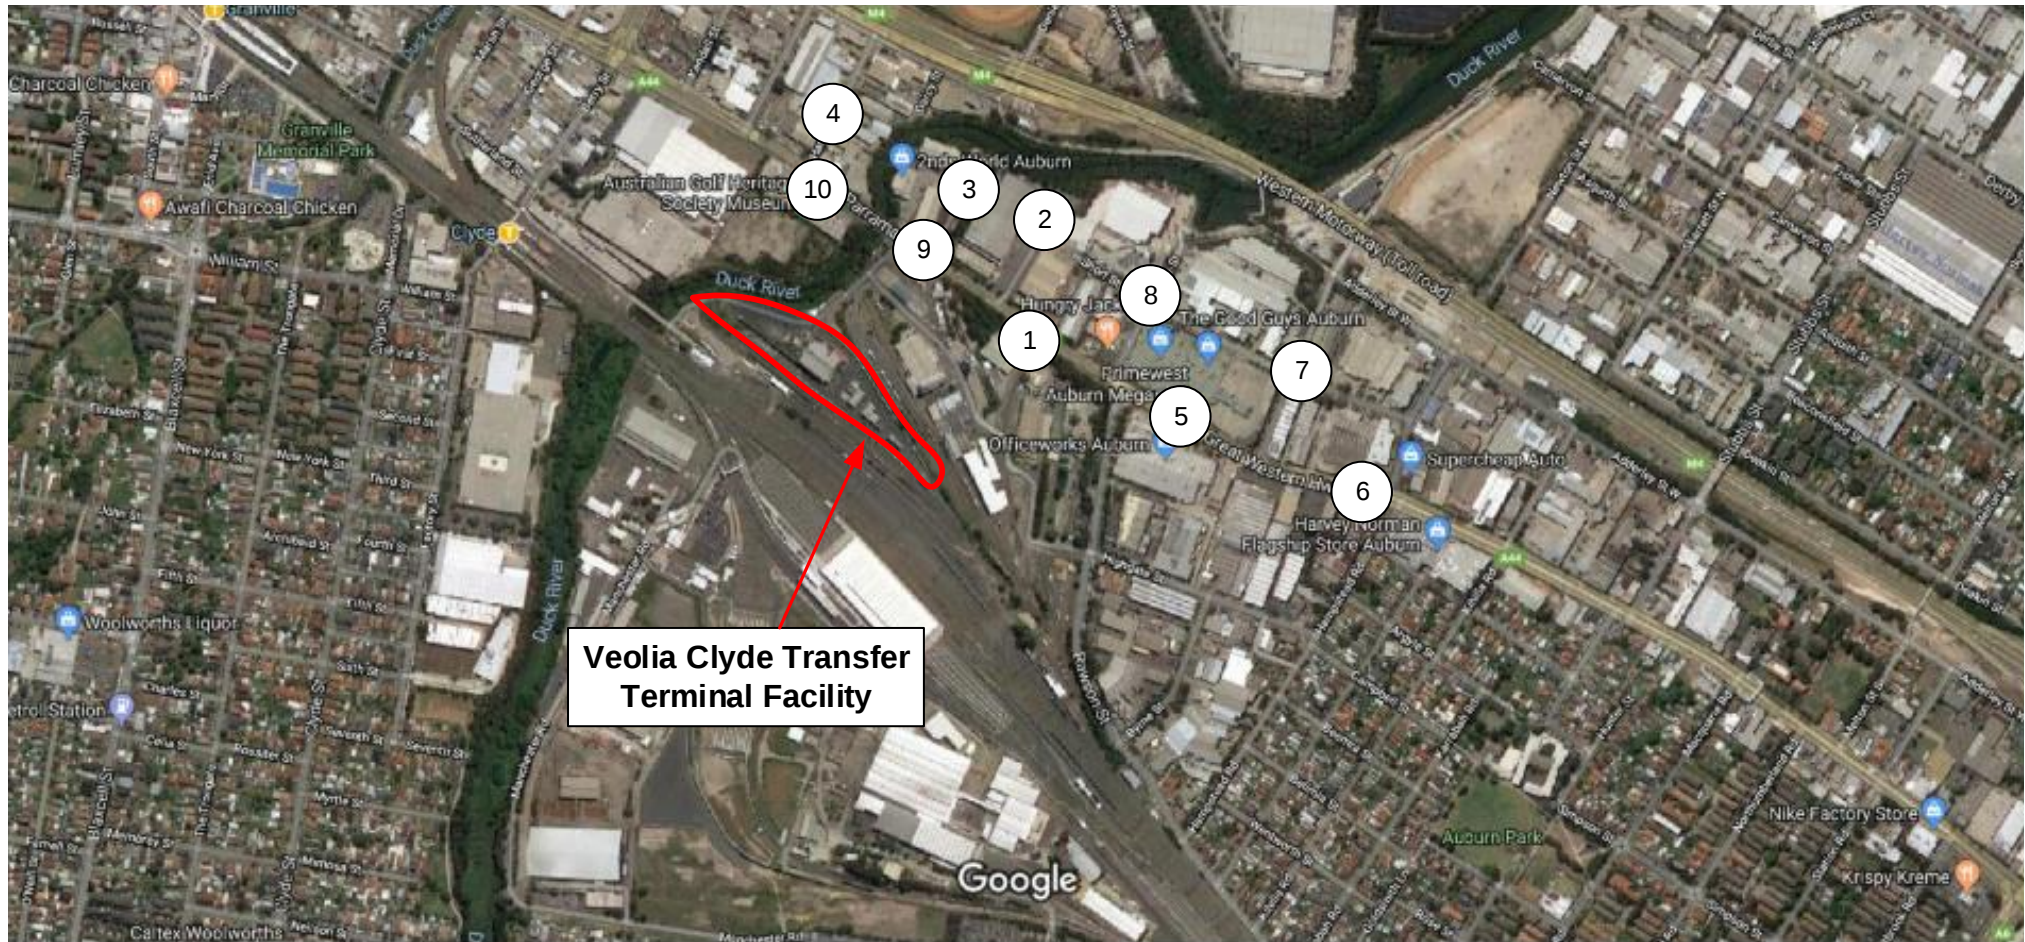
The container packing area and site roadways were found to be clean and well managed with no evidence of waste or exposed leachate. Like previous Odour Audits, the container compacting/train packing area had a weak to distinct odour that was intermittently detectable but was confined to this area only (see **Appendix C** for Field Ambient Odour Assessment Survey results). It appeared during the Odour Audit visit that both compactors were in operation. The general house-keeping around this area was observed to be of high quality, with no evidence to suggest otherwise. The condition of the compactor area as found on 15 November 2018 is shown in **Photo 2.2** and **Photo 2.3**.
