Annual Environmental Management Report - Clyde Transfer Terminal 2023-2024

Name of operation	Clyde Transfer Terminal
Name of operator	Veolia Environmental Services
Development consent / project approval #	DA 205-08-01
Name of holder of development consent / project approval	Veolia Environmental Services
Mining lease #	NA
Name of holder of mining lease	NA
Water licence #	NA
Name of holder of the water licence	NA
MOP/RMP start date	NA
MOP/RMP end date	NA
Annual Review start date	15th of January 2023
Annual Review end date	14th of January 2024
<p>I, Anae Ressos, certify that this audit report is a true and accurate record of the compliance status of Clyde Transfer Terminal for the period 15 January 2023-14 January 2024 and that I am authorised to make this statement on behalf of Veolia Environmental Services.</p> <p>Note:</p> <p>a) <i>The Annual Review is an 'environmental audit' for the purposes of section 122B(2) of the Environmental Planning and Assessment Act 1979. Section 122E provides that a person must not include false or misleading information (or provide information for inclusion in) an audit report produced to the Minister in connection with an environmental audit if the p

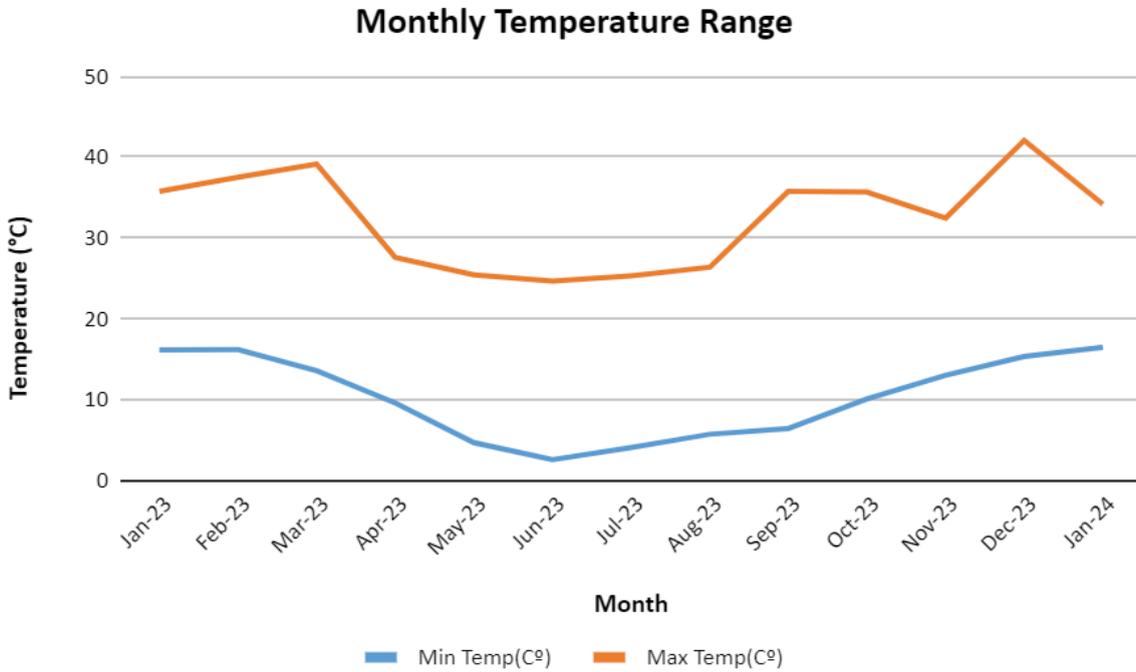
Figure 2.1 - Average Monthly Temperature rates at the Terminal

A summary of monthly rainfall and evaporation rates, as well as minimum and maximum monthly temperatures at the Terminal during this reporting period is presented below in **Figures 2.1** and **2.2** respectively.

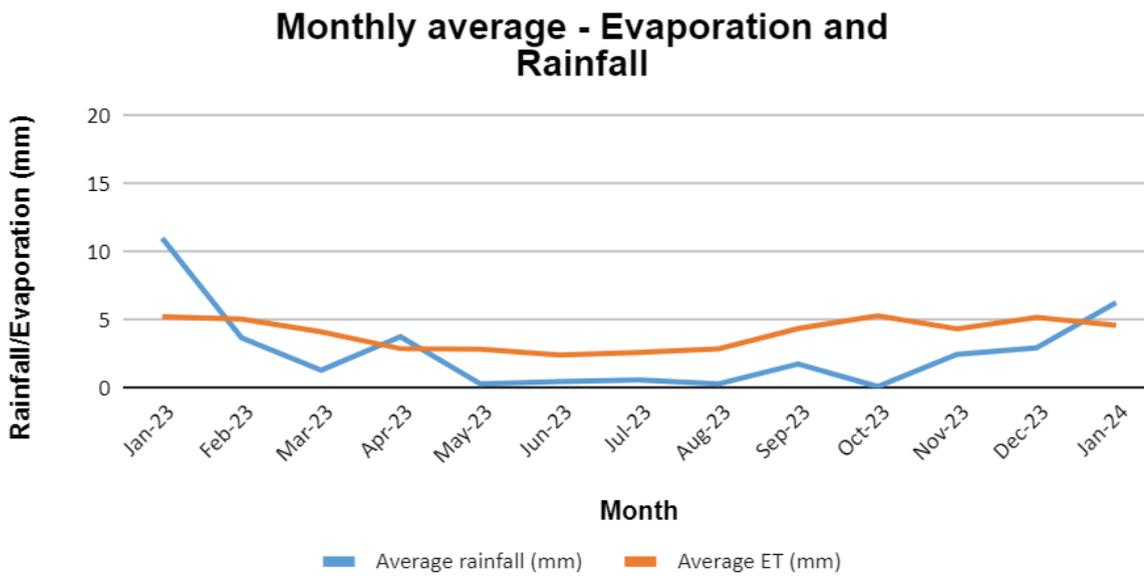
Figure 2.2 - Average Evaporation and Rainfall rates at the Terminal

Overall, the average rainfall for the Terminal during this reporting period was recorded at 60 mm per month.
