**Clyde Waste Transfer Terminal**

**Odour Audit XLI**

**Final Report**

**July 2023**

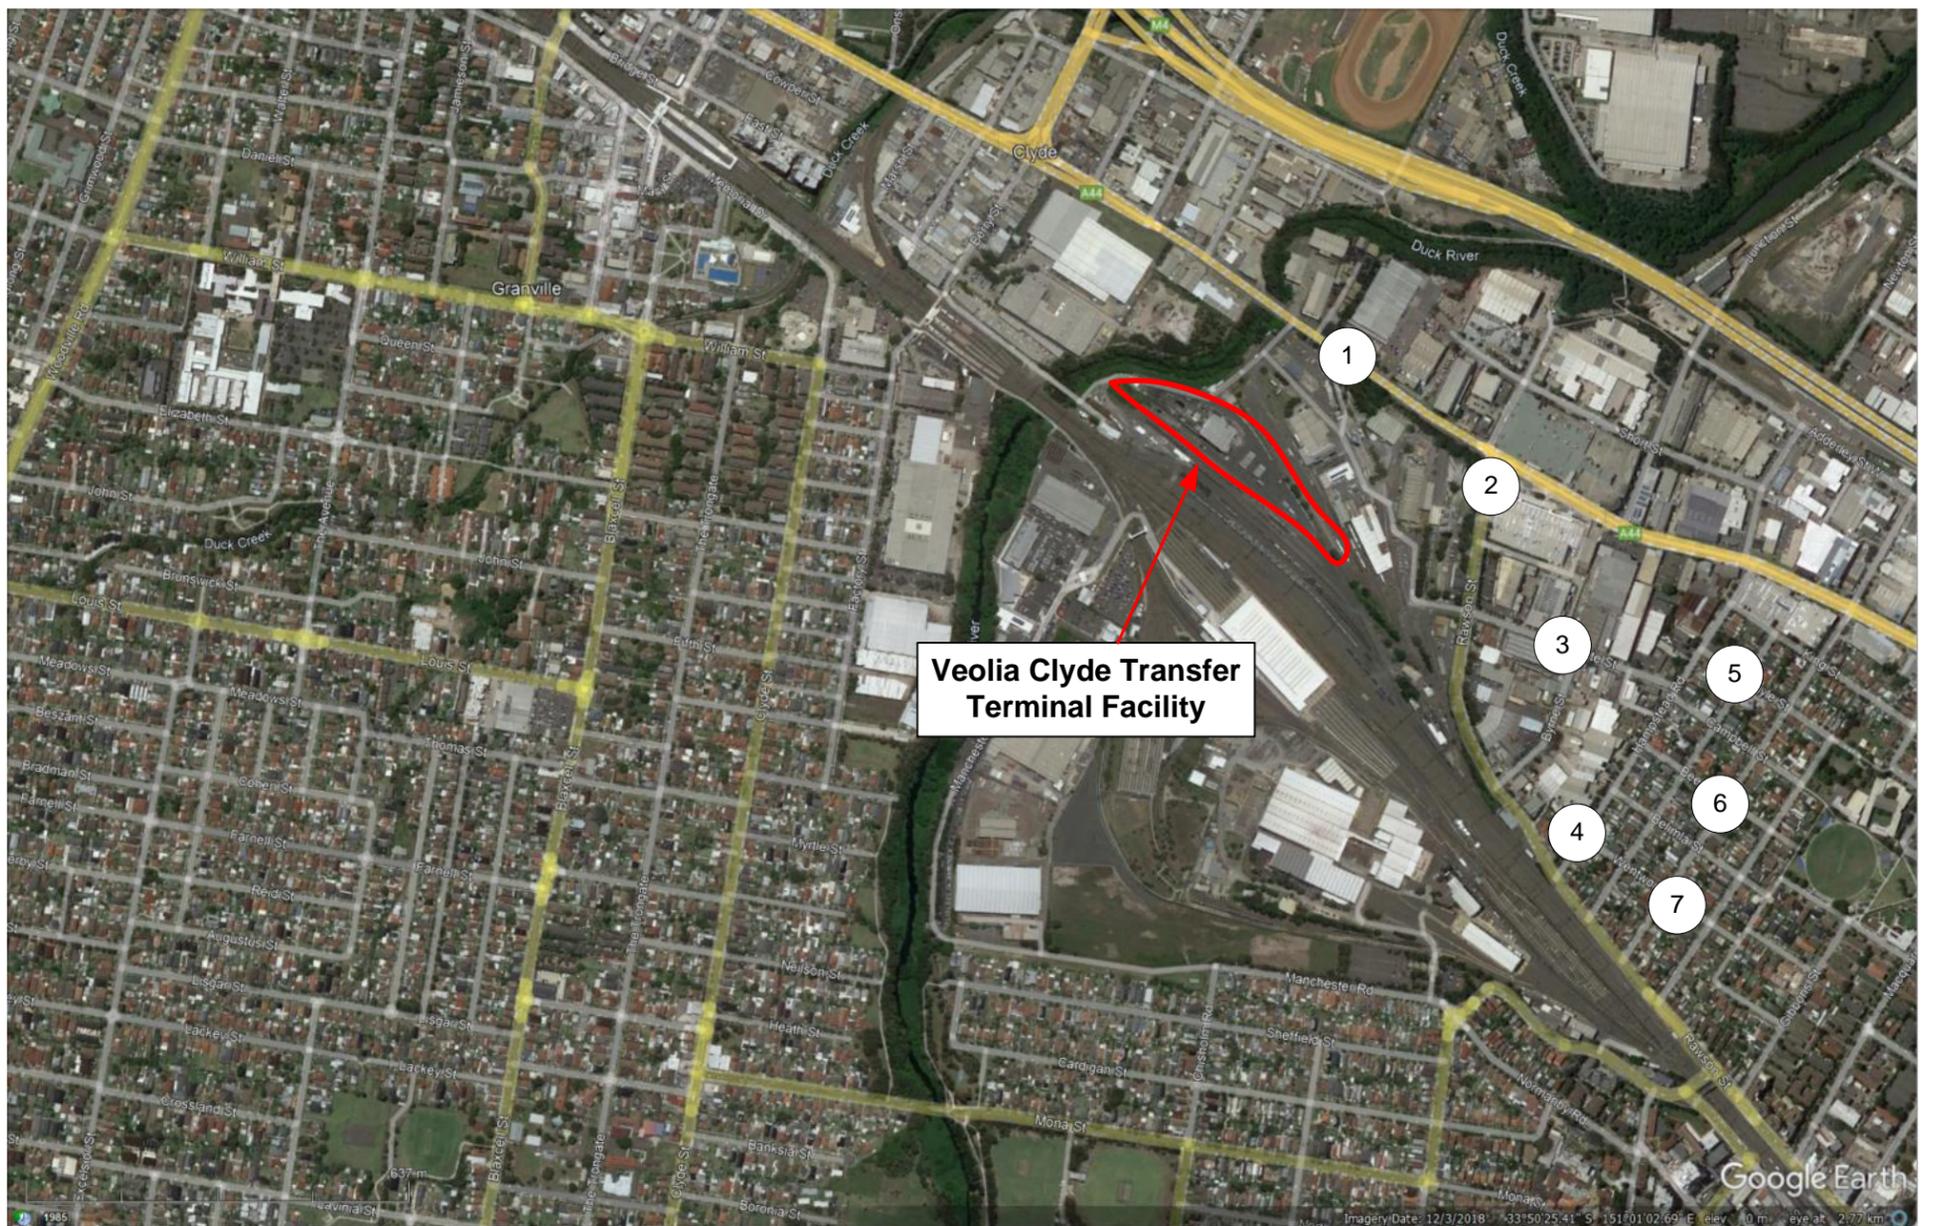
**Survey Reference Plot No:** N1473L-XXXX

GRIF REF. POSITION	MEASUREMENT TIME PERIOD (hrs)	WIND DIRECTION	WIND SPEED (m/s)	ODOUR PRESENT (Y/N)	ODOUR CHARACTER	VDI 3940 INTENSITY SCALE 0-6	COMMENTS
1	13:15 – 13:20hrs	WNW	1 - 2 m/s	N	--	0	--
2	13:25 – 13:30hrs	WNW	1 – 2 m/s	N	--	0	--
3	13:33 – 13:38hrs	WNW	1 m/s	N	--	0	--
4	13:41 – 13:46hrs	WNW	1 – 2 m/s	N	--	0	--
5	13:49 – 13:54hrs	WNW	1 – 2 m/s	N	--	0	--
6	13:59 – 14:04hrs	WNW	1 – 3 m/s	N	--	0	--
7	14:11 – 14:16hrs	WNW	1 – 3 m/s	N	--	0	--
