Annual Environmental Performance Report 2021-22

Woodlawn Bioreactor
and Crisps Creek Intermodal
Facility

November 2022

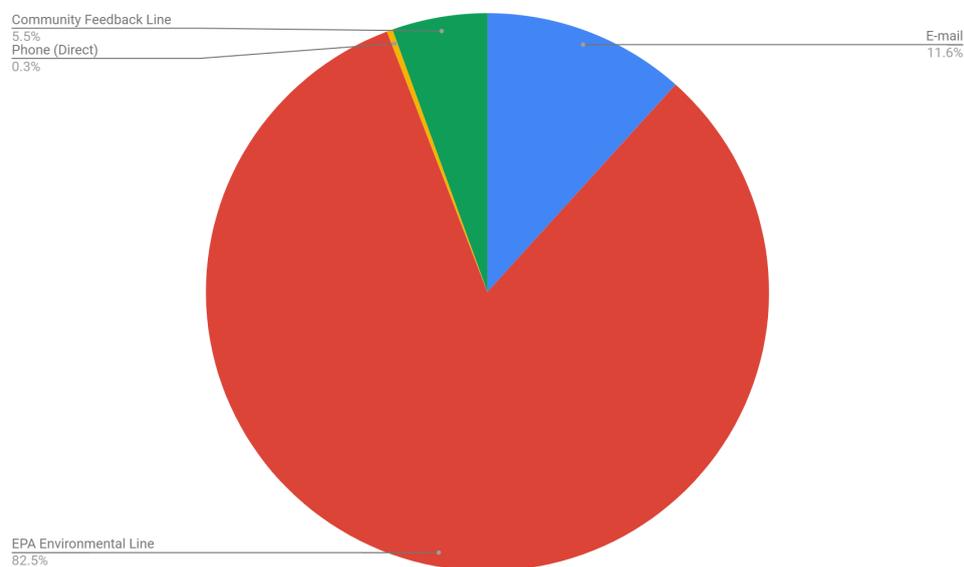
Figure 1.3.2.1 Odour Complaint Method of Reporting

The majority of odour complaints were reported using the EPA Environmental Line as demonstrated in the graph above (refer **Figure 1.3.2.1**).

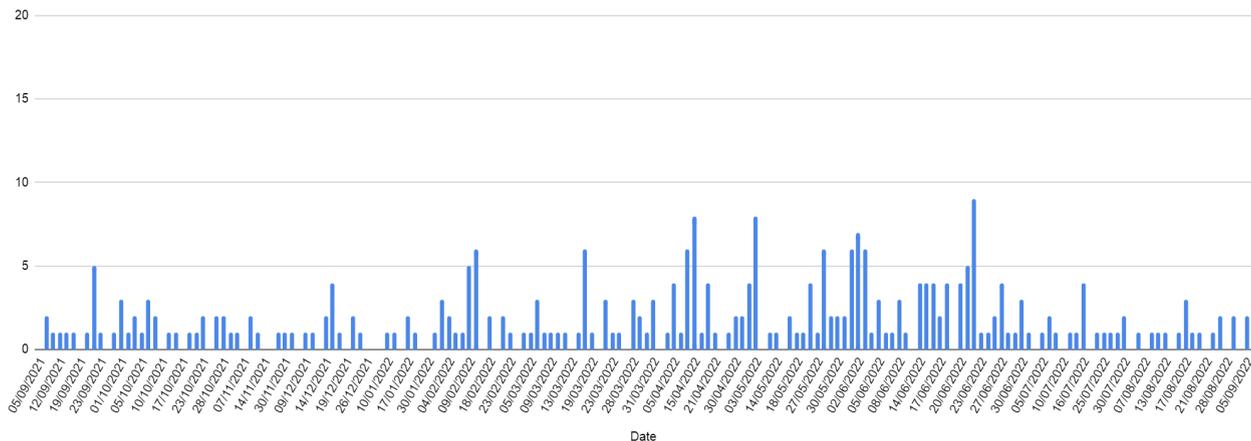
Figure 1.3.2.2 Odour Complaints

The number of reports of odour received during the reporting period has shown a clear downward trend, indicating that the continuous improvements in gas capture which have resulted in a reduction in landfill gas emissions and significantly reduced odour impacts. This is demonstrated in **Figure 1.3.2.2** below.

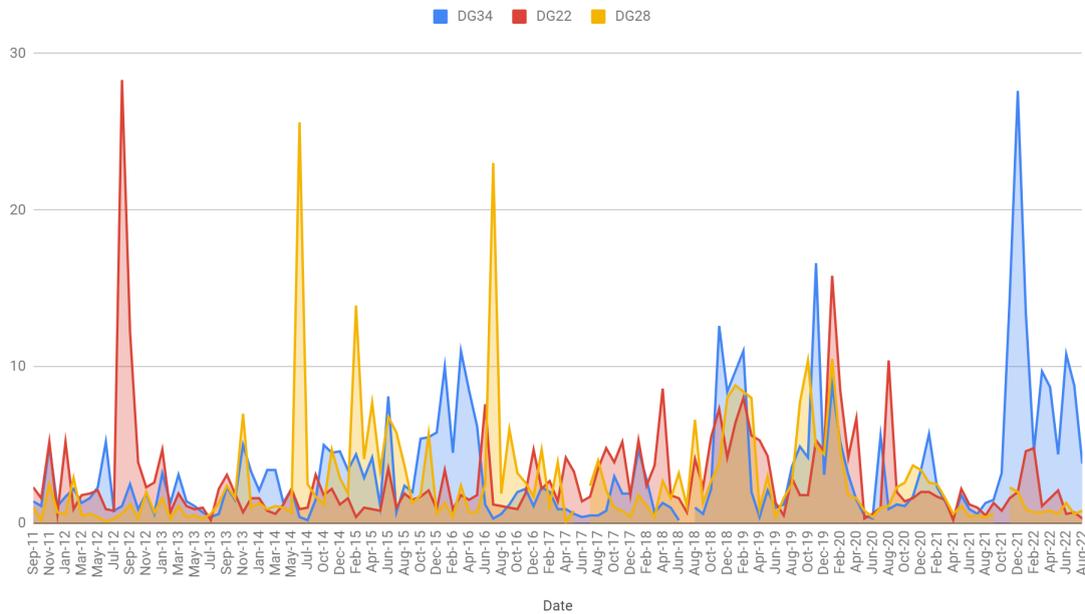
Figure 1.5.2.2 Bioreactor Dust Monitoring Results

<p>The maximum dust level recorded in this reporting period was 27.6 g/m²/month at DG34 (December 2021) which is located on the West side of the Bioreactor.</p> <p>As mentioned in the Annual Return and previous correspondence with the EPA, higher than usual levels of dust are attributed to a period of extremely high pollen count between December 2021 and March 2022.</p>	Dust Gauge	Summary Total Insoluble Solids (g/m ² /month)			Minimum	Average	Maximum	DG22	0.3	1.7	4.8	DG34	1.5	9.2	27.6	DG28	0.6	1.0	2.3
Dust Gauge	Summary Total Insoluble Solids (g/m ² /month)																			
	Minimum	Average	Maximum																	
DG22	0.3	1.7	4.8																	
DG34	1.5	9.2	27.6																	
DG28	0.6	1.0	2.3

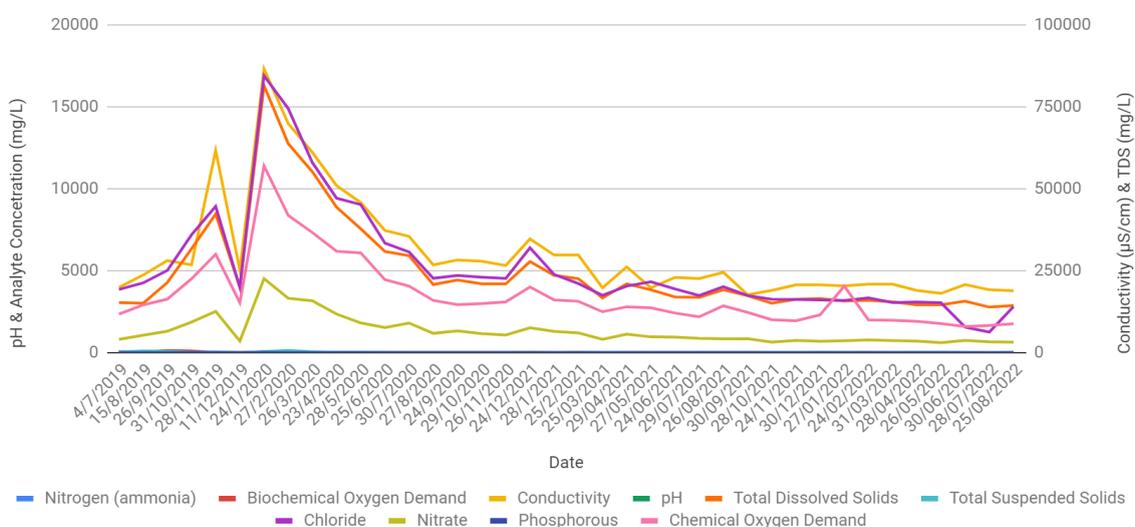
Figure 1.5.3.1 ED1 Coffe Dam Monitoring Results

<ul style="list-style-type: none"> Chloride averages (2882 mg/L) remained stable however declining over the reporting period. <p>No significant variations or anomalies were recorded for any analyte tested at this location during this monitoring period. Figure 1.5.3.1 demonstrates stabilising trends since the commissioning of the LTP.</p>
--	---

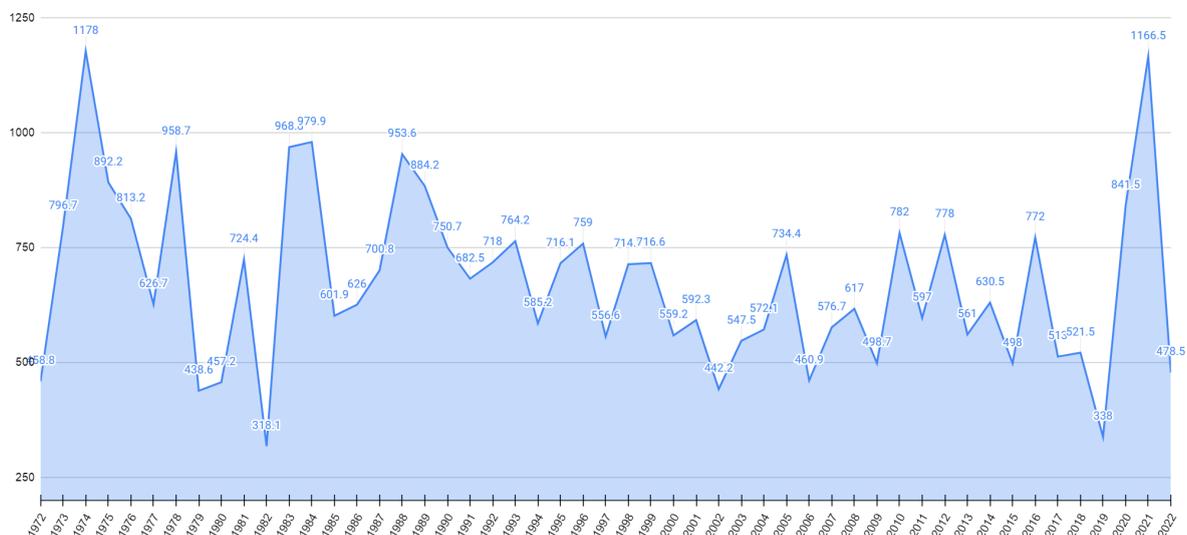
Figure 1.5.7 50 Year Rainfall Pattern

Using Lake Bathurst and Woodlawn rainfall data, the graph below illustrates the rarity of the recent consecutive La Nina events in 2020-2021 in comparison to the past 50 years. These weather patterns have had a detrimental impact on the entire east coast of NSW, which includes the Premises.

As demonstrated above (refer **Figure 1.5.7**), a total of 1,166.5mm rainfall was recorded in 2021. This was the highest annual rainfall since 1974 (1,178.0mm), and the third highest rainfall since 1950 (1,305.1mm). According to the Woodlawn Weather Station, total rainfall over the reporting period was 1085.5mm, which is approximately 100 mm above the previous 2020/2021 period (983.5mm).

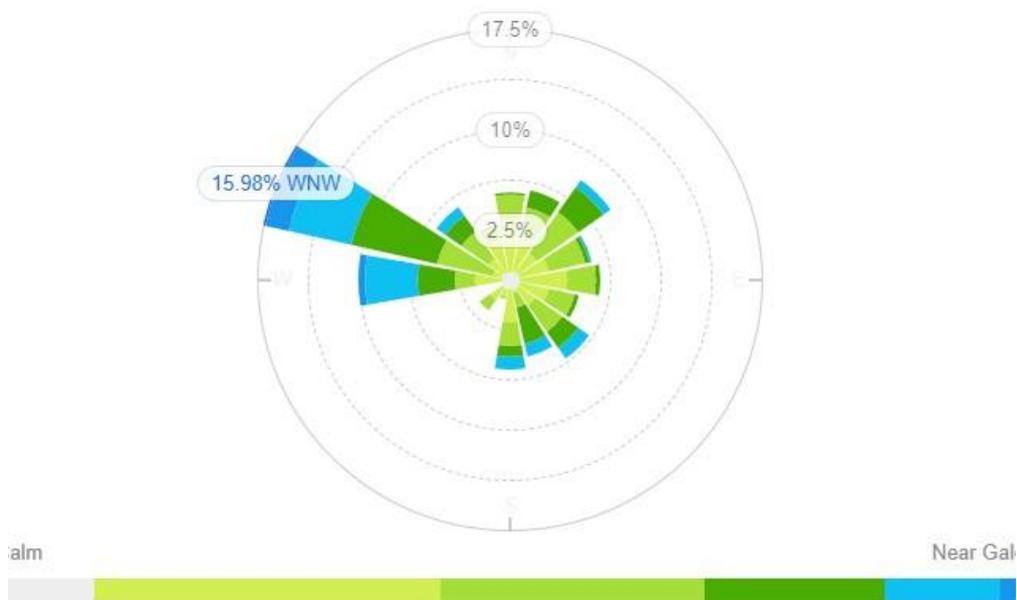
Figure 1.5.8 Average Wind Speed (km/h) and Direction

Figure 1.5.8 below indicates average wind speed and direction during the reporting period.

The wind rose above depicts the average wind speed and direction recorded at 10m above ground level from September 2021 to September 2022. Average wind speeds over the reporting period ranged from 0 km/h to 43.3km/h with strong prevailing winds typically from the West North West (WNW) directly toward Tarago and surrounding areas.

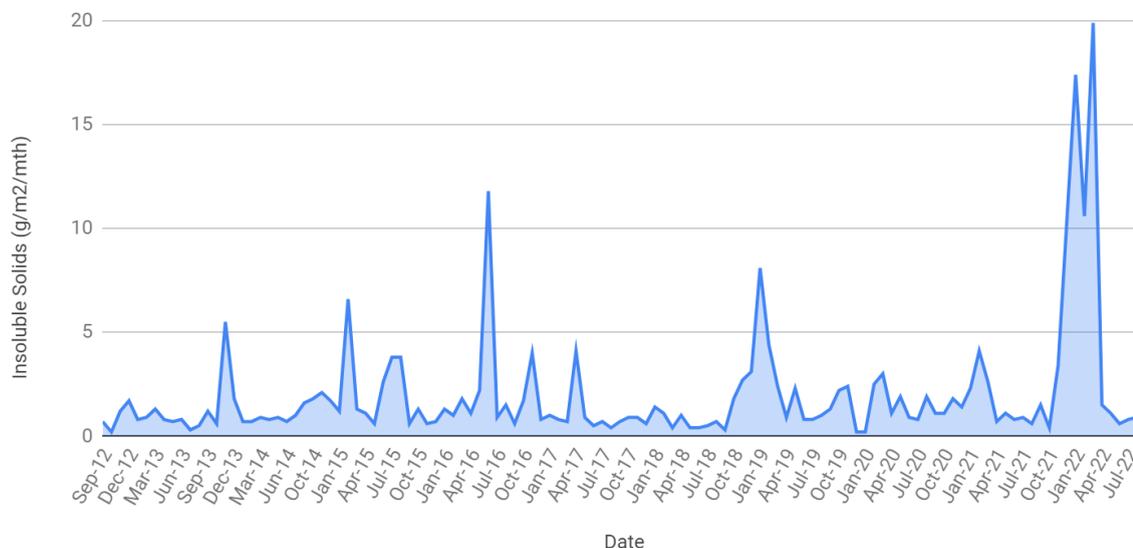
Figure 2.4.2.1 Crisps Creek IMF Depositional Dust Levels

The results at DG18 indicate an average level of total insoluble solid matter is 5.7 g/m²/month, which is consistent with historical trends as seen in the subsequent graph in **Figure 2.4.2.1**, with the exception of between December 2021 and March 2022 where elevated insoluble solids were consistently detected at all dust monitoring locations at the Crisps Creek IMF, and Woodlawn Bioreactor due to a period of extremely high pollen in the air.

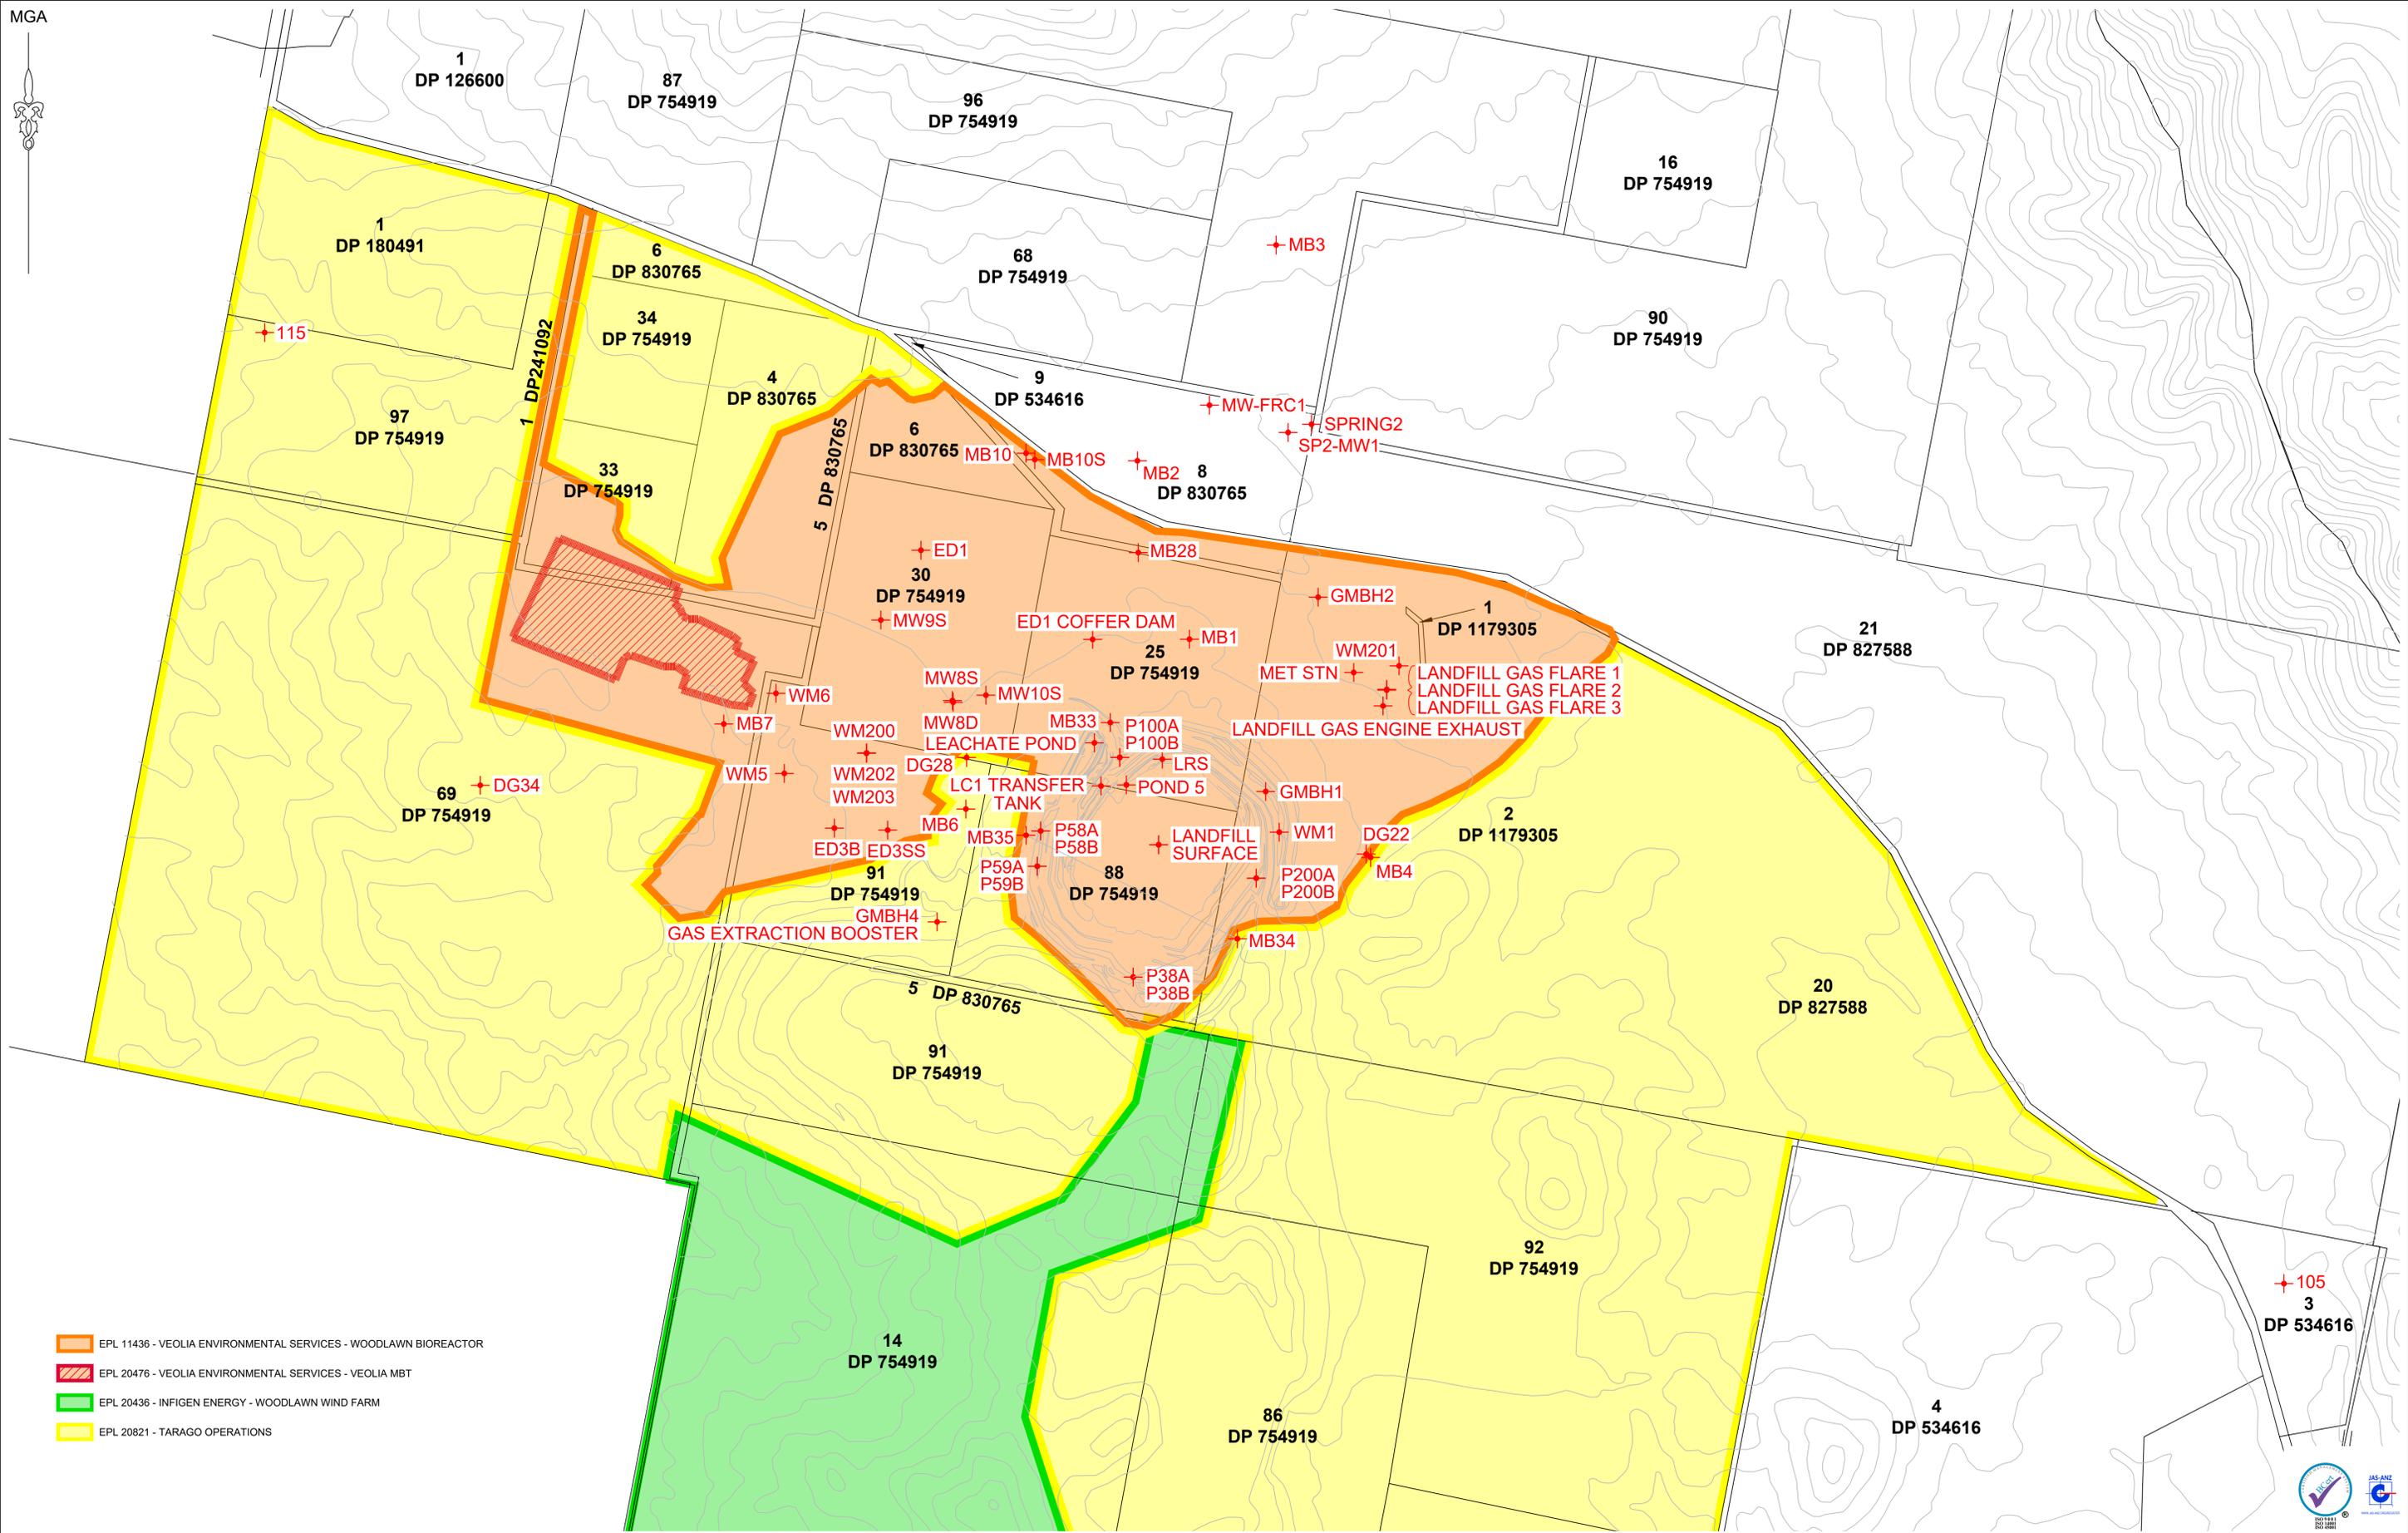
- EPL 11436 - VEOLIA ENVIRONMENTAL SERVICES - WOODLAWN BIOREACTOR
- EPL 20476 - VEOLIA ENVIRONMENTAL SERVICES - VEOLIA MBT
- EPL 20436 - INFIGEN ENERGY - WOODLAWN WIND FARM
- EPL 20821 - TARAGO OPERATIONS

A1 SHEET	VEOLIA ENVIRONMENTAL SERVICES		WOODLAWN BIOREACTOR COLLECTOR ROAD, TARAGO	
	WOODLAWN ENVIRONMENTAL PROTECTION LICENCE SITE MONITORING LOCATIONS			
DATUM	AHD	CONTOUR INTERVAL	10m	DATE
				24/05/2022
DESIGNED: N/A DRAWN: MK CHECKED: JK DRAWING No.				ISSUE C
				16800-225

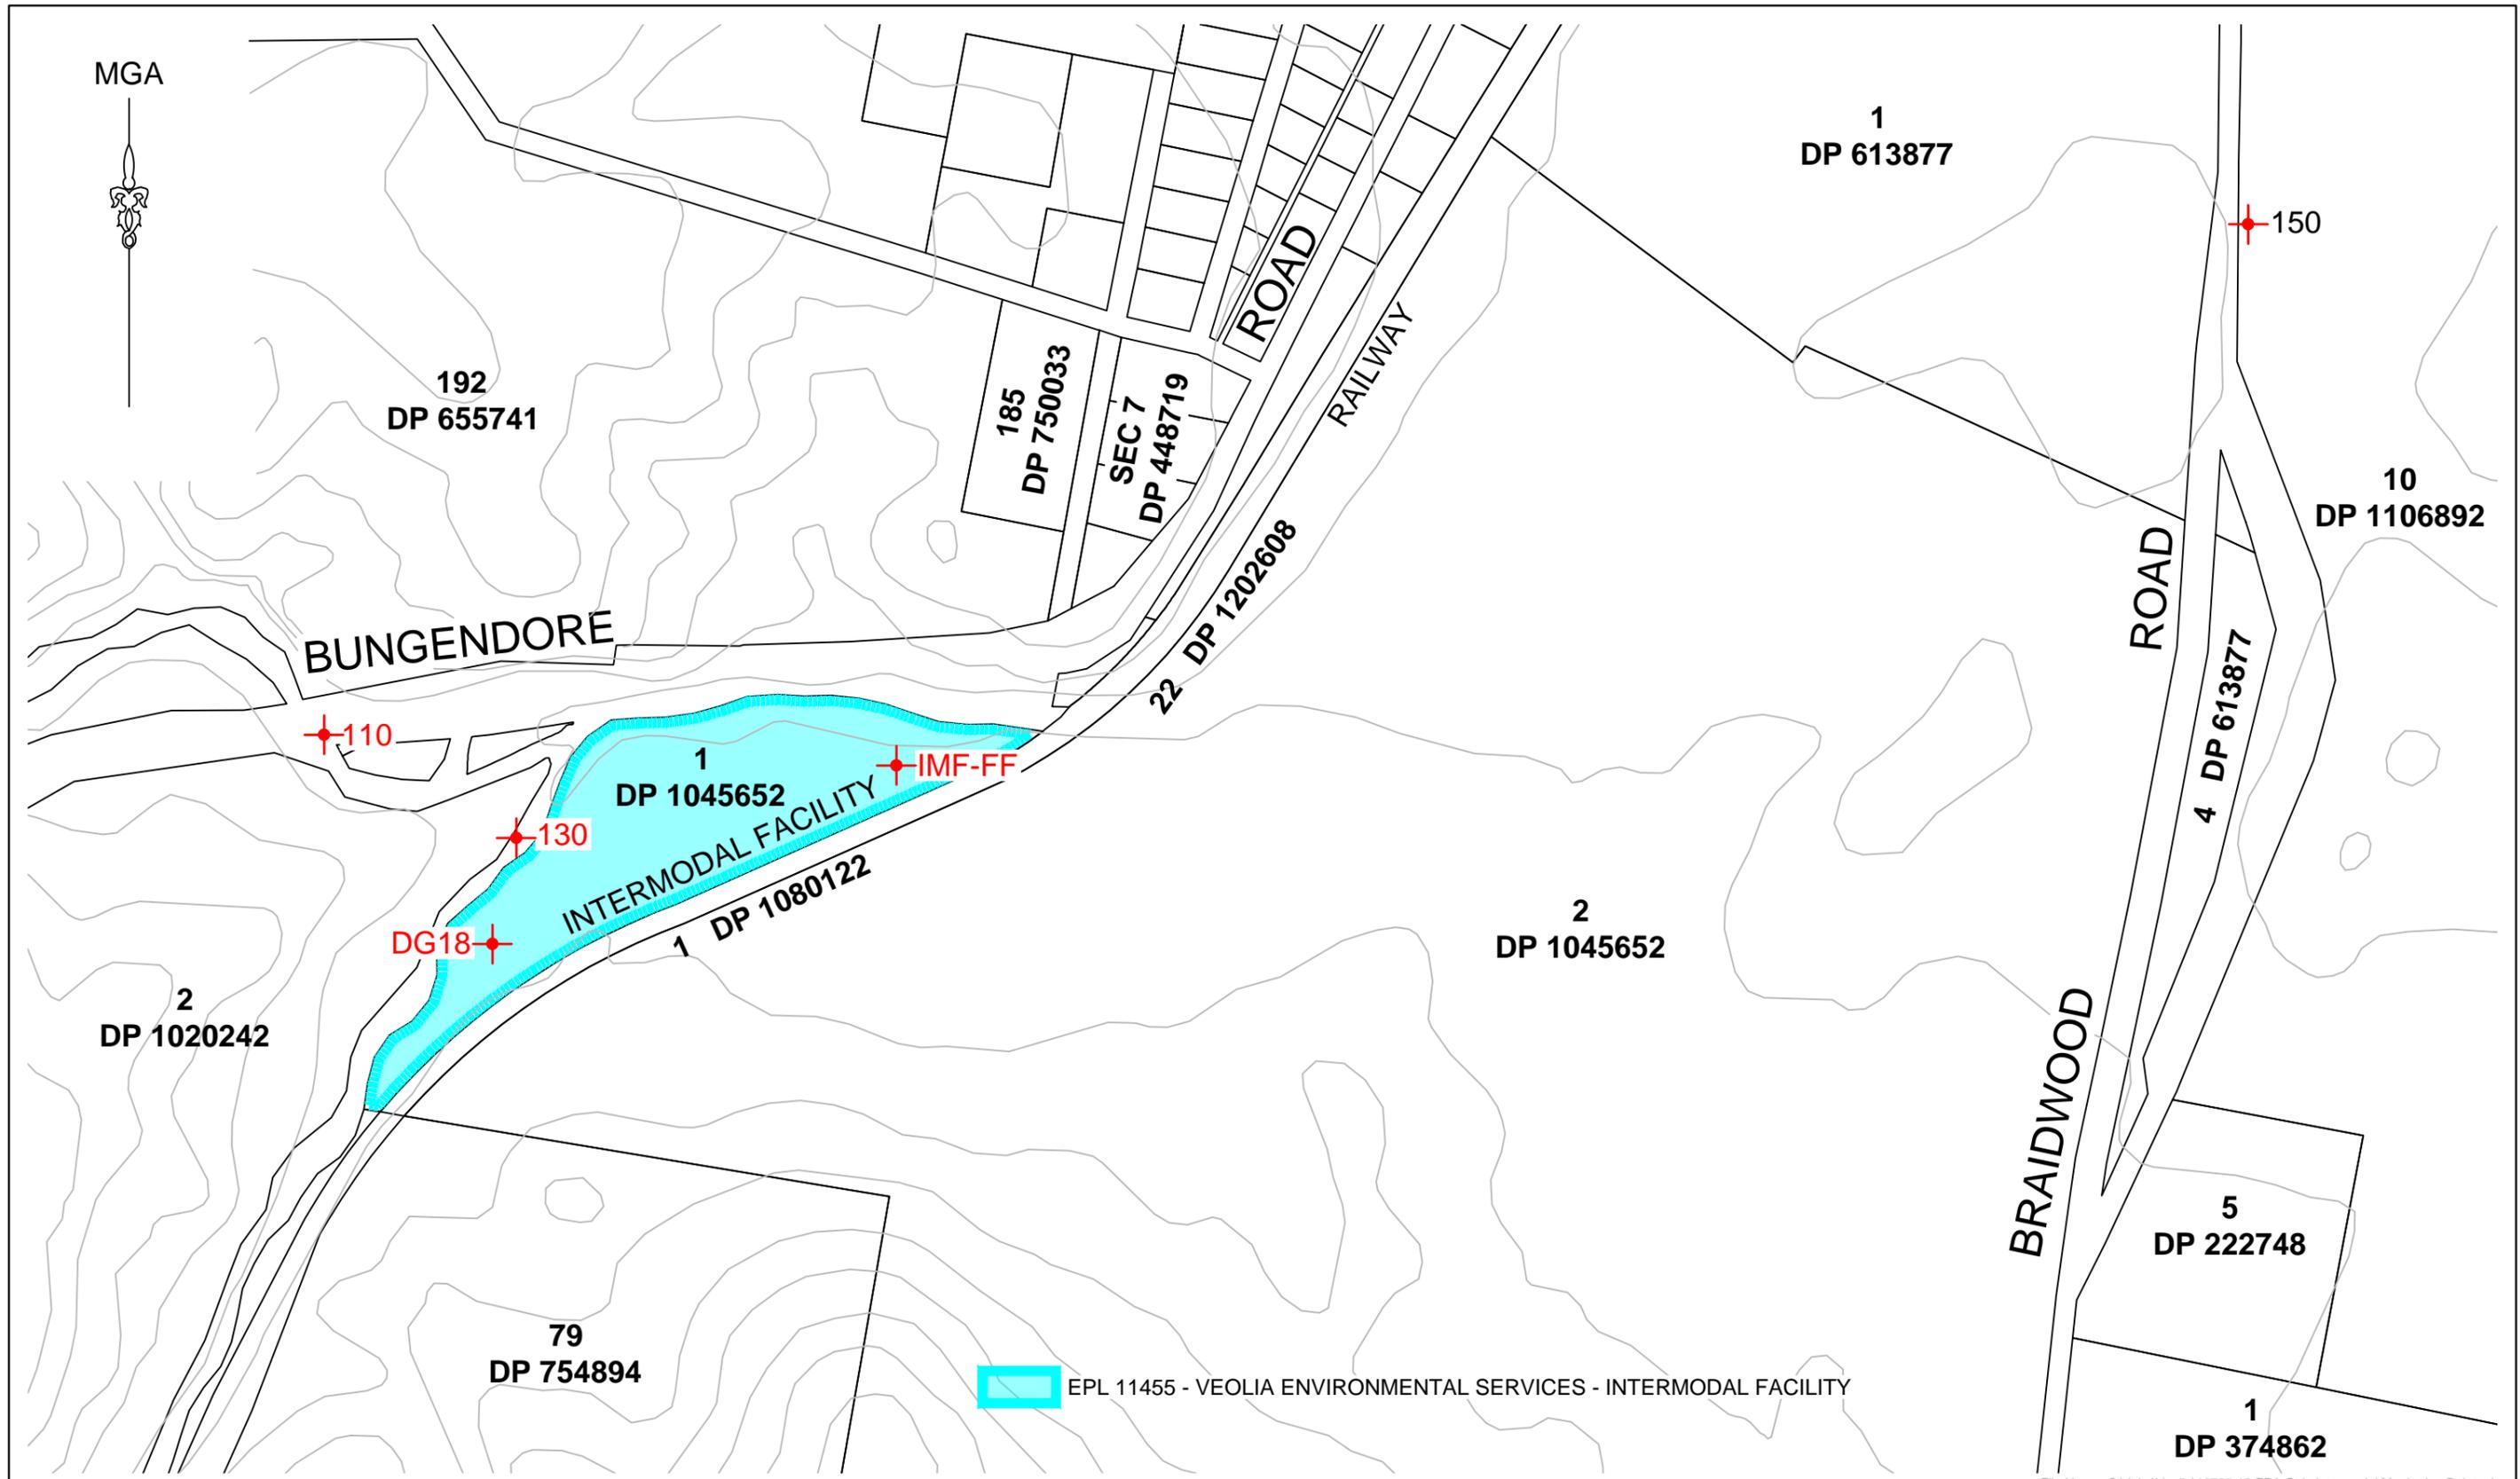
VEOLIA ENVIRONMENTAL SERVICES		DATE: 15/04/2020
ENVIRONMENTAL PROTECTION LICENCE SITE MONITORING LOCATIONS VEOLIA INTERMODAL FACILITY BUNGENDORE ROAD, TARAGO		SURVEYED: N/A
		ISSUE
DRAWING No.		A
DRAWING No.		16735-16
DATUM	AHD	CONTOUR INTERVAL 10m

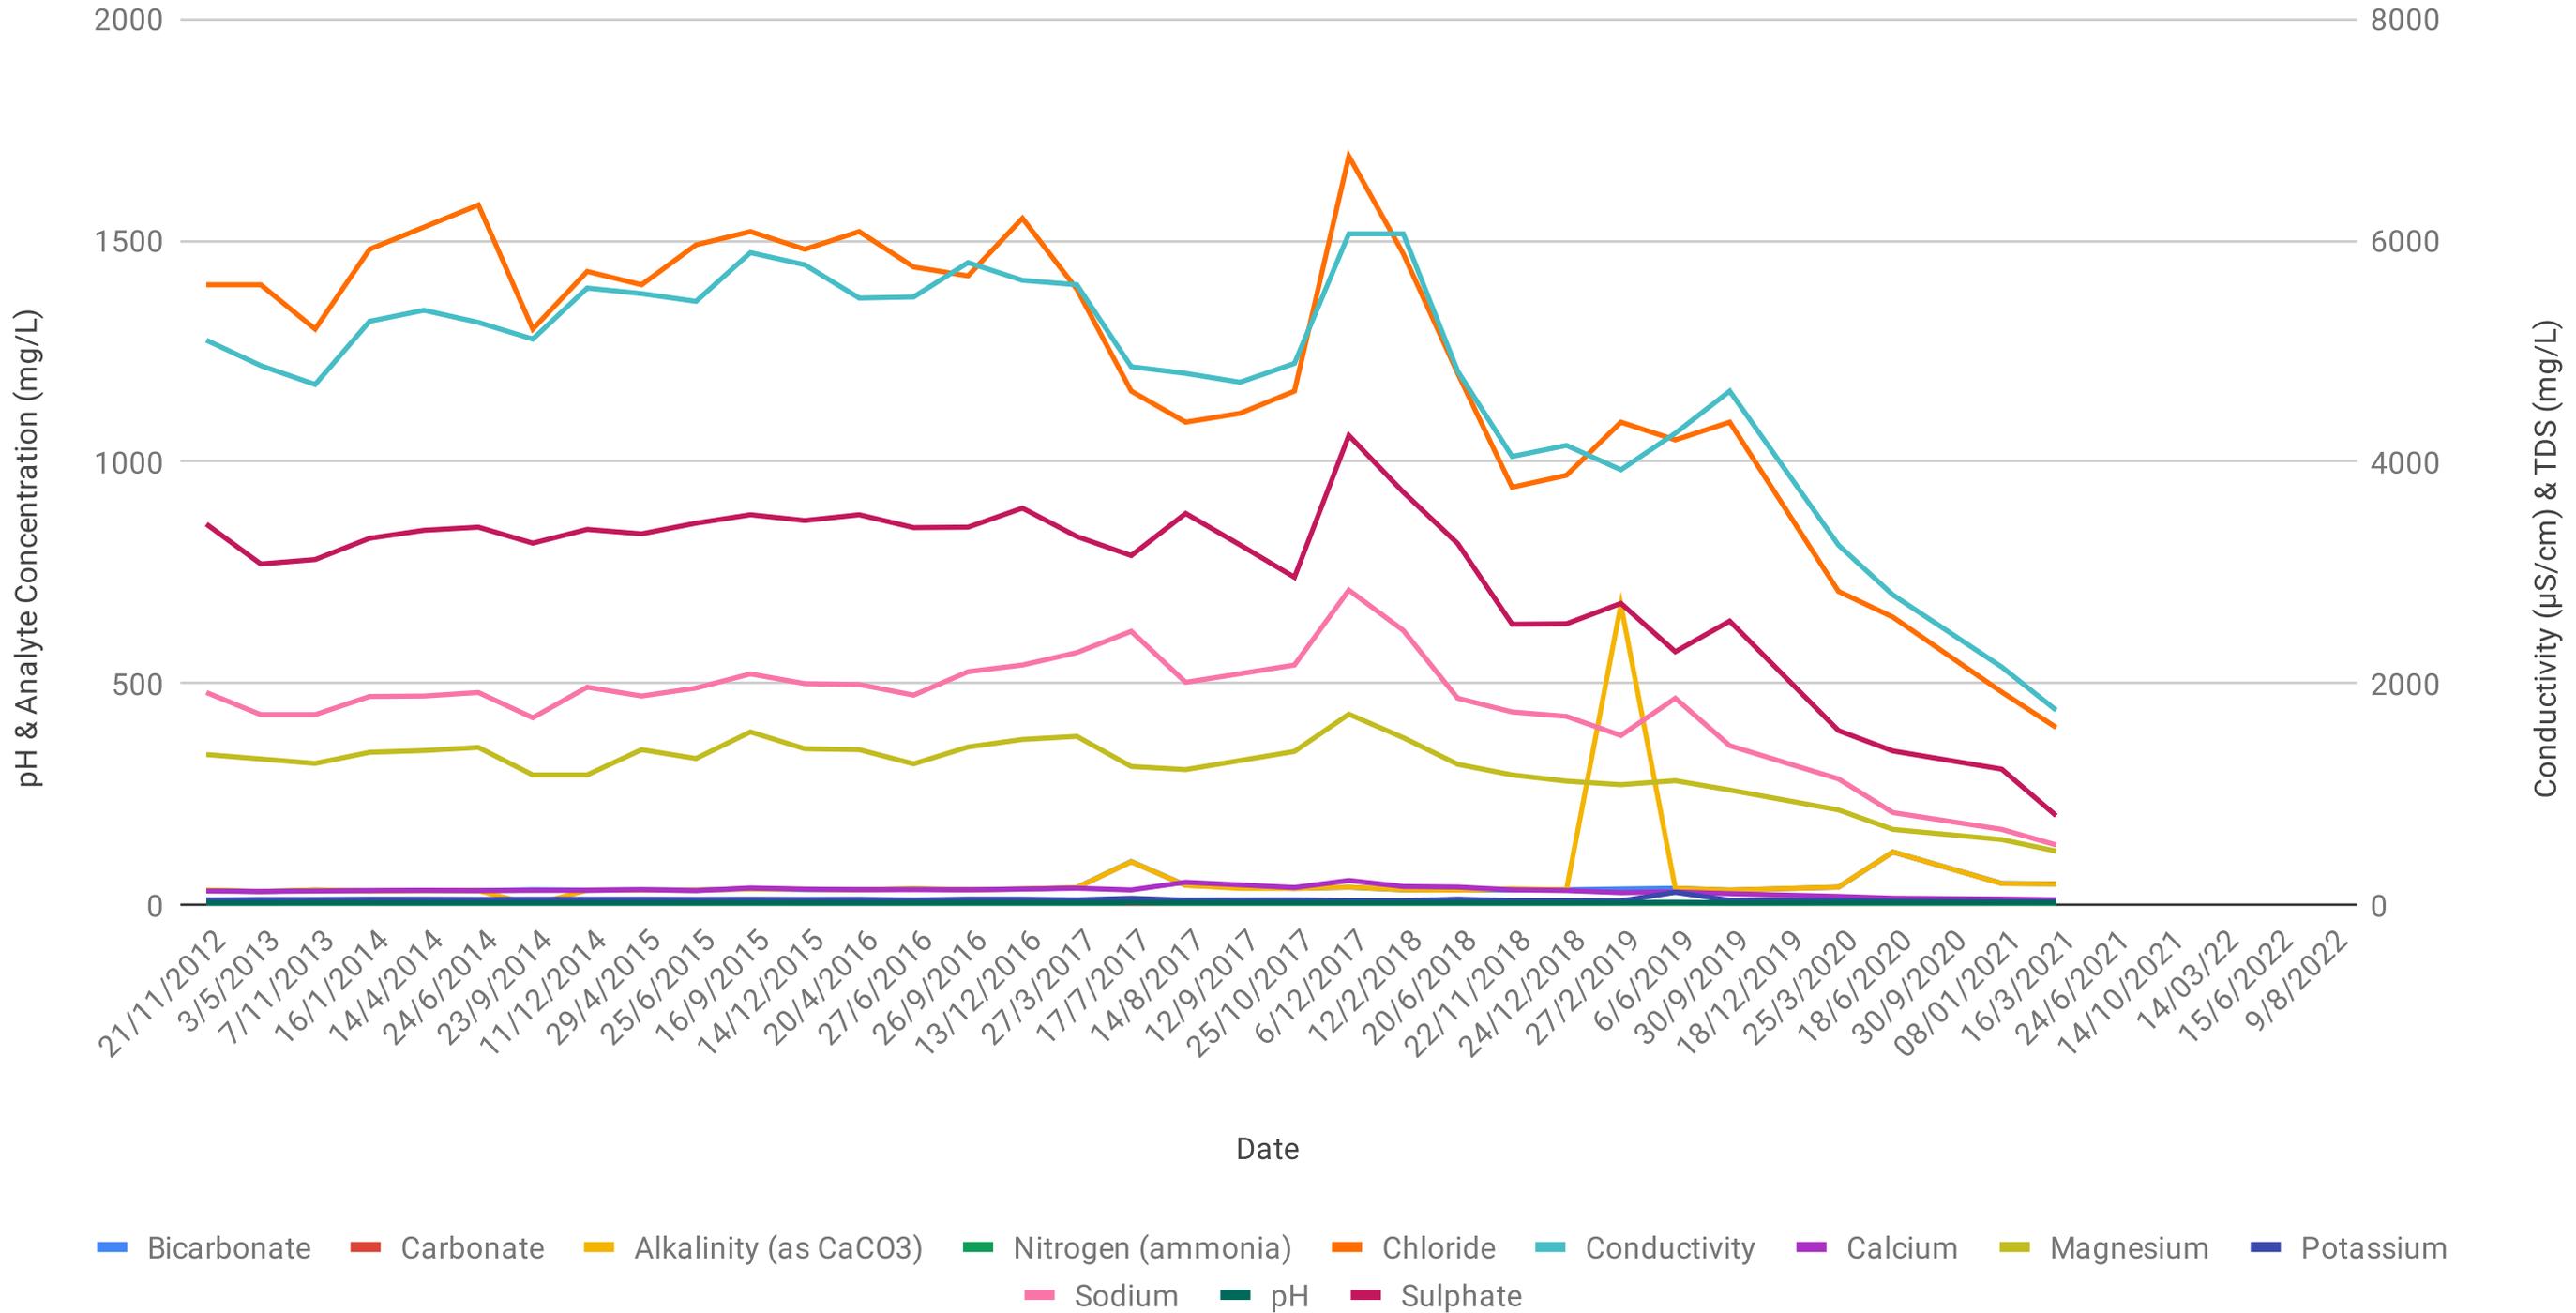
Figure 1.5.5.5 MB6

- Bicarbonate
- Carbonate
- Alkalinity (as CaCO3)
- Nitrogen (ammonia)
- Chloride
- Conductivity
- Calcium
- Magnesium
- Potassium
- Sodium
- pH
- Sulphate

<p>MB6</p>	<p>MB6 is located to the west of the landfill void and downstream of Evaporation Dam 3 and upstream of the Bioreactor. MB06 was observed to be dry at the time of sampling during the reporting period, deeming the long term reliability of this bore for monitoring is uncertain.</p>
<p>MB7</p>	<p>MB7 is located upstream of Evaporation Dam 3. Based on the results provided in Table 9.6 (refer Appendix 4), the groundwater quality at this location can be described as:</p> <ul style="list-style-type: none"> • SWL (average 788.0 m RL) was consistent with long term average since 2004; • pH (average 7.3) neutral is consistent with the previous reporting period; • EC (average 7073 $\mu\text{S}/\text{cm}$) and SO_4 (average 150.8 mg/L) follow a similar stable trend to previous reporting periods ; • Pb (0.001 mg/L) is consistent throughout the reporting period whilst Zn (0.1 mg/L) shows a fluctuating trend consistent with historical cycles; • NH_3 (0.1 mg/L) is consistent with previous monitoring periods of non detection rates; • TOC (7 mg/L) is fairly consistent with the previous reporting period. The concentration is indicative of natural conditions. Veolia will continue monitoring this parameter in the future to ensure water quality at this location is preserved. <p>All trends indicate fairly stable concentration and there is no indication of contamination from mining or Bioreactor activities.</p>

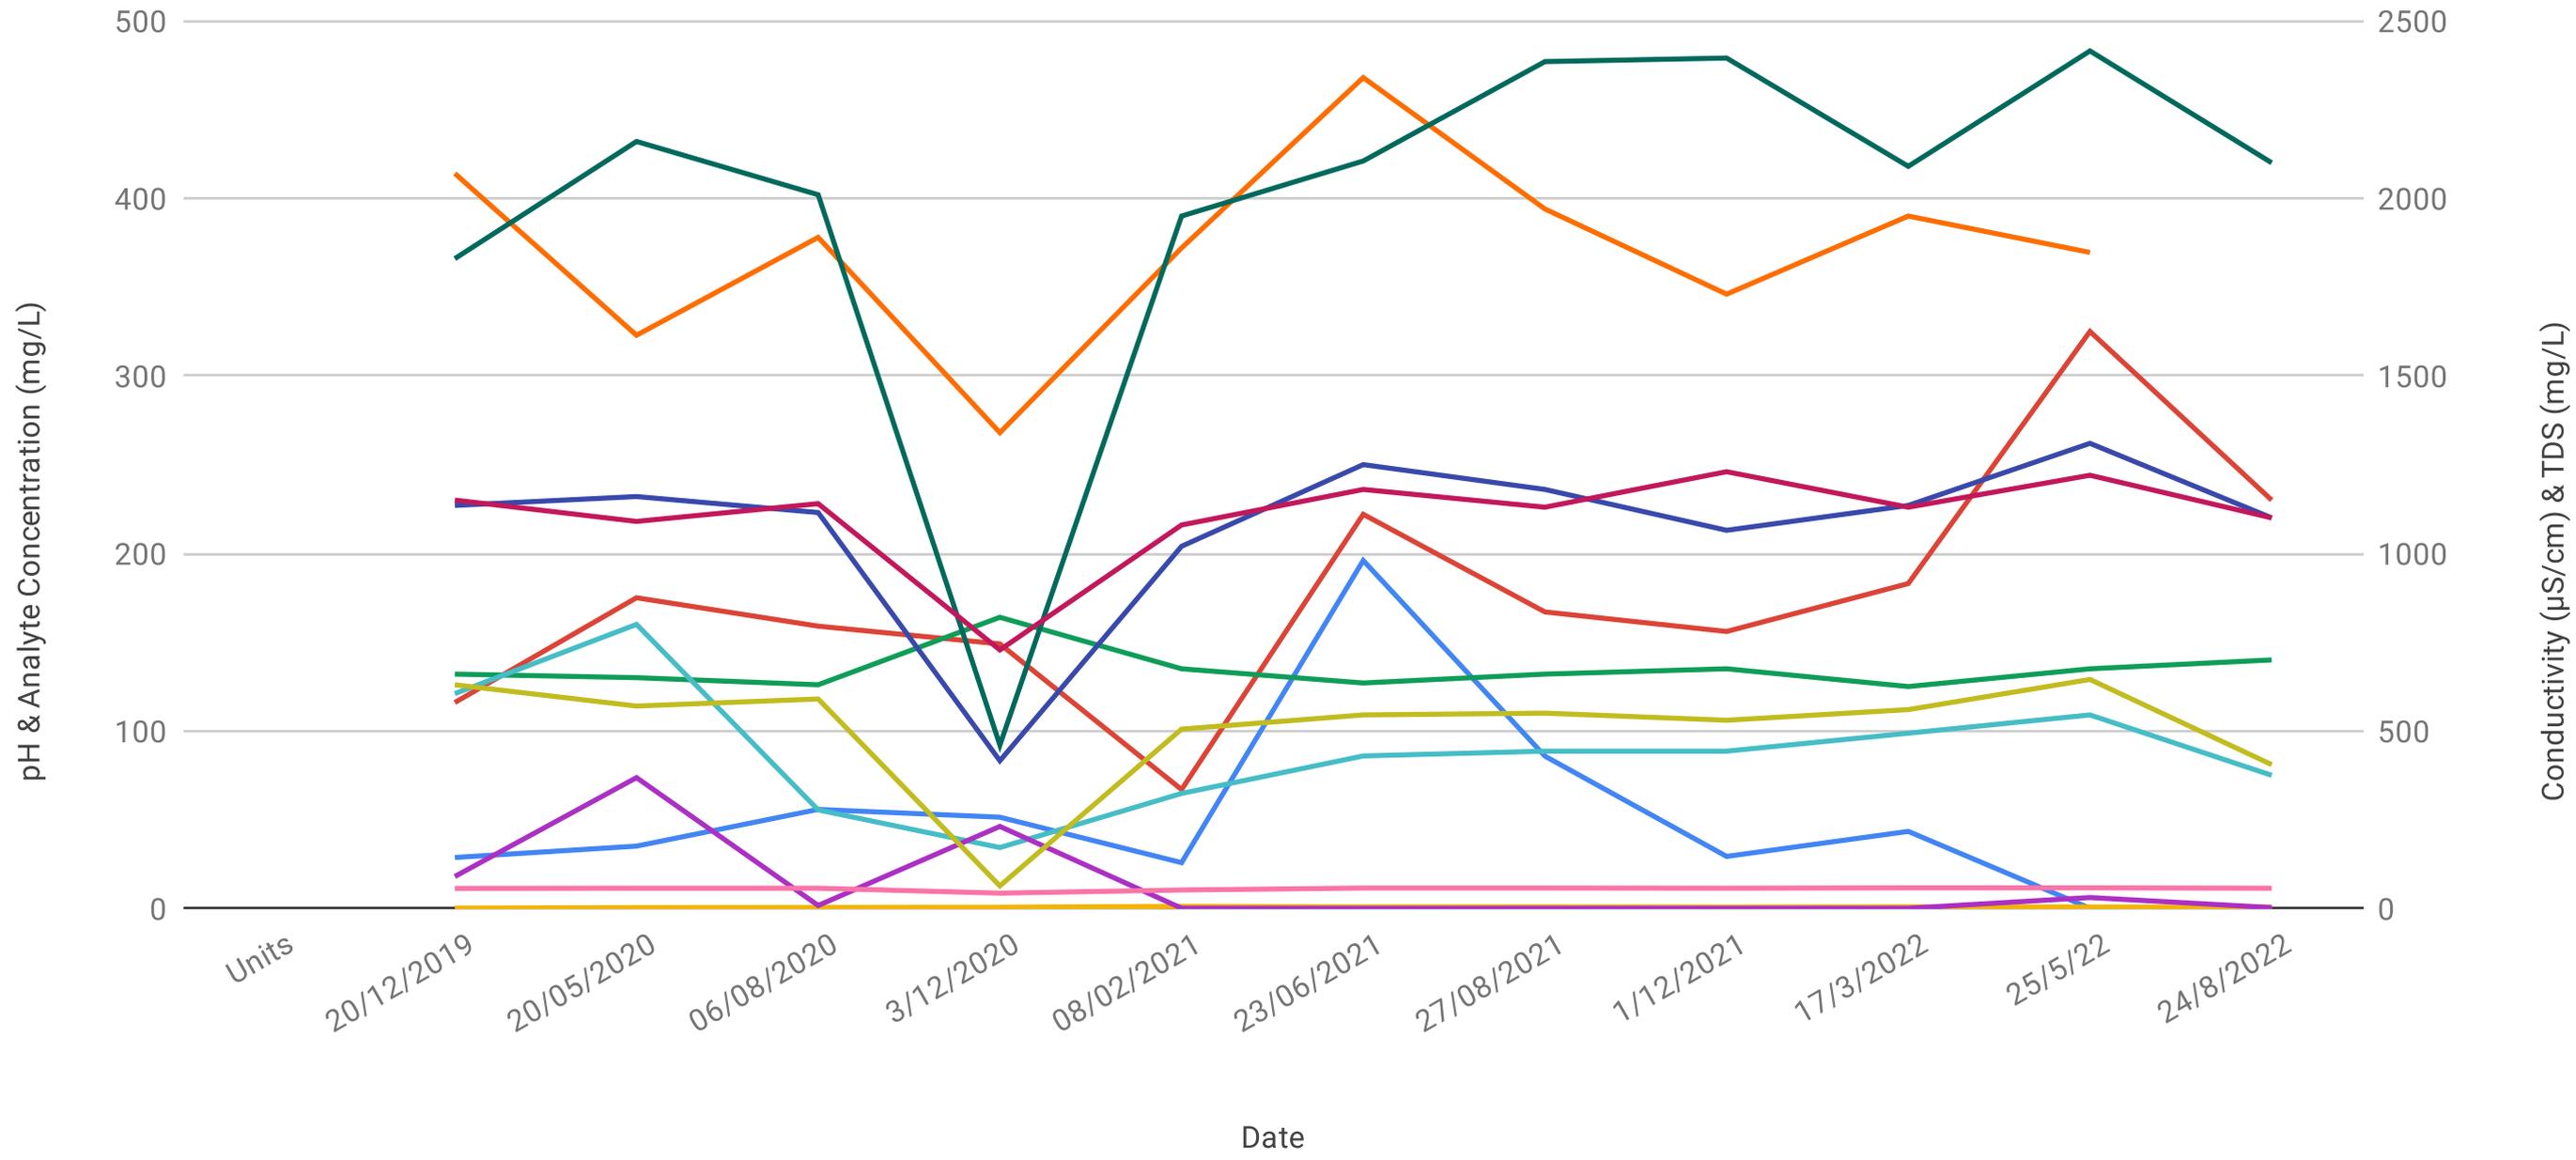
Figure 1.5.5.16 MB33

■ Bicarbonate
 ■ Carbonate
 ■ Alkalinity (as CaCO3)
 ■ Nitrogen (ammonia)
 ■ Chloride
 ■ Conductivity
 ■ Calcium
 ■ Magnesium
 ■ Potassium
■ Sodium
■ pH
■ Sulphate
■ Total Dissolved Solids

<p>MB33</p>	<p>MB33 is a 75m deep groundwater monitoring bore to replace a waste covered well (WM4) in the Void.</p> <p>A bailer was used to retrieve the groundwater samples from this bore during the reporting period due to pump limitations resulting from the >35m below ground level (BGL) depth of the standing water level (SWL).</p> <p>Based on the results provided in Table 9.17 (refer Appendix 4), the groundwater quality at this location can be described as:</p> <ul style="list-style-type: none"> ● SWL (average 753.4m RL) was consistent throughout this reporting period; ● pH (average 11.5) showing an upward trend; ● EC (average 1842 $\mu\text{S}/\text{cm}$) remains stable, throughout the reporting period; ● SO_4 (average 450 mg/L) is consistent with previous periods; ● Pb (0.03mg/L) and Zn (3.1 mg/L) were both generally consistent in this reporting period; ● NH_3 (0.8 mg/L) is close to, or within, non-detection rates; ● TOC (5 mg/L) reflecting natural conditions is consistent throughout this reporting period. <p>No significant variations or anomalies were recorded for any analyte tested at this location during this monitoring period.</p>

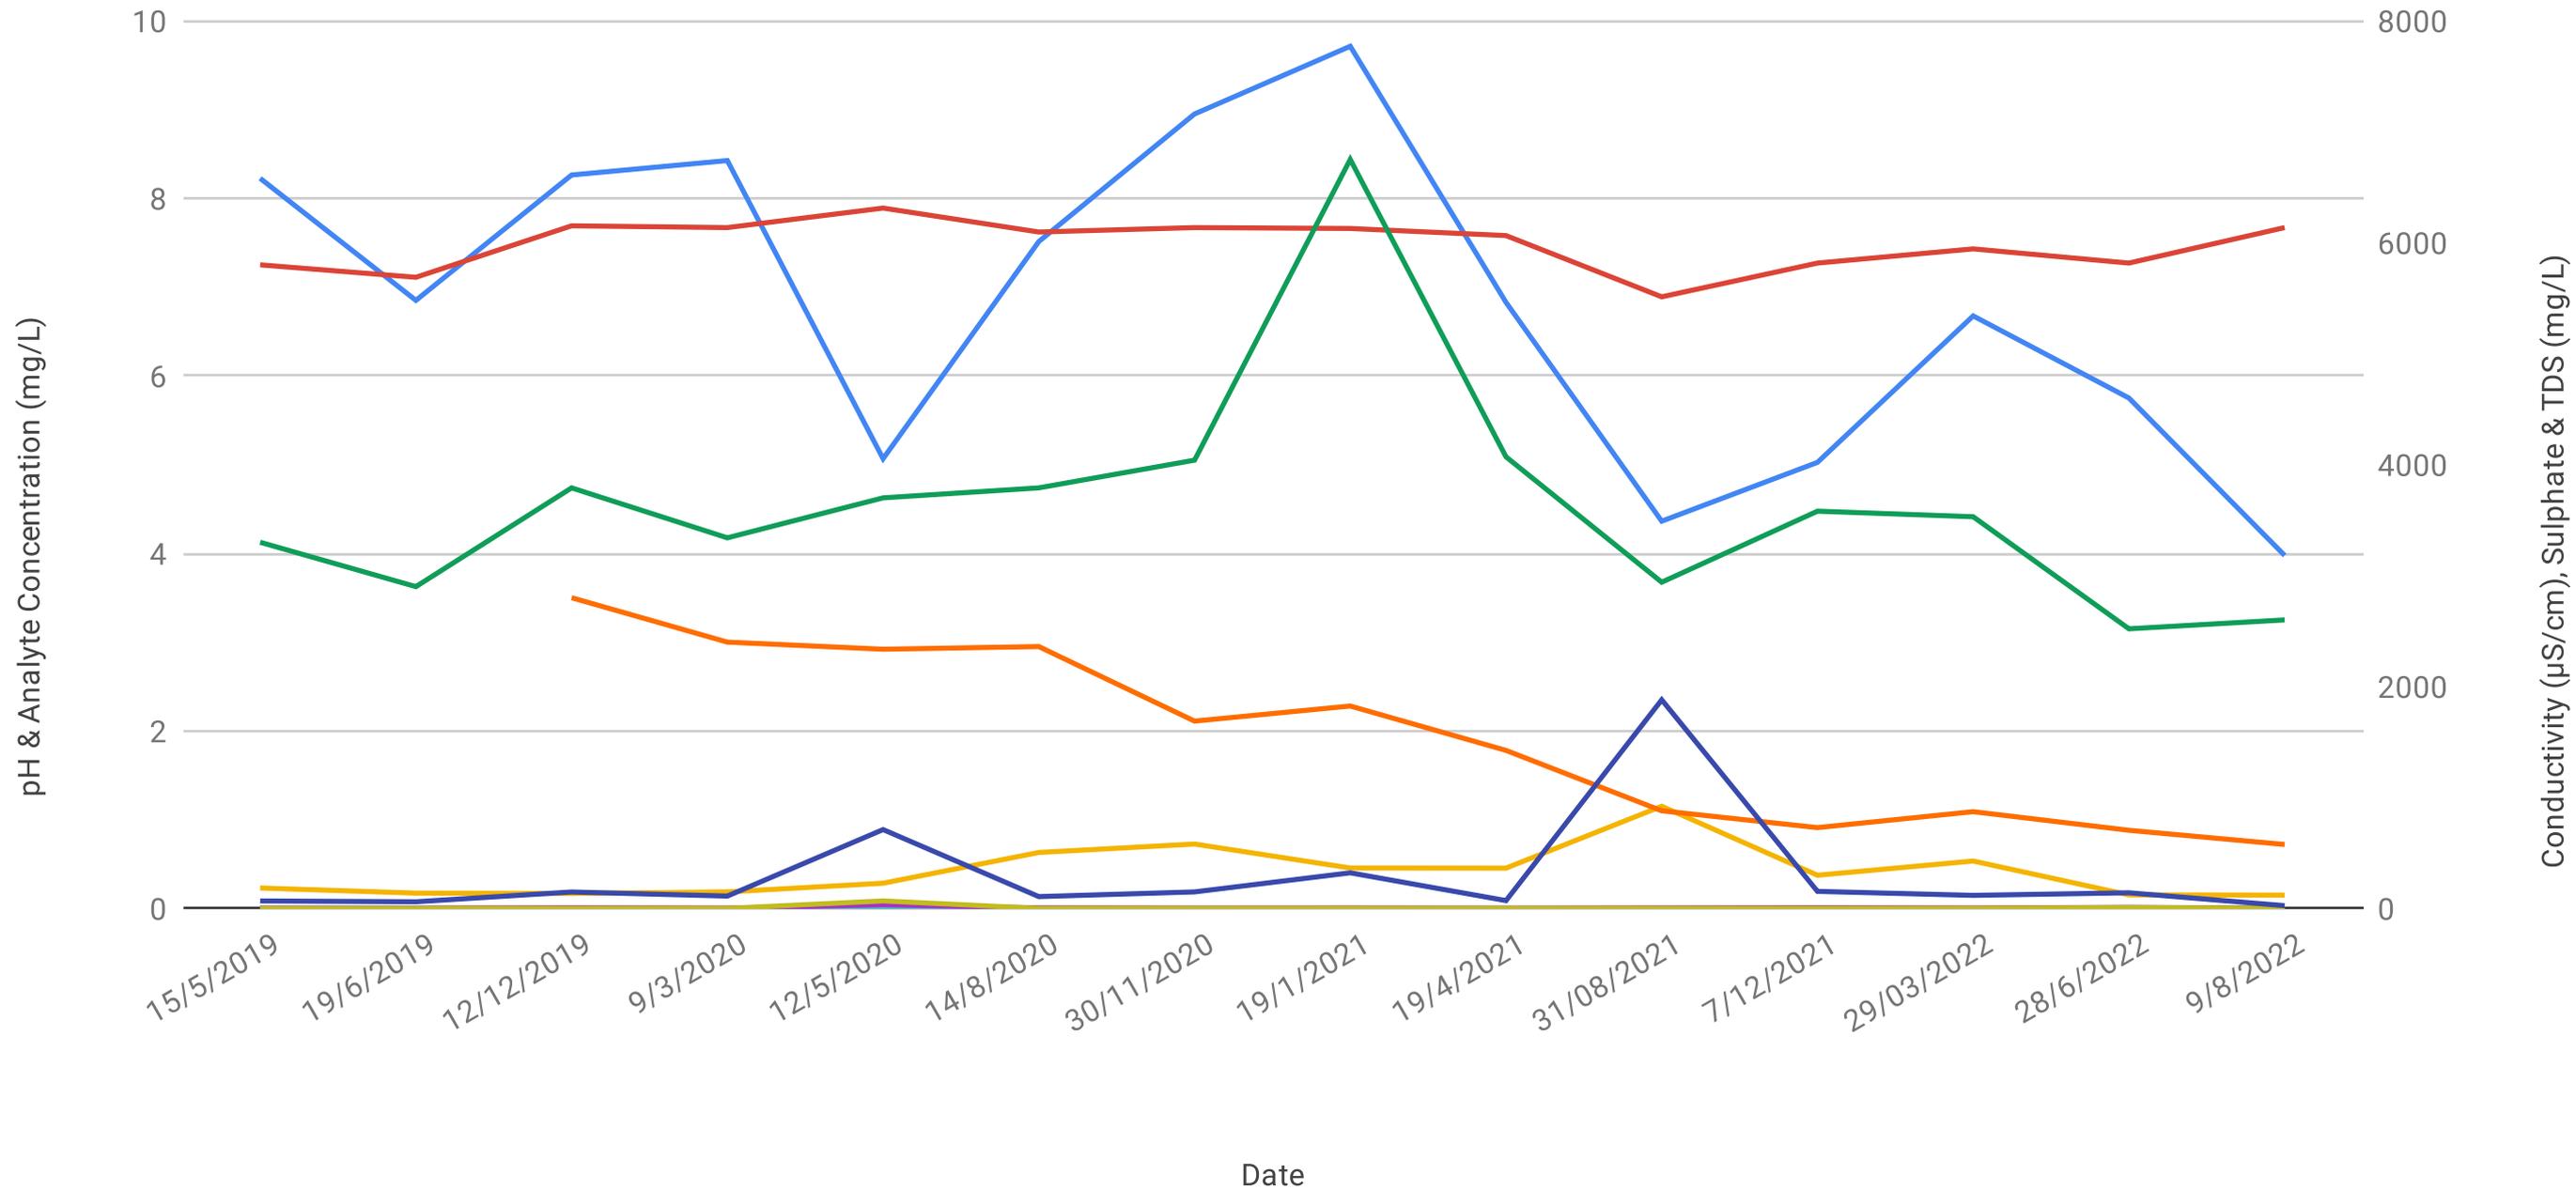
Figure 1.5.5.18 MW FRC-1

- Conductivity
- pH
- Sulphate
- Total Dissolved Solids
- Standing Water Level
- Cadmium
- Copper
- Lead
- Zinc
