Annual Environmental Performance Report 2021-22

Woodlawn Bioreactor
and Crisps Creek Intermodal
Facility

November 2022

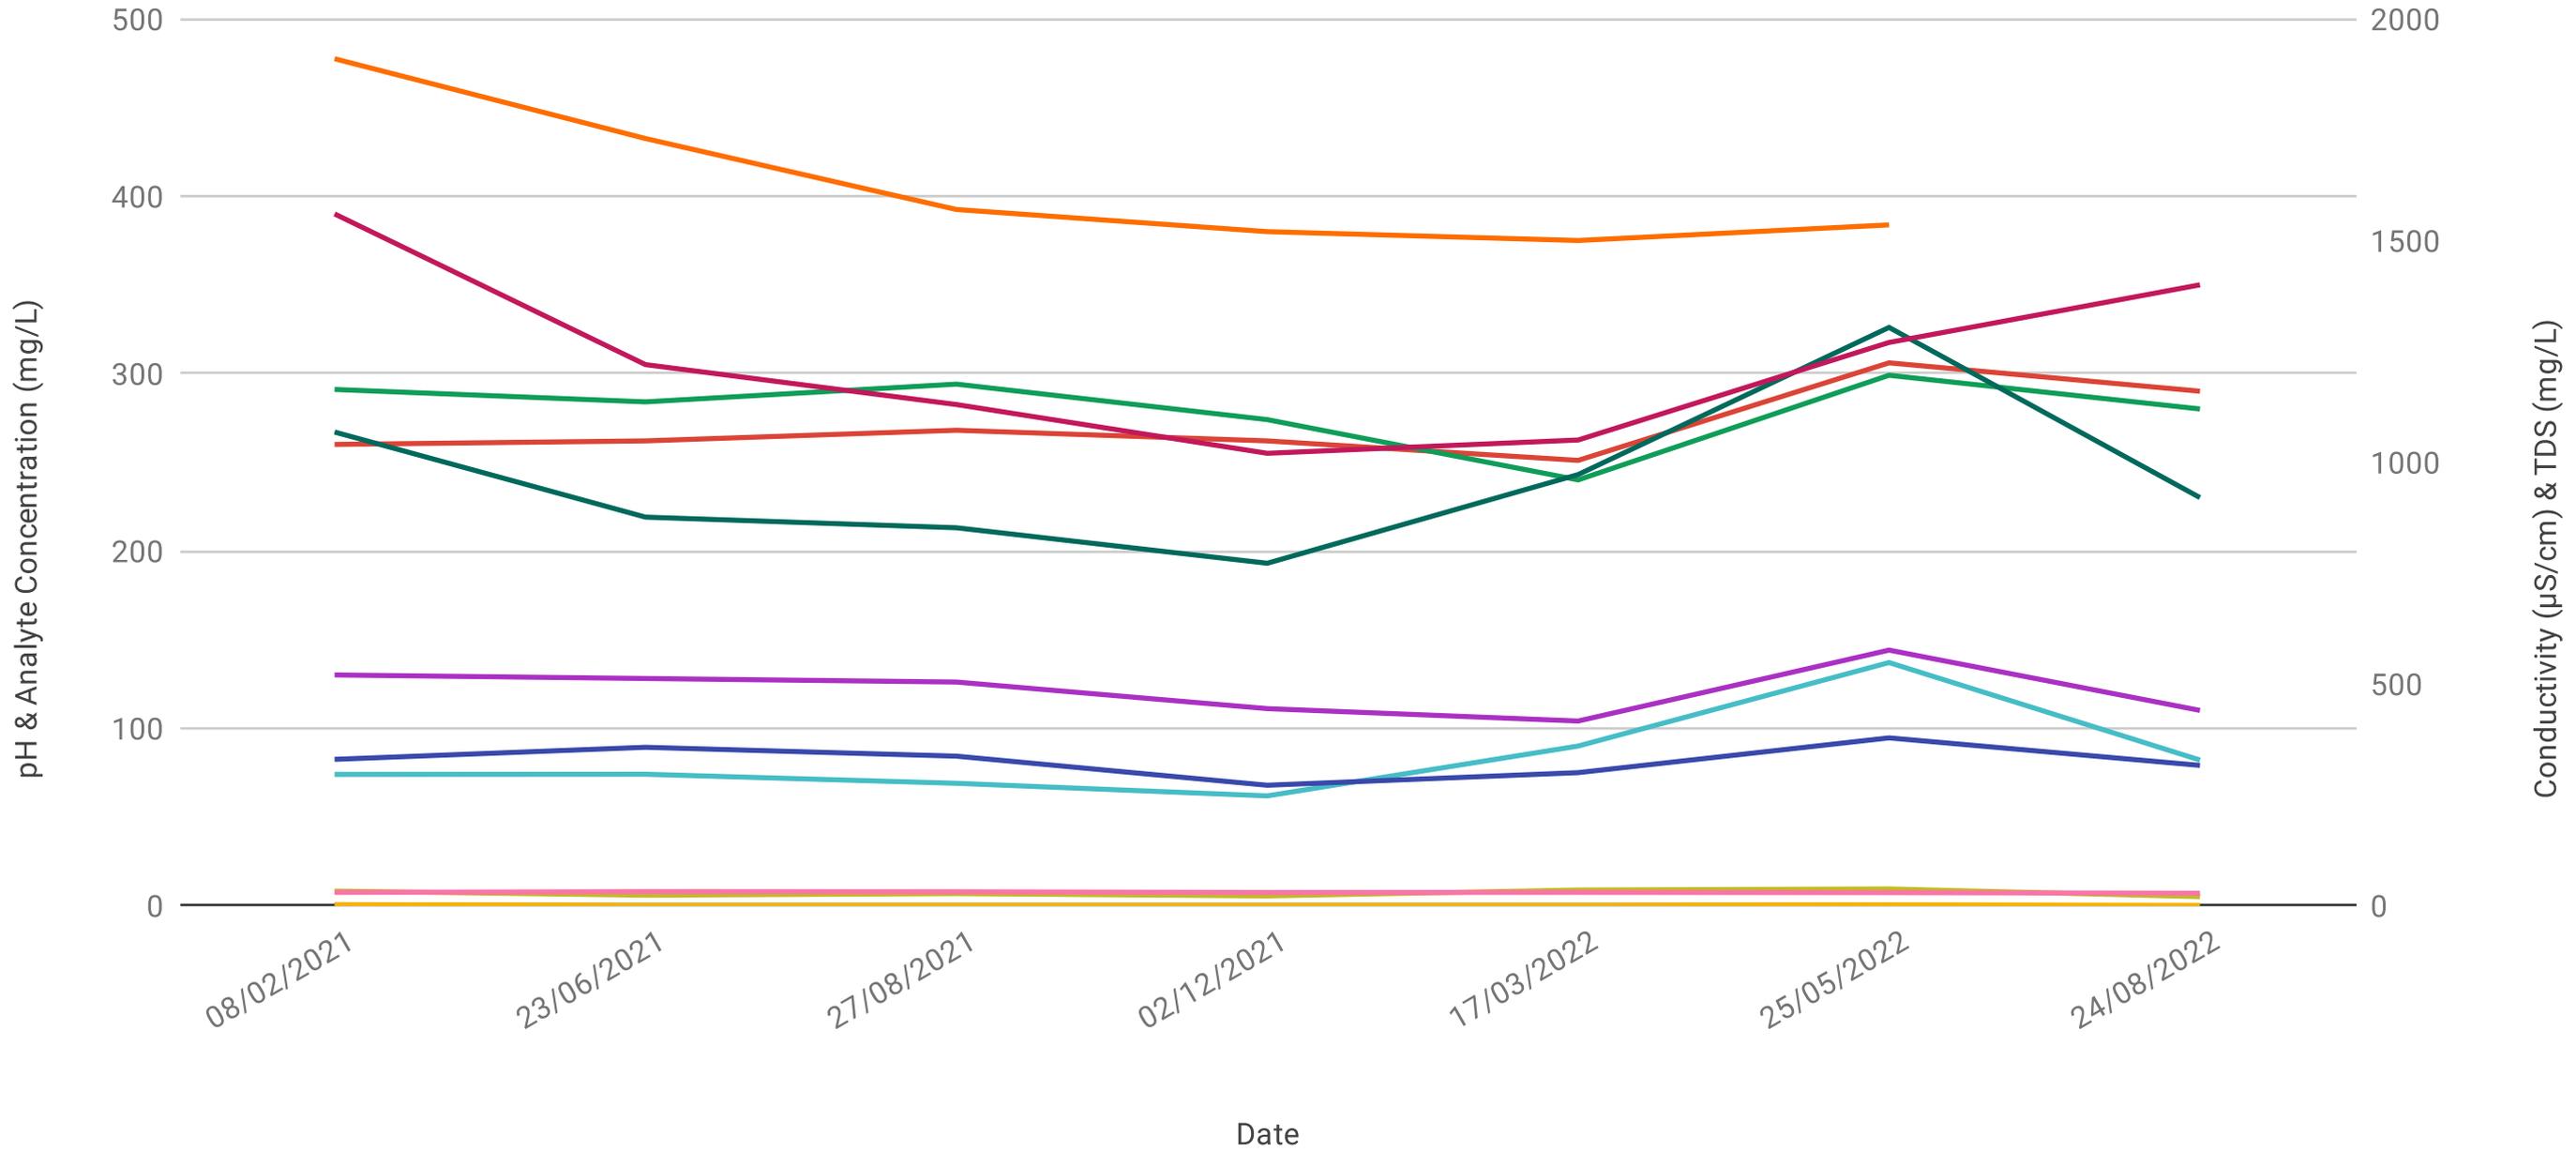
Figure 1.5.5.20 MB34

- Carbonate
- Alkalinity (as CaCO3)
- Nitrogen (ammonia)
- Chloride
- Conductivity
- Calcium
- Magnesium
- Potassium
- Sodium
- pH
- Sulphate
- Total Dissolved Solids

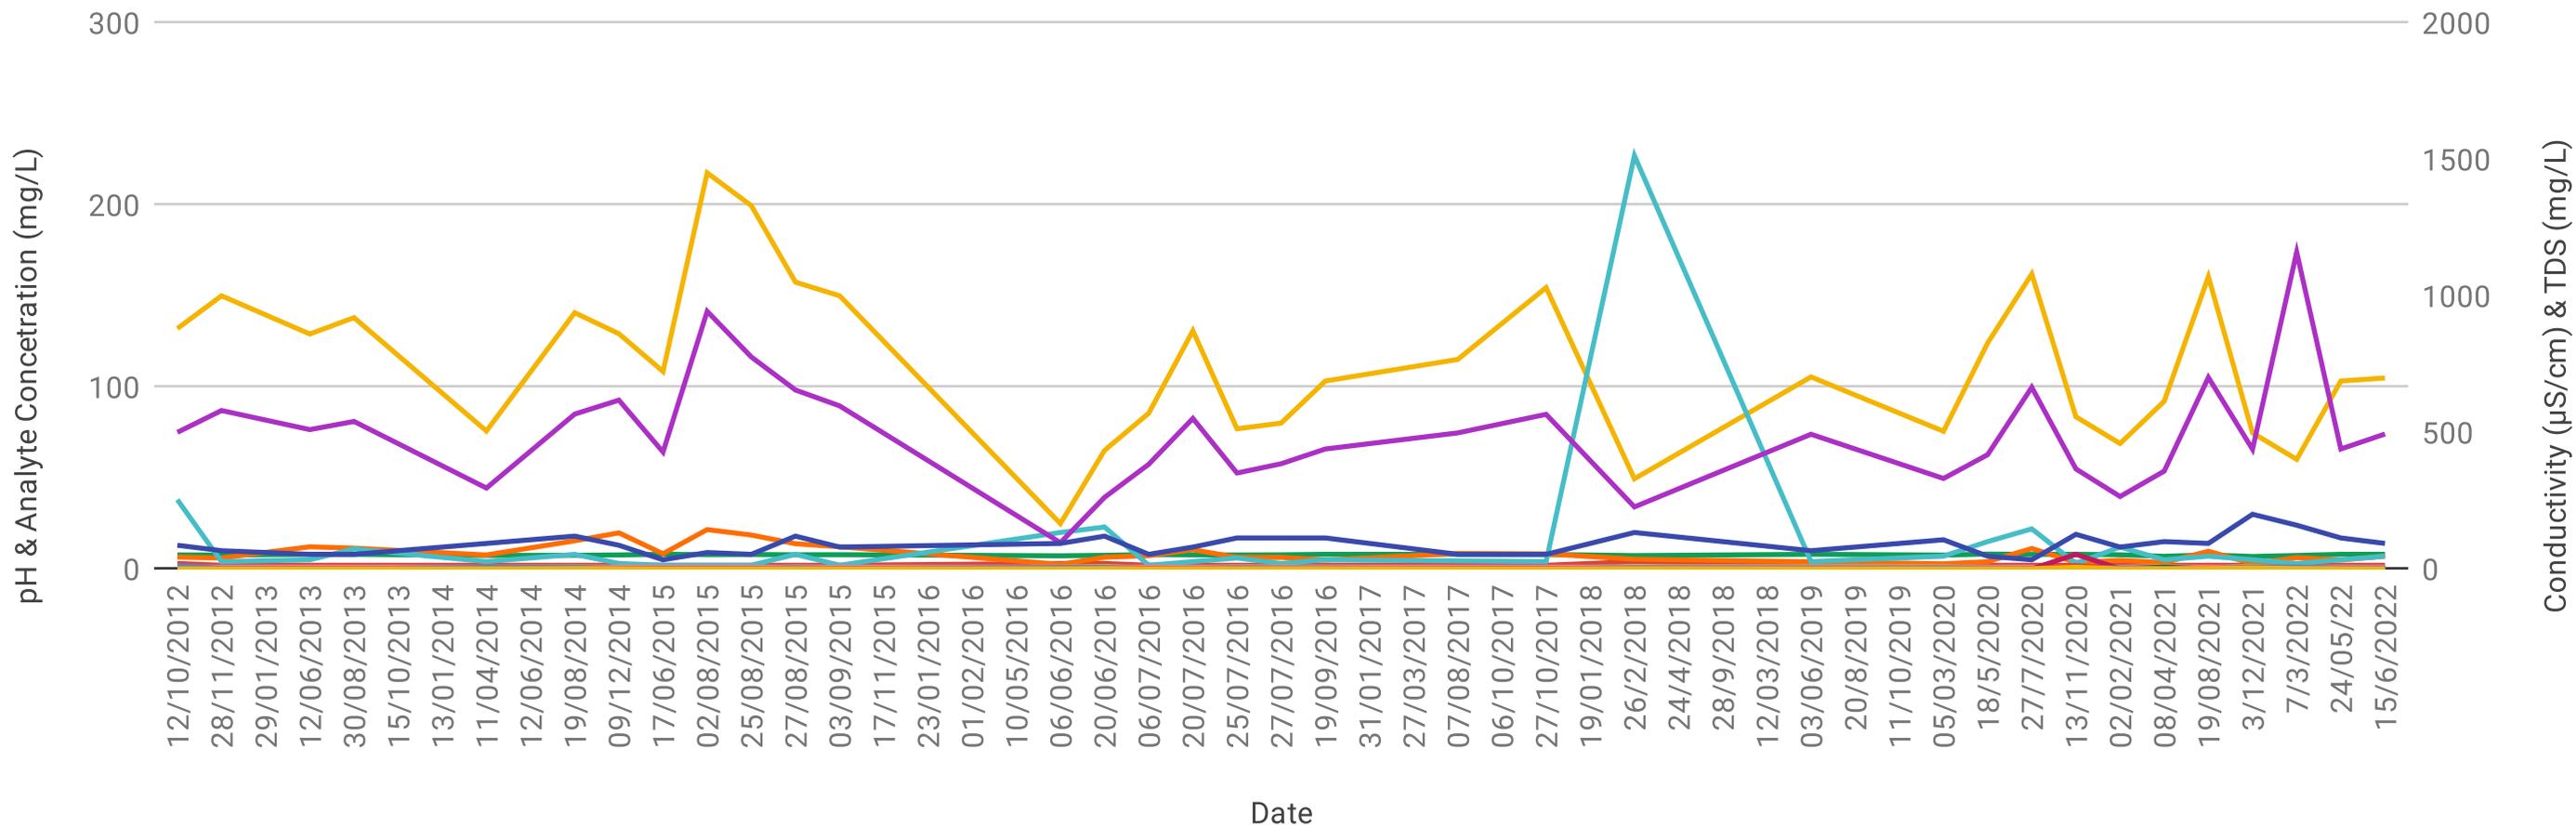
Figure 2.4.1.2 Site 150 - Mulwaree River

- Nitrogen (ammonia)
- Biochemical Oxygen Demand
- Conductivity
- pH
- Sulphate
- Total Suspended Solids
- Total Dissolved Solids
- Total Kjeldahl Nitrogen
- Total Organic Carbon
- Oil & Grease
- Phosphorous
- Total Copper
- Total Iron
- Total Lead
- Total Zinc

These are depicted in trend graphs (**Figures 2.4.1.1 to 2.4.1.3**) provided in **Appendix 5**.
