# Soil and Water Management Plan - Woodlawn Bioreactor

<b>PURPOSE</b>	This Soil and Water Management Plan (SWMP) has been prepared in accordance with conditions 13 - 18 of the COCs for the Woodlawn Bioreactor (the Bioreactor) to ensure that soil and water is successfully controlled and managed during the operation of the Bioreactor.
----------------	--

Woodlawn Bioreactor; Construction Quality Control  
Assurance for Lining Evaporation Dam (ED3SS),  
November 2015 to July 2016.

Report E2W-0243 (R001-V2)

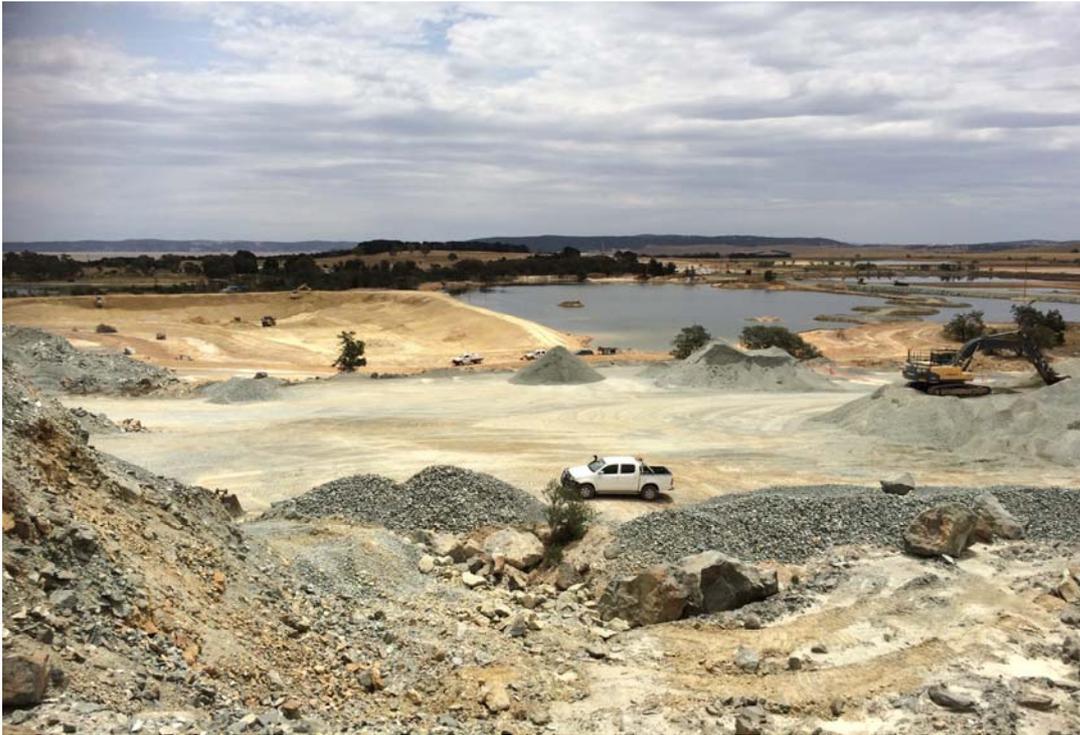
**Plate 1** (15 December 2015) Viewing south west over the construction of ED3SS (left of frame). Batter slopes nearly complete and construction of the floor levels and liner still in progress. Existing evaporation dam (No3 lagoons- south & north) are full and right of ED3SS.

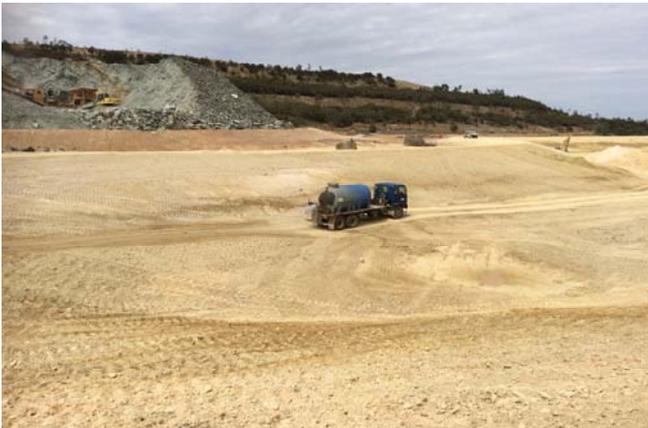
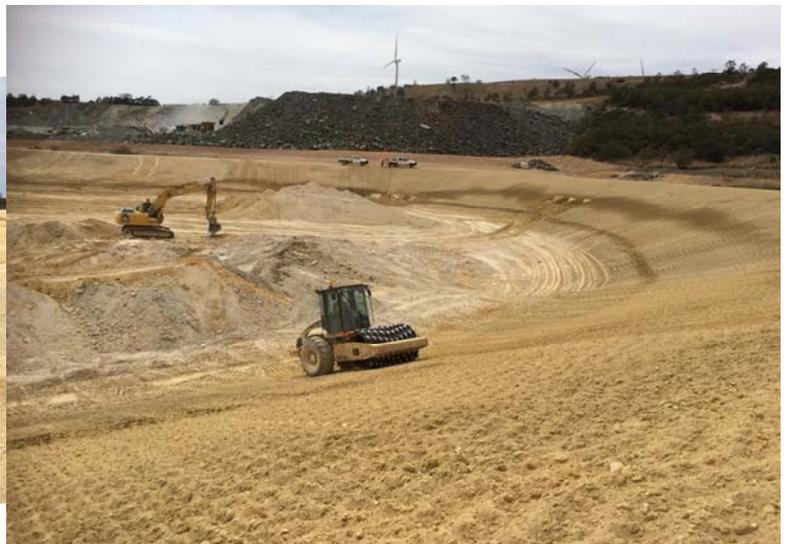
**Plates 2 & 3** (15 December 2015) View of over the construction of ED3SS showing batter slopes, water cart (moisture control during reworking and compaction), roller (14 t sheep foot) on southern batter, and excavator (20 t) used to excavate & load materials (light brown weathered tuff and silty clay, D8 used to rip & spread materials in 150mm layers). Batter slopes nearly complete whilst floor levels are still in progress showing excess stockpiled materials.

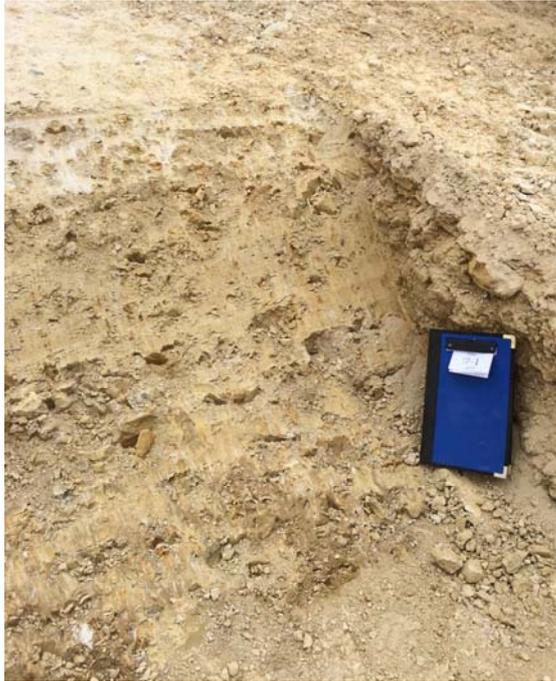
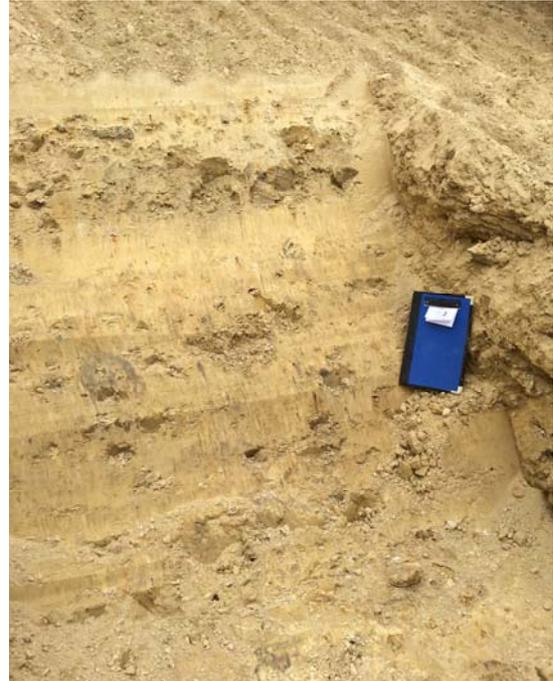
**Plates 4 & 5** (15 December 2015) Testpits -1& 2 (battered slope). Compacted light brown silty clay with gravel (tuffaceous weathered rock <10 %). (K Test=Wall 6 &1).

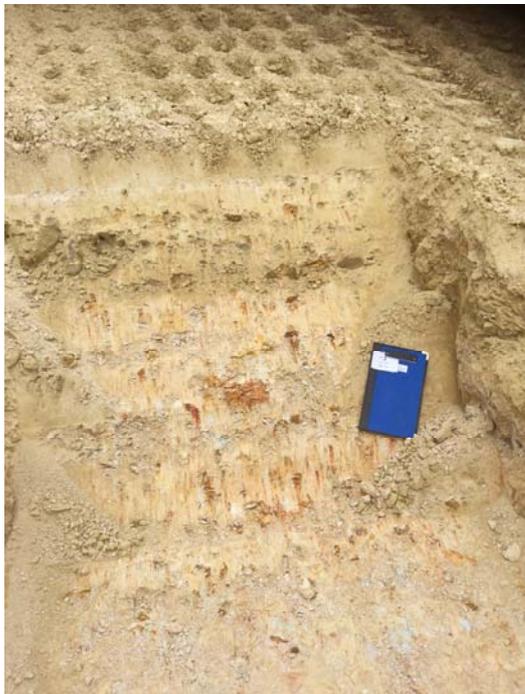
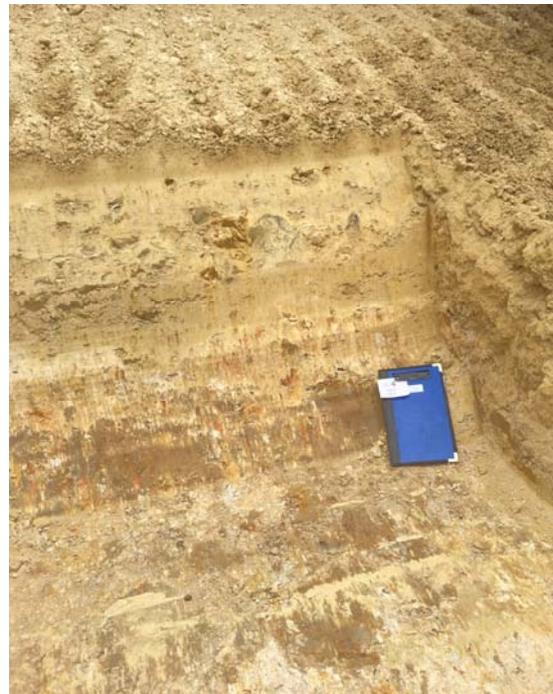
**Plates 6 & 7** (15 December 2015) Testpits -3& 4 (battered slope). Compacted light brown silty clay with gravel (tuffaceous weathered rock <10%). (K Test=Wall 2 & 3).

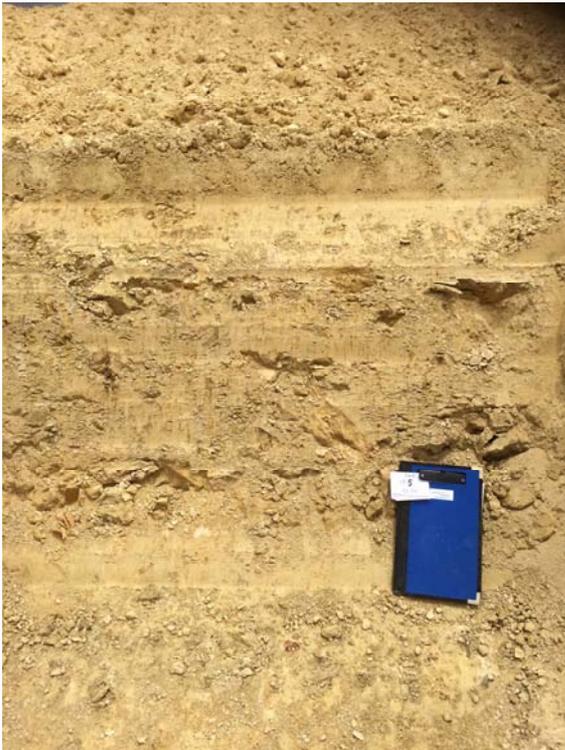
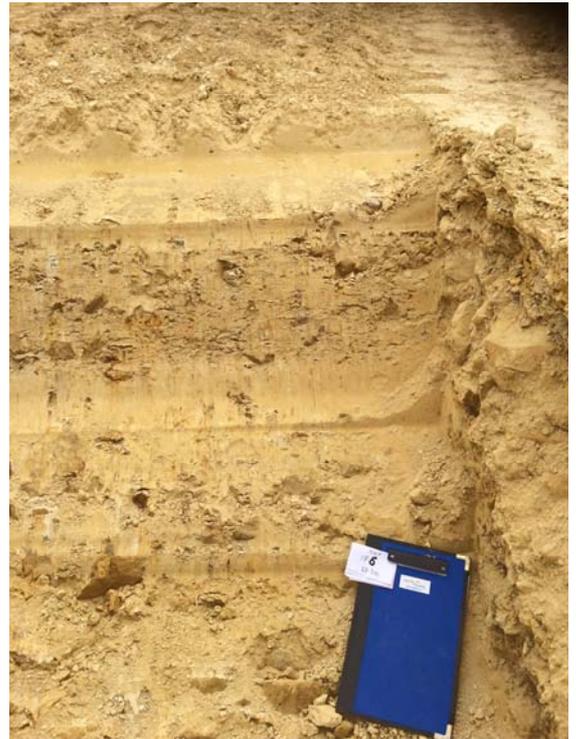
**Plates 8 & 9** (15 December 2015) Testpits -5 & 6 (battered slope). Compacted light brown silty clay with gravel (tuffaceous weathered rock <10%). (K Test=Wall 4 & 7).

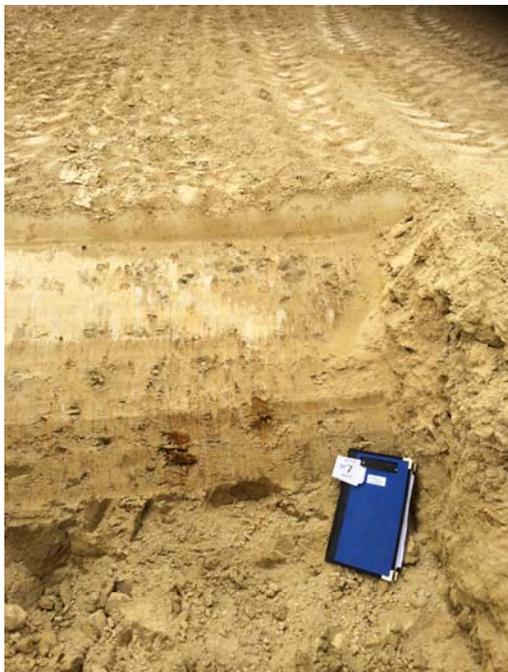
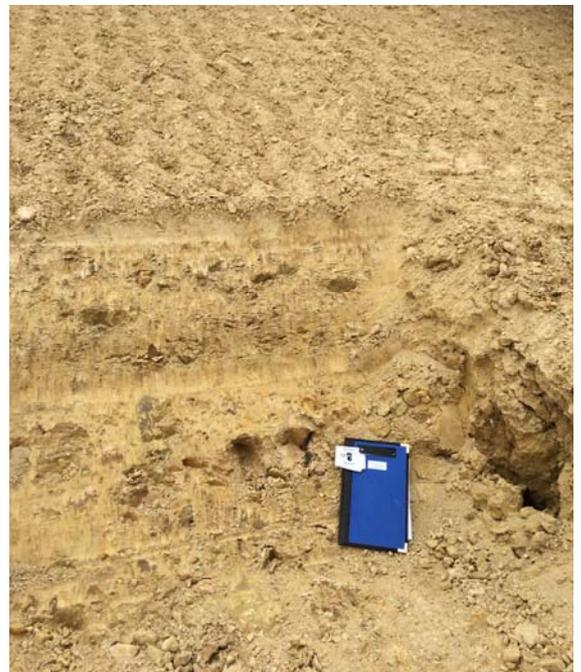
**Plates 10 & 11** (15 December 2015) Testpits -7 & 8 (battered slope). Compacted light brown silty clay with gravel (tuffaceous weathered rock <5%). (K Test=Wall 8 & 5).

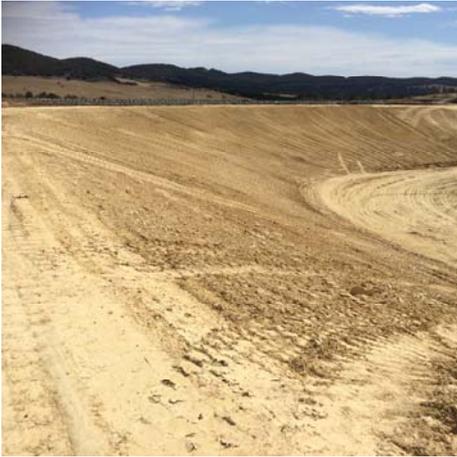
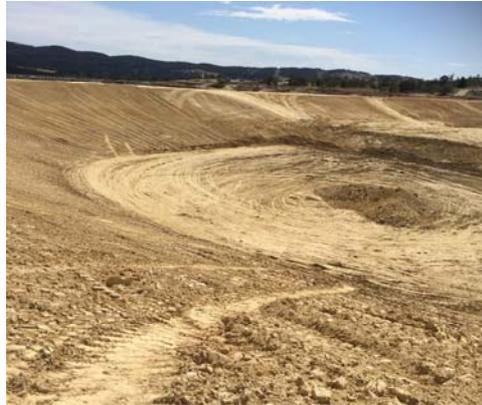
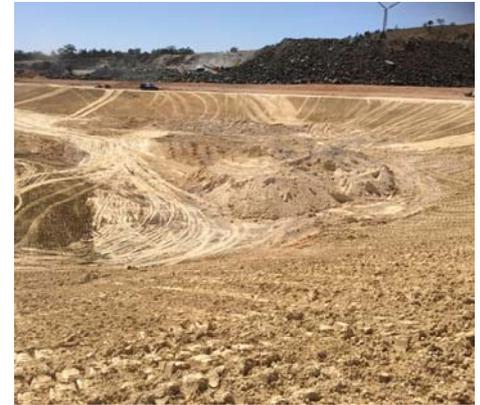
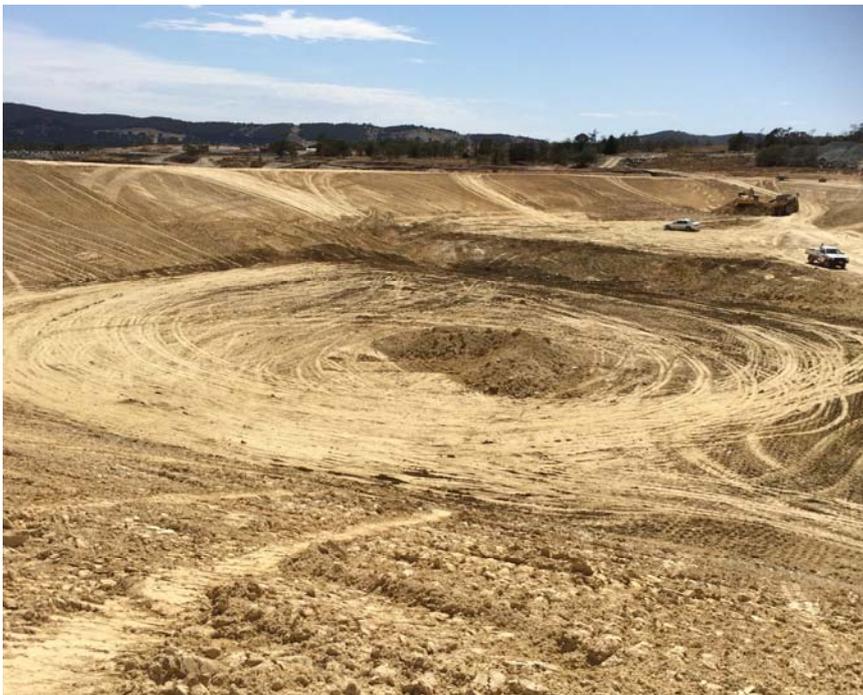
Figure 1A: Site Layout & Testing Locations at Evaporation Dam (E2W, 12 January 2016).  
Plates 1 to 5 (12 January 2016)

**Plates 1 to 5** (12 January 2016) Viewing north over liner construction works at ED3SS (use of D8, roller, excavator, water cart). An area of approximately 2500m<sup>2</sup> completed on SW corner to 0.9m thickness using re-worked and compacted weathered bedrock (siltstone) and clayey silt. Batter slopes completed using reworked insitu material (few meters thick). Two areas on the floor comprise hard rock which is removed and reused in the VOID.

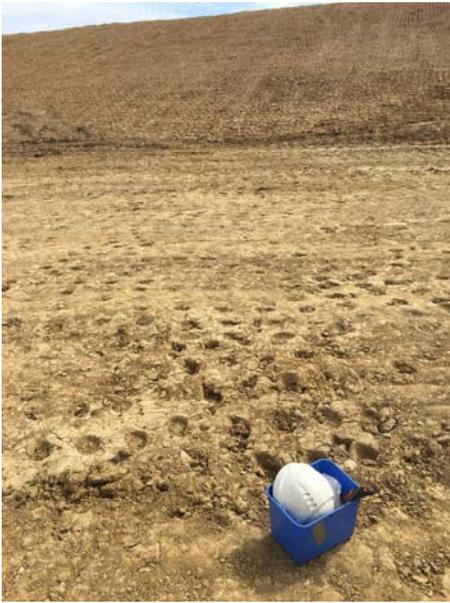
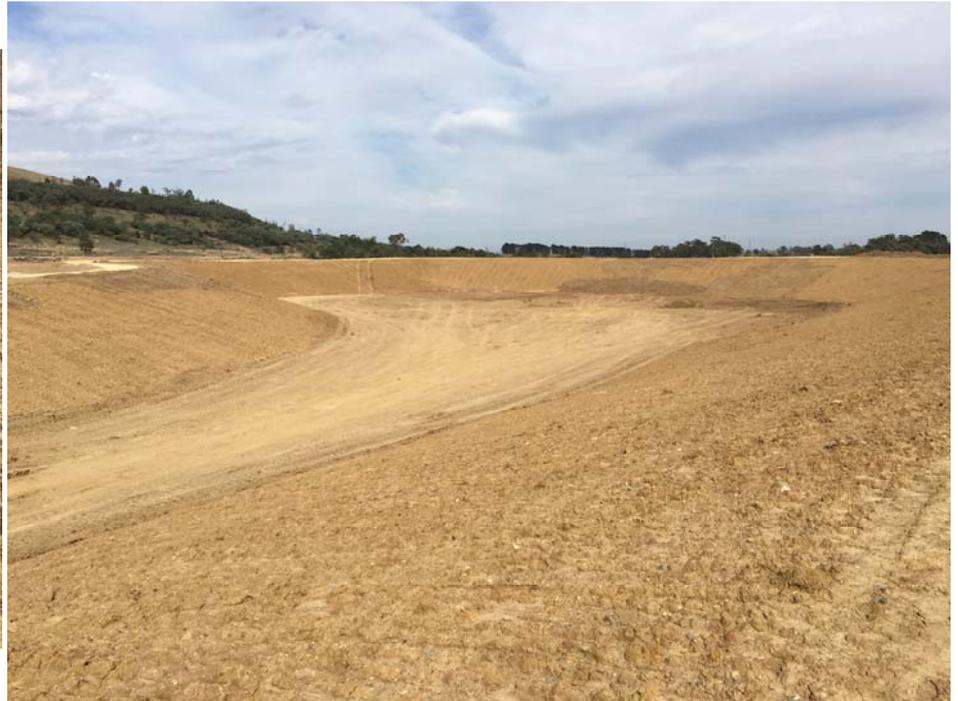
**Plates 1 & 2** (10 March 2016) Viewing south over the construction of ED3SS, showing completed batter slopes and floor levels (capped by 0.3m of MBT clay). Further compaction (smooth drum) and installation of the gravel layer (0.1m) is still in progress. The left plate shows the completed floor and walls and sampling location of ED3ss (F1= floor, blue bucket) and ED3SS (W1=wall).

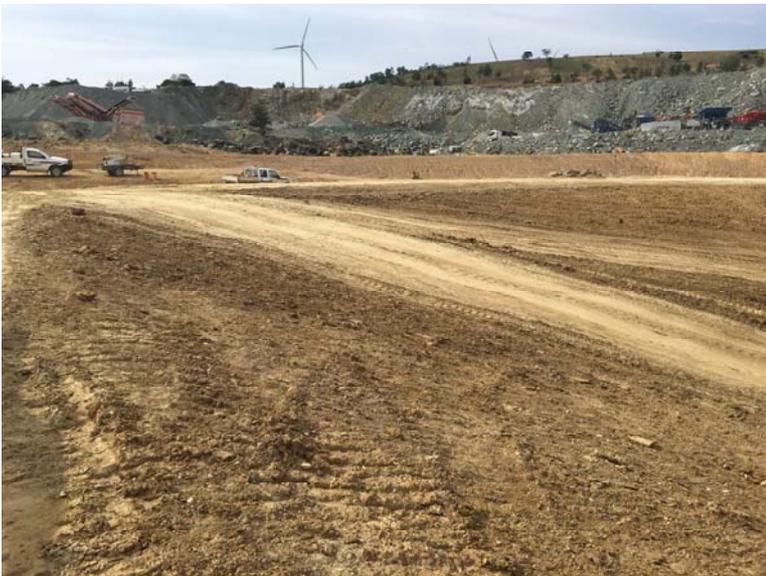
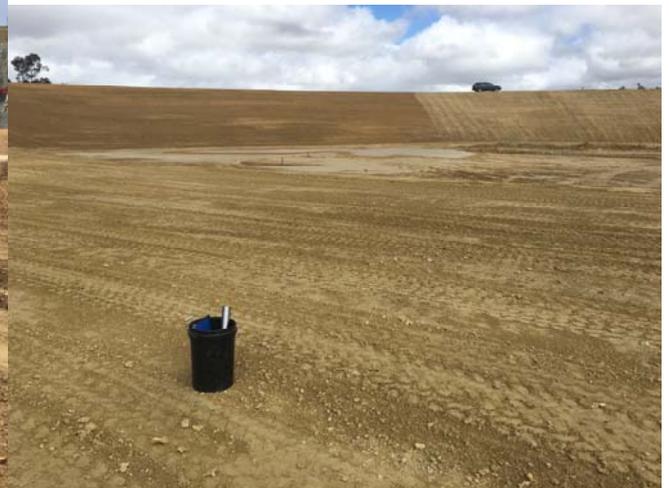
**Plates 3 & 4** (10 March 2016 & 5 February 2016). View over the northern end of ED3SS showing the access ramp used to transport clay materials (& remove waste rock) for the liner construction (completed with 0.3m capping of MBT). The completion of the insitu floor liner (i.e. 1.2 m) using reworked insitu clay-silt is shown (5 Feb 2016) before capping by MBT clay (0.3m thick).

**Plates 3 & 4** (10 March 2016 & 5 February 2016). View over the northern end of ED3SS showing the access ramp used to transport clay materials (& remove waste rock) for the liner construction (completed with 0.3m capping of MBT). The completion of the insitu floor liner (i.e. 1.2 m) using reworked insitu clay-silt is shown (5 Feb 2016) before capping by MBT clay (0.3m thick).

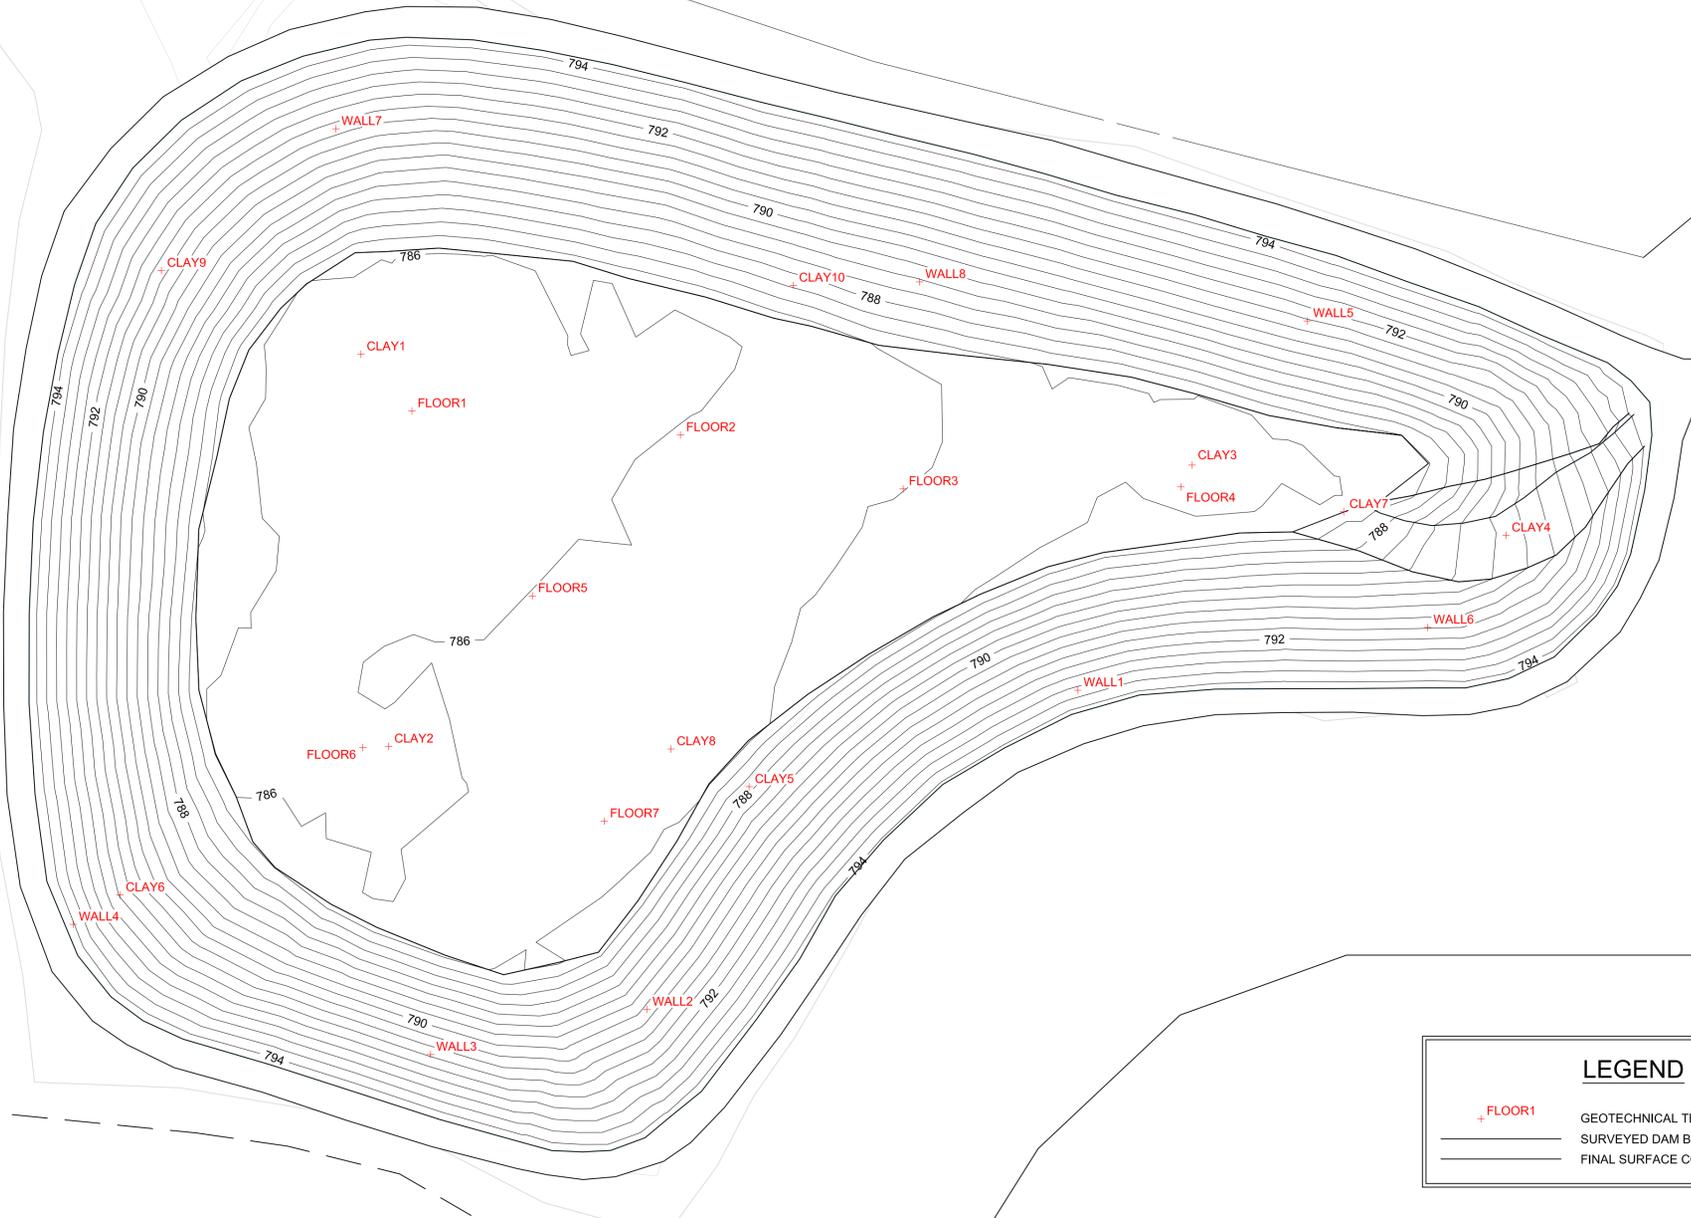
SCHEDULE OF TEST POINT COORDINATES					
POINT	EASTING	NORTHING	RL	PERMEABILITY (m/s)	
WALL1	733696.74	6117020.17	792.40	-----	
WALL2	733635.68	6116975.01	789.46	-----	
WALL3	733605.05	6116968.64	791.00	$9.0 \times 10^{-9}$ (AT 0.5m)	
WALL4	733554.39	6116987.05	793.40	-----	
WALL5	733729.27	6117072.40	790.98	$2.0 \times 10^{-9}$ (AT 0.2m)	
WALL6	733746.31	6117029.05	790.89	-----	
WALL7	733591.62	6117099.58	790.34	-----	
WALL8	733674.34	6117077.93	788.84	$5.0 \times 10^{-9}$ (AT 0.5m)	
FLOOR1	733602.39	6117059.66	785.50	-----	
FLOOR2	733640.45	6117056.27	785.83	-----	
FLOOR3	733671.99	6117048.64	786.32	-----	
FLOOR4	733711.33	6117048.92	786.79	-----	
FLOOR5	733619.46	6117033.52	785.65	-----	
FLOOR6	733595.45	6117012.07	785.51	-----	
FLOOR7	733629.65	6117001.65	785.95	-----	
CLAY1	733595.18	6117067.70	785.79	-----	
CLAY2	733599.10	6117012.22	785.89	-----	
CLAY3	733712.93	6117052.01	786.88	-----	
CLAY4	733757.41	6117042.08	790.14	-----

CLAY5	733650.17	6117006.51	787.79	-----	
CLAY6	733561.04	6116991.20	791.44	-----	
CLAY7	733734.41	6117045.41	787.85	$2.0 \times 10^{-10}$	
CLAY8	733639.10	6117011.85	786.23	$1.0 \times 10^{-11}$	
CLAY9	733566.91	6117079.53	791.33	$5.0 \times 10^{-11}$	
CLAY10	733656.43	6117077.43	787.57	$2.0 \times 10^{-11}$

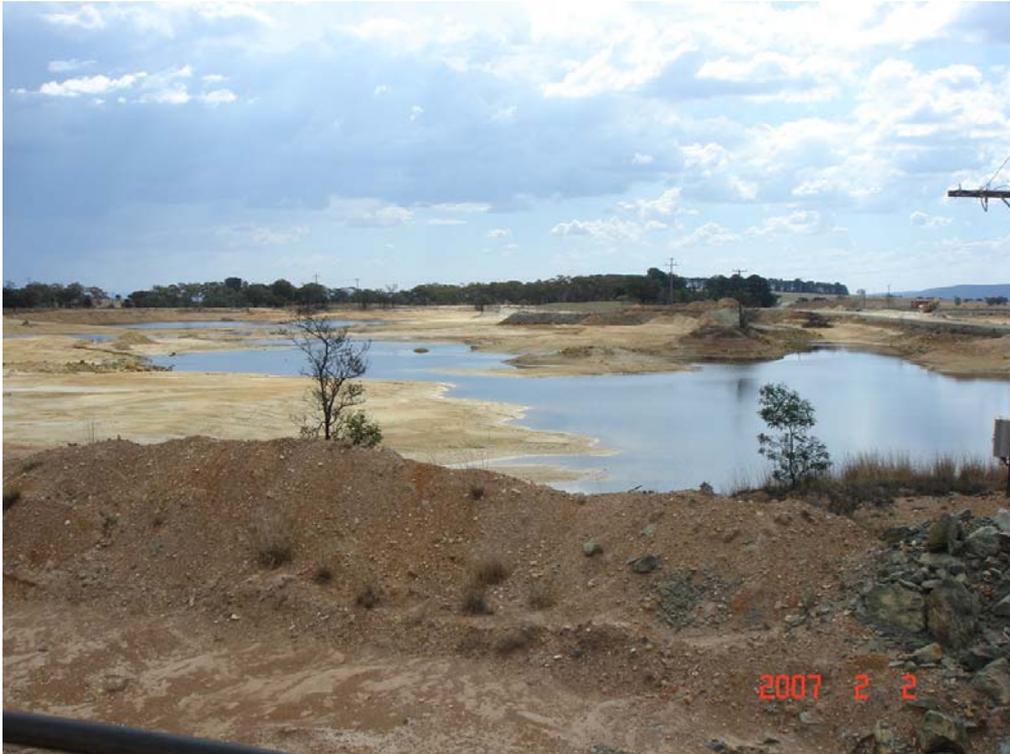
**Plate 1** (2 February 2007). Viewing south over evaporation dam (ED3 south) prior to construction of the clay liner (2016). Floor of liner showing the silty clay overlying the siltstone bedrock.

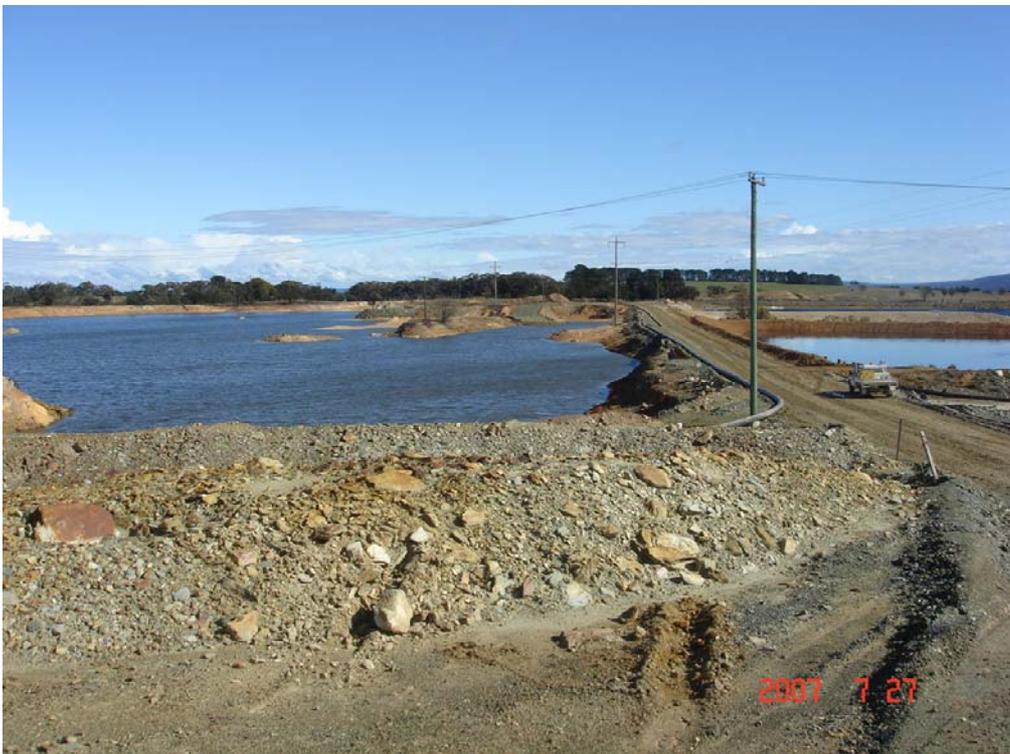
**Plate 2** (27 July 2007). Viewing south over evaporation dam (ED3 south, full of water) prior to construction of the clay liner (2016).

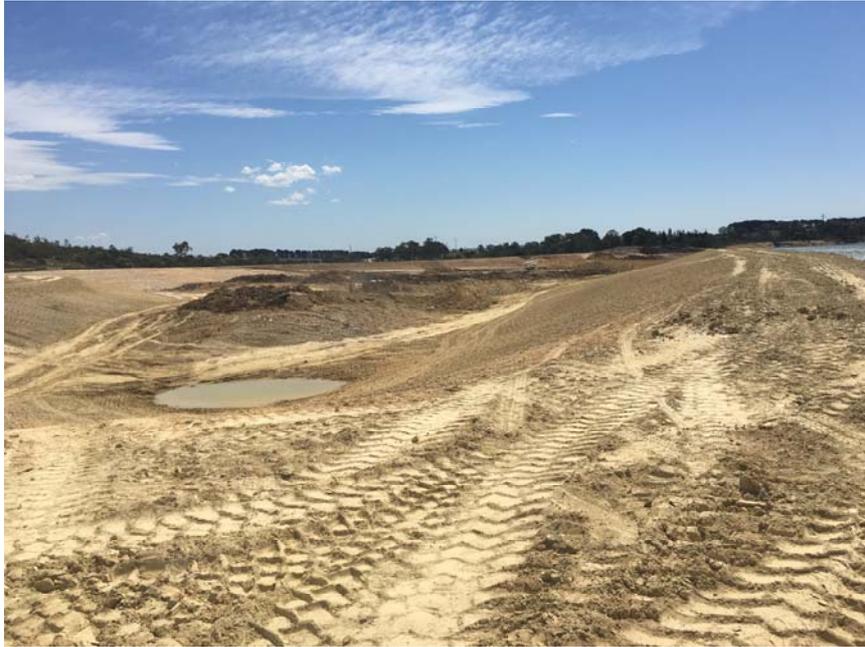
**Plate 1** (19 November 2015). View over the construction works and liner preparation at evaporation dam (ED3SS). The brown weathered bedrock (Silurian siltstone/tuff) is levelled and re-worked to provide a clay seal foundation over the floor of the dam. Evidence of the impervious fine grained material is shown by the ponded water (centre of frame).

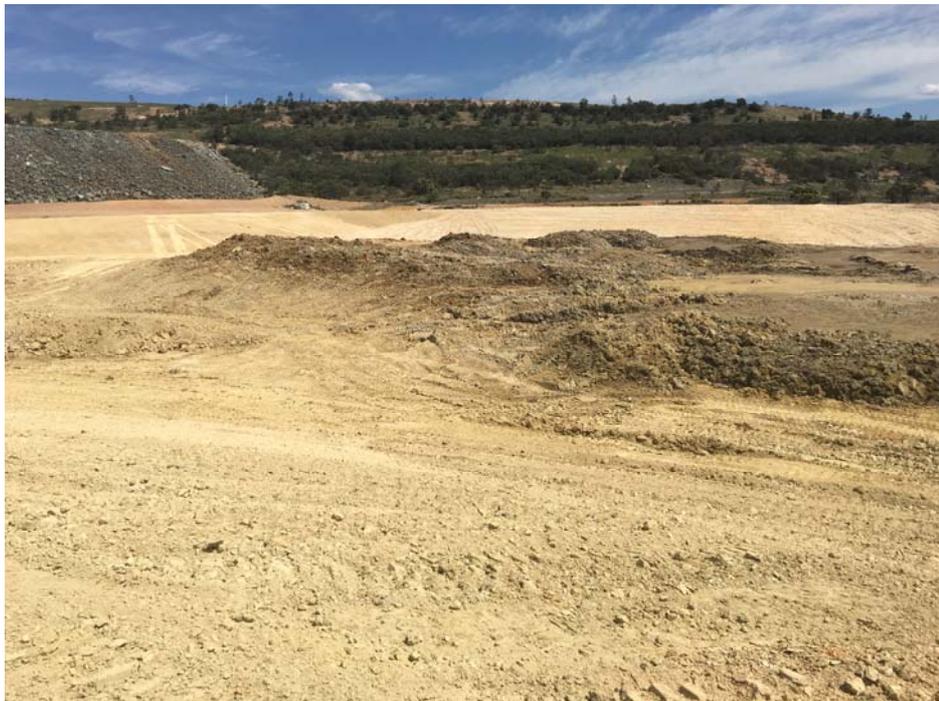
**Plate 2** (19 November 2015). View over floor liner preparation at evaporation dam (ED3SS). The weathered bedrock (Silurian siltstone/tuff) is re-worked to provide an impervious clay barrier/foundation. Stockpiled material is predominantly silty clay with weathered siltstone gravel.

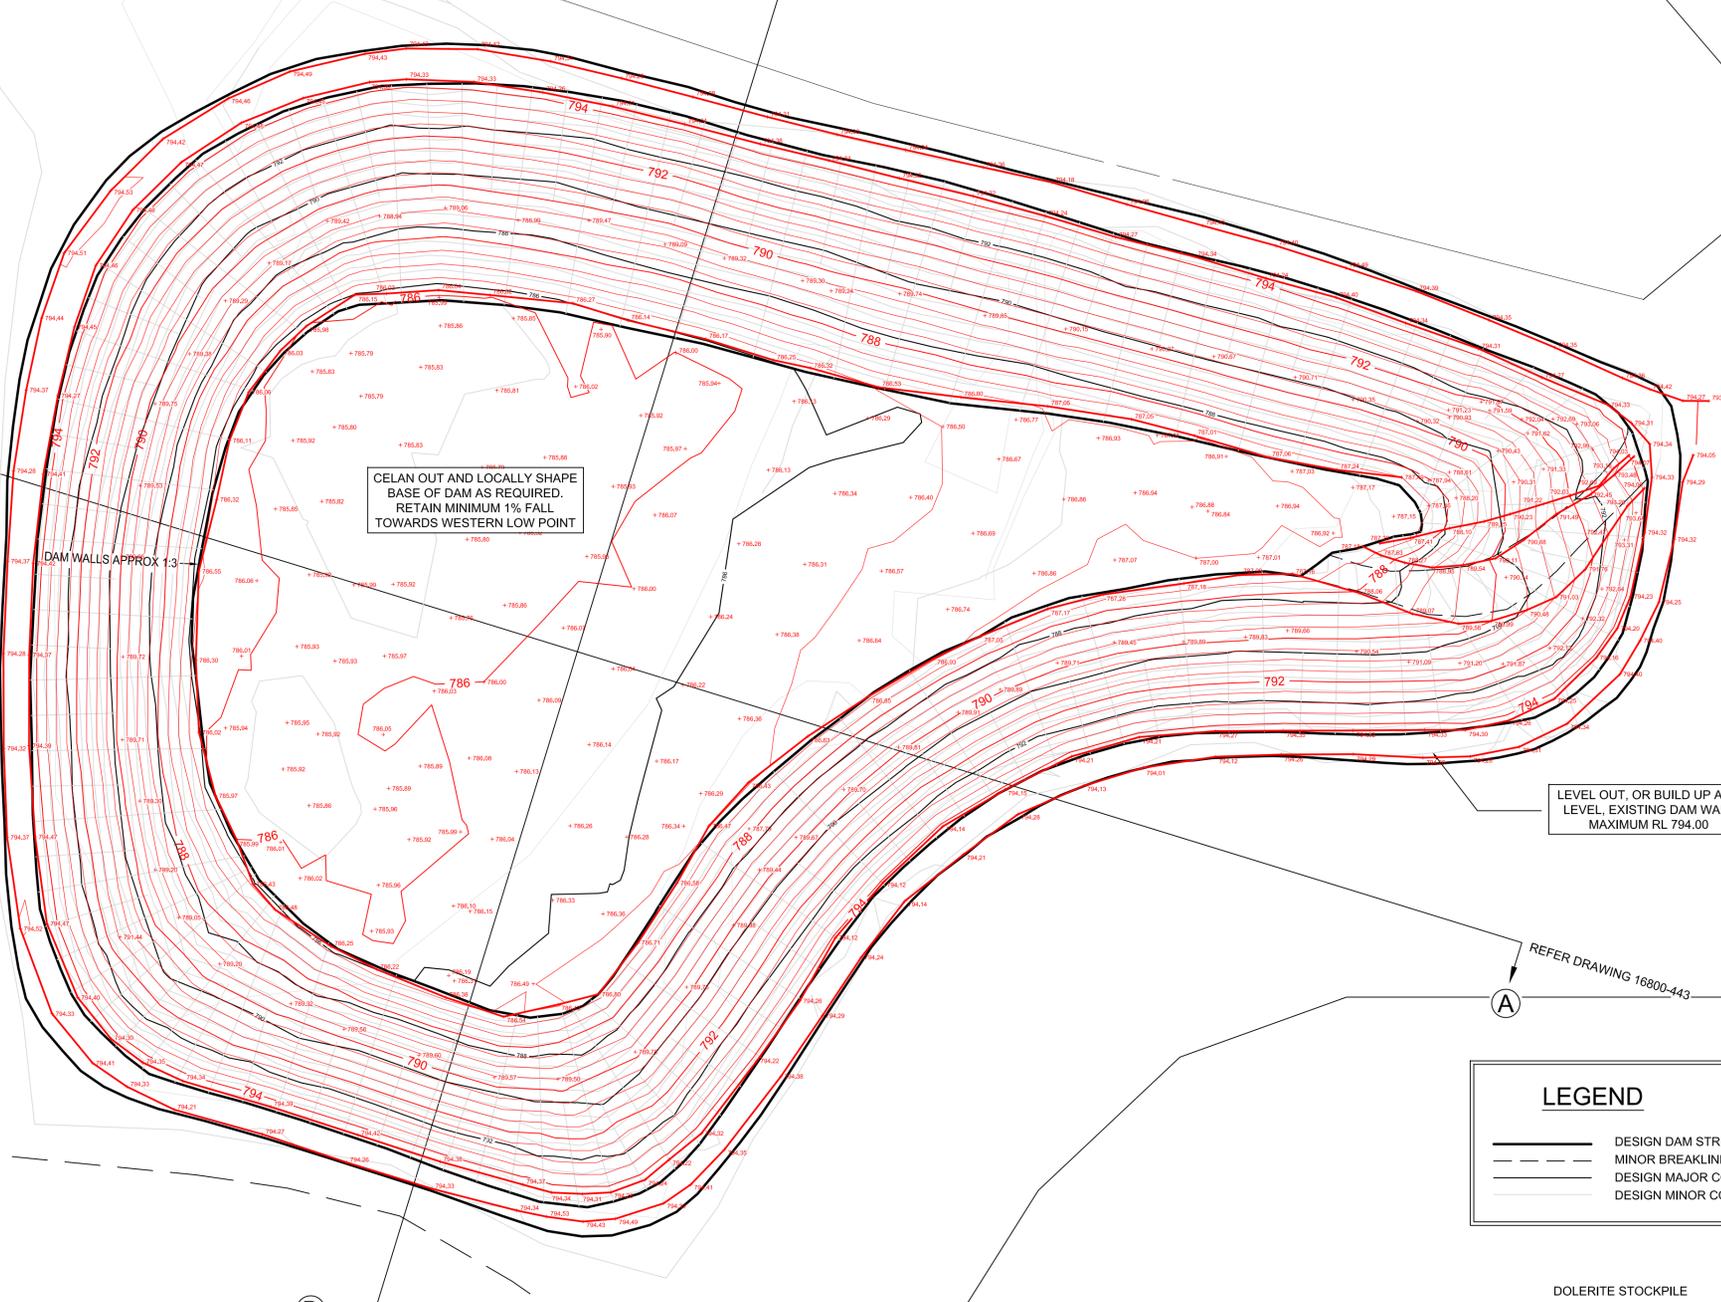
CLAY LINER ON DAM WALLS TO BE SEALED WITH A LAYER OF COMPACTED CRUSHED ROCK/AGGREGATE (PARTICLE SIZE GENERALLY 10mm - 100mm) COVERING MINIMUM 95% OF DAM WALL SURFACE AREA.

REFER DRAWING 16800-443 FOR DETAILS.

LEVEL OUT, OR BUILD UP AND LEVEL, EXISTING DAM WALL MAXIMUM RL 794.00

REFER DRAWING 16800-443

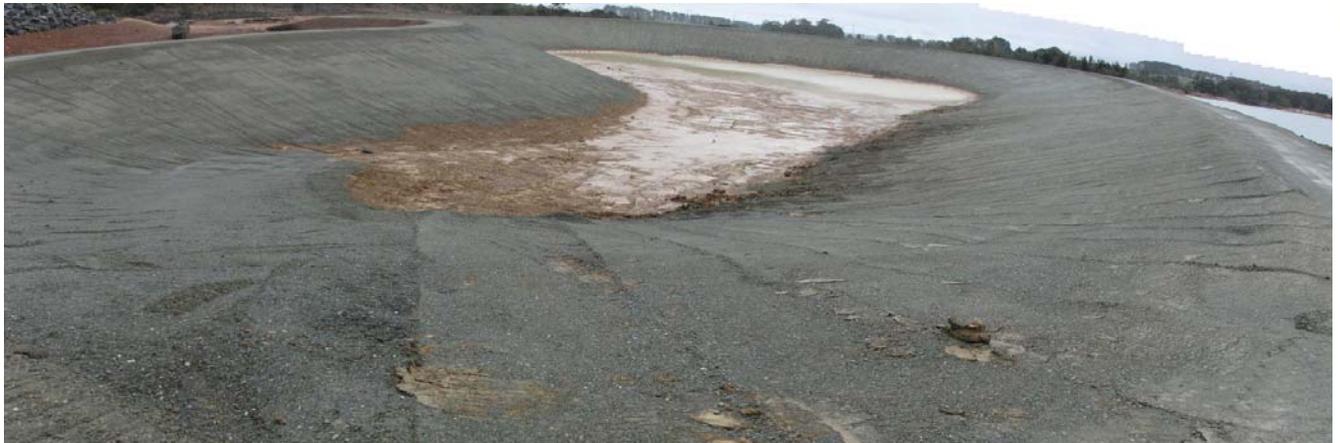
**Plate 1** (20 July 2016). Viewing south over the completion of ED3SS construction works. Plate showing the clay floor and installation (0.10 m thick blue metal) protective gravel layer over the walls and top access road). Floor comprises a clay cap (~0.3m thick) of very low permeability materials (MBT clays of E-011 M/sec).

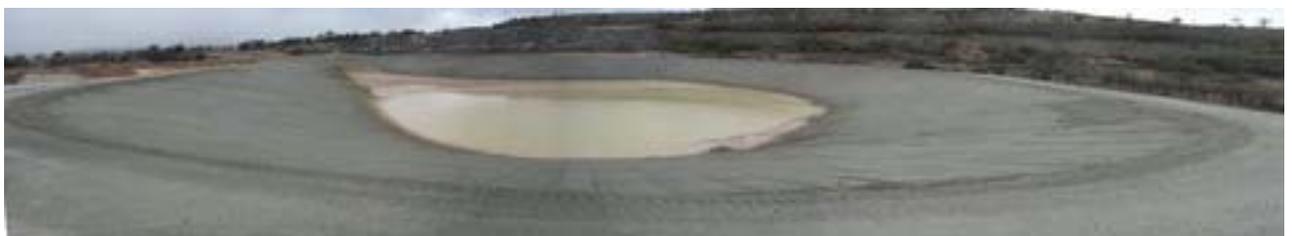
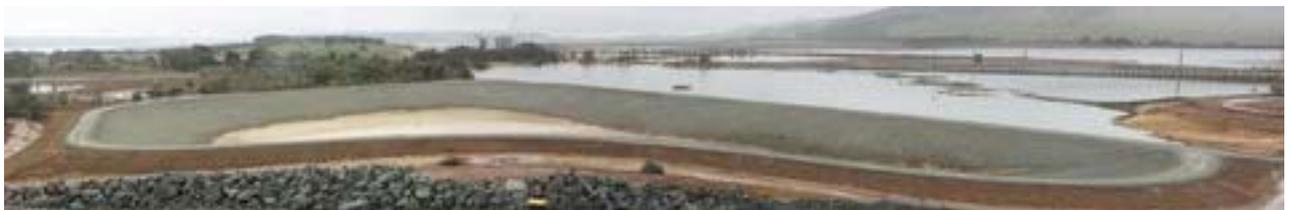
**Plates 2 & 3** (20 July 2016). Panoramic views (north and south) over the completed ED3SS evaporation dam with recent construction of gravel layer.

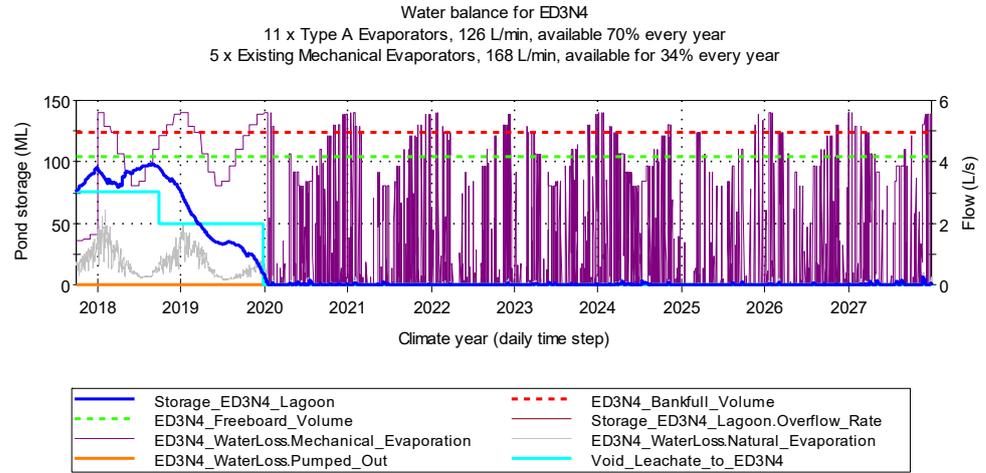
Figure 7.23 Simulated result for ED3N4 in the wettest climate sequence

Daily simulated results for the wettest climate sequence (worst case for volume build up) are presented in Figure 7.19 for ED3SS, Figure 7.20 for ED3N1, Figure 7.21 for ED3N2, Figure 7.22 for ED3N3 and Figure 7.23 for ED3N4.

The simulated results presented in Figure 7.23 for ED3N4 illustrates that the leachate during 2018 and 2019 can be supplied to ED3N4 and managed via the proposed number of evaporators operating as per the specification outlined in Table 3.1.

Water volumes in ED3N3 and ED3N4 did not exceed the freeboard level in the simulation for the wettest climate sequence (refer to Figure 7.22 for ED3N3 and Figure 7.23 for ED3N4).
